February 1, 2002

**Subject:** 3M Ames Iowa

**DESCRIPTION OF FINDINGS**

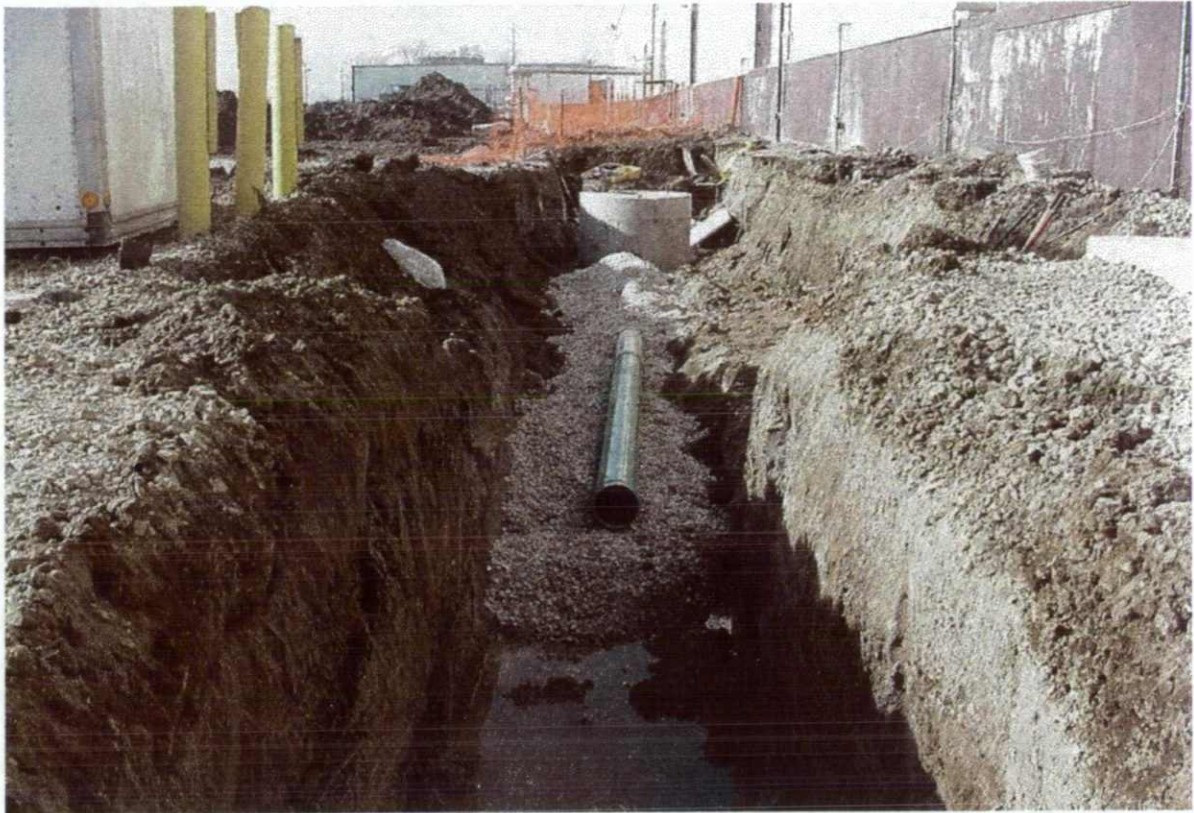
During recent trenching for installation of a sanitary sewer line along the southern edge of the Facility stained soil was observed at a depth of approximately 6 feet below grade (fbg). The stained soil was approximately 3 inches in thickness and 2 to 3 feet wide, as shown in Figures 1 and 2 (attached). The soil exhibited a "petroleum like" odor. Based on the odor and black color an effort was made to remove and segregate the discolored soils as shown in Figures 3 and 4. Excavation of the stained soils was stopped after approximately one cubic yard of material was removed.

**Figure 1-** Overview of the sanitary sewer installation, showing the discolored soils on the left (photo taken facing West).

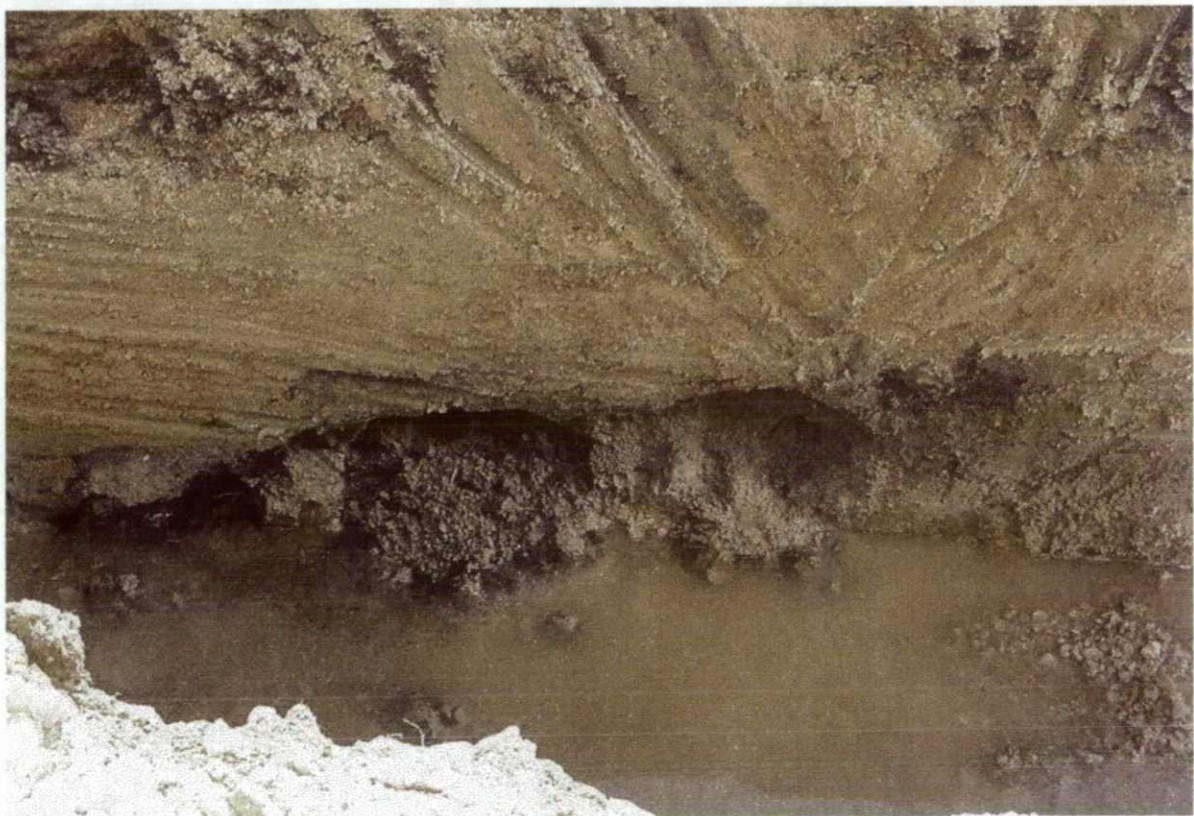
**Figure 2-** Close up of the discolored area in the trench (photo taken facing South)

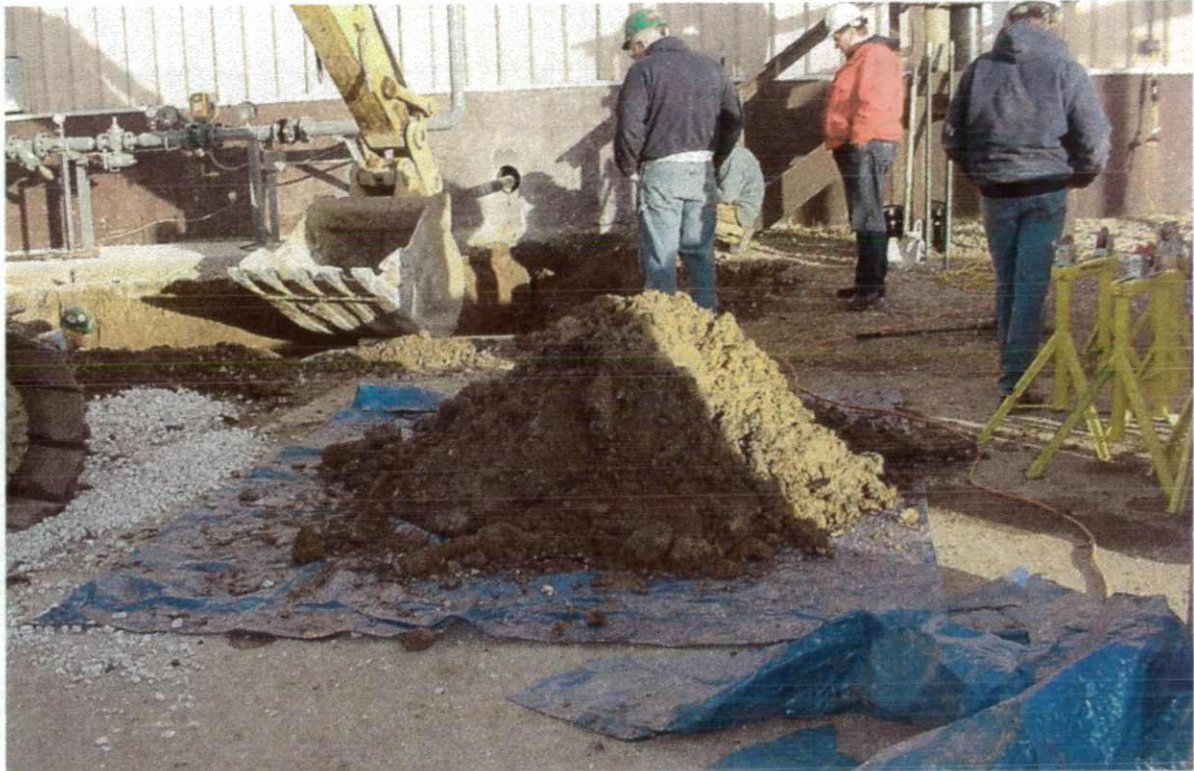
**Figure 3-** Segregated soil was placed on a plastic tarp and covered (photo taken facing North).

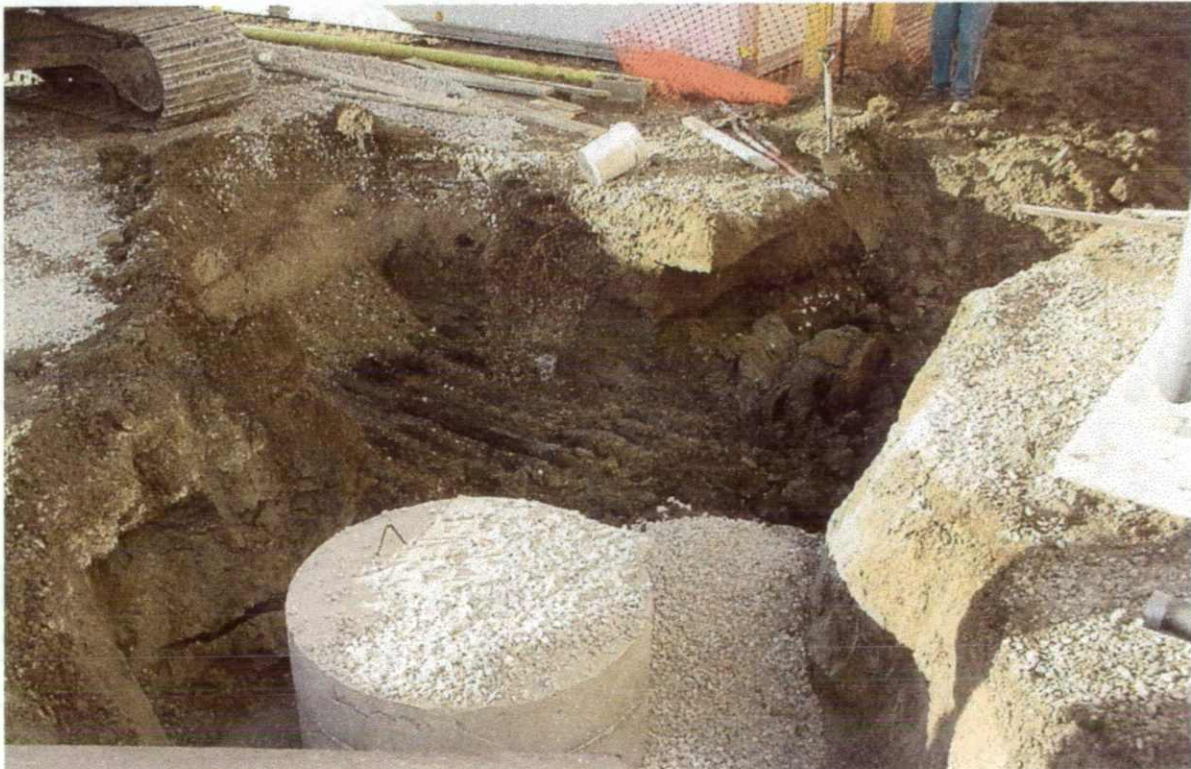
**Figure 4-** Extent of excavation (photo taken facing Southwest).

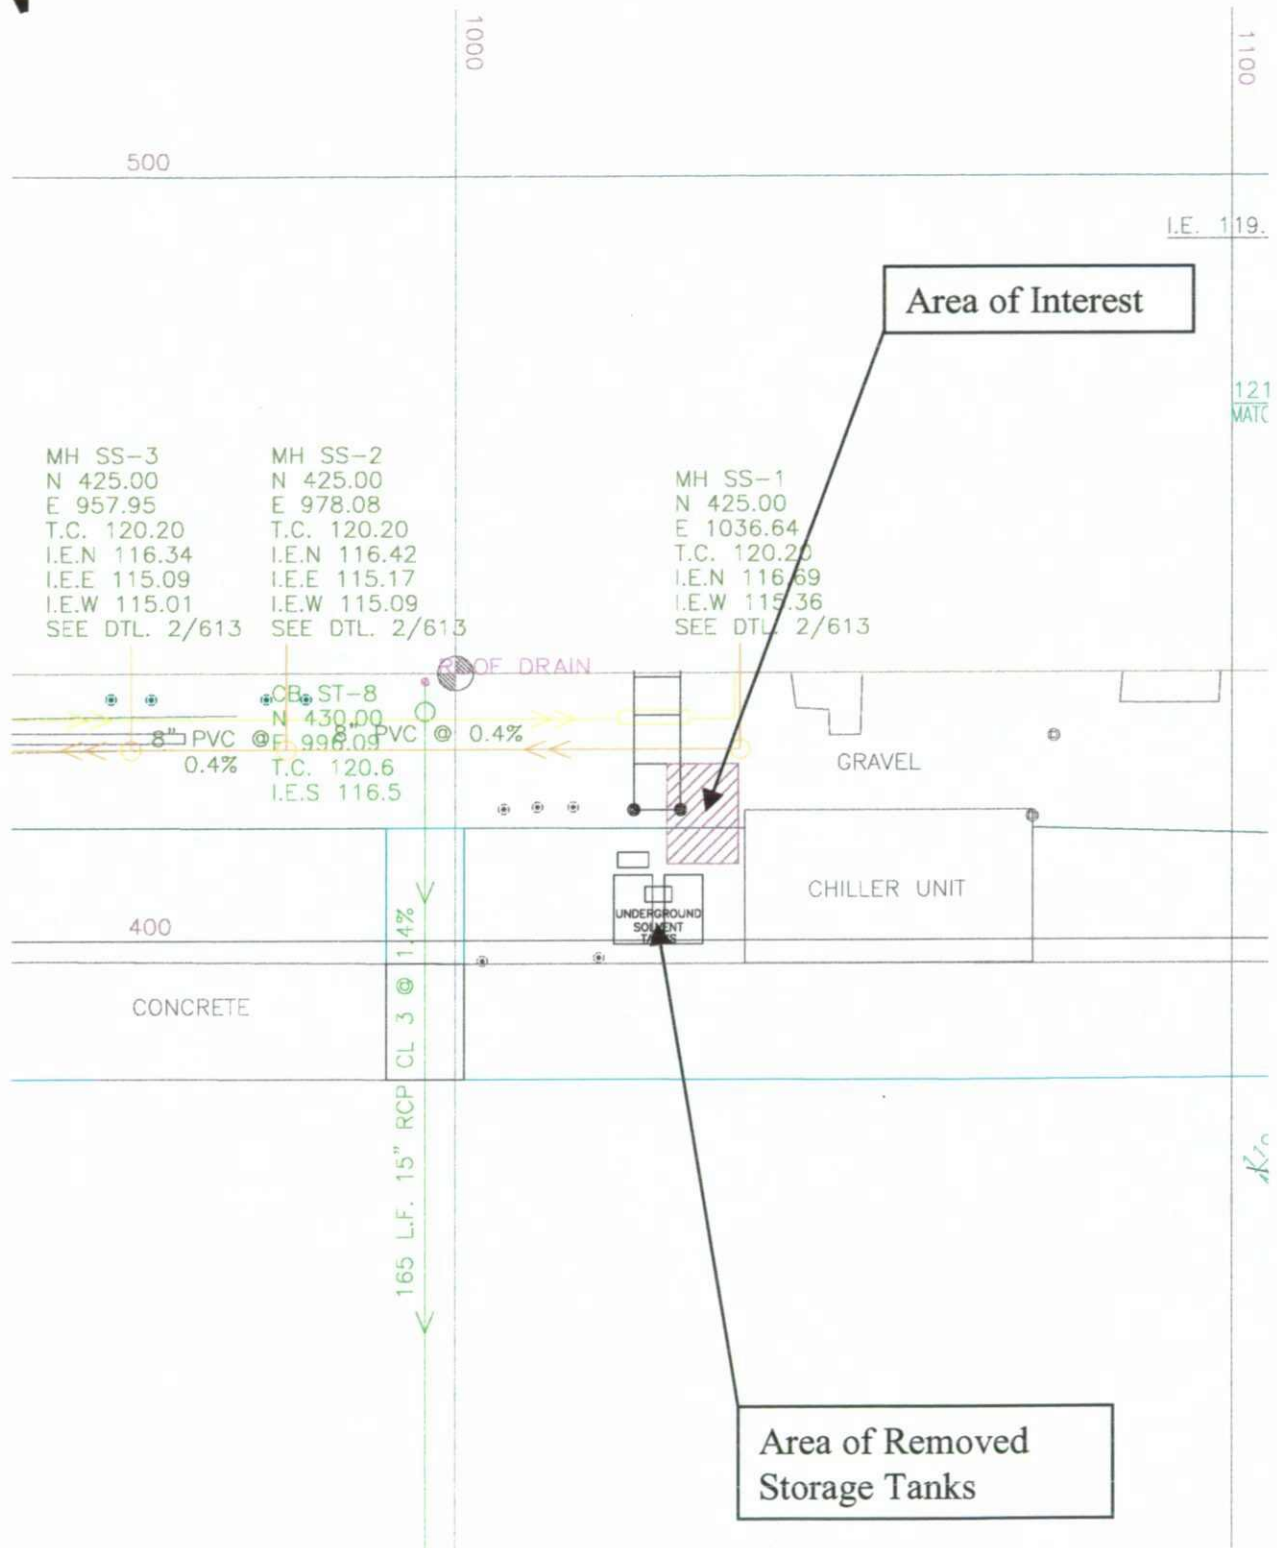
Figure 6- Detailed Map of the Area of Interest.

After conducting a historical review of the operations in that area, it was determined that there were two underground storage tanks (UST) within 50 feet of the area of interest (Figure 6), which were removed in June of 1986. The USTs were 1,000-gallon tanks used to store gasoline, mineral sprits, and toluene over a period of 6 years. Based on the historical use of the tanks and on the results of the laboratory analysis, the material identified by the laboratory in the stained soil appears to be mineral spirits. The analytical results for the analysis of a soil sample of the affected material are presented on Table 1.
