**RE: REMEDIAL OVERSIGHT ACTIVITIES  
AMERICAN RECYCLING, 1207 WEST BROADWAY, COUNCIL BLUFFS, IOWA  
TG# 98315.3**

This letter report summarizes the results of remedial oversight activities conducted for the above-referenced site on September 28, 2007.

A site visit was conducted in order to assess the condition of the Recompacted Clay Liner (RCL) installed approximately one year ago. The RCL was inspected in order to ascertain the general condition of the soil and vegetation. The RCL appeared to be covered with vegetation, with no noticeable signs of animal burrows, significant weeds or erosion. Photographs of the site, taken during the site visit on September 28, 2007 are attached to this report.

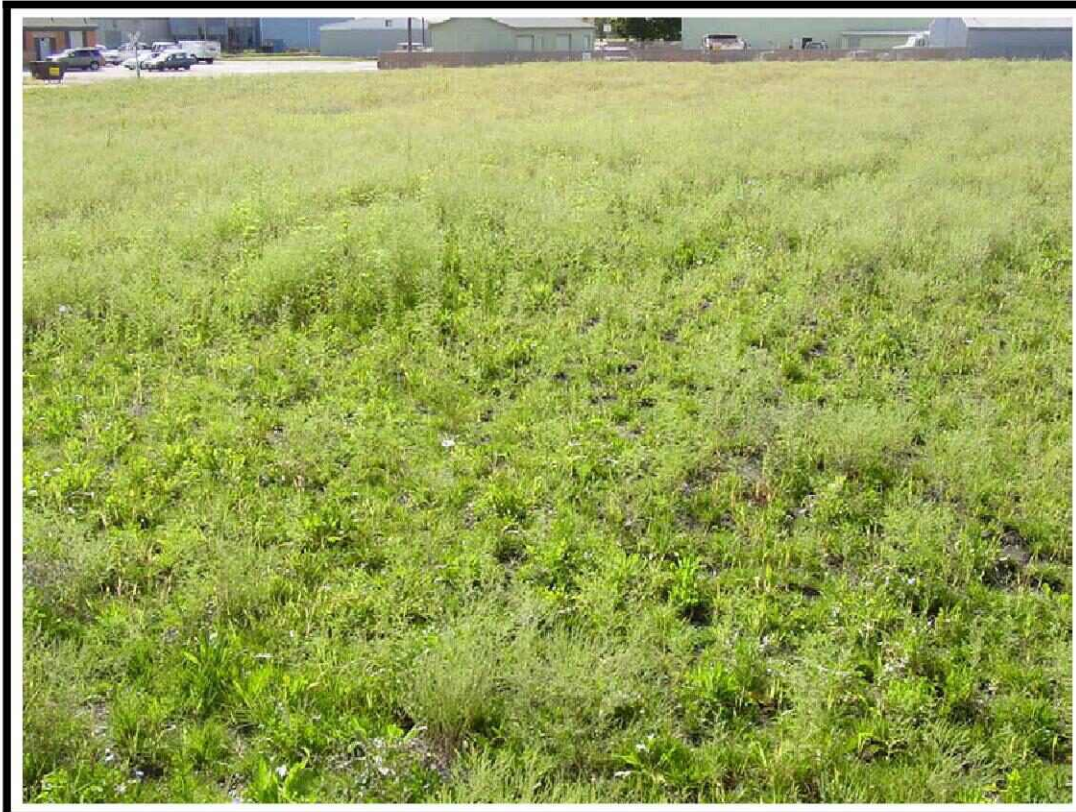
**PHOTO NUMBER 1**

View across the site from its northwest corner.

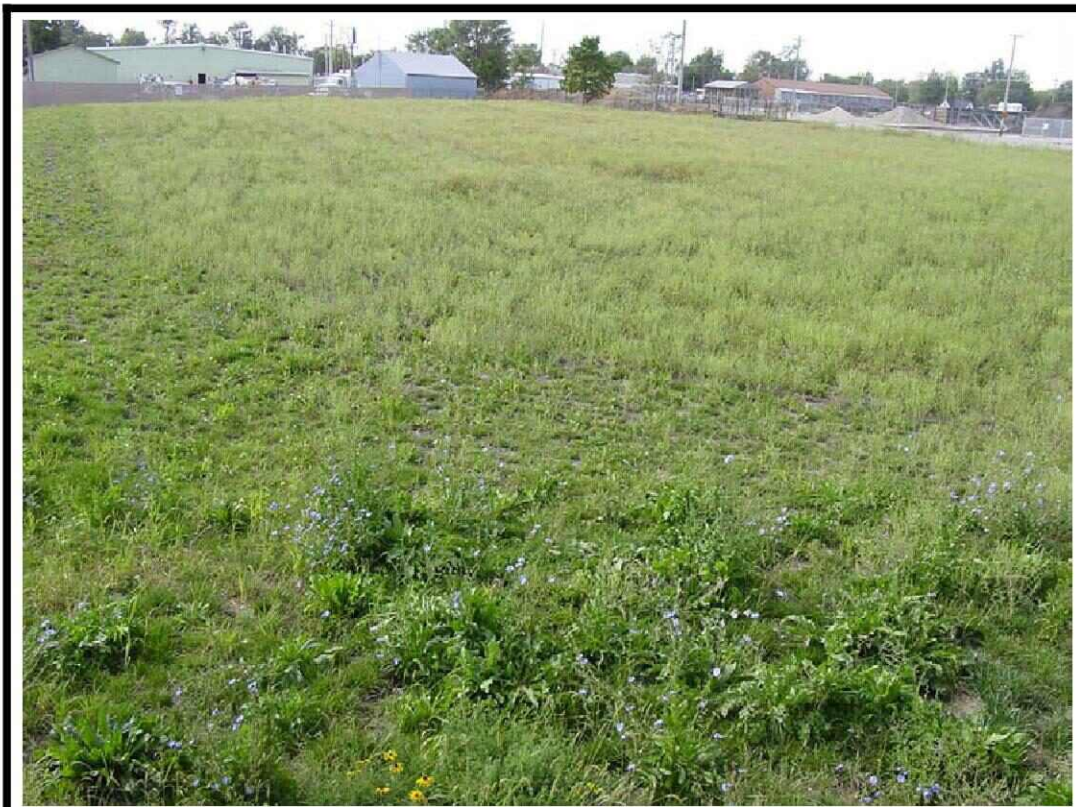
**PHOTO NUMBER 2**

View across the site from its northeast corner.

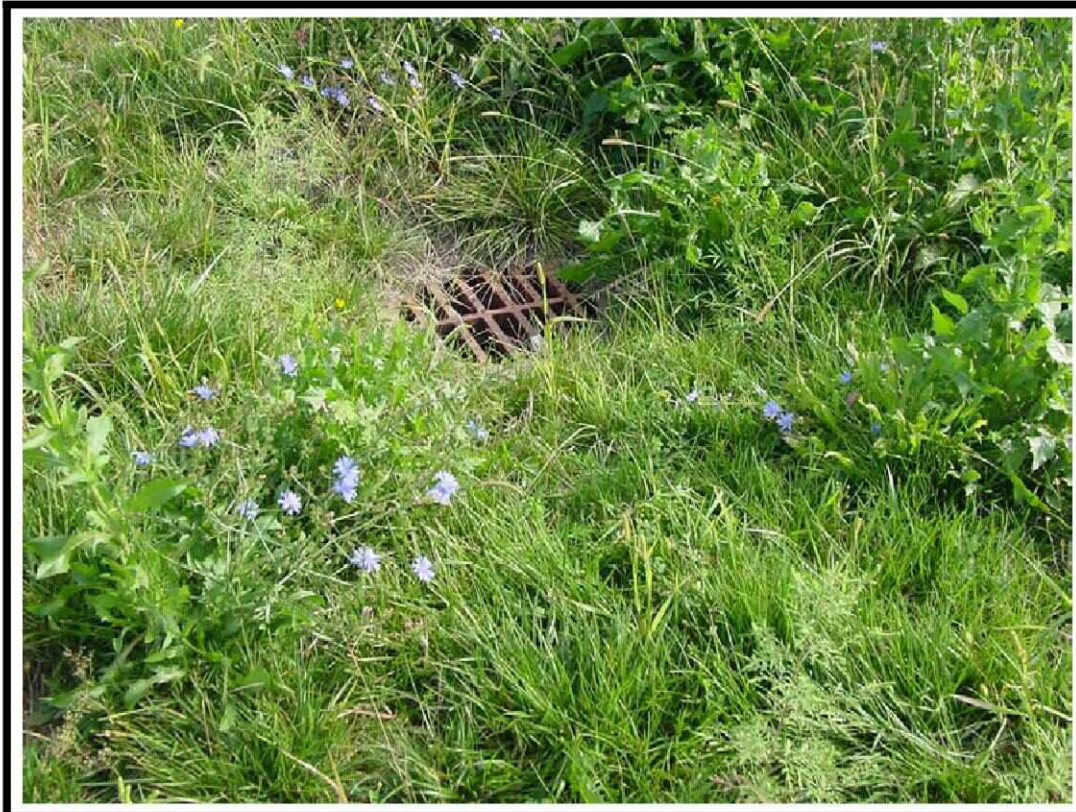
**PHOTO NUMBER 3**

View of the drain near the northeast corner of the site.

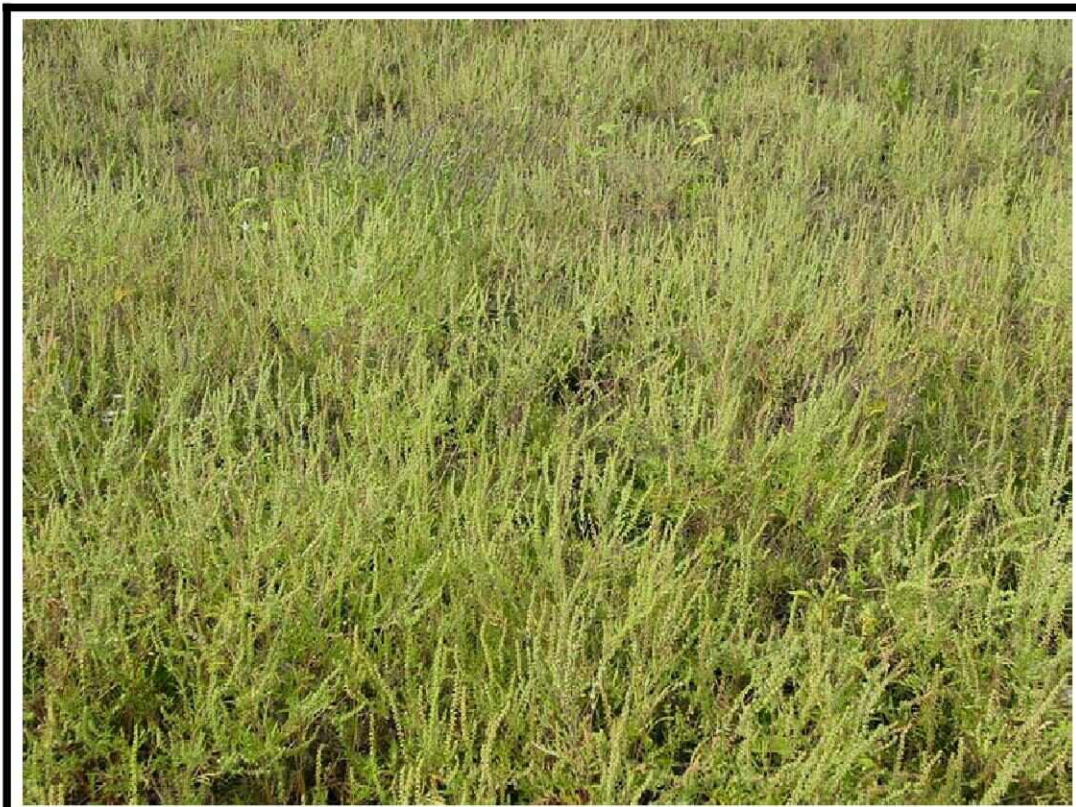
**PHOTO NUMBER 4**

A typical view of the vegetation, near the middle of the site.

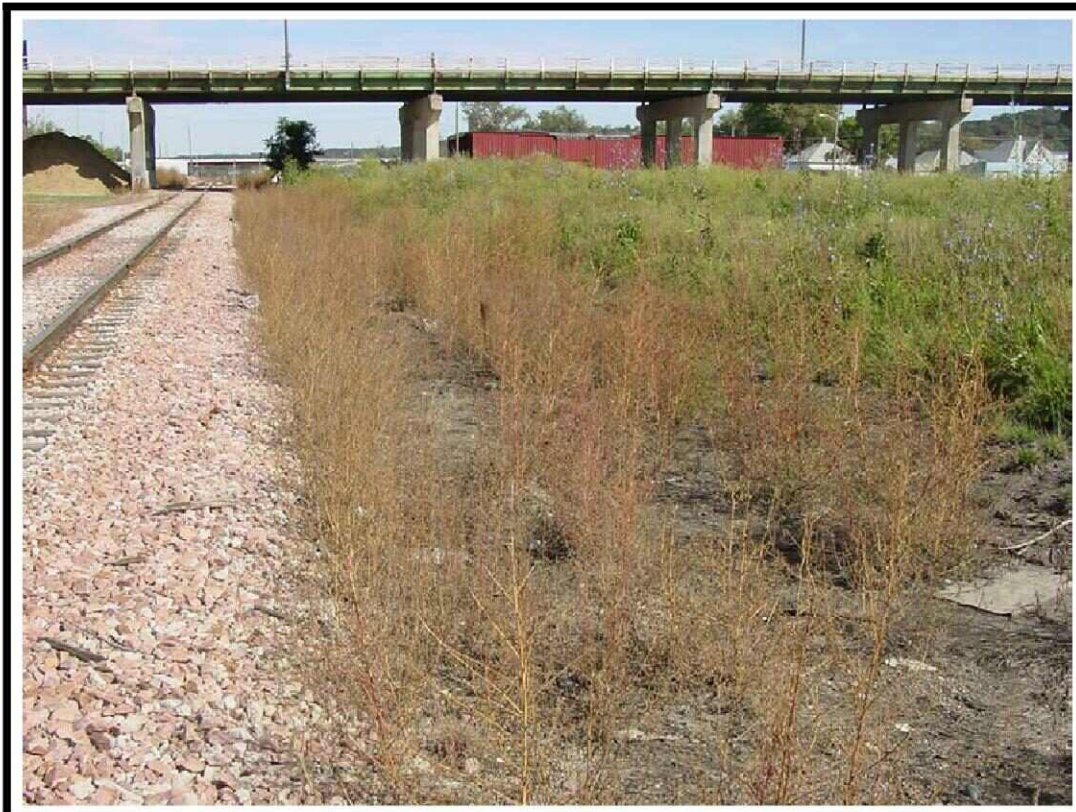
**PHOTO NUMBER 5**

View of the western slope/boundary of the site along the railroad right-of-way.

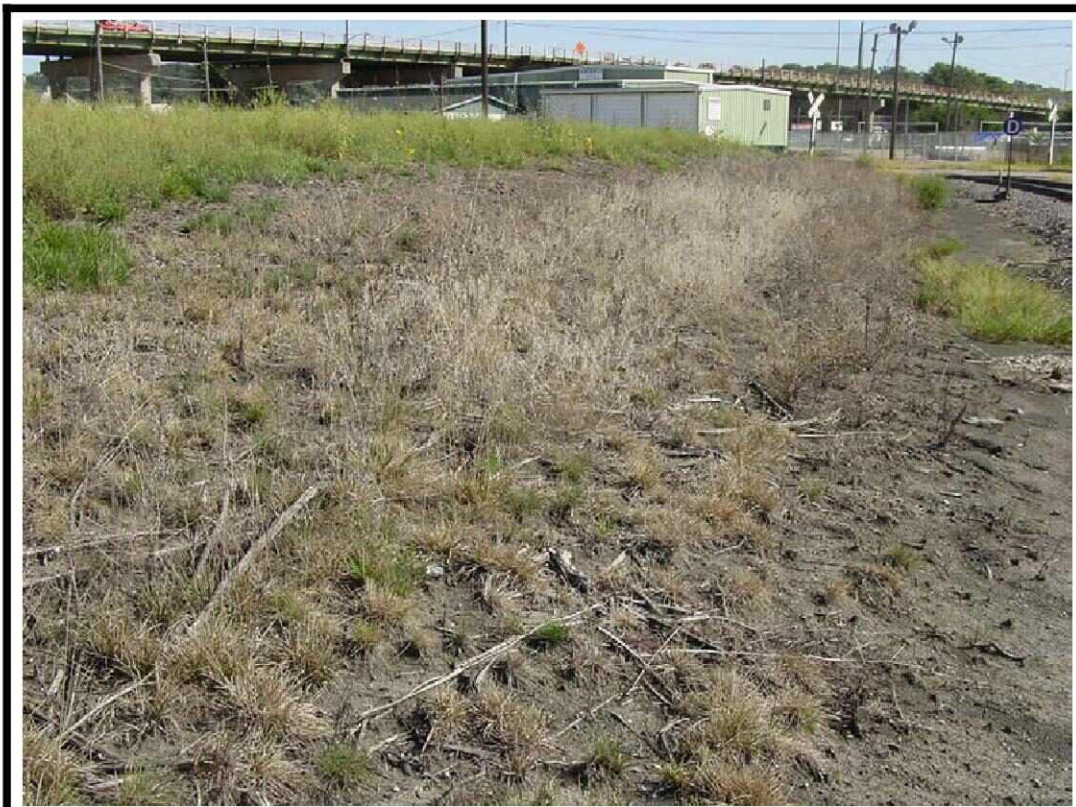
**PHOTO NUMBER 6**

View of the southern slope/boundary of the site along the railroad right-of-way.

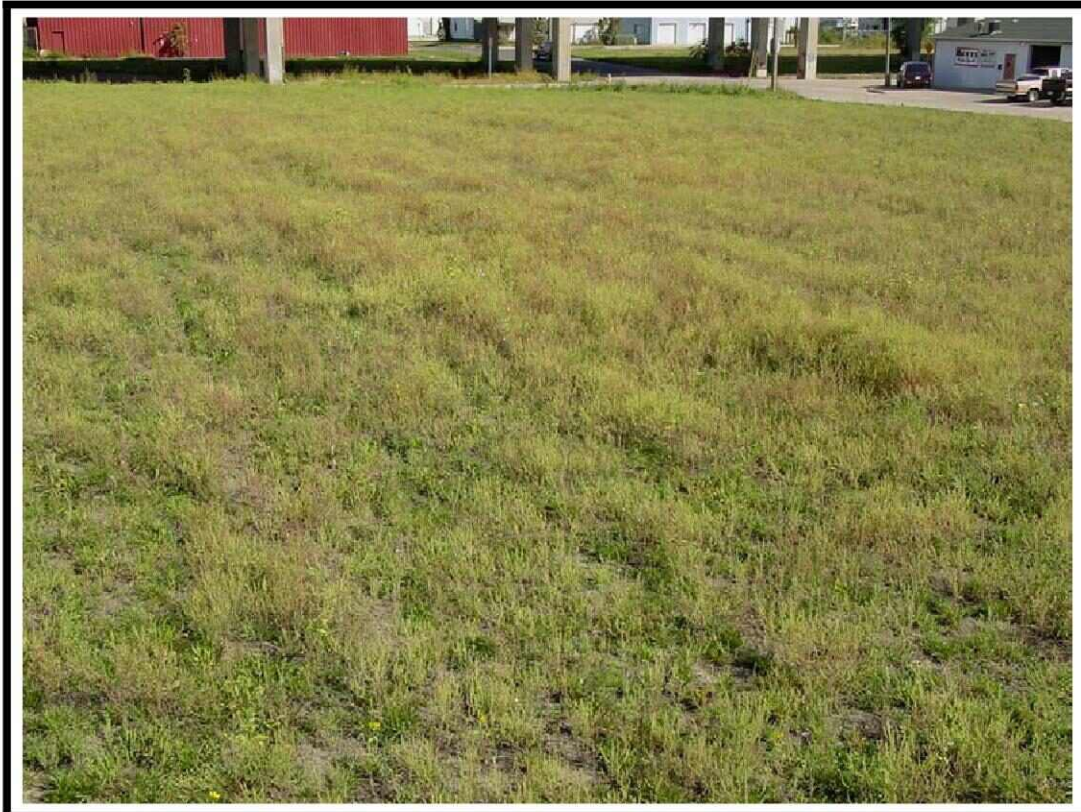
**PHOTO NUMBER 7**

View across the site from its southwest corner.

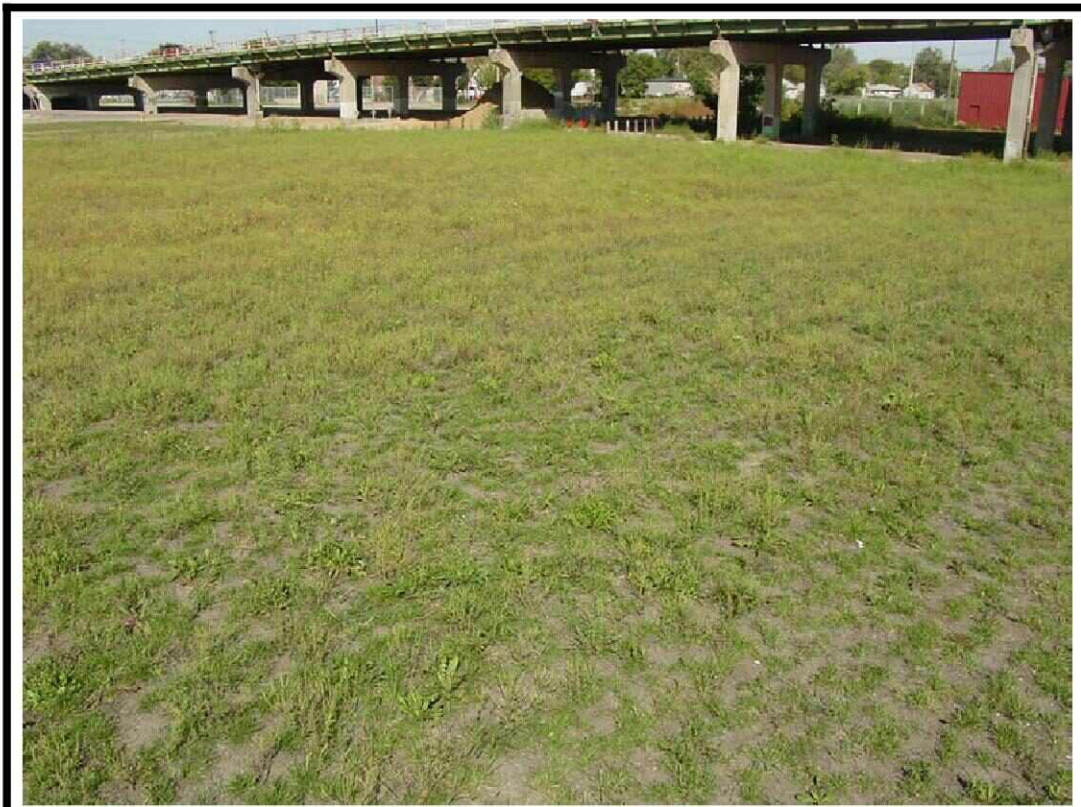
**PHOTO NUMBER 8**

View across the site from its southeast corner.
