GENERAL DESCRIPTION OF SITE

(Reilly Dump Site)

SUBJECT: SAUSR Eligibility Determination: Gra-Iron Foundry Corp,
Marshalltown

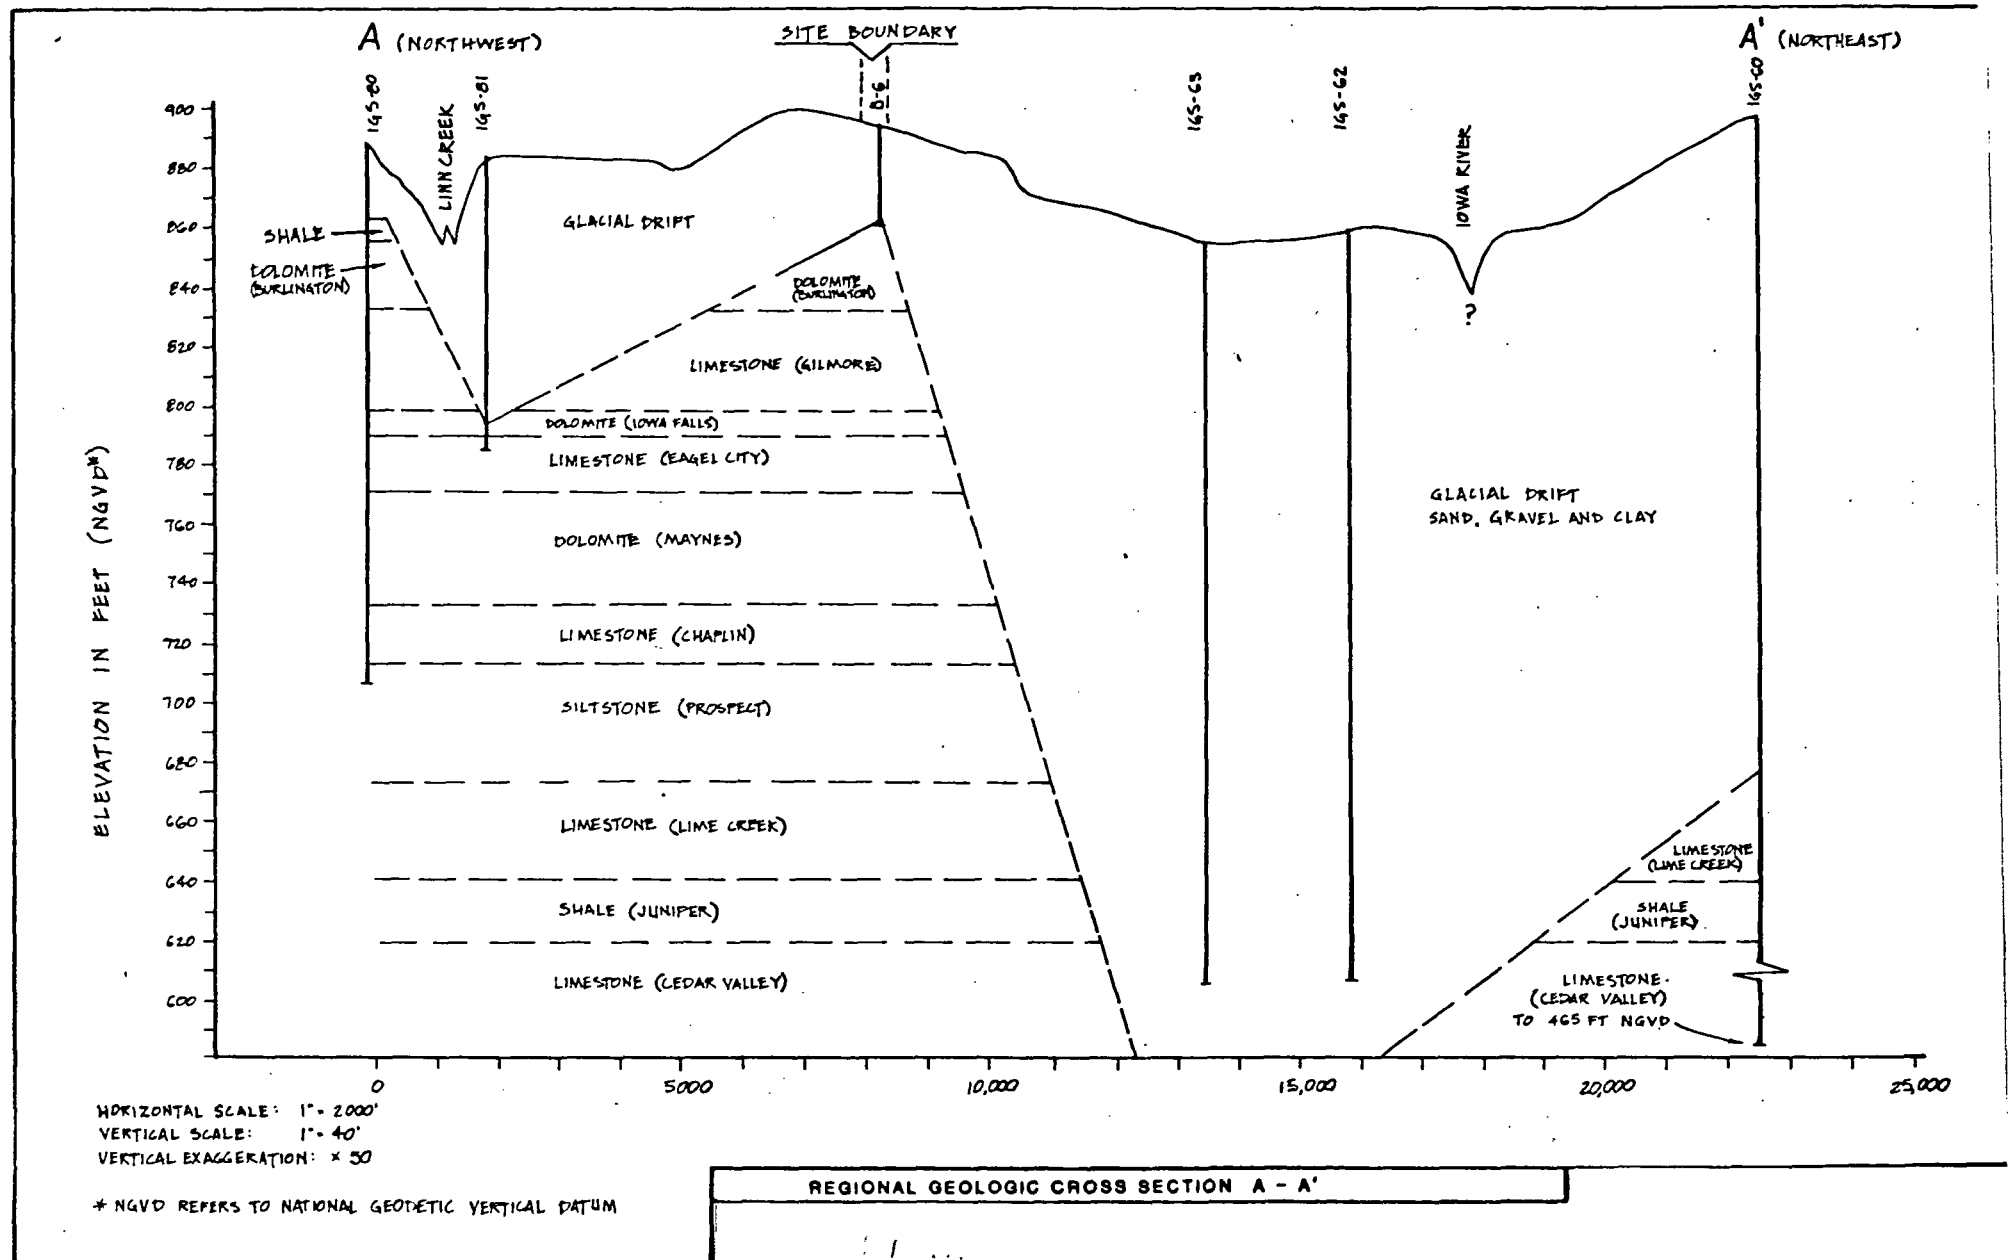
FIGURE 3A: GEOLOGICAL CROSS SECTION (Hickok, 1986a)

From one drill hole and from information obtained from the Iowa Geological Survey, Gra-Iron has developed a regional geological cross section for the area. This cross section shows glacial drift, at depths over three hundred feet, immediately to the east of the site. The lower part of this "drift" is the Poweshiek buried-channel aquifer. The upper part is the alluvial aquifers of the Iowa River floodplain (Twenter & Cobble, 1965). This geological cross section is shown in Figure 3a. The surface location of this geological cross section is shown in Figure 3b.

Based on a nine borehole drilling program, Gra-Iron has developed a partial geological profile of the glacial drift beneath the Reilly site. The stratigraphic cross section from the boring logs indicates that the waste foundry sand and combined cupola dust cover the disposal area and are up to 13 feet deep near the center. The cross section indicates that the waste material is underlain by a sandy clay which is approximately four feet thick (Hickok, 1986a). However, Gra-Iron did not collect enough information to define the vertical and horizontal boundaries of the uppermost aquifer beneath the waste (Jacob, 1986). They also did not provide information about the relationship of these features to the nearby alluvial and buried channel aquifers.

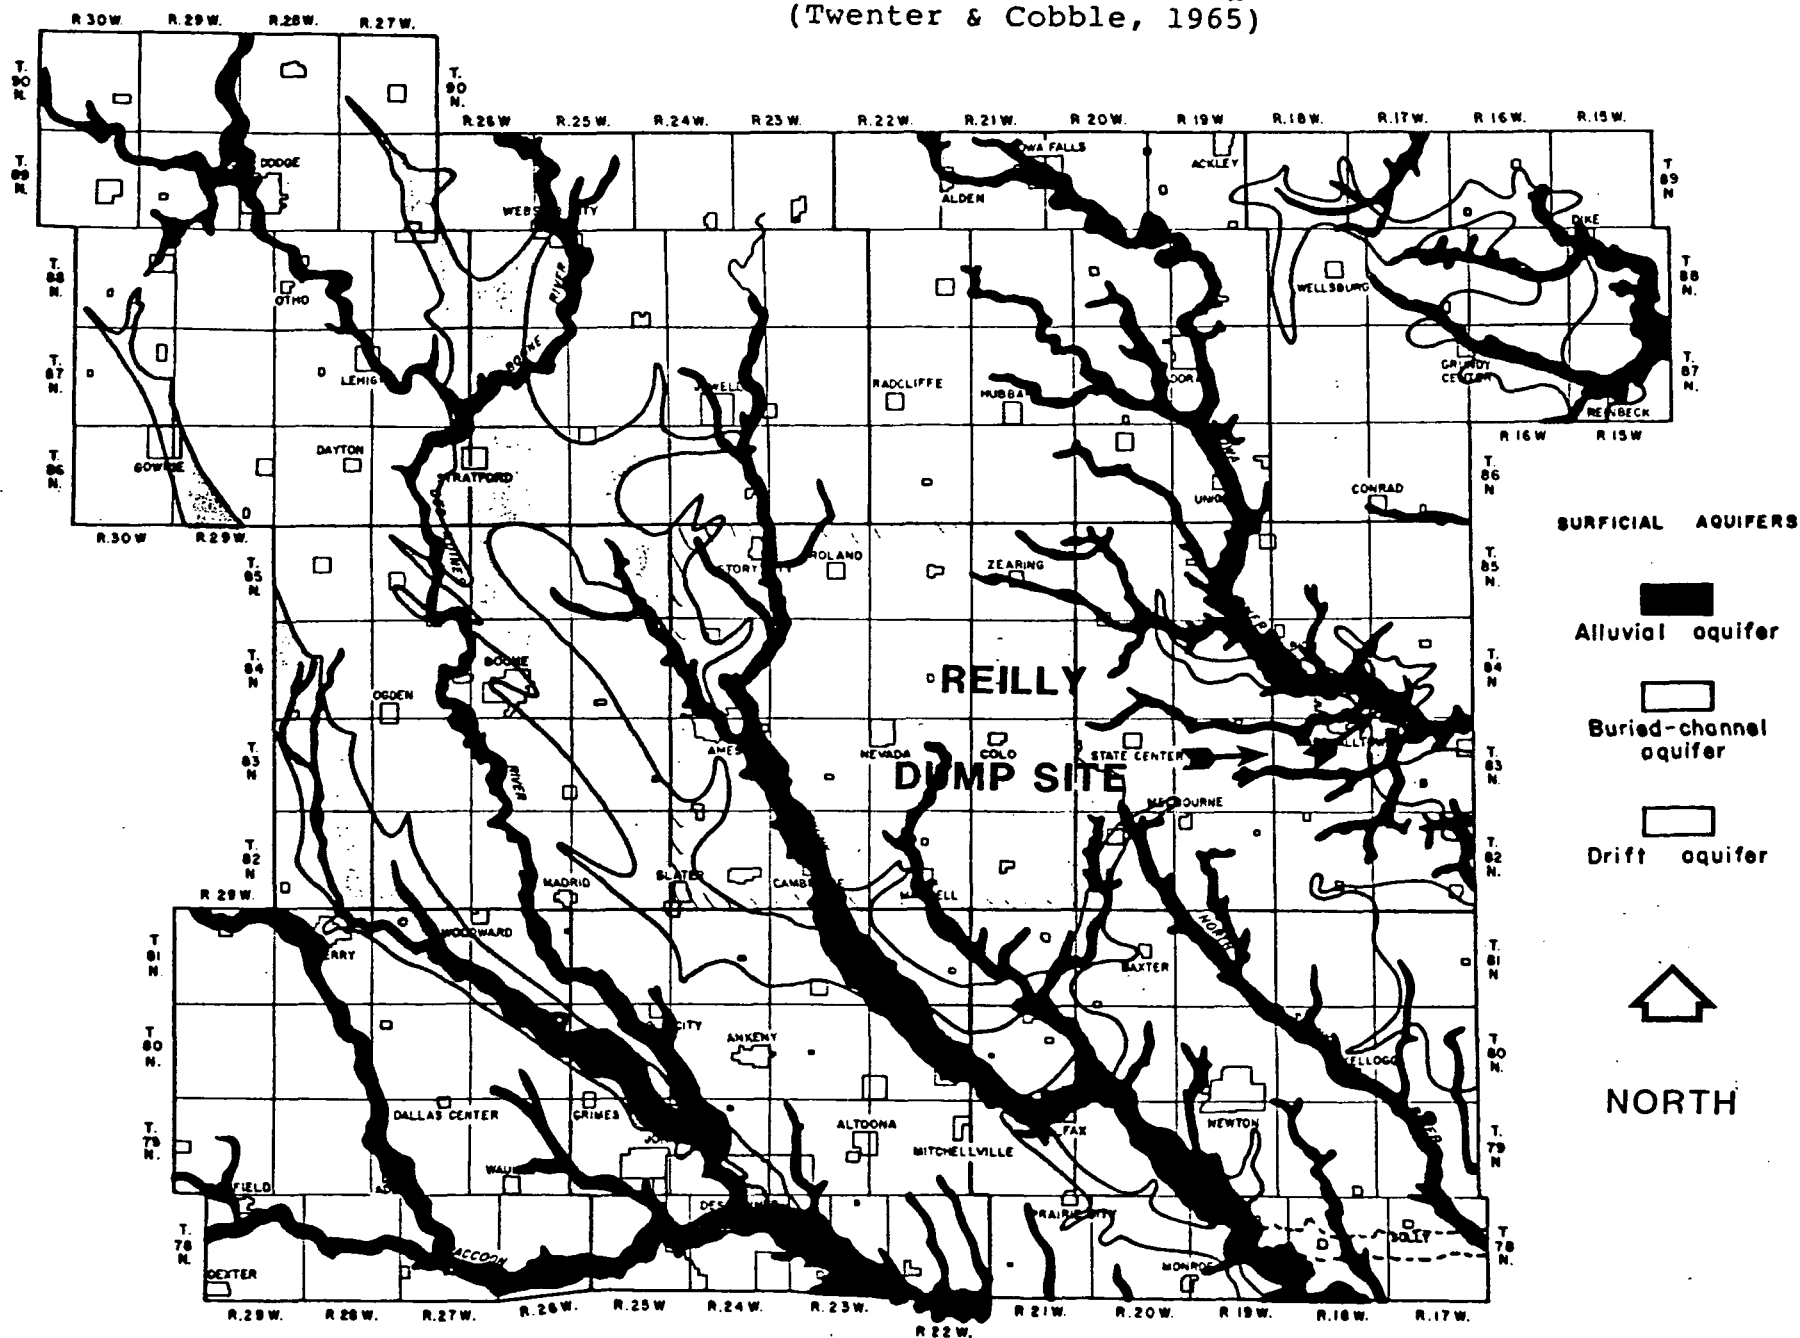
FIGURE 4: SURFICIAL AQUIFERS
(Twenter & Cobble, 1965)

Gra-Iron has presented a determination that groundwater flow in the uppermost aquifer is from southeast to northwest (Hickok, 1986c). However, this determination was not supported by enough information to adequately define groundwater flow patterns in the area of the site (Roberts, 1986). The location of the surficial aquifers that provide water to the Marshalltown area are shown in Figure 4.

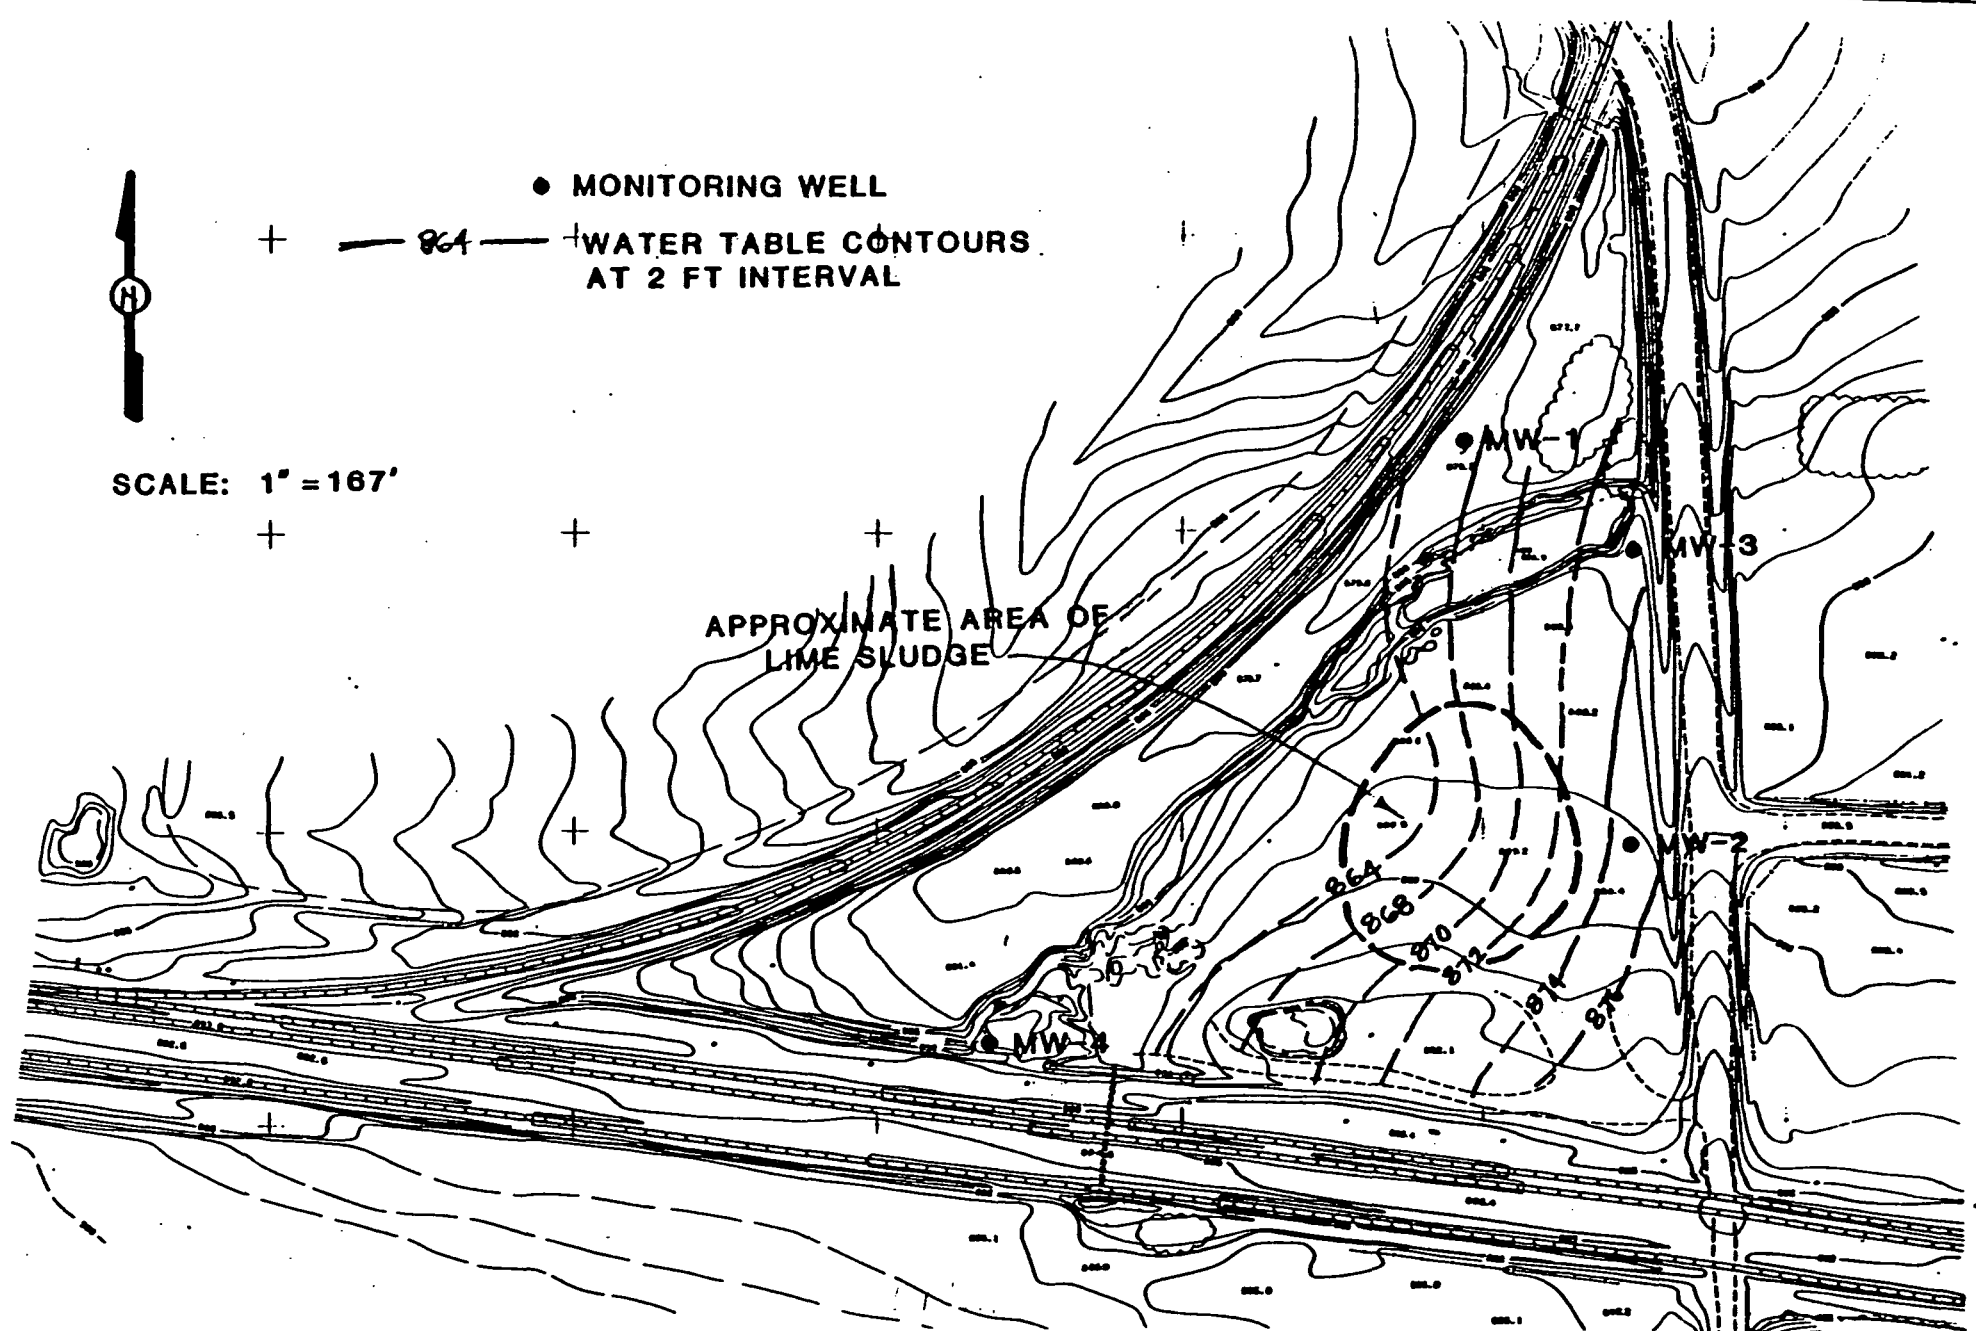
FIGURE 5a: MONITOR WELL LOCATIONS (Hickok, 1986c)

Gra-Iron has conducted groundwater monitoring from three monitoring wells at the site. The location of these wells is shown in Figure 5a. This topographic map of the Reilly site also shows the projected gradient of the groundwater table and the approximate location of the lime sludge in the fill area.

The results of the first sampling period showed cadmium and lead pollution levels above the drinking water standard. Lead exceeded the standard at all three wells, while cadmium exceeded the standard at two wells. However, during the next two sampling periods there were no cadmium or lead pollution levels above the drinking water standard.

The department and EPA have not accepted these suggestions, because of uncertainties about groundwater flow and the proper placement of monitoring wells. These objections included the possibility that the monitoring wells were not downgradient from the waste site (Jacobs, 1986 & Roberts, 1987).

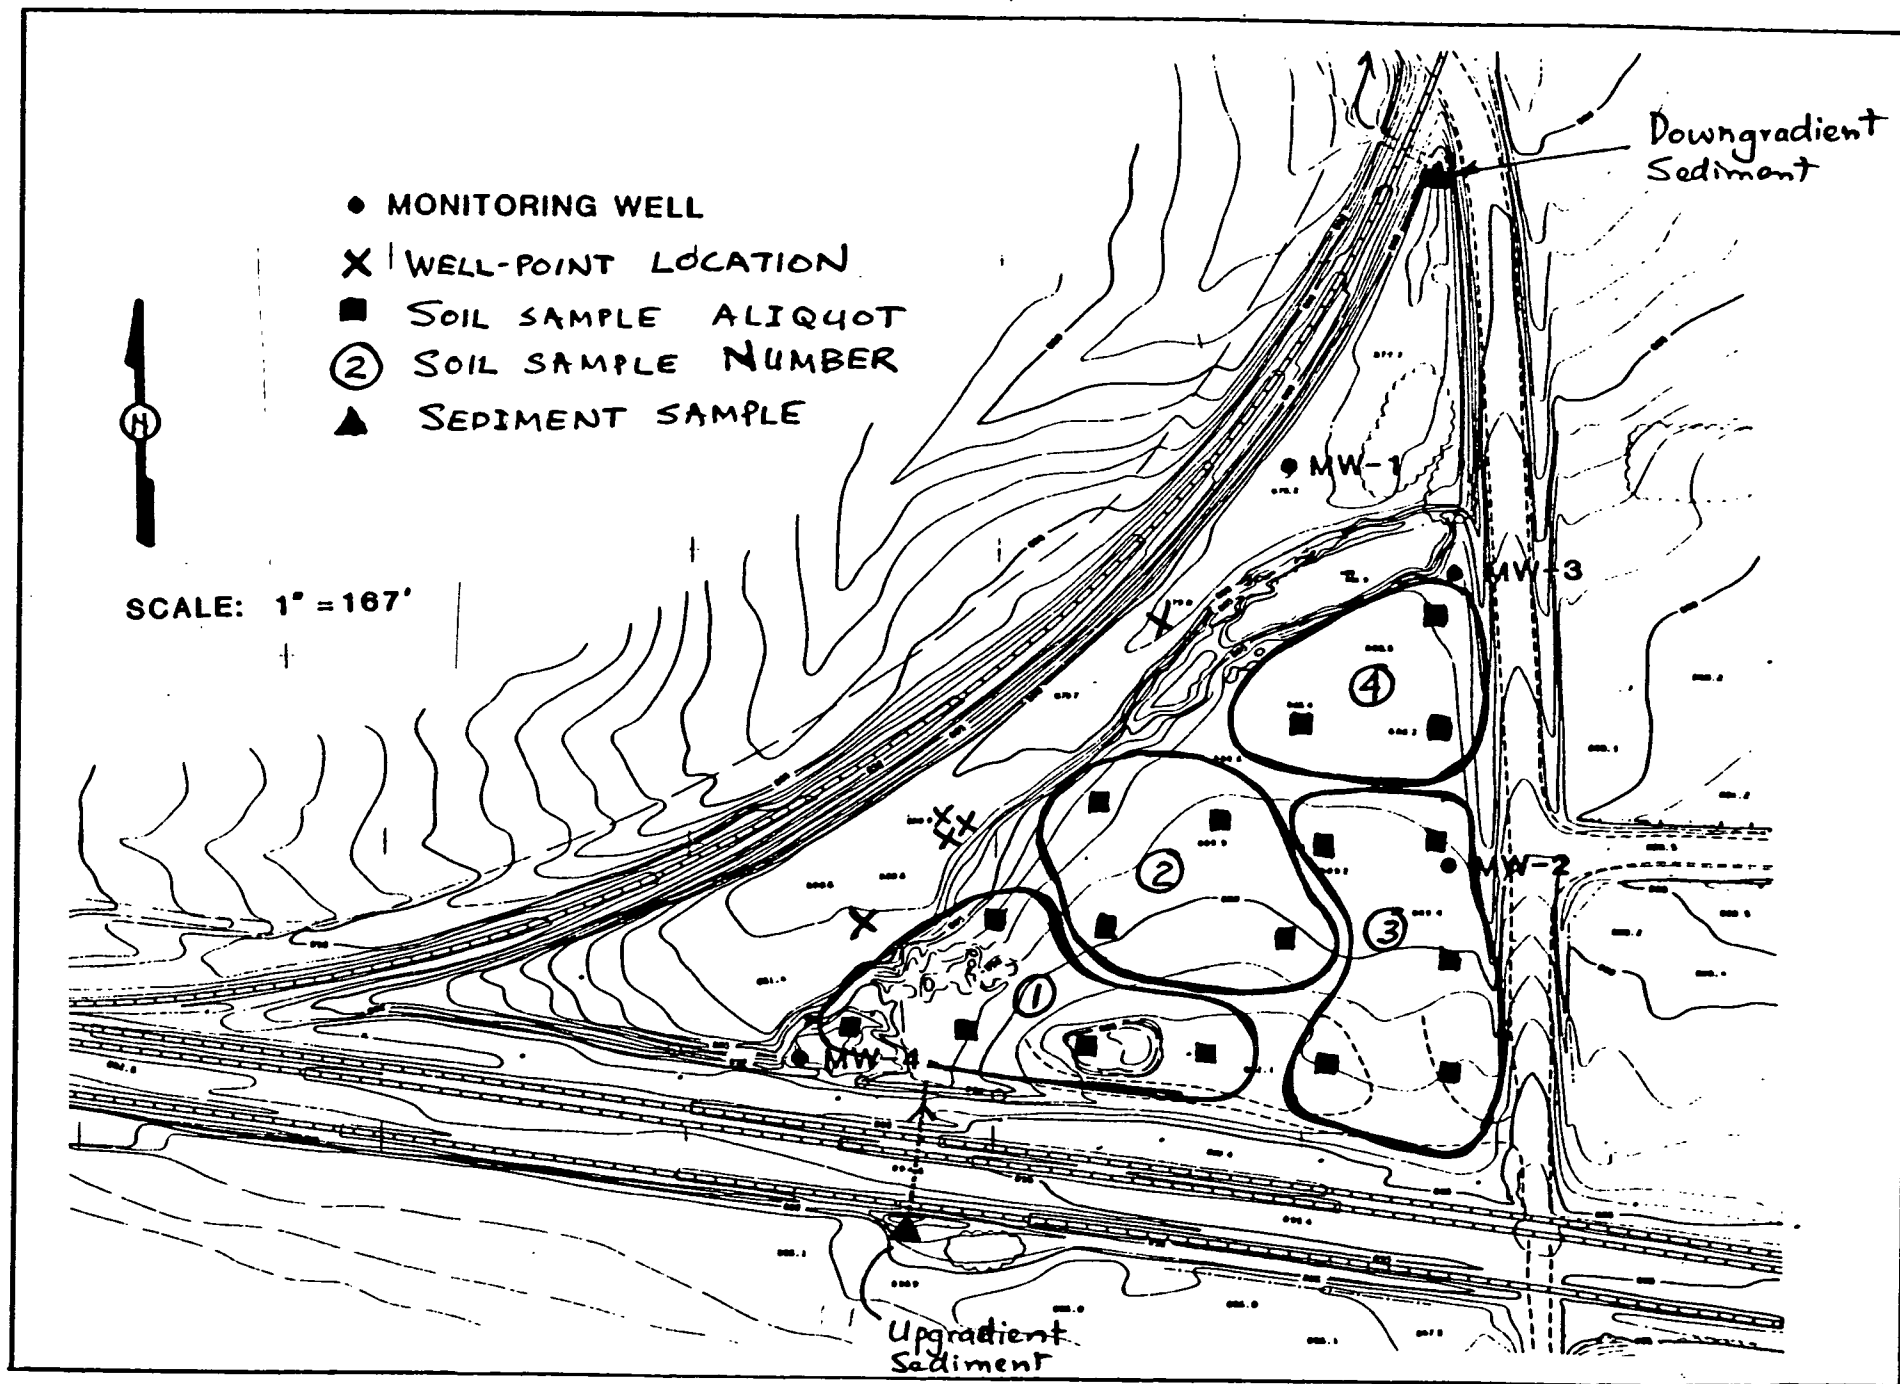
FIGURE 5b: SOIL AND SEDIMENT SAMPLE LOCATIONS (Drustrup, 1988b)

In September 1988, four surface soil samples were collected at depths of 0-6 inches. Three to five aliquots were taken per sample. The sample locations are shown in Figure 5b. The area of sample #1 had considerable black sandy material at the surface which apparently is foundry sand. Asphalt rubble partially covered the area of sample #2. Some foundry sand (?) and yellow clay were encountered in the area of sample #3. Mainly yellow clay was encountered in the area of sample #4 (Drustrup, 1988b). The results of the soil sample analysis are shown in Table 2.

The results of upgradient/downgradient sediment samples indicate that no significant release of contaminants is occurring due to erosion and runoff from the site (Dustrup, 1988b). The sample locations are shown in Figure 5b and the sample results are shown in Table 2.

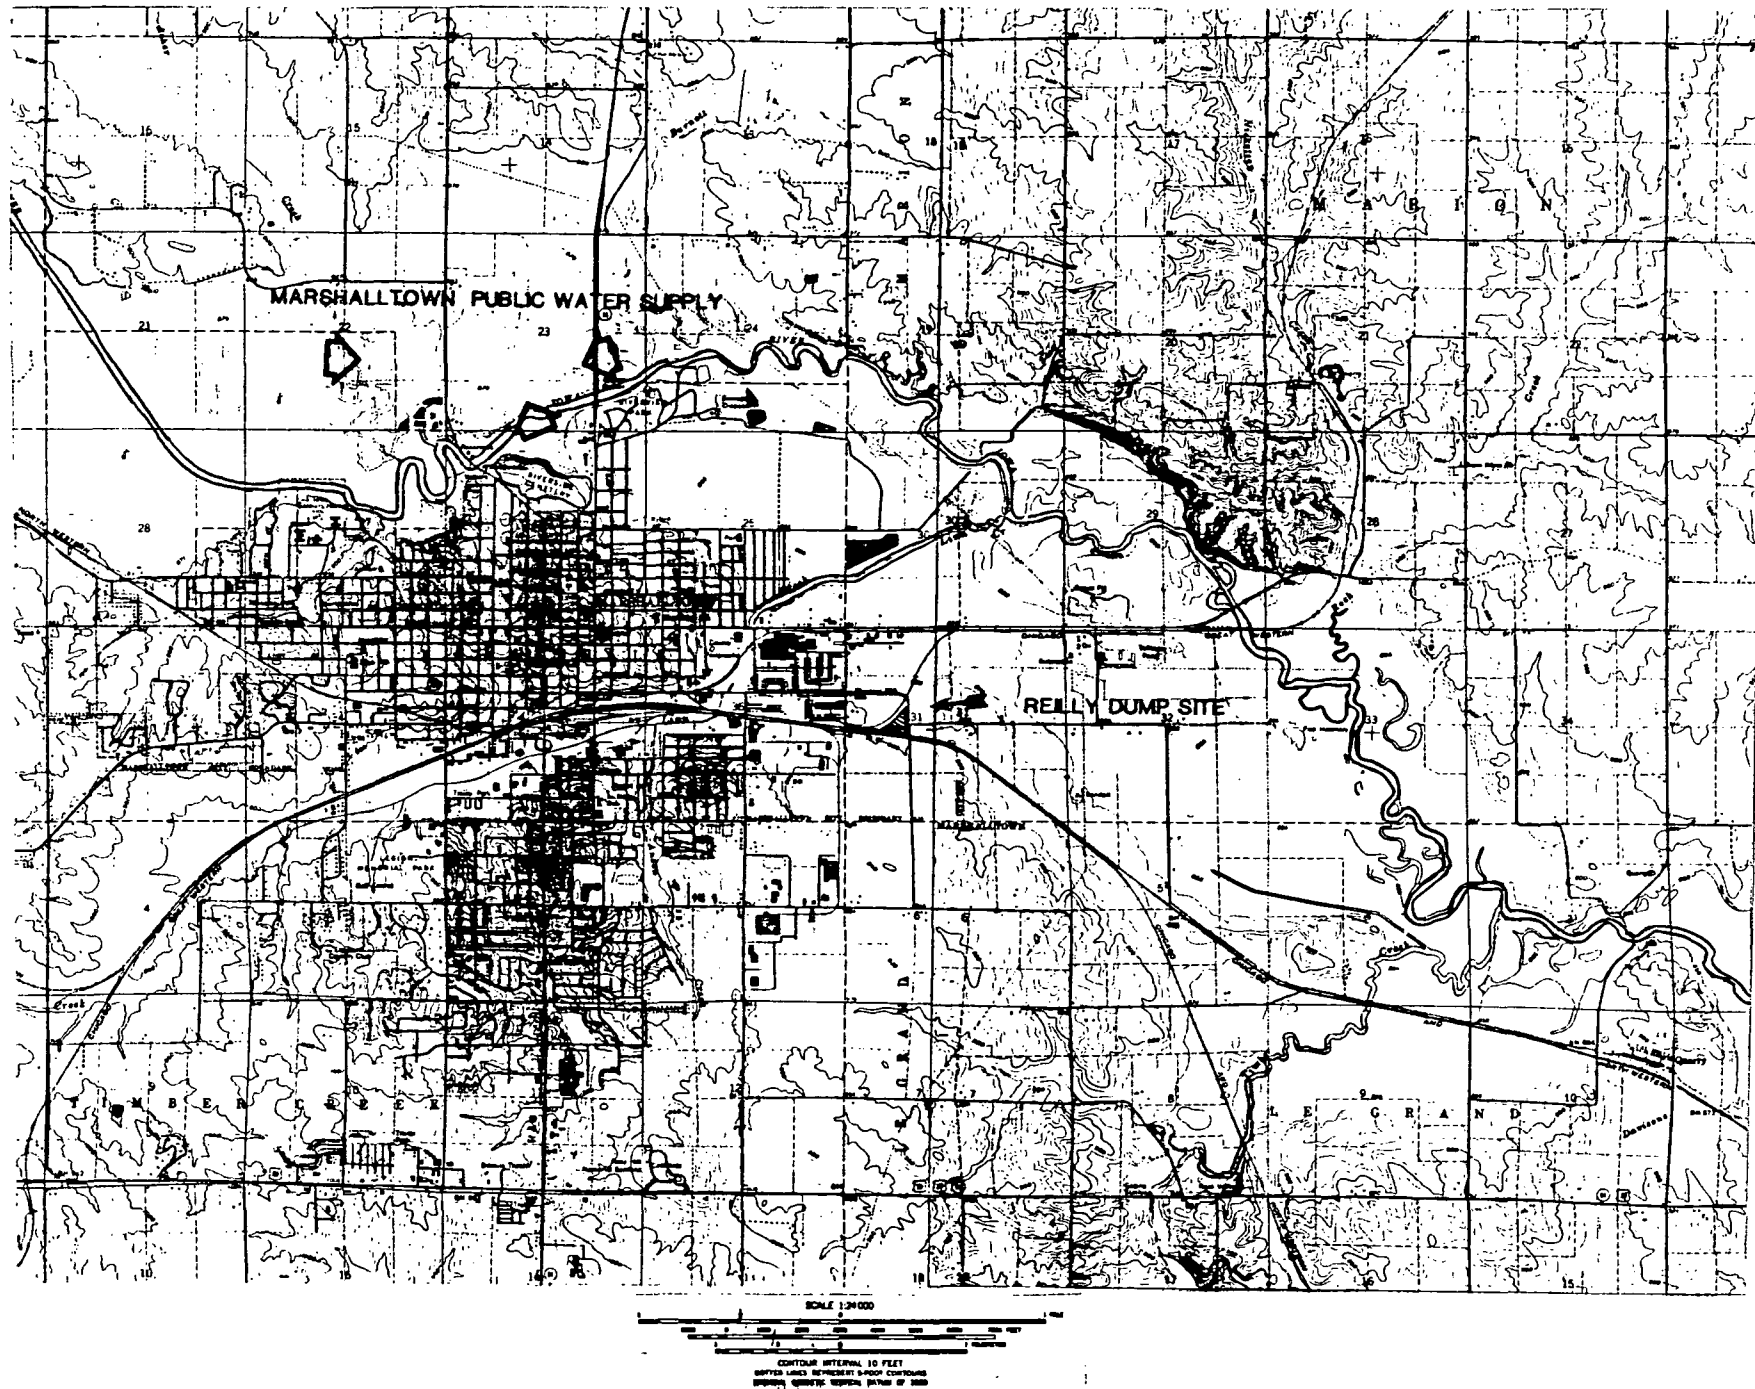
FIGURE 6: TOPOGRAPHIC MAP OF THE MARSHALLTOWN AREA

Figure 6 shows the position of the Reilly site with respect to the Marshalltown public water supply, the Iowa River valley and the City of Marshalltown.
