Site Name: Larimore Properties, Cedar Rapids

Brownfield Initial Site Screening (ISS)

Date: February 7, 2011

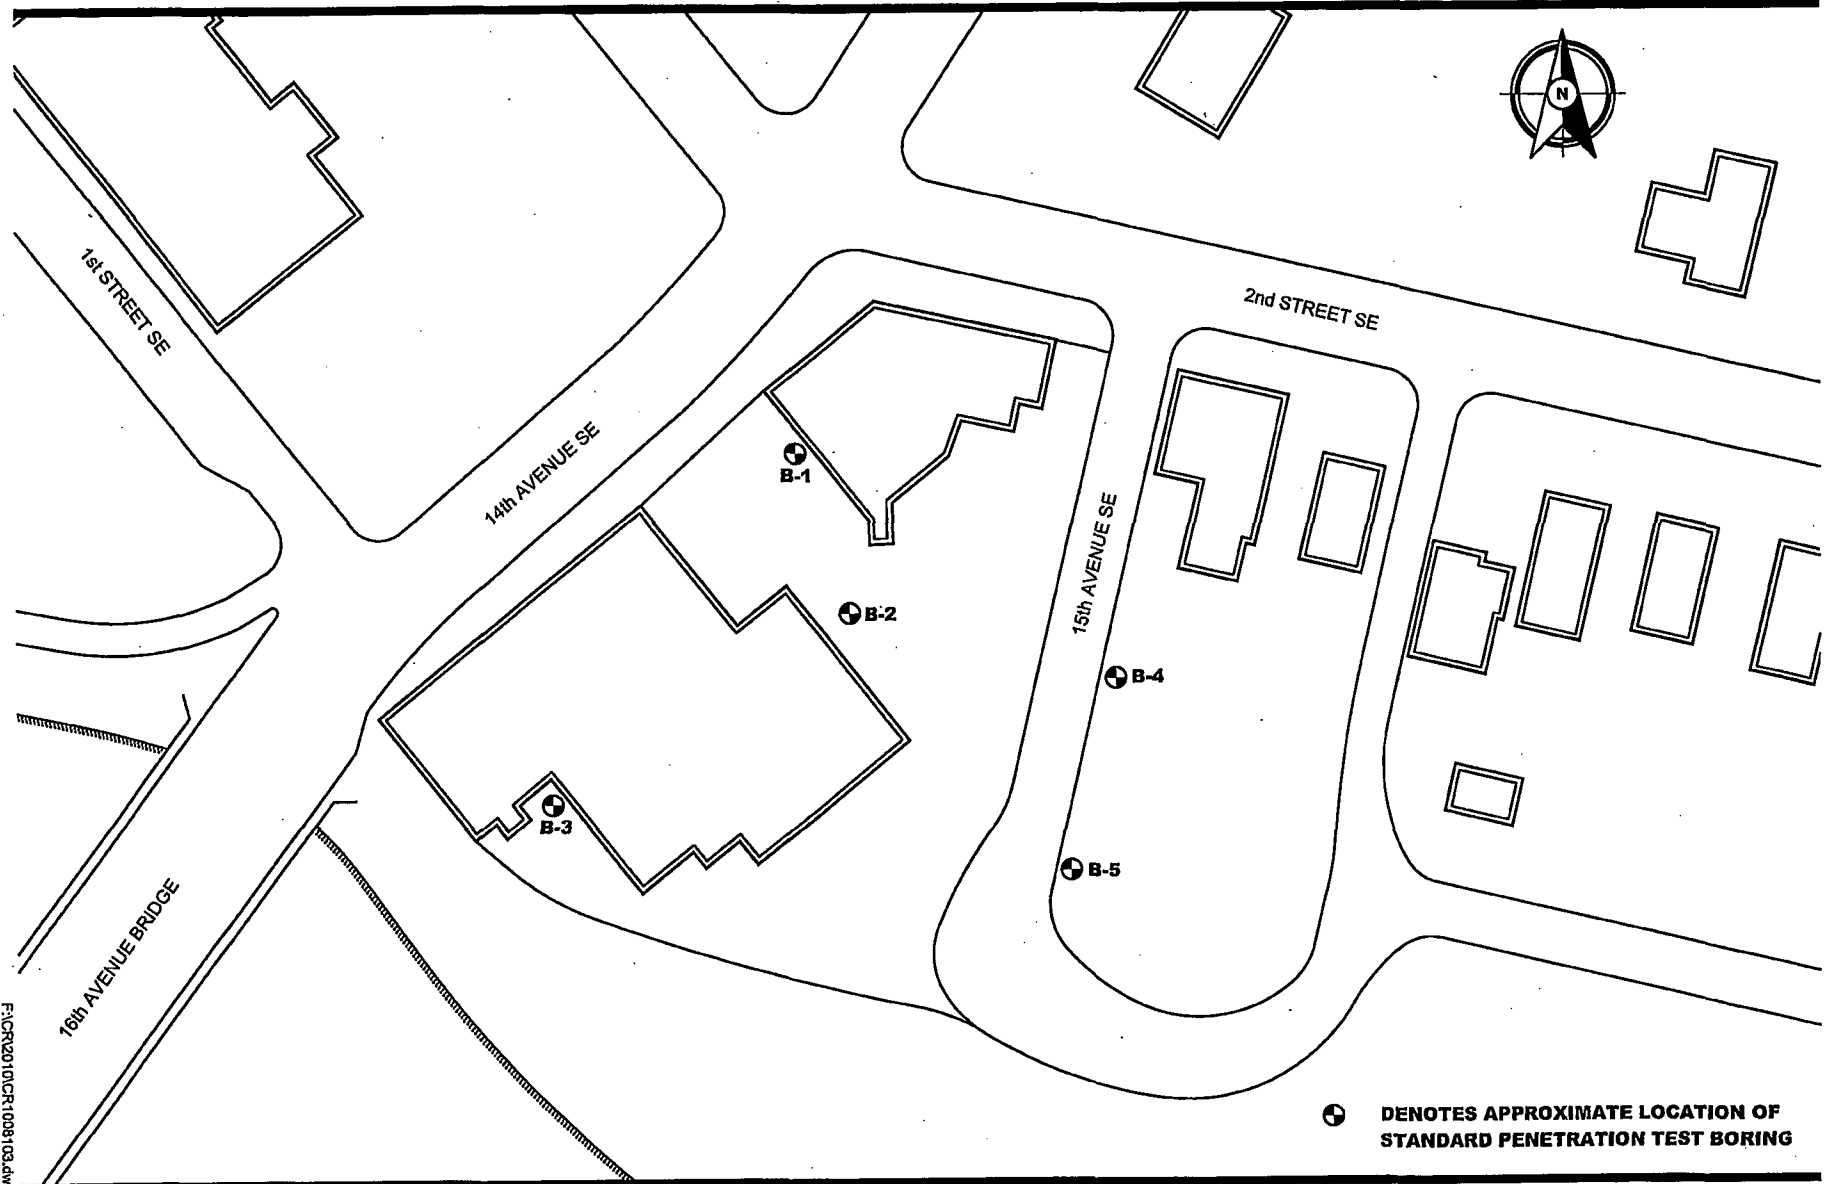
SOIL BORING LOCATION SKETCH
 PHASE II ENVIRONMENTAL SITE ASSESSMENT
 LARIMORE PROPERTIES
 123 14th AVE SE, 119 & 123 15th AVENUE SE
 CEDAR RAPIDS, IOWA

The site assessment consisted of five soil borings (B1 through B5) conducted to depths of 15 to 20 feet. The soil borings were field screened using a photo-ionization detector (PID) for the presence of volatile organic compounds (VOCs). A soil sample was collected from each boring for analysis of semi-volatile organic compounds (SVOCs), volatile organic compounds (VOCs), RCRA metals, and total extractable hydrocarbons (TEH). A temporary monitoring well was installed in each boring for collection of groundwater samples which were analyzed for SVOCs, VOCs, RCRA metals, and TEH. Groundwater was encountered at depths ranging from 11 to 17 feet.
