Site Name: Cretex Concrete Products, Prairie City

Brownfield Initial Site Screening (ISS)

Date: January 11, 2012

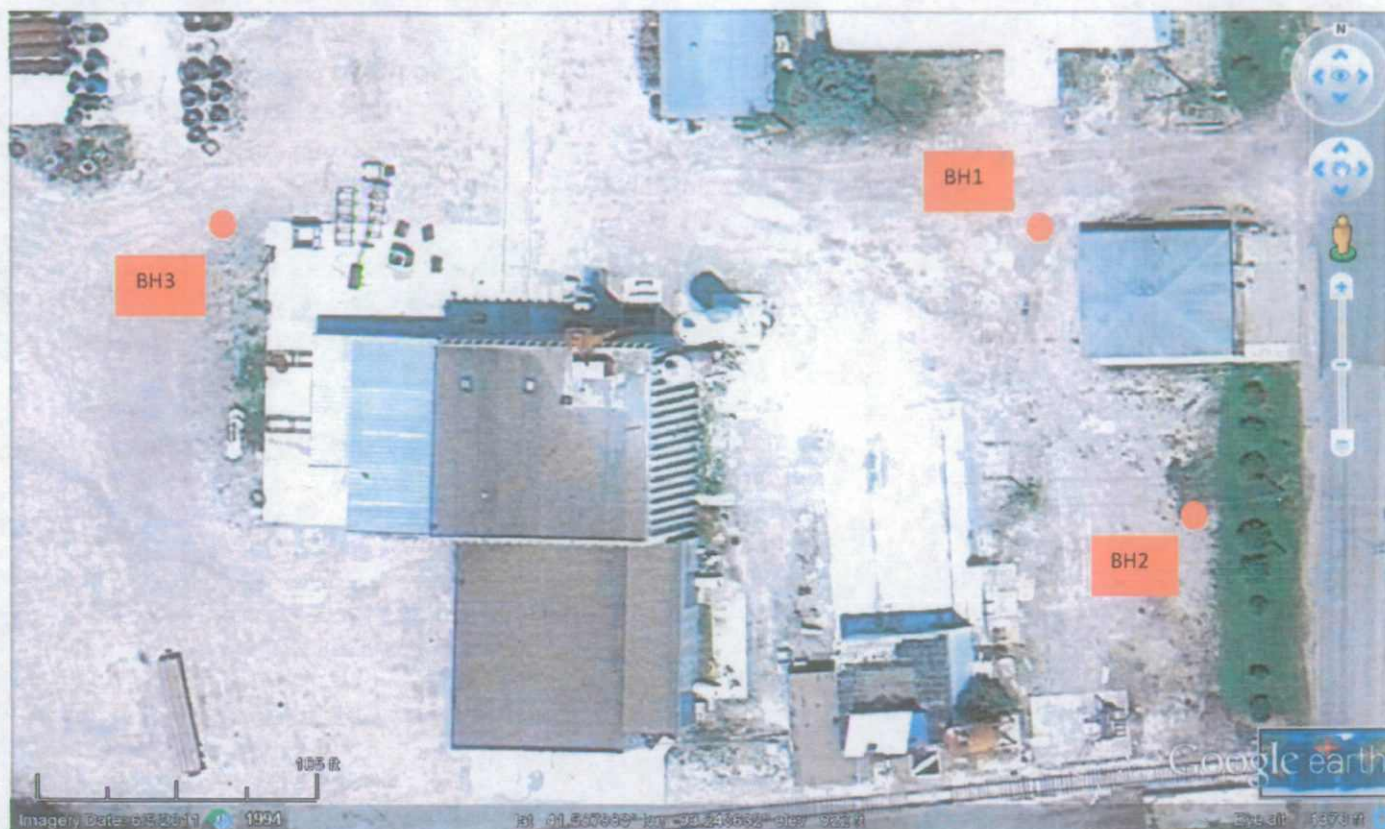
Borehole Locations

Locations of the three (3) borings at the site are shown on copy of 2011 Google Earth aerial photograph. Borings were placed to best indicate conditions at areas shown on figure "Areas of Concern". Borings were moved to northwest (assumed groundwater flow direction) to avoid structures (if now) over areas of concern.
