GEODE STATE PARK  
VALVE REPLACEMENT PLAN  
HENRY COUNTY, IOWA  
PROJECT NUMBER: 18-06-44-02

**Valve Tower Evaluation Summary:**

RE: LAKE GEODE VALVE REPLACEMENT

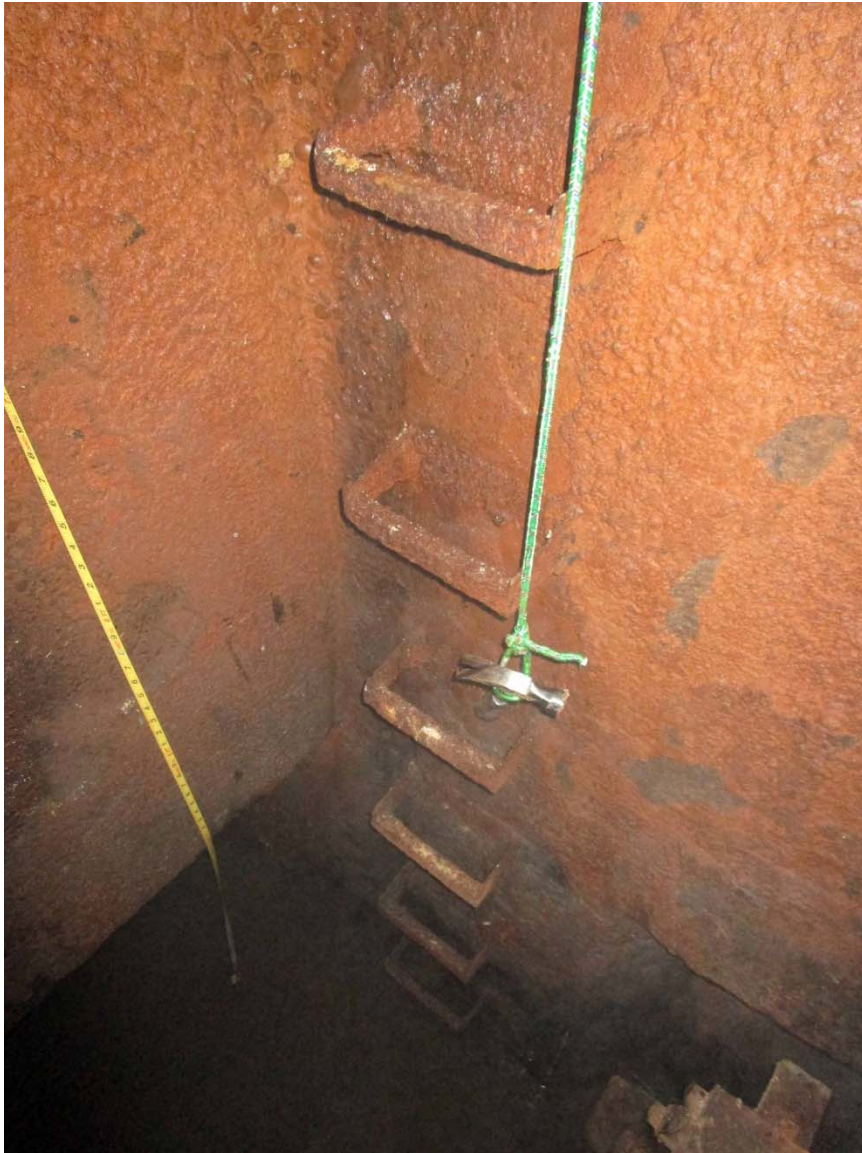
- Interior concrete surfaces on approximately the upper half of the tower were found to be in good condition. No surface deterioration was observed.
- Spalling and scaling were observed on the interior concrete surfaces from the base up to a height of 25'. Aggregate is exposed and appears to be river rock. A buildup of what appears to be iron oxide is present on the surface of the concrete.

- The iron oxide buildup on the walls is most likely from aggregate in the concrete that contains high levels of iron oxide minerals. The minerals begin to oxidize when exposed to moisture and air. This type of aggregate is commonly found in river rock.

Photo 1 – Typical iron oxide buildup on tower walls near base

Concrete repairs are recommended for the lower 25' of the tower shaft. Iron oxide buildup should be removed along with any loose or delaminated concrete. This can be accomplished using light chipping hammers. Concrete repair mortar would then be applied to the walls. Depending on the depth of removals, a self-consolidating repair mortar may be used in conjunction with formwork. The full extents of wall repair will not be known until the iron oxide buildup is removed.

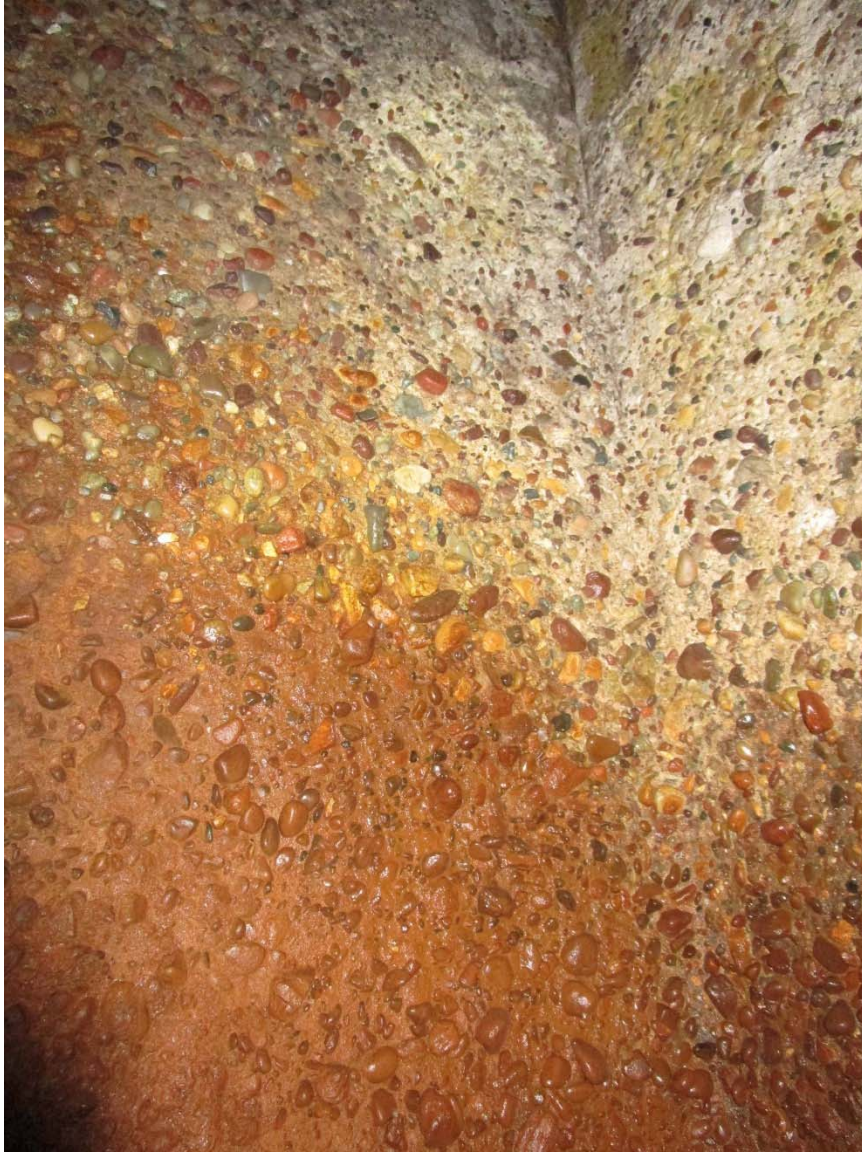
Photo 2 – Typical concrete surface deterioration on lower portion of tower

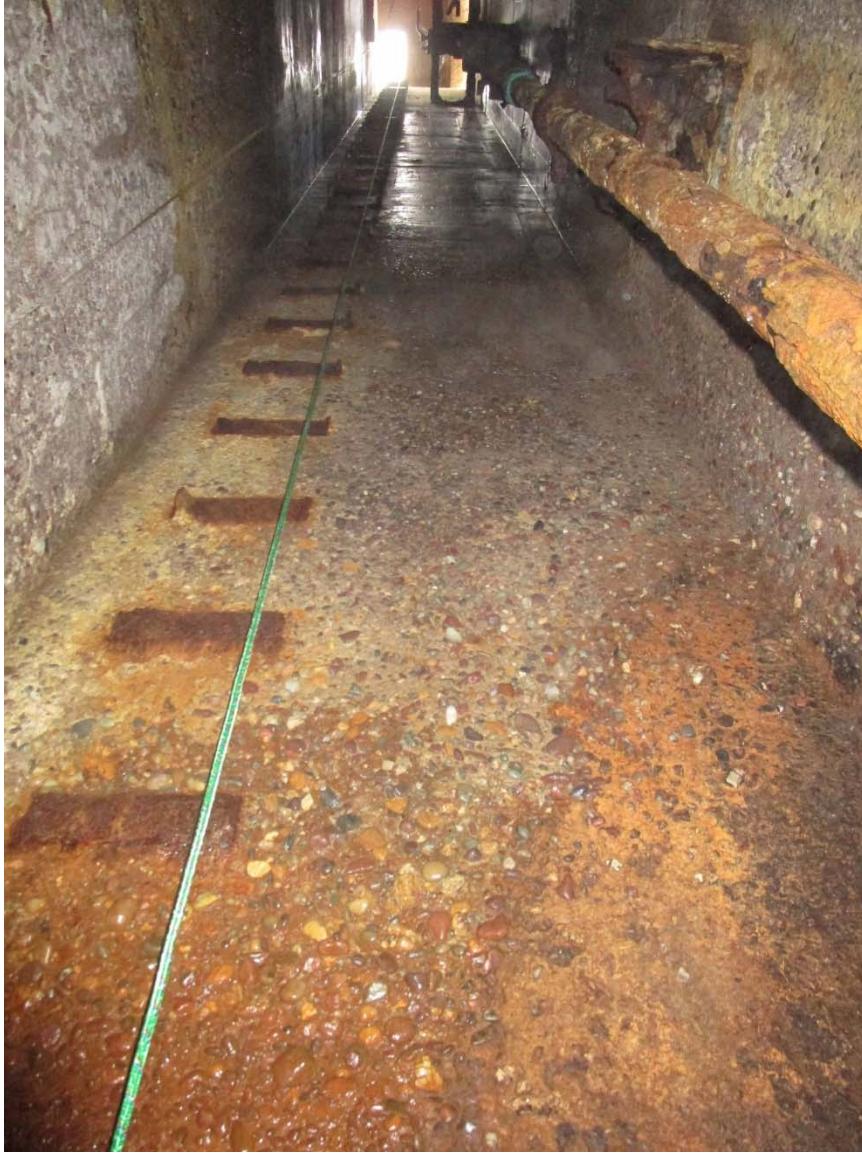
- Existing ladder rungs are severely corroded and major section loss is present. The majority of the rungs are missing from the base of the tower up to a height of 28'.

Photo 3 – Concrete surface deterioration and missing ladder rungs on lower portion of tower

- The existing ladder rungs should not be used in their current condition. They should be cut off flush with the wall surface. Any remaining steel embedded in the concrete should have loose material removed. The remaining steel can then be coated with a rust converting compound and painted.

If it is desired to maintain vertical access in the tower, a new prefabricated ladder should be installed. The ladder should have an integral fall protection system. Stainless steel should be considered for the new ladder to provide corrosion protection in the highly damp environment.

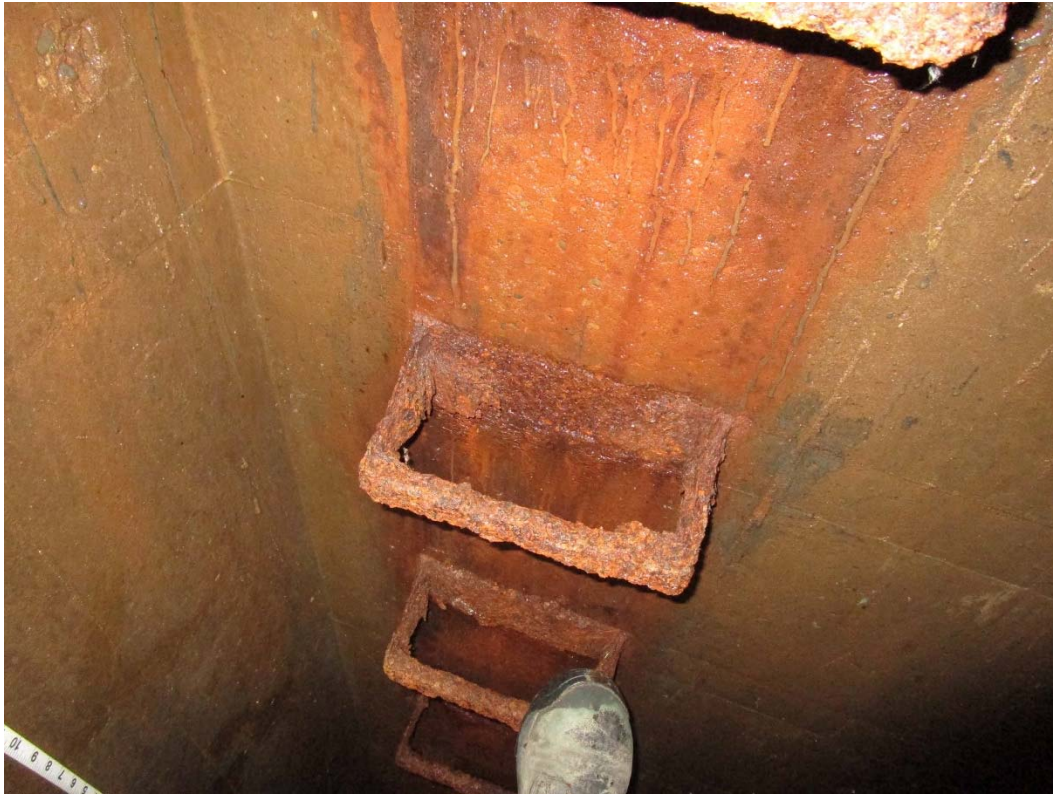
Photo 4 - Typical ladder rung corrosion and section loss

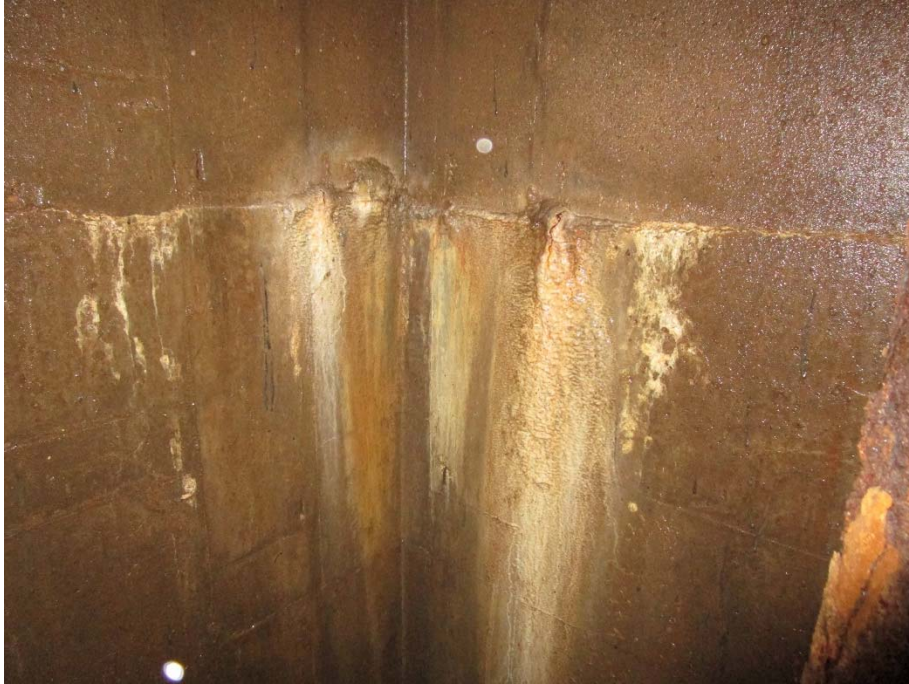
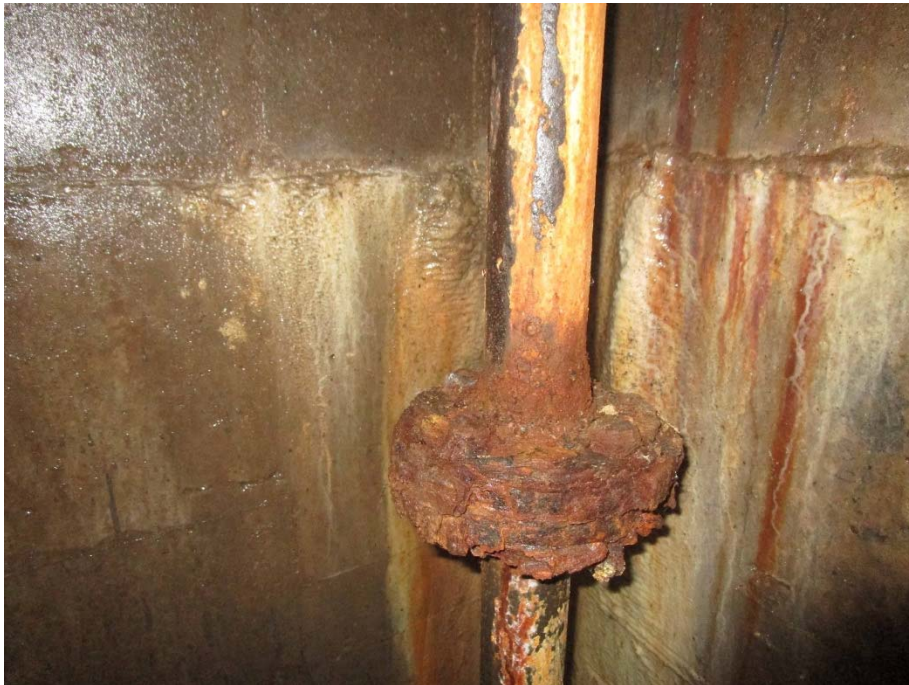
- Efflorescence was observed on the north wall in a range from 27' to 31' above the base. The efflorescence continues around the corners of the north wall onto intersecting walls.

- Efflorescence is caused by water migrating through the concrete walls that brings soluble salts to the surface. Efflorescence buildup should be removed from the walls.

Photo 5 – Efflorescence on north tower wall (31' above base)

Photo 6 – Efflorescence on north tower wall (31' above base)

Once the efflorescence is removed, the concrete walls should be observed for open cracks or construction joints. If the cracks or joints are 1/8" or wider, they should be sealed with an epoxy crack injection system.

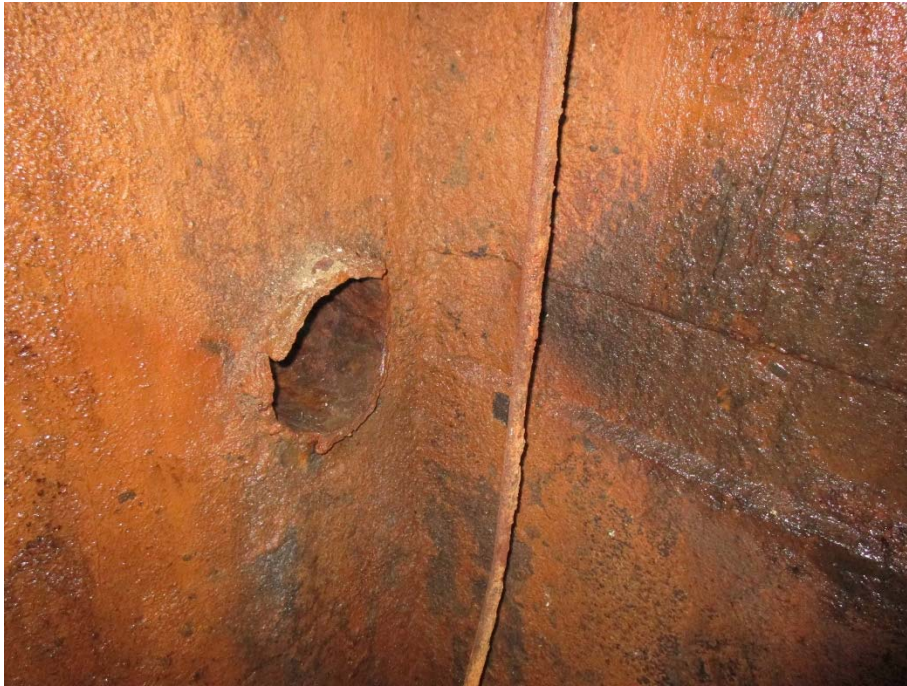
Photo 7 – Existing 8” pipe removed within interior of tower

- o Grouting of the existing 8" pipe is not required.
  8. In the specs under Quality Control, I see we are to pay for Concrete and Aggregate Testing. Is this only for the concrete collar plug, or do we have to also perform the testing on the concrete repair mortar? The concrete mortar will most likely be mixed from bags depending on the depth of the concrete patches. We can make test cylinders from the bag mixes, but it may be difficult to perform the other testing required.

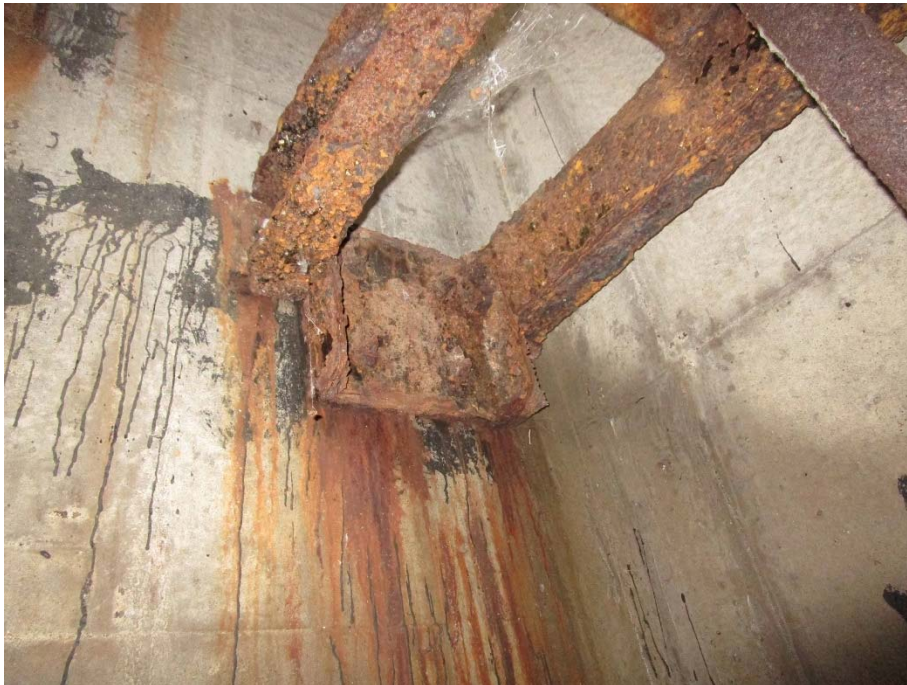
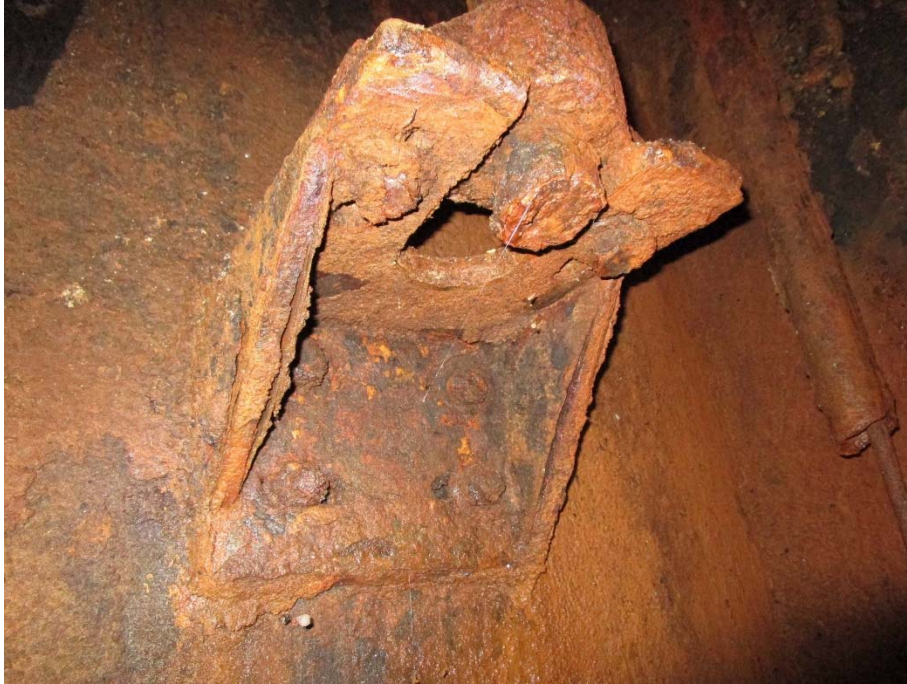
- Existing valve equipment attached to the walls is severely corroded and major section loss is present.
- Existing sluice gate and thimble are severely corroded, not functional, and will be replaced.

Photo 8 – Typical corrosion and section loss on existing valve equipment

Photo 9 – Typical corrosion and section loss on existing valve equipment

- The existing sluice gate assembly and all mounting and operating hardware should be removed. It will be replaced with a 24" gate valve and 24" ductile iron pipe with mechanical joints mounted in a concrete plug to fill the 3' by 3' gate opening.

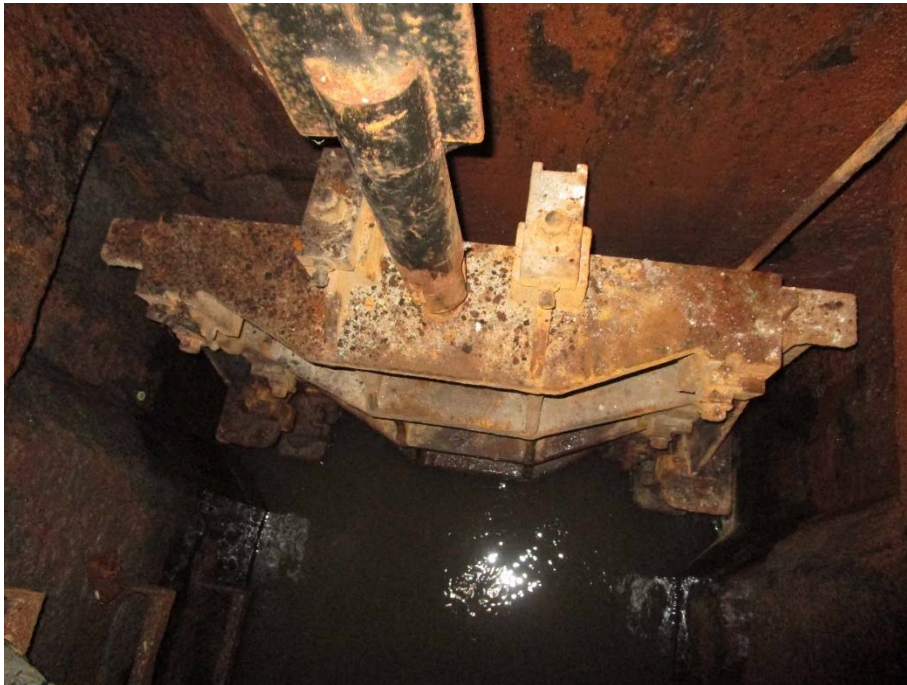
Photo 10 – Existing valve gate
