GREEN ISLAND AND PRINCETON LEVEE REPAIRS

MAQUOKETA WILDLIFE UNIT

JACKSON AND SCOTT COUNTY

LEVEE REPAIRS AT SITE 7 & 8

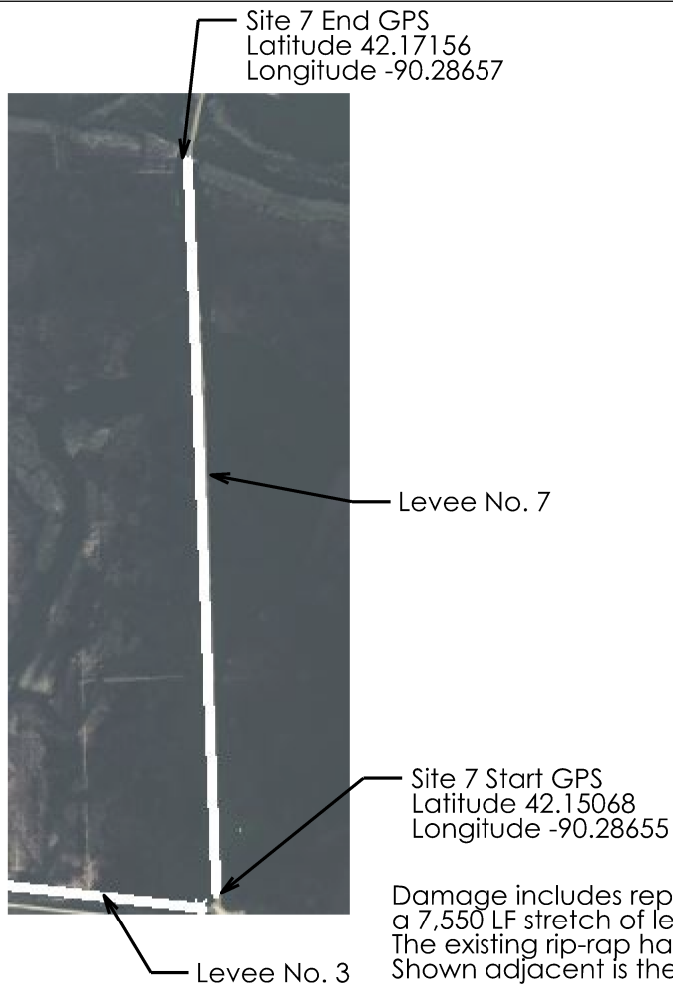
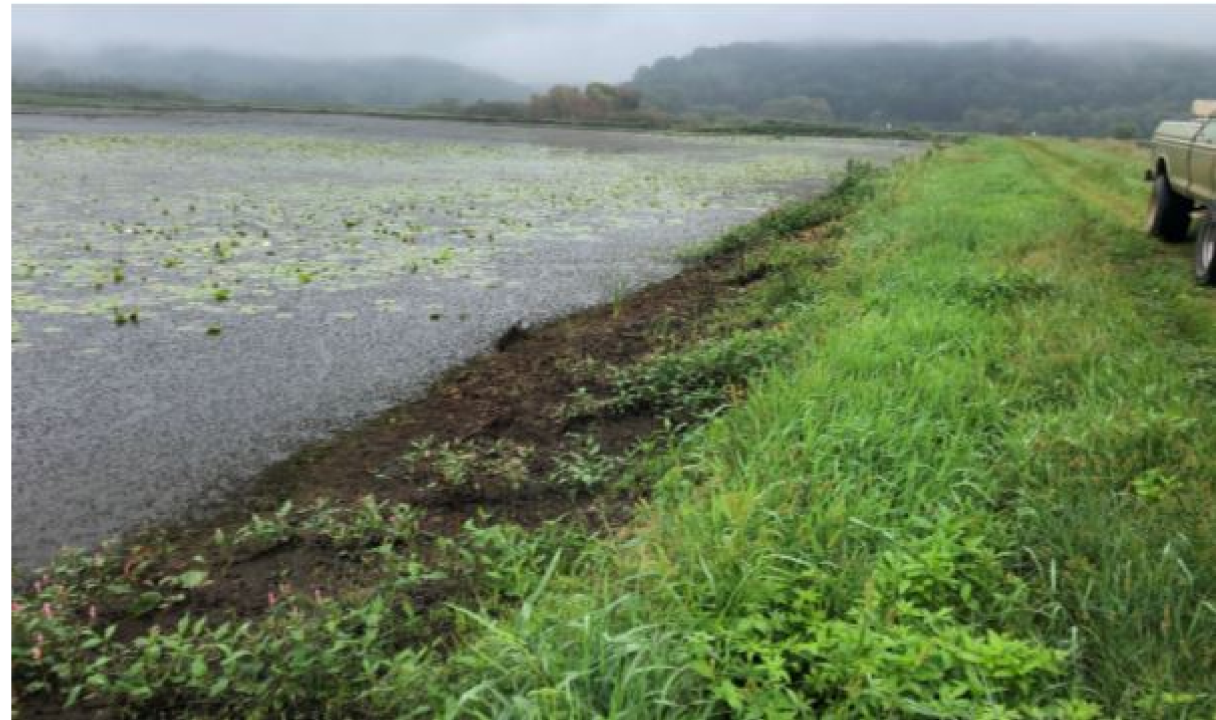
Site 7 - 4th Ditch Dike

Damage includes repair of washouts along a 7,550 LF stretch of levee called the 4th Ditch Dike. The existing rip-rap has been displaced as well. Shown adjacent is the location of the flood damage.

- Repair work includes
1. Clear, grub and strip vegetation to 6-inch depth.
 2. Level out all washout areas where possible.
 3. Place unclassified fill along levee edge (estimate at 4" depth by 15' wide) to fill in areas that need additional material to reestablish original side slopes.
 4. Place engineering fabric.
 5. Place Class E revetment along edge (15' wide and a depth of 2')

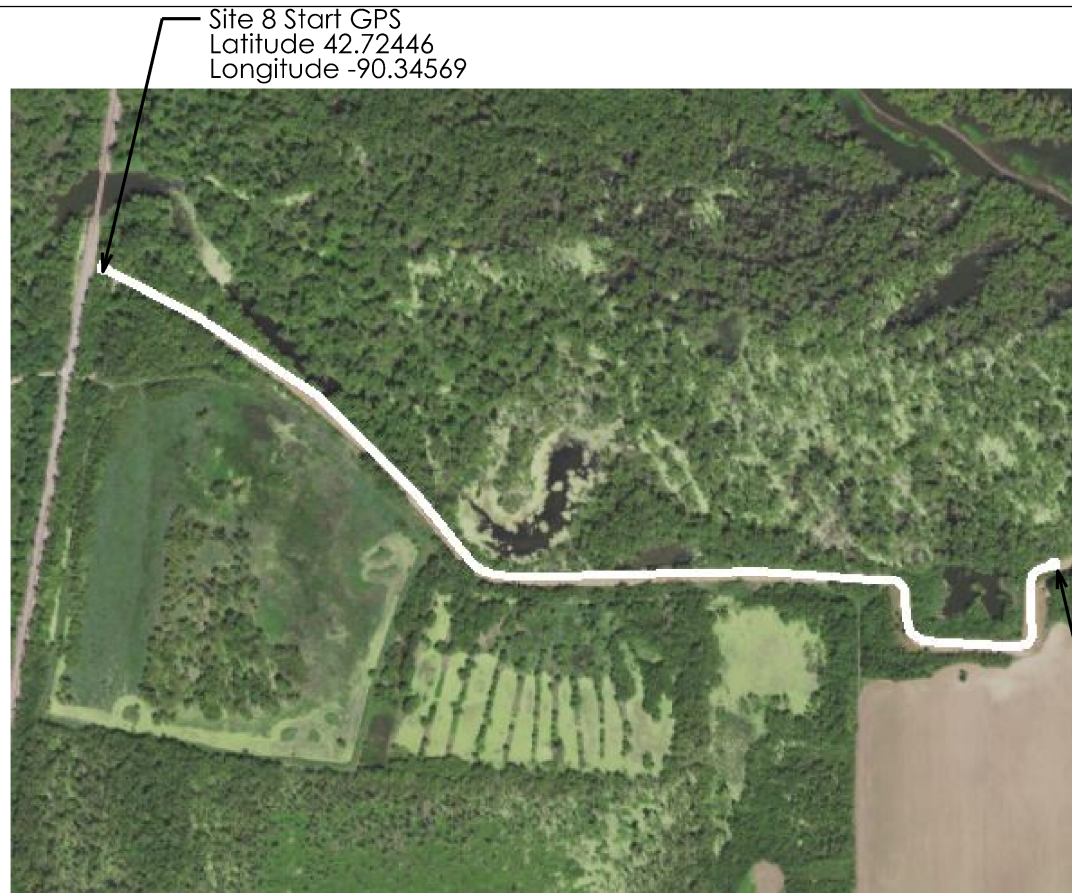
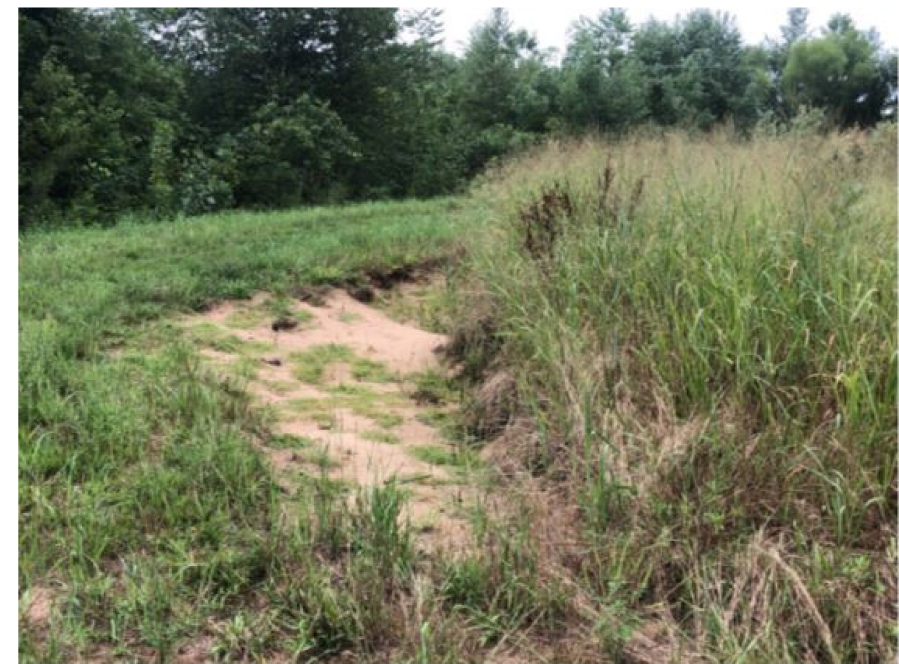
Site 8 - Princeton Levee

Damage includes repair of washouts along a 3,405 LF stretch of levee within Princeton WMA. Above is a location of the flood damage.

- Repair work includes:
1. Clear, grub and strip vegetation to 6-inch depth.
 2. Level out all washout areas where possible.
 3. Place unclassified fill along levee edge (estimate at 4" depth by 15' wide) to fill in areas that need additional material to reestablish original side slopes.
 4. Seed with an erosion control mix.
 5. Place erosion control matting.
