RED HAW STATE PARK  
DESIGN GUIDE SHELTER  
LUCAS COUNTY, IOWA  
PROJECT NUMBER: 22-05-04-02

August 4, 2023

**Asbestos Reporting**

Former Concession Building, toilets  
Red Haw State Park  
24550 US-34  
Chariton IA 50049

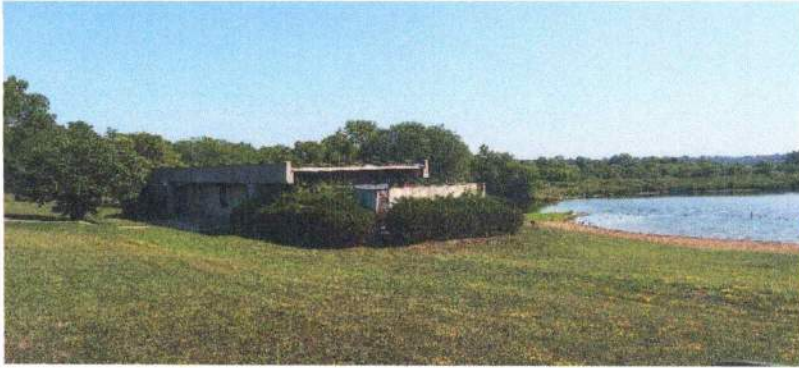
Red Haw SP, Landscape layout, brush perimeter

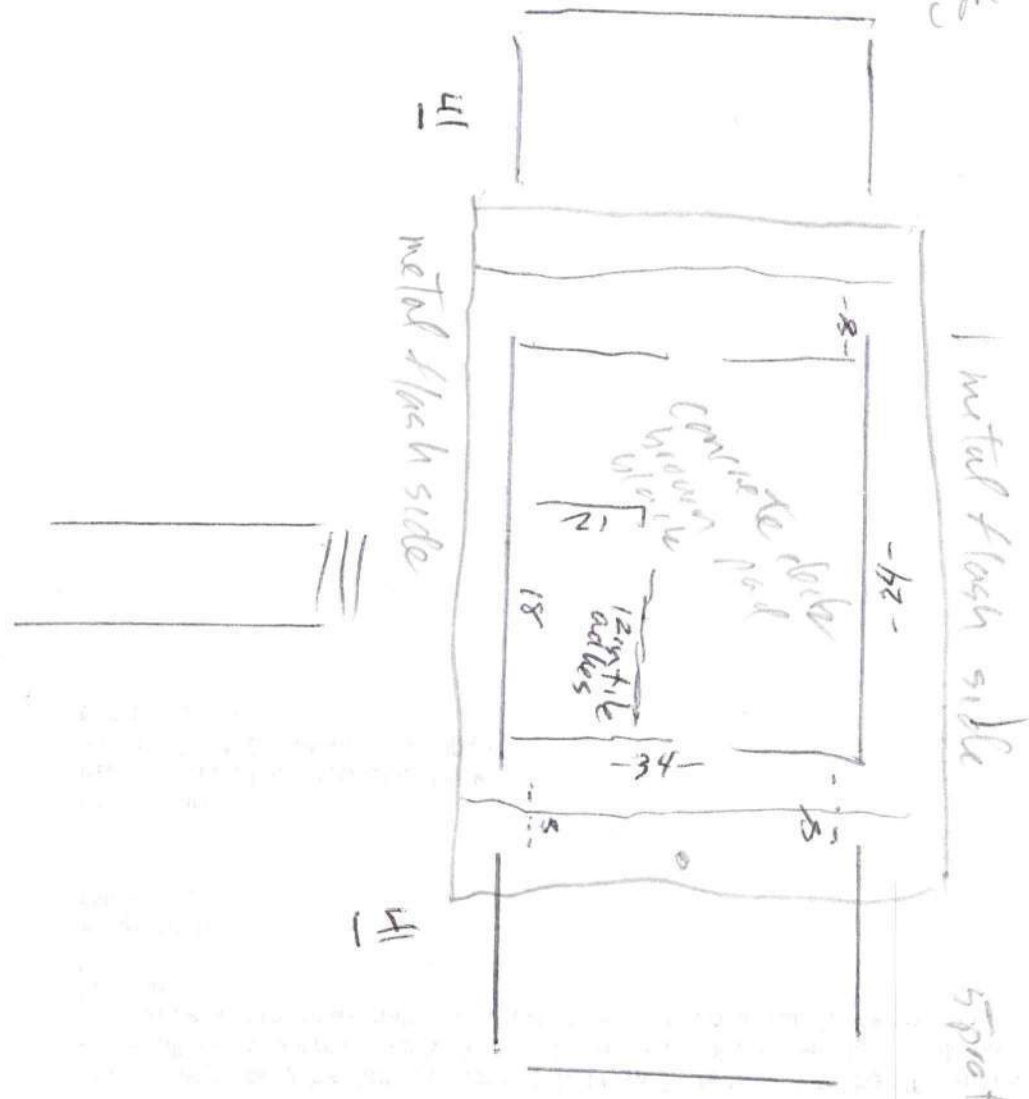
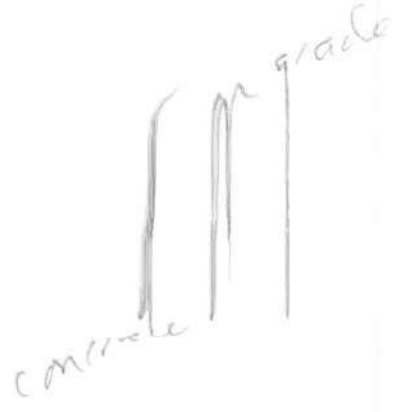
fire hydrant

water pump stand pipe

concrete apron E/W

curb

5 protrusions von

Concession Building  
lake side

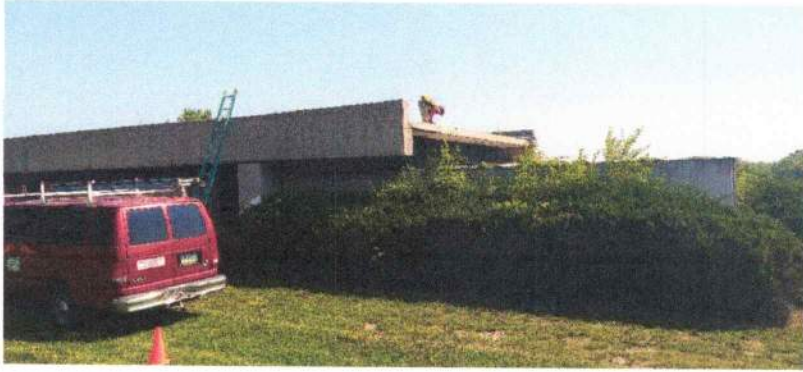
Red Haw SP. Concession Bld. Built up roof/tar.

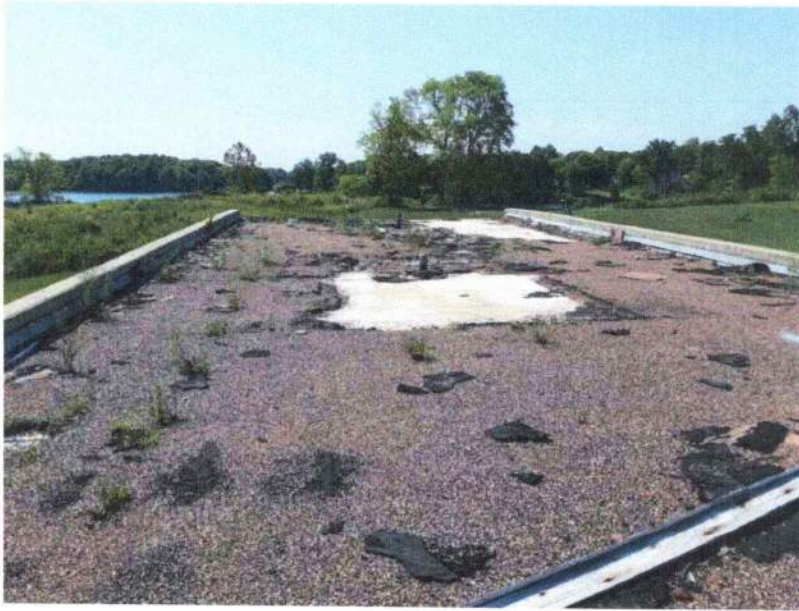
Red Haw SP. Concession roofing.

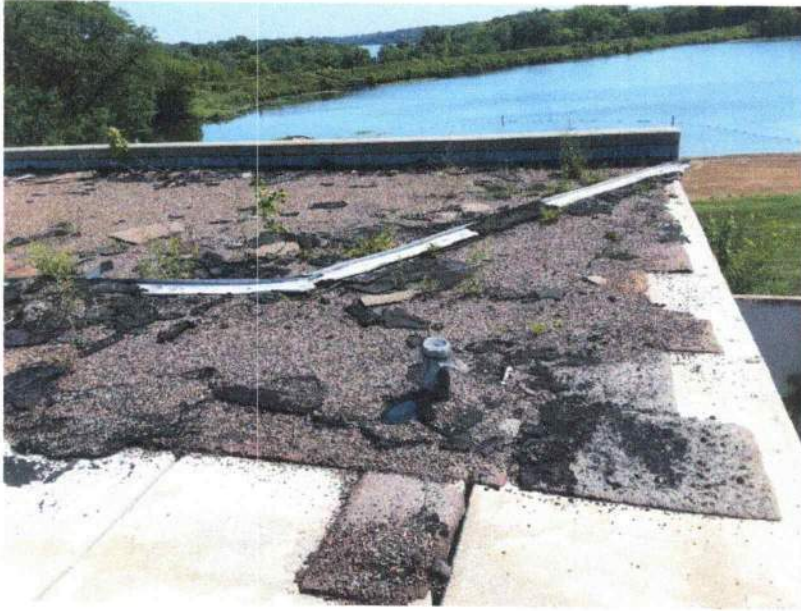
Red Haw SP. Concession roofing.

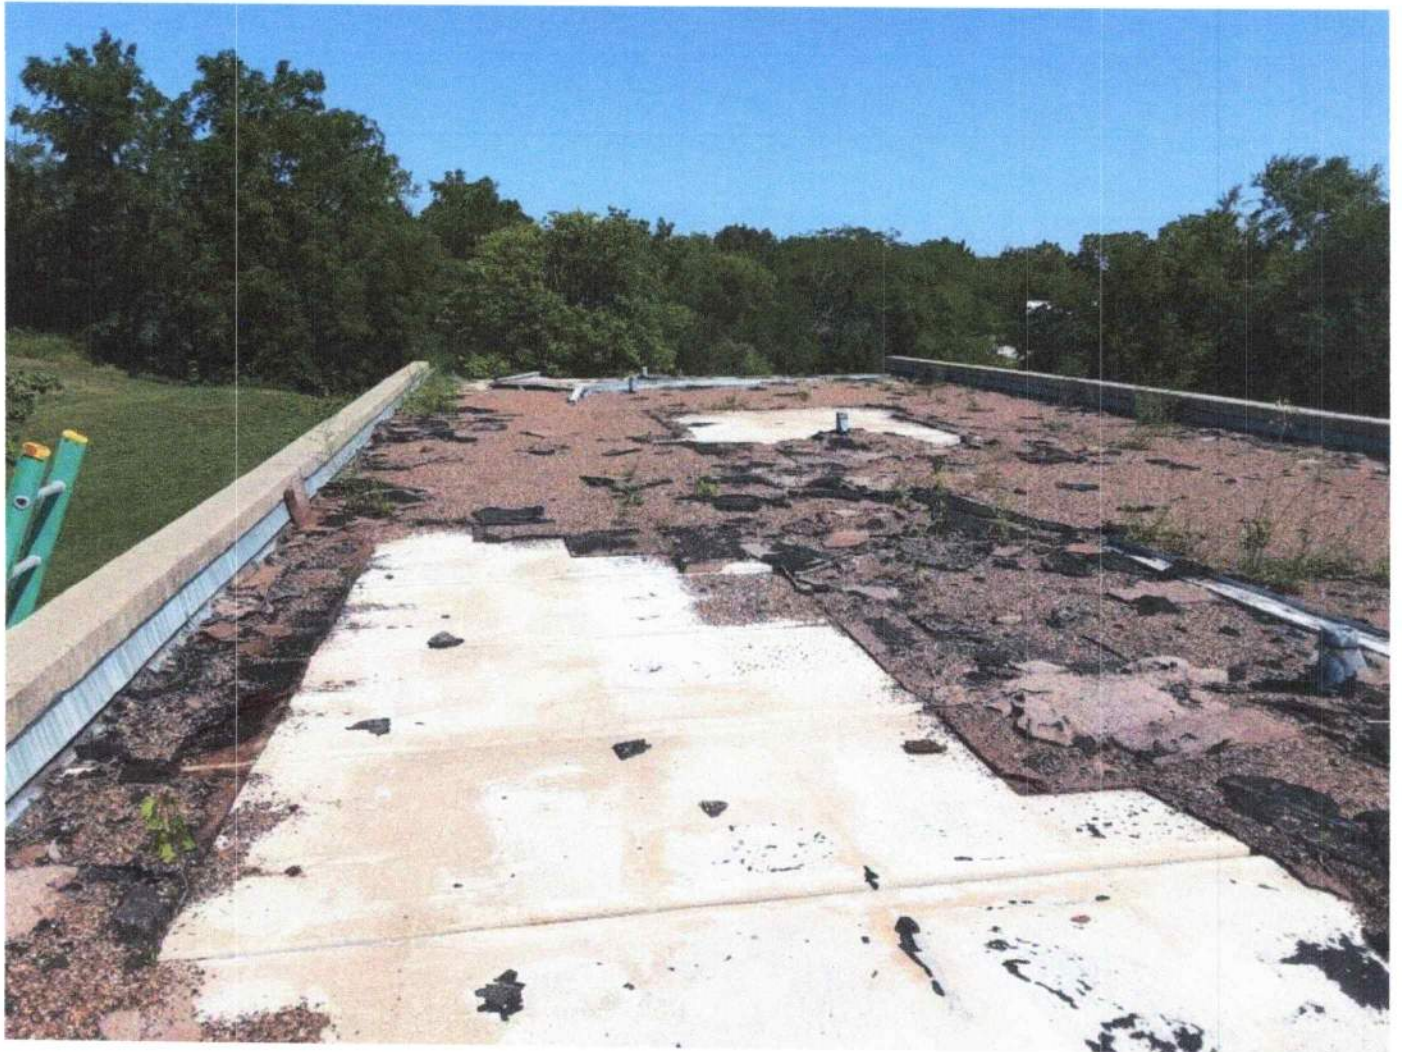
## Read Haw SP, Concession roofing

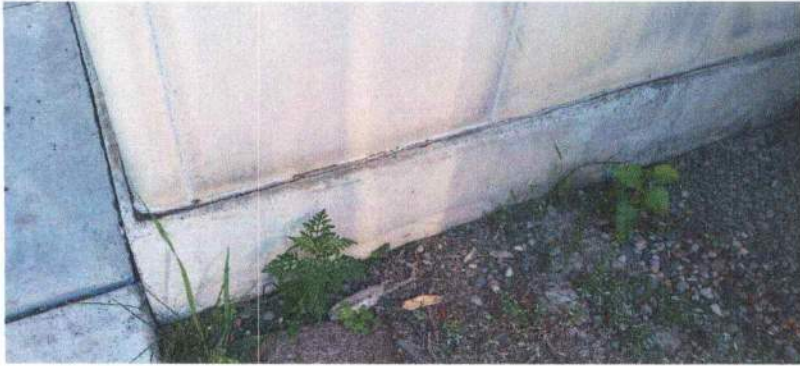
Red Haw SP, Horizontal seams to wall panels.

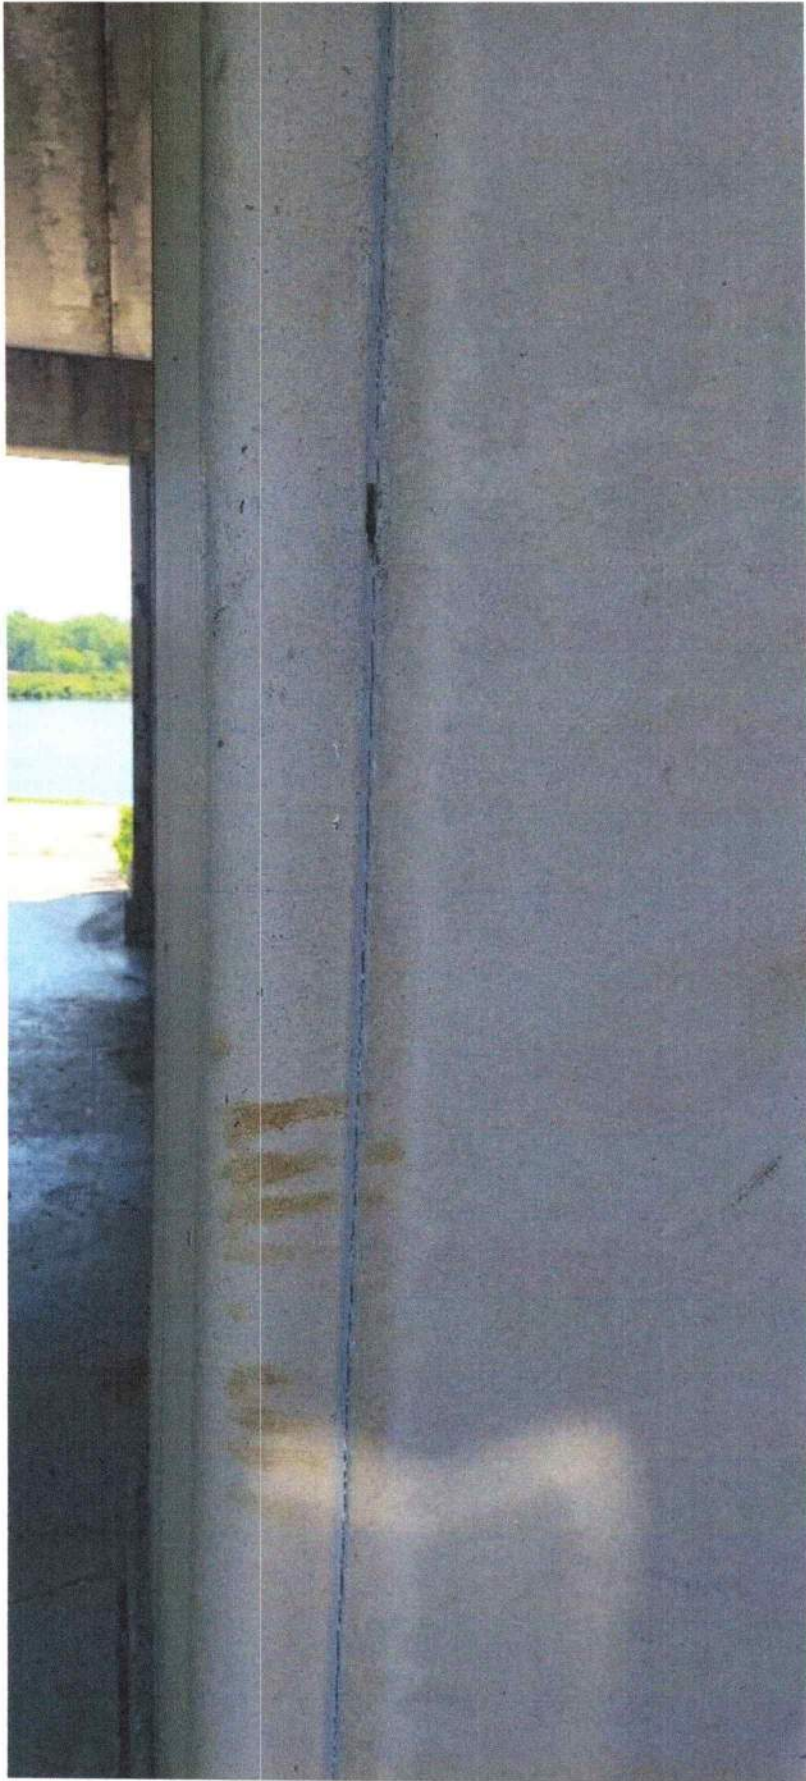
Red Haw SP. Vertical seams to wall panels.

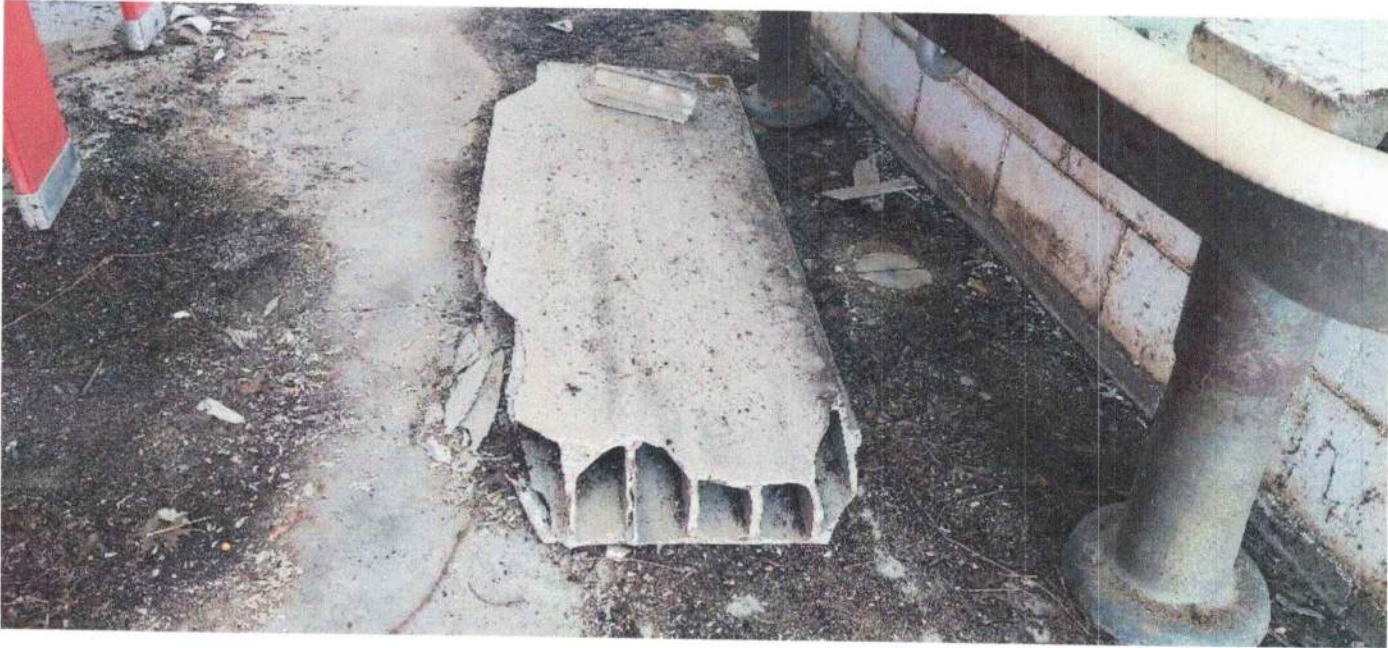
Red Haw SP. South locker room, wall debris.

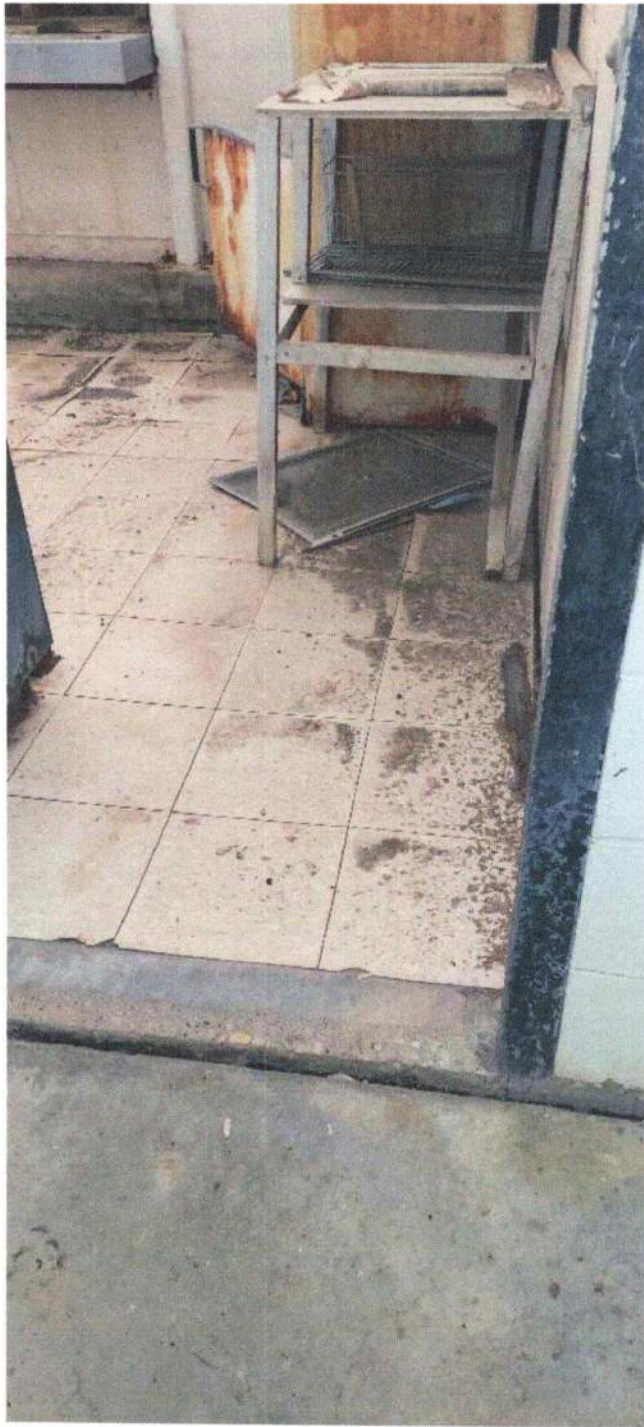
RH-20a	<b>12inch tile , whit</b>	<b>2% Chrysotile asbestos</b>	<b>kitchen floor, 10 x 18 ft</b>
RH-20b	adhesive, black/yellow	None detected	glue for tile to concrete
RH-21a	<b>12inch tile, white</b>	<b>2% Chrysotile asbestos</b>	<b>kitchen floor finish</b>
RH-21b	adhesive, black/yellow	None detected	glue for tile to concrete
RH-22	countertop, to wood	None detected	sink formica finish, 3 x 5 ft
RH-22	adhesive to countertop	None detected	glue for formica to cabinet
RH-23	countertop, to wood	None detected	sink formica finish, 3 x 5 ft
RH-23	adhesive to countertop	None detected	glue for formica to cabinet
RH-24	sink coating, dark	Insufficient material	basins were heavily rusted

Red Haw SP, interior kitchen, 12inch tiles.

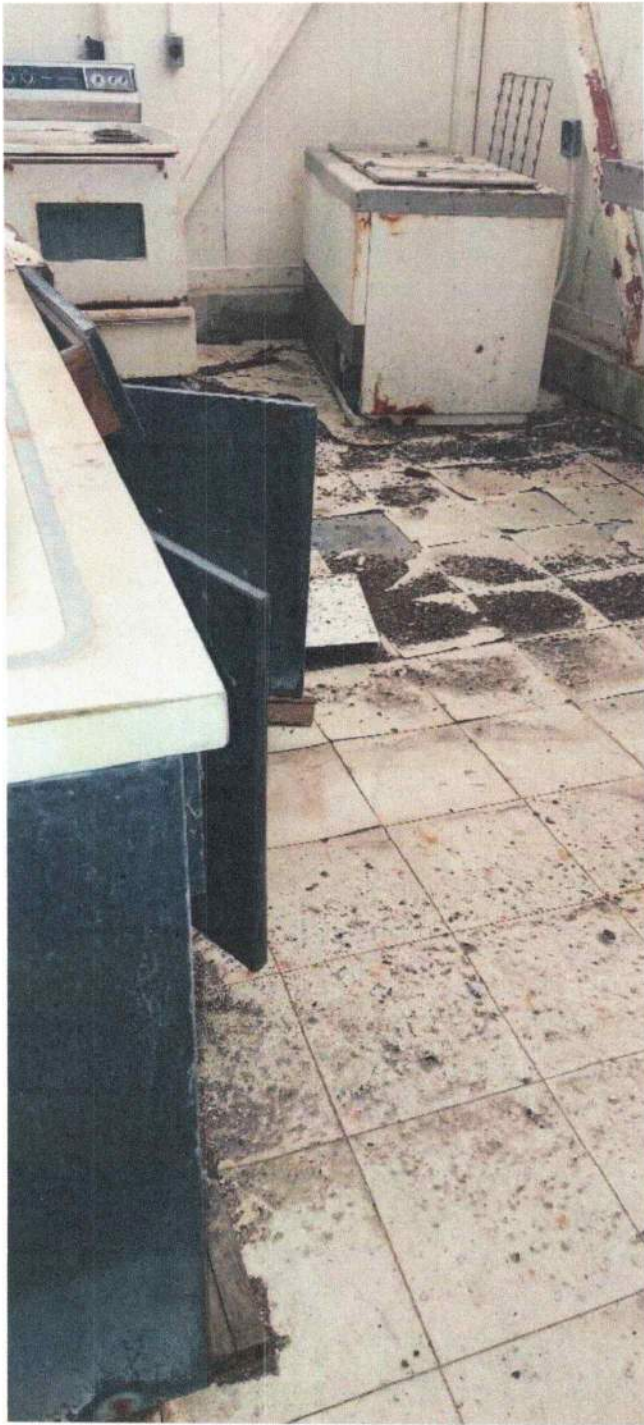
Red Haw SP. kitchen 12inch tile, debris.

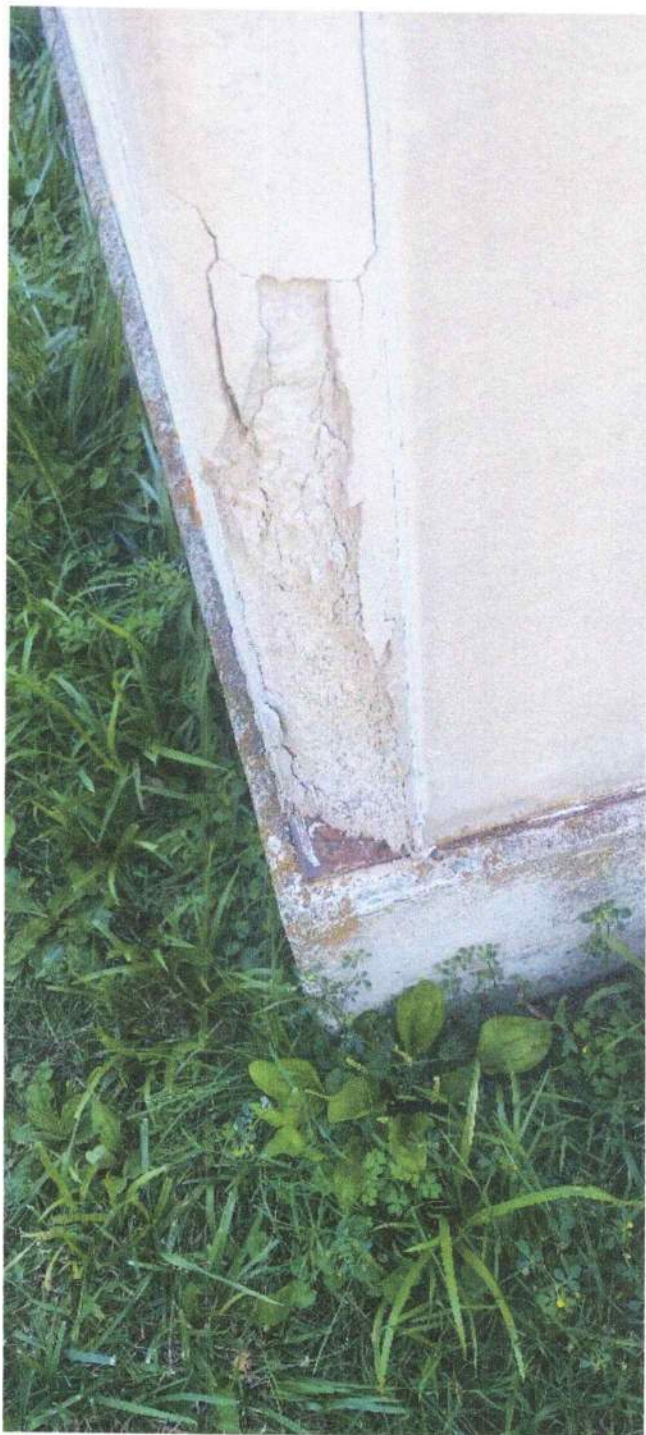
RH-13	<b>cement walls, vertical</b>	<b>10% Chrysotile asbestos</b>	<b>151 wall panels. See pictures</b>
RH-14	seam, white, N toilet walls	<1% Chrysotile asbestos	vertical + horizontal seams
RH-15	seam, white, along N walls	None detected	vertical + horizontal seams
RH-16	seam, white, middle walls	None detected	vertical + horizontal seams
RH-17	seam, white, vertical walls	None detected	vertical + horizontal seams
RH-18	seam, white, S toilet walls	None detected	vertical + horizontal seams
RH-19	seam, white, vertical walls	None detected	vertical + horizontal seams

Red Haw SP. 151 wall panels.

- **Attached is the asbestos testing report. The Contractor is responsible for abating all asbestos materials contained in/on the building prior to demolition.**
- **Project is located in Lucas County**

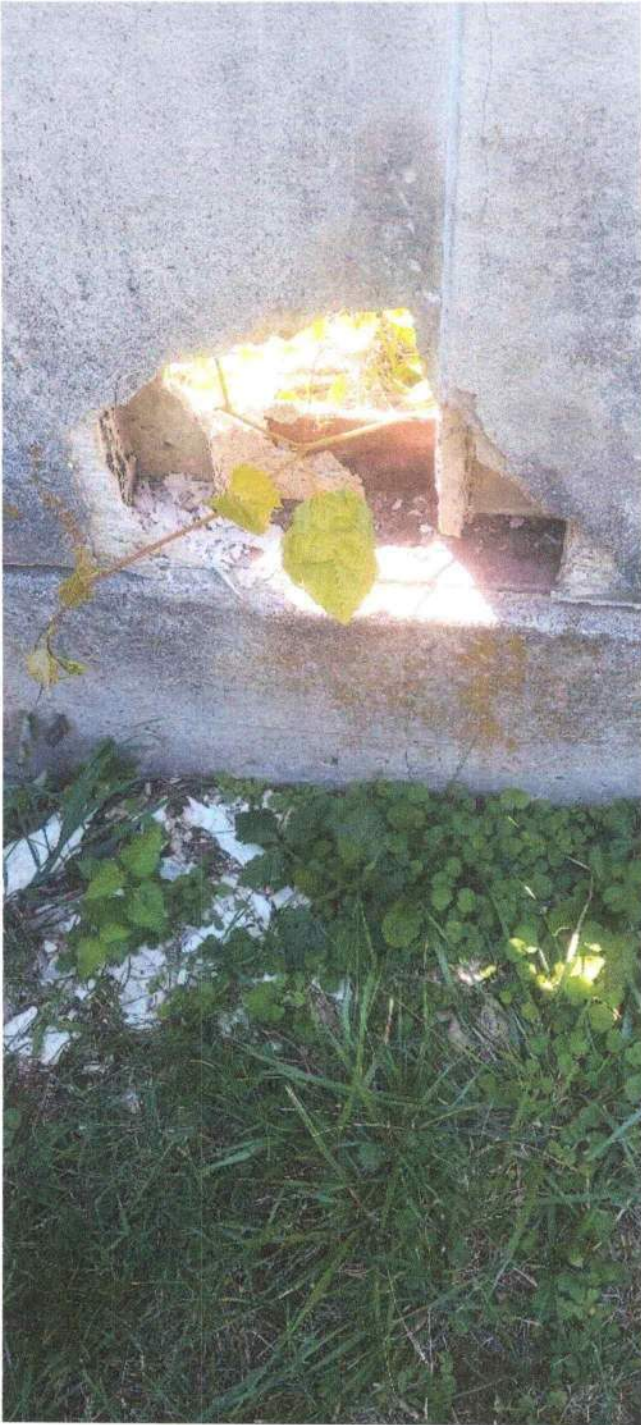
Red Haw SP, Chariton, 151 wall panels
