Notice of Violation: Fugitive Dust - Paragraph 567 IAC 23.3(2)"c"
Failure to Maintain Control Equipment 567 IAC 24.2(1

RE: Air Compliance Evaluation / Complaint Investigation
Facility No. 82-01-064
Title V Permit No. N/A
Complaint ID: 31314

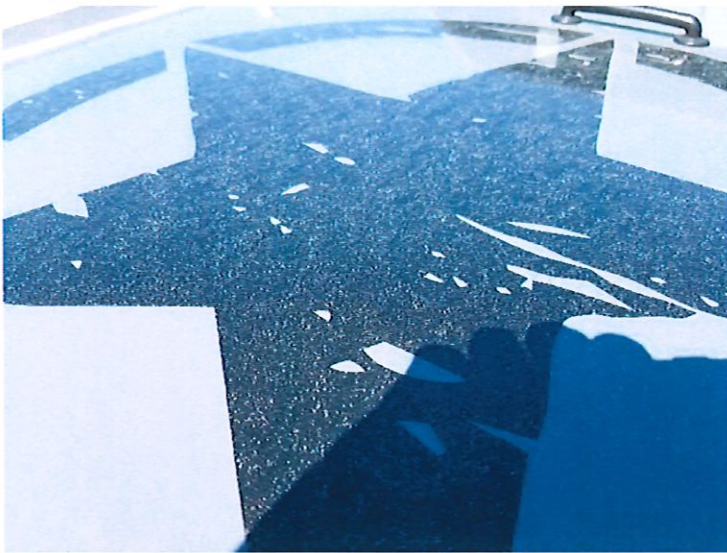
View of dust on vehicle to the north of the PB Leiner Offices.

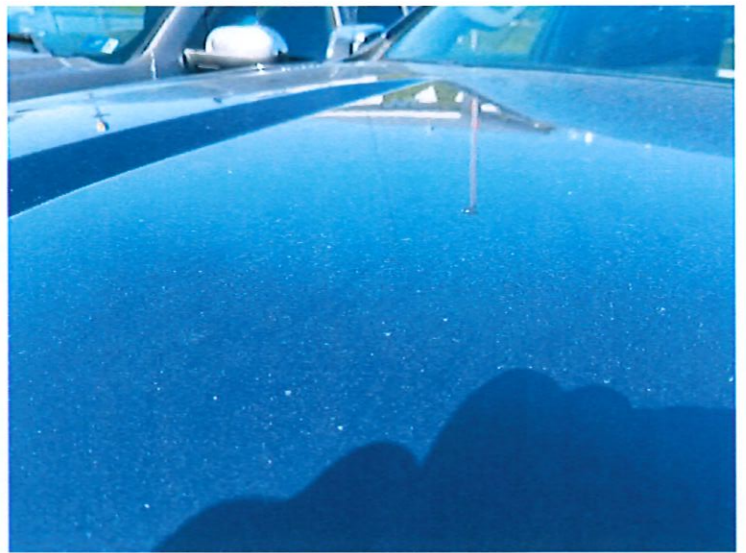
View of dust on vehicle to the north of the PB Leiner Offices.

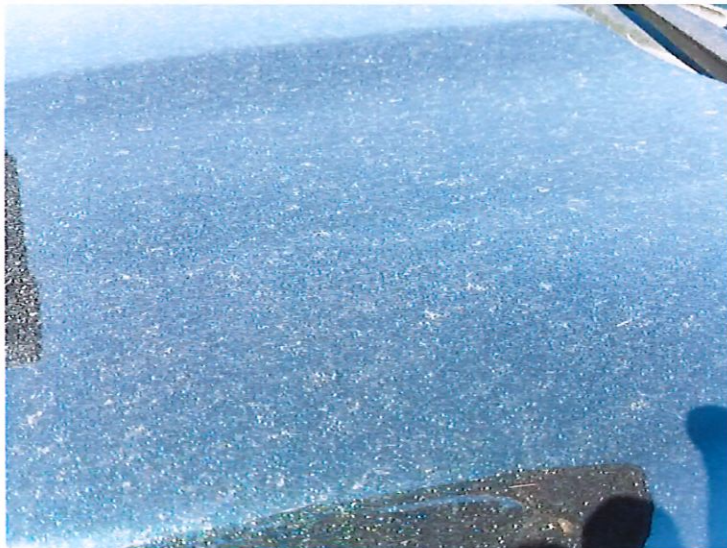
View of dust on vehicle to the north of the PB Leiner Offices.

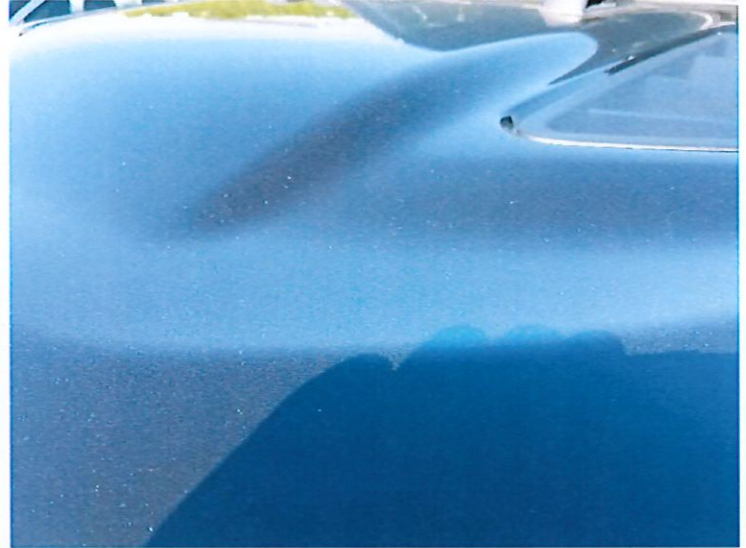
View of dust on vehicle to the north of the PB Leiner Offices.
