Re: Cedar Valley Recycling and Transfer Stormwater Compliance Inspection

REPORT OF COMPLIANCE EVALUATION INSPECTION
(INDUSTRIAL STORMWATER)

AT
Cedar Valley Recycling & Transfer
1920 Water Street
Waterloo, Iowa 50703

ON
MAY 10 AND 12, 2022

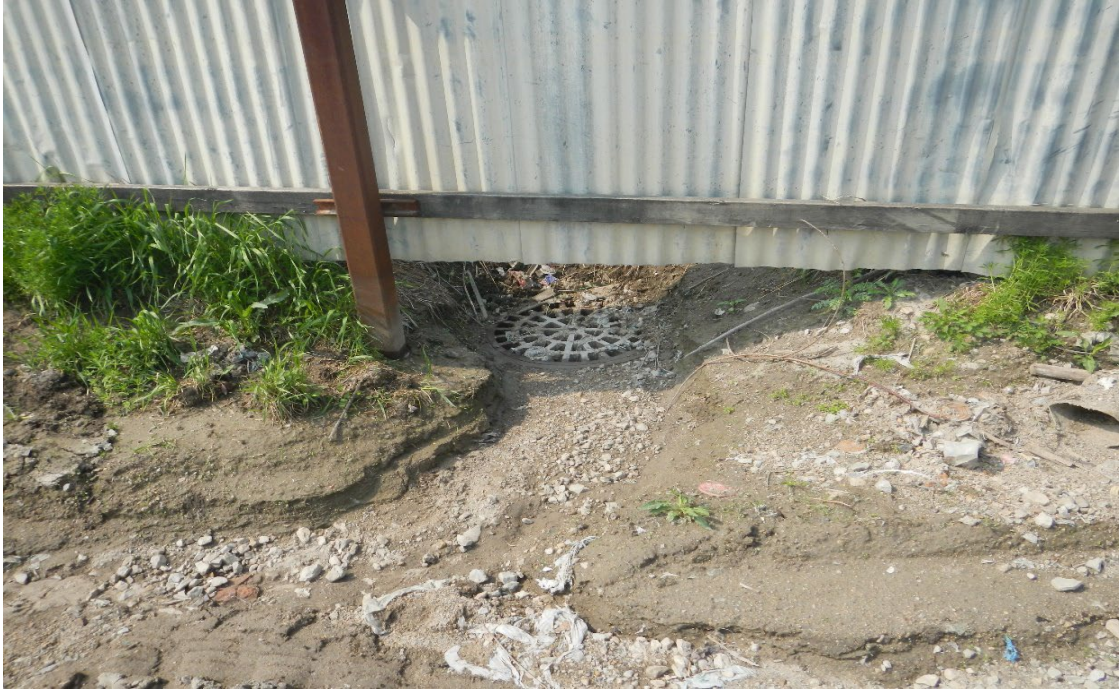
the facility. Mr. Benham indicated that he is aware of the three inlets but was not aware of where about the three inlets discharge to. The three inlets had evidence of stormwater discharge (photos #: DSCN1216-1219 and 1220). One of which was completely covered with sediment as shown in photo #: DSCN1220.

Photo #: DSCN1217, stormwater runoff entering one of the inlet to the MS4

Therefore, I issued the first Notice of Preliminary Finding (NOPF #1), because Cedar Valley Recycling & Transfer facility failed to submit a notice of intent to obtain a stormwater discharge authorization to the IDNR.

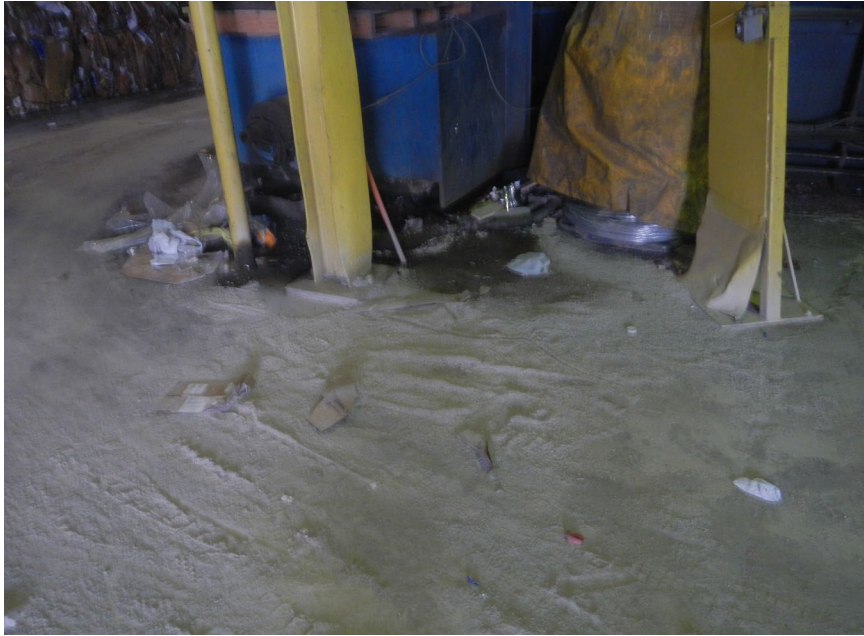
Industrial Stormwater Inspection Direction: SE	DESCRIPTION	Evidence of spill in the indoor process area.	DSCN1200
	PHOTOGRAPHER	Naji J. Ahmad 913 551 7190	Date: 05/10/2022

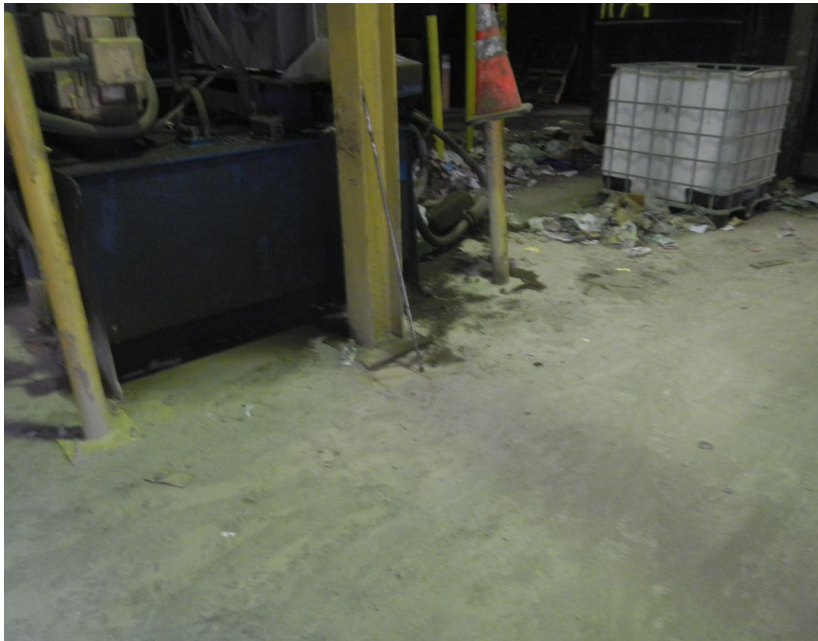
Industrial Stormwater Inspection Direction: West	DESCRIPTION	Evidence of spill in the indoor process area.	DSCN1201
	PHOTOGRAPHER	Naji J. Ahmad 913 551 7190	Date: 05/10/2022

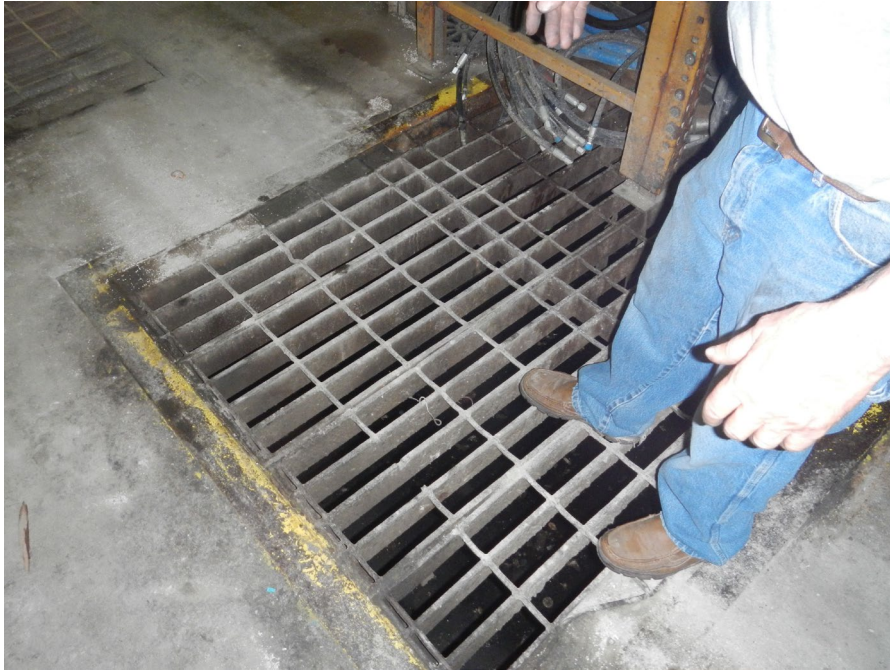
Industrial Stormwater Inspection Direction: SE	DESCRIPTION	Floor pit. This floor pit has no outlet.	DSCN1206
	PHOTOGRAPHER	Naji J. Ahmad 913 551 7190	Date: 05/10/2022

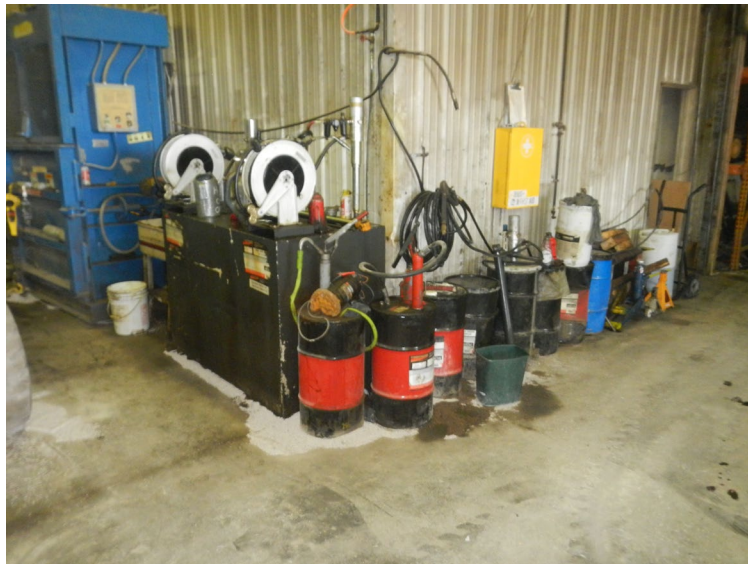
3. Cedar Valley Recycling & Transfer facility has an aggregate aboveground storage capacity over 1,320 U.S. gallons of petroleum products (diesel fuel, gasoline, hydraulic fluid, oil, and used oil) stored onsite in various containers such as double-wall tanks, totes, and 30 to 50-gallon drums. According to 40 CFR Part 112, §112.3, the Cedar Valley Recycling & Transfer facility must prepare in writing and implement a Spill Prevention Control and Countermeasure (SPCC) plan in accordance with §112.7 and any other applicable section of this Part. Therefore, I issued NOPF #3, because Cedar Valley Recycling & Transfer failed to develop and implement a SPCC plan as required by 40 CFR Part 112, §112.3.

Industrial Stormwater Inspection Direction: West	DESCRIPTION	Indoor storage of petroleum products.	DSCN1207
	PHOTOGRAPHER	Naji J. Ahmad 913 551 7190	Date: 05/10/2022

site at the time of the inspection, Cedar Valley Recycling & Transfer must prepare in writing and implement a Spill Prevention Control and Countermeasure (SPCC) plan in accordance with §112.7 and any other applicable section of 40 CFR Part 112, §112.3.

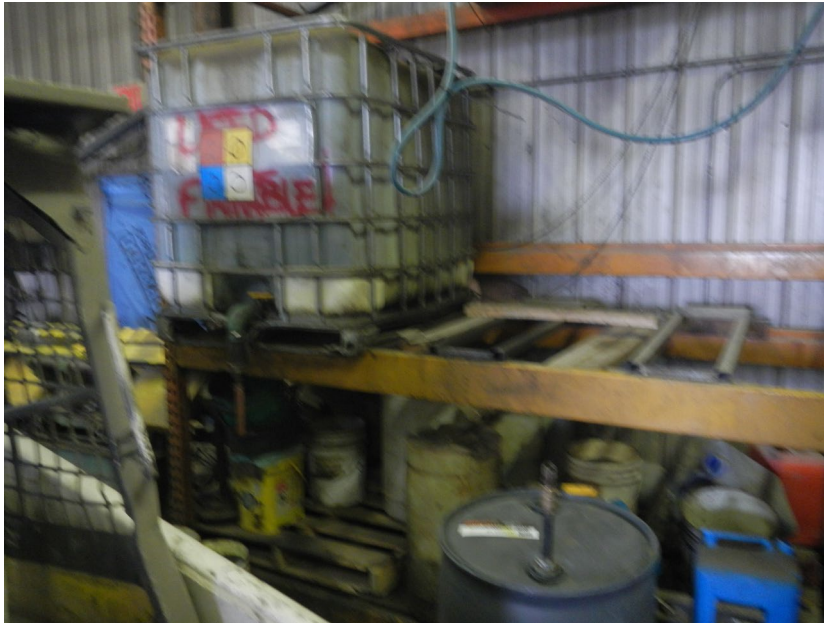
Industrial Stormwater Inspection Direction: SE	DESCRIPTION	More containers of petroleum products stored indoor.	DSCN1208
	PHOTOGRAPHER	Naji J. Ahmad 913 551 7190	Date: 05/10/2022

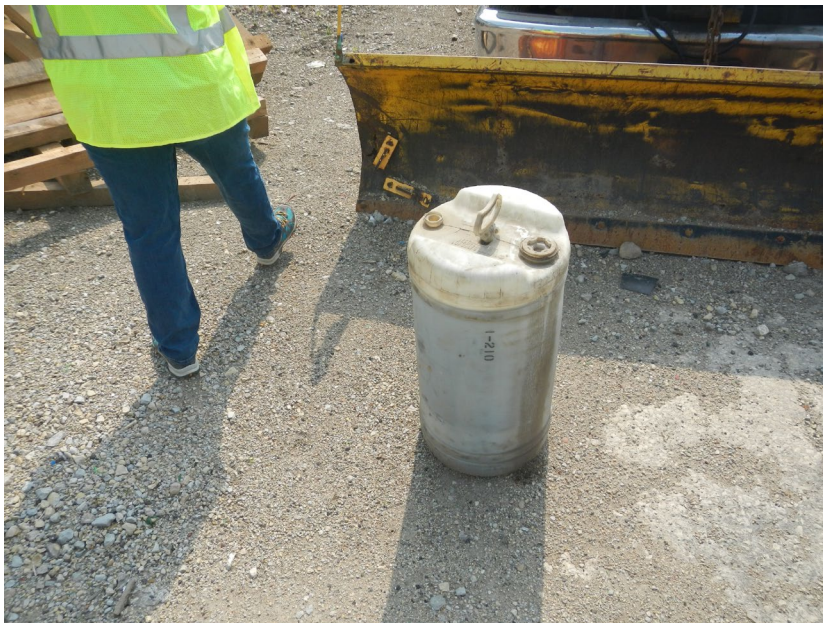
Industrial Stormwater Inspection Direction: West	DESCRIPTION	Used oil container improperly stored at the outdoor equipment maintenance area.	DSCN1209
	PHOTOGRAPHER	Naji J. Ahmad 913 551 7190	Date: 05/10/2022

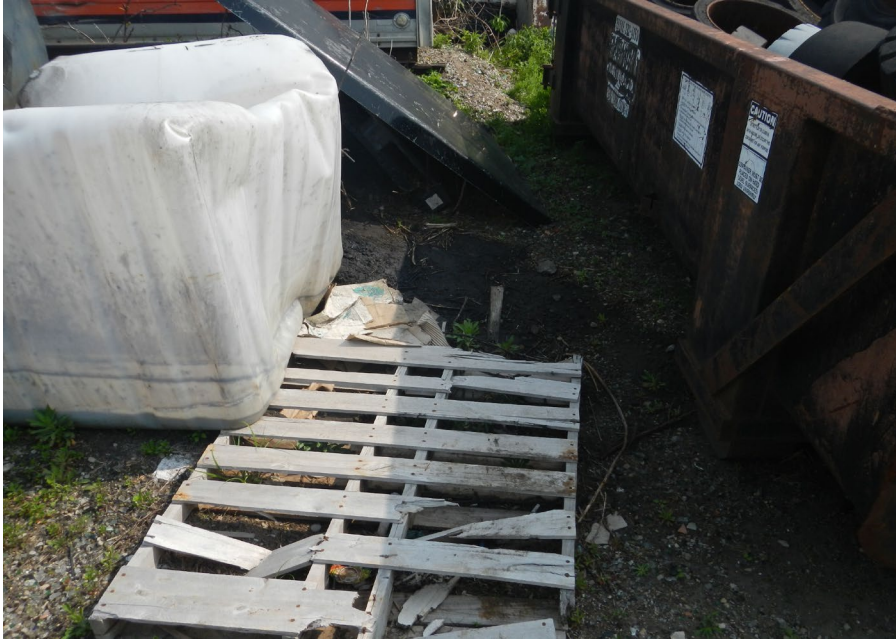
2. I issued NOPF #2 because there was evidence of ground discoloration in the outdoor equipment maintenance area located in the northwest section of the facility (photos #: DSCN1210-1212, 1215, and 1219).

I pointed out my observation of the ground discoloration to Mr. Benham. He indicated that he was not aware of the ground discoloration because he does not inspect this part of the facility. I also explained to Mr. Benham that surface runoff from this area where the equipment is being maintained would flow toward the three inlets and would also leave the site from beneath the fence into the grassy area on the other side of the fence.

Industrial Stormwater Inspection Direction: SE	DESCRIPTION	Significant ground discoloration the outdoor equipment maintenance area.	DSCN1210
	PHOTOGRAPHER	Naji J. Ahmad 913 551 7190	Date: 05/10/2022

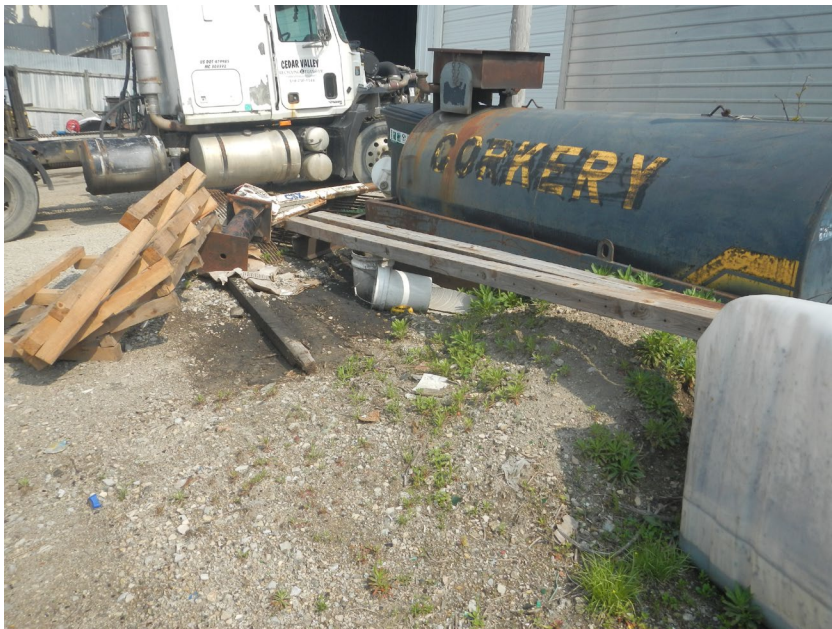
Industrial Stormwater Inspection Direction: West	DESCRIPTION	Significant ground discoloration the outdoor equipment maintenance area.	DSCN1211
	PHOTOGRAPHER	Naji J. Ahmad 913 551 7190	Date: 05/10/2022

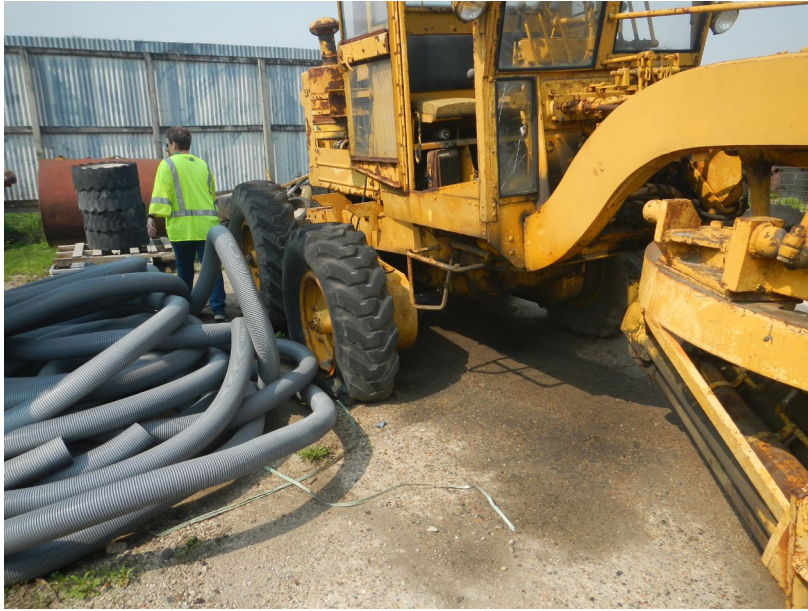
Industrial Stormwater Inspection Direction: SE	DESCRIPTION	More evidence of significant ground discoloration the outdoor equipment maintenance area.	DSCN1212
	PHOTOGRAPHER	Naji J. Ahmad 913 551 7190	Date: 05/10/2022

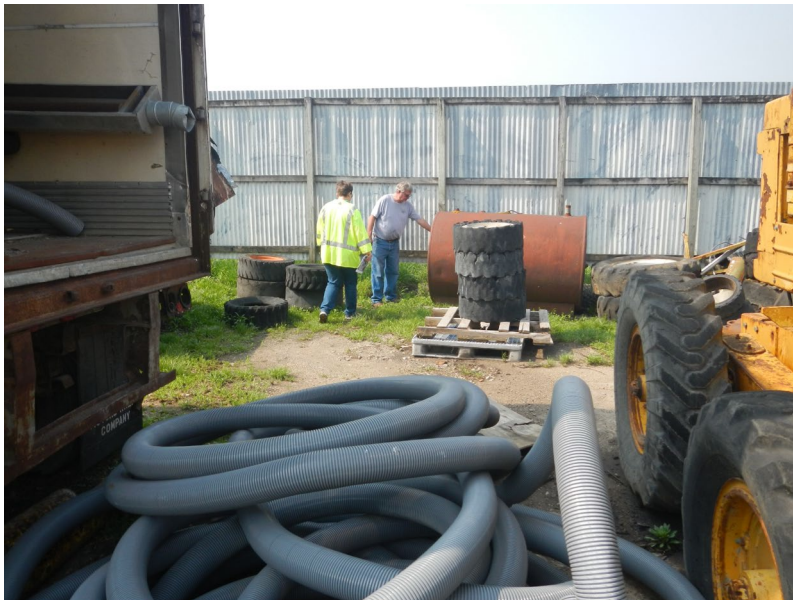
Industrial Stormwater Inspection Direction: West	DESCRIPTION	Empty AST near the drainage of a stormwater inlet.	DSCN1213
	PHOTOGRAPHER	Naji J. Ahmad 913 551 7190	Date: 05/10/2022

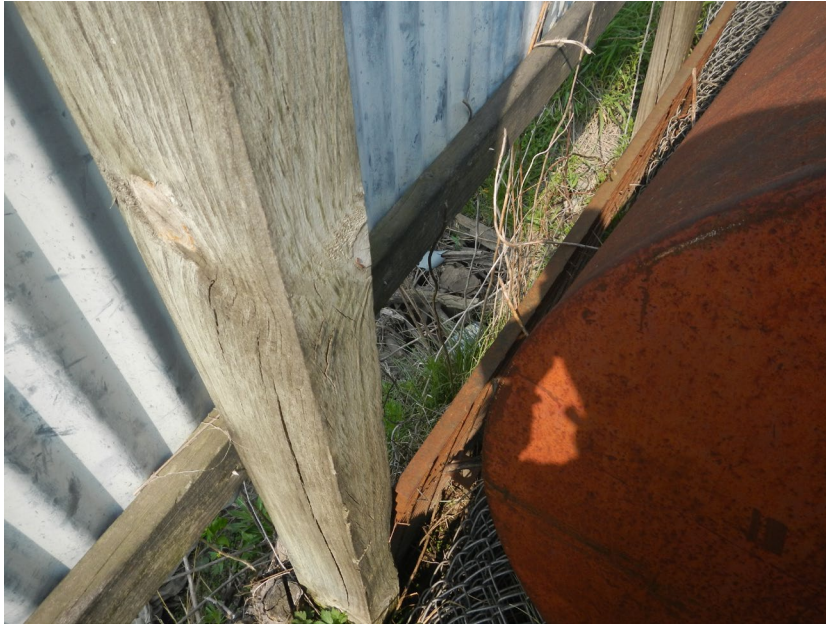
Industrial Stormwater Inspection Direction: SE	DESCRIPTION	Closeup picture of DSCN1213.	DSCN1214
	PHOTOGRAPHER	Naji J. Ahmad 913 551 7190	Date: 05/10/2022

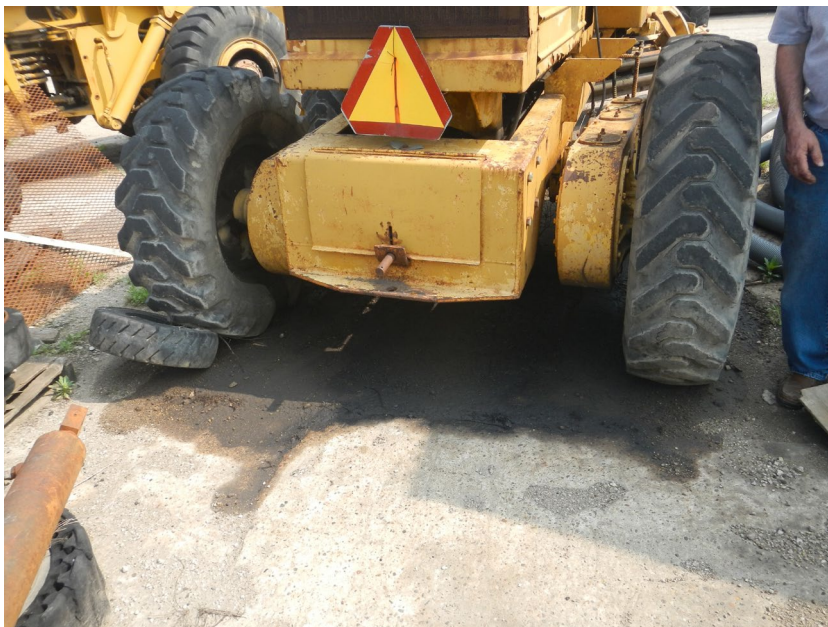
Industrial Stormwater Inspection Direction: West	DESCRIPTION	More evidence of significant ground discoloration the outdoor equipment maintenance area.	DSCN1215
	PHOTOGRAPHER	Naji J. Ahmad 913 551 7190	Date: 05/10/2022

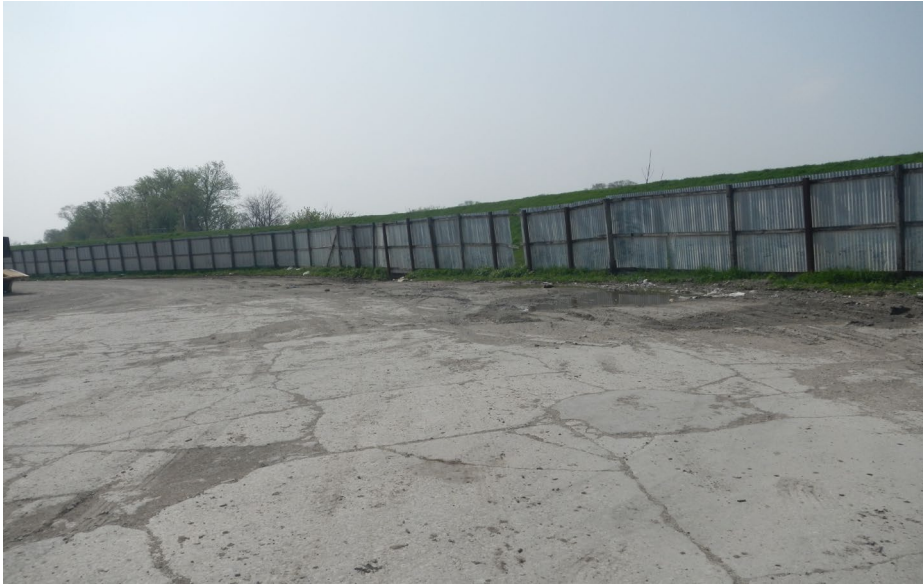
Industrial Stormwater Inspection Direction: SE	DESCRIPTION	Looking toward one stormwater inlet.	DSCN1216
	PHOTOGRAPHER	Naji J. Ahmad 913 551 7190	Date: 05/10/2022

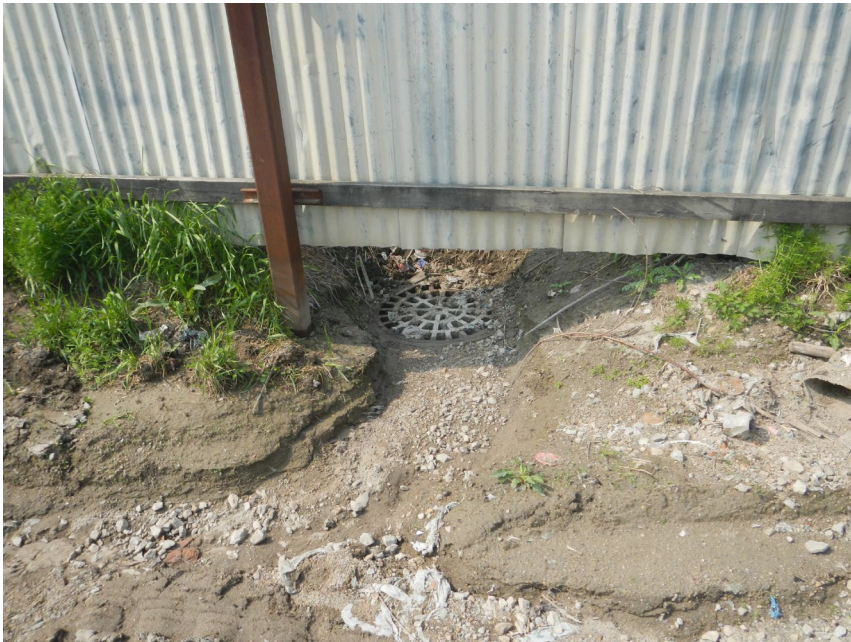
Industrial Stormwater Inspection Direction: West	DESCRIPTION	One of three stormwater inlets. Unprotected.	DSCN1217
	PHOTOGRAPHER	Naji J. Ahmad 913 551 7190	Date: 05/10/2022

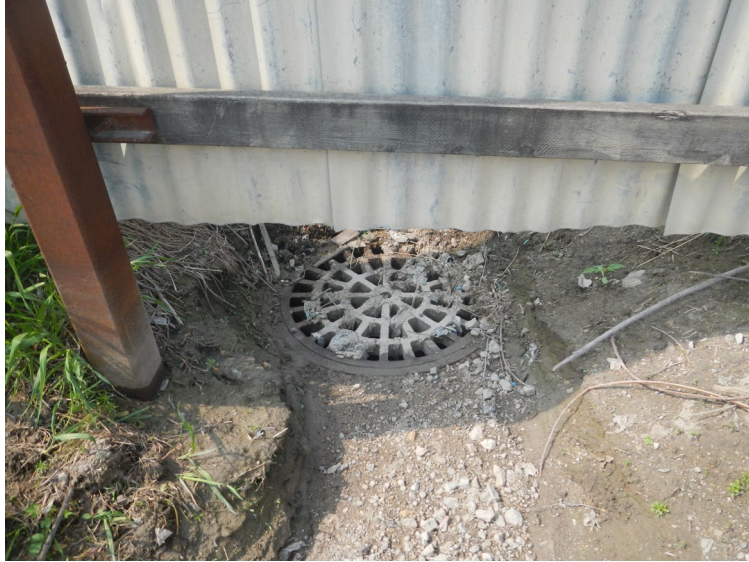
Industrial Stormwater Inspection Direction: SE	DESCRIPTION	On of the three unprotected stormwater inlets.	DSCN1218
	PHOTOGRAPHER	Naji J. Ahmad 913 551 7190	Date: 05/10/2022

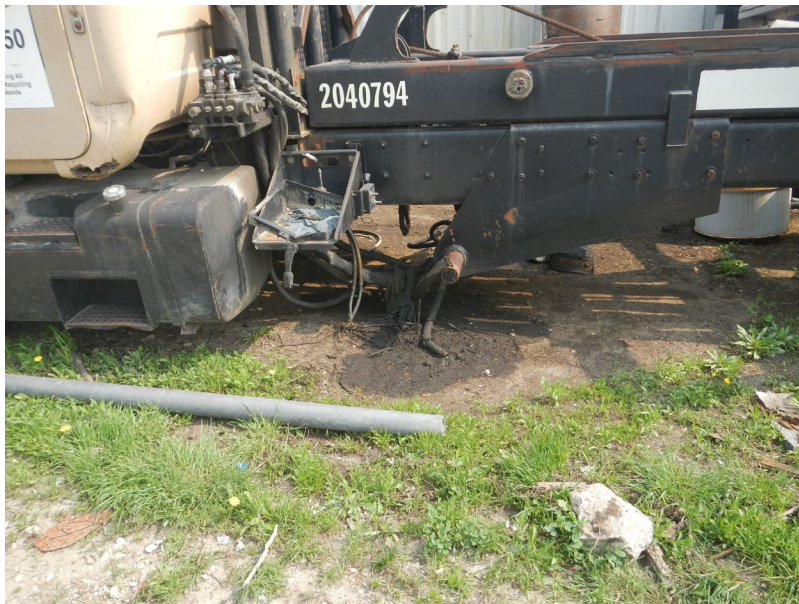
Industrial Stormwater Inspection Direction: West	DESCRIPTION	More evidence of significant ground discoloration the outdoor equipment maintenance area in the SW inlets.	DSCN1219
	PHOTOGRAPHER	Naji J. Ahmad 913 551 7190	Date: 05/10/2022

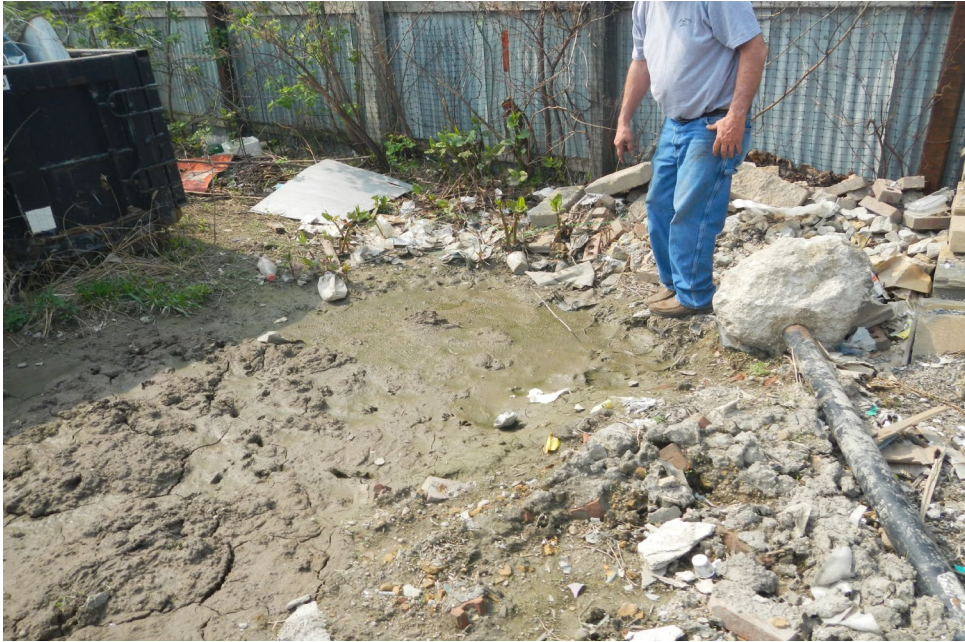
Industrial Stormwater Inspection Direction: SE	DESCRIPTION	Accumulated sediment near on of the SW inlets.	DSCN1220
	PHOTOGRAPHER	Naji J. Ahmad 913 551 7190	Date: 05/10/2022

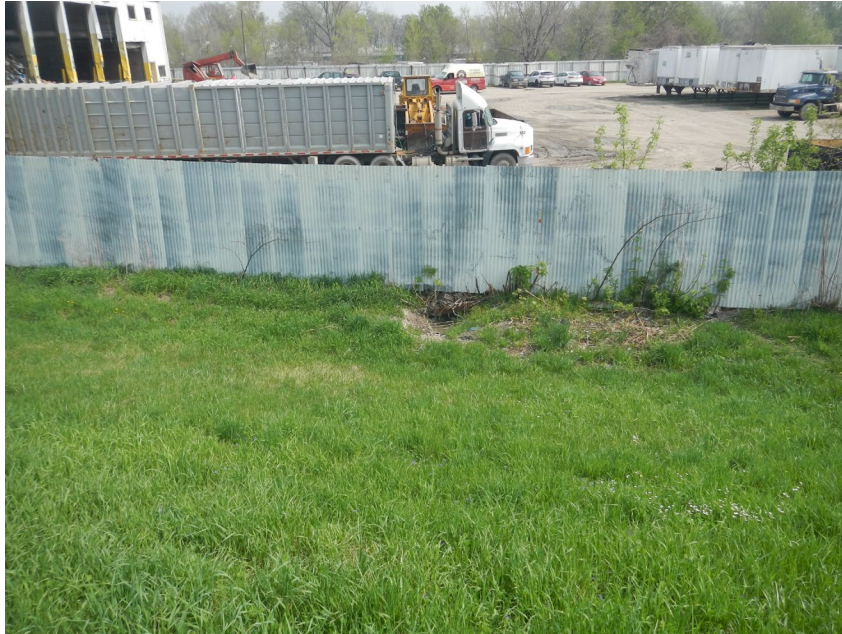
We walked along the grassy area between the facility's west fence line and the Cedar River levee. At the grassy area we observed two discharge points where stormwater surface runoff would leave the site from beneath the west fence and puddle on the grassy area and absorbed by the ground (photos #: DSCN1224 and 1225).

Industrial Stormwater Inspection Direction: North.	DESCRIPTION	Surface discharge from the site into the grassy area.	DSCN1224
	PHOTOGRAPHER	Naji J. Ahmad 913 551 7190	Date: 05/10/2022

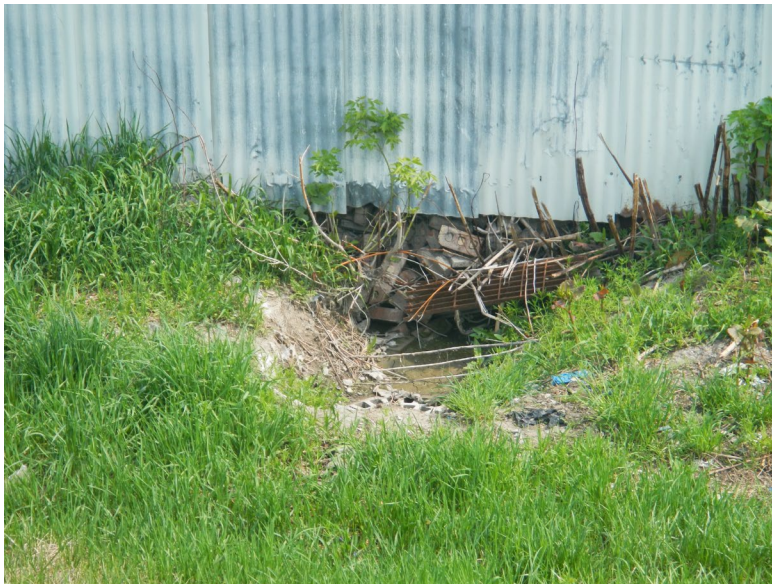
Industrial Stormwater Inspection Direction: N	DESCRIPTION	Closeup picture of DSCN1224.	DSCN1225
	PHOTOGRAPHER	Naji J. Ahmad 913 551 7190	Date: 05/10/2022

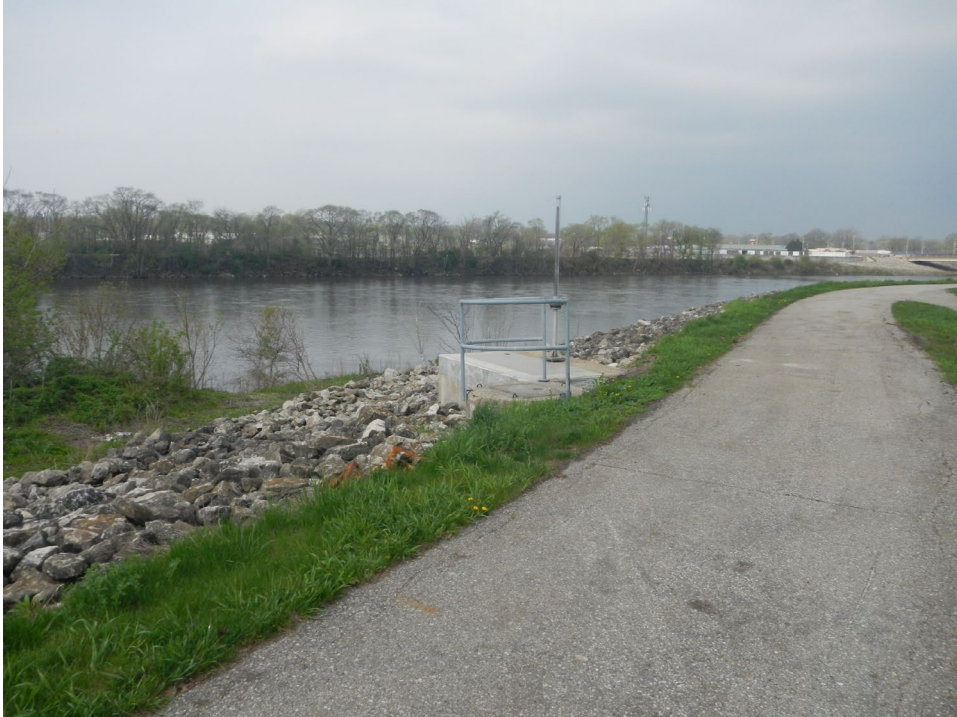
We also walked the bank of the Cedar River to locate outlets of the three stormwater inlets, but we were unsuccessful (photo #: DSCN1226).
