**COMPLAINT RECORD**

SUBJECT: Animal Feeding Operations Complaint Investigation  
Complaint No: 11/06-10 Carroll County

## Report of Investigation

Re: Animal Feeding Operations Complaint Investigation  
Complaint No. 11/06-10, Pig Haven Swine Confinement

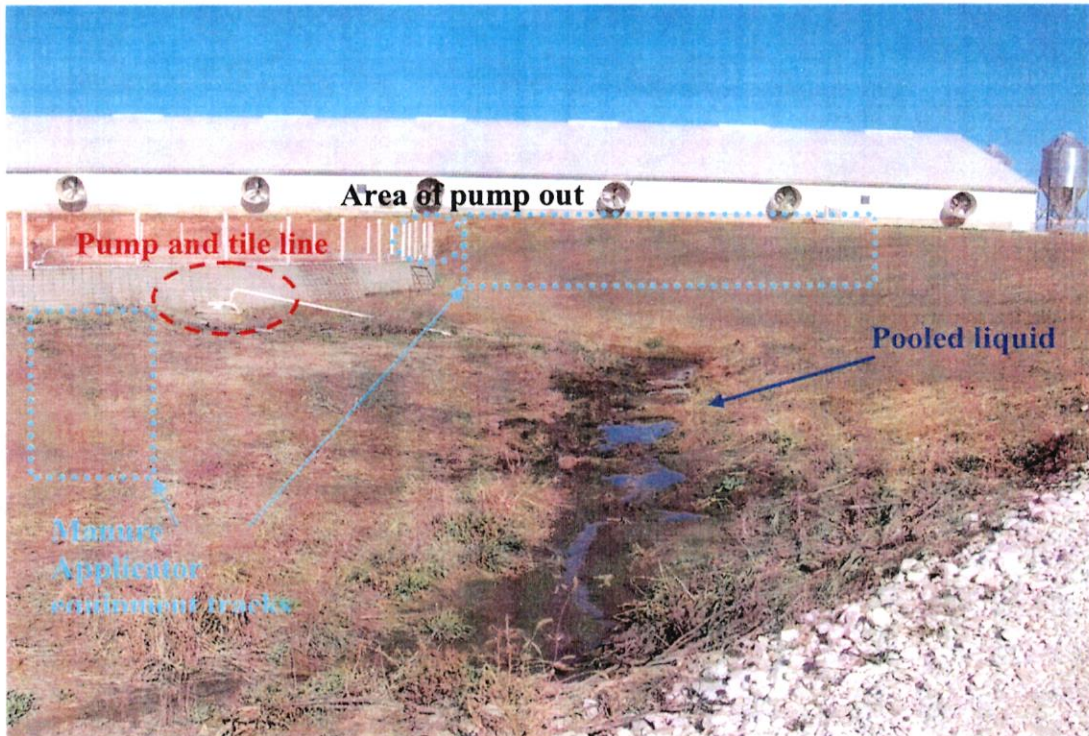
During the investigation it was observed that a tile line does outlet near the concrete manure structure. However, according to Kevin Pietig, Site Manager, a groundwater lowering tile was installed at the base of the structure when it was constructed. A pump is located in a wet well that pumps the groundwater through the tile line onto the surface of the ground. Liquid was pooled on the ground. Photos below document the observations made during the investigation.

While the pump was not running and the tile line was not flowing during this investigation, field tests of the liquid were conducted. The ammonia concentration of the liquid was more than 250 mg/L. A sample of the liquid was obtained and was submitted to the University Hygienics Laboratory to be analyzed. A follow-up investigation will be conducted in the near future in an attempt to obtain a sample of the liquid flowing out of the tile outlet.

Steve Hugerich, Environmental Manager, was contacted by telephone. It was required that an extension to the tile outlet be added and be directed back into the concrete structure immediately. Mr. Hugerich stated that the tile would be installed that day.

It is required that an engineer licensed in the State of Iowa evaluate the concrete structure to determine if is leaking. The evaluation must be submitted to this office no later than **January 1, 2007**.

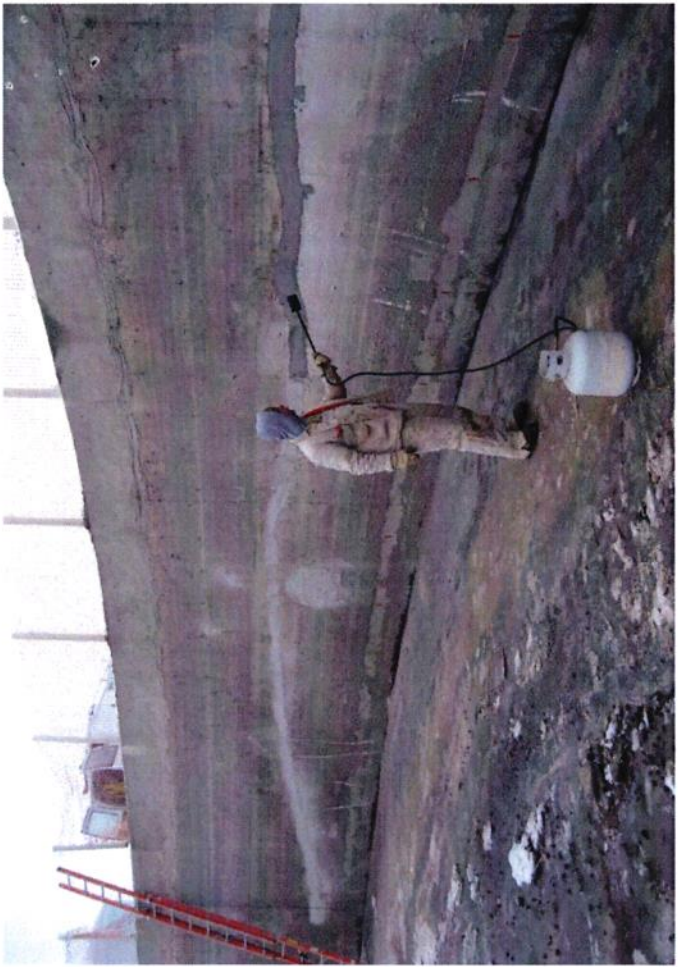
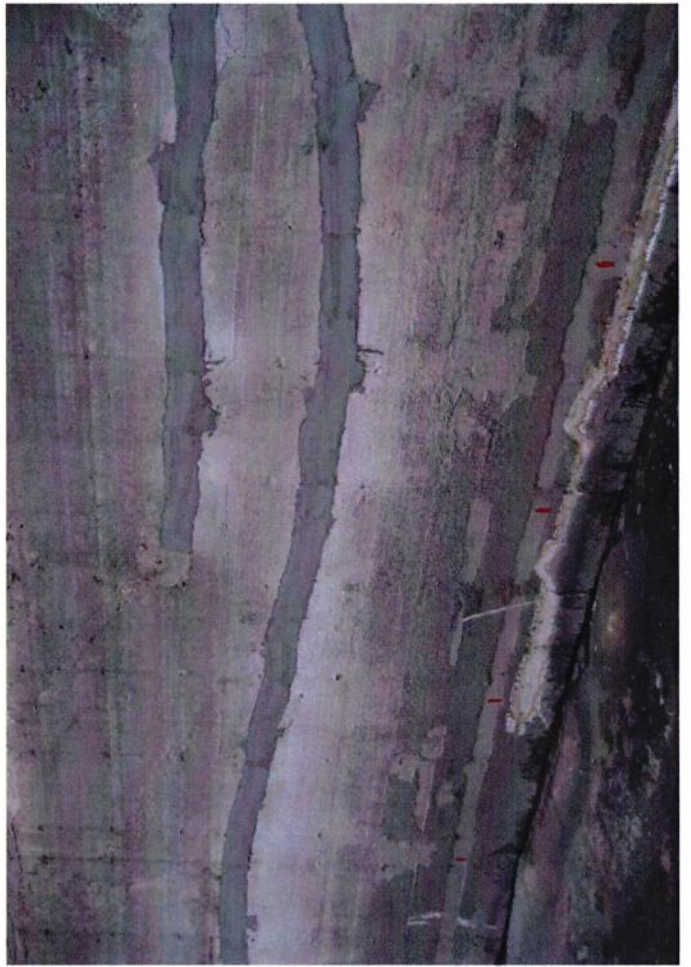
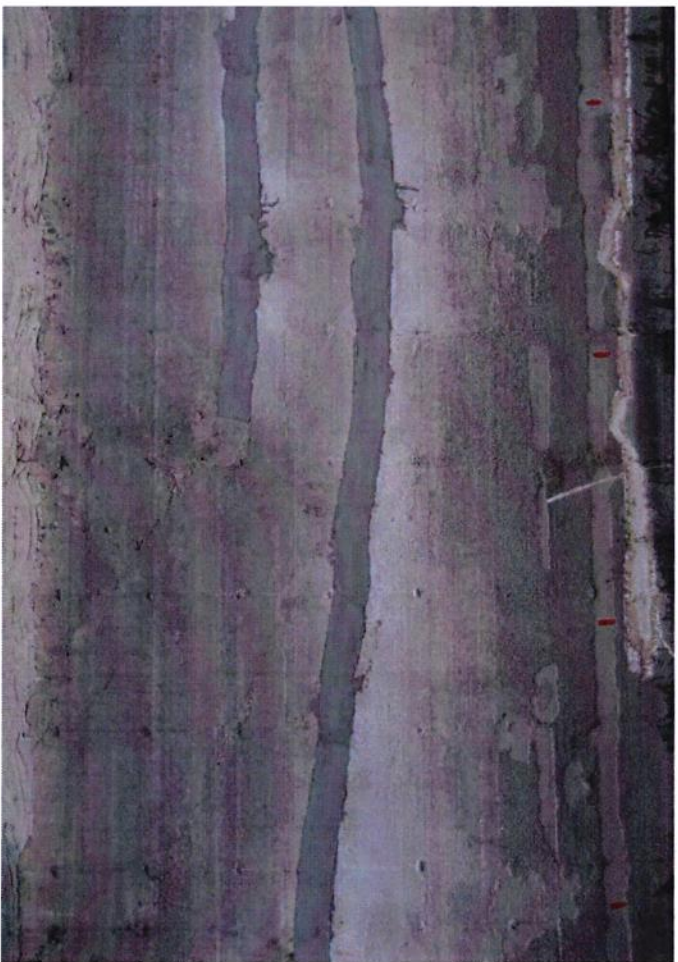
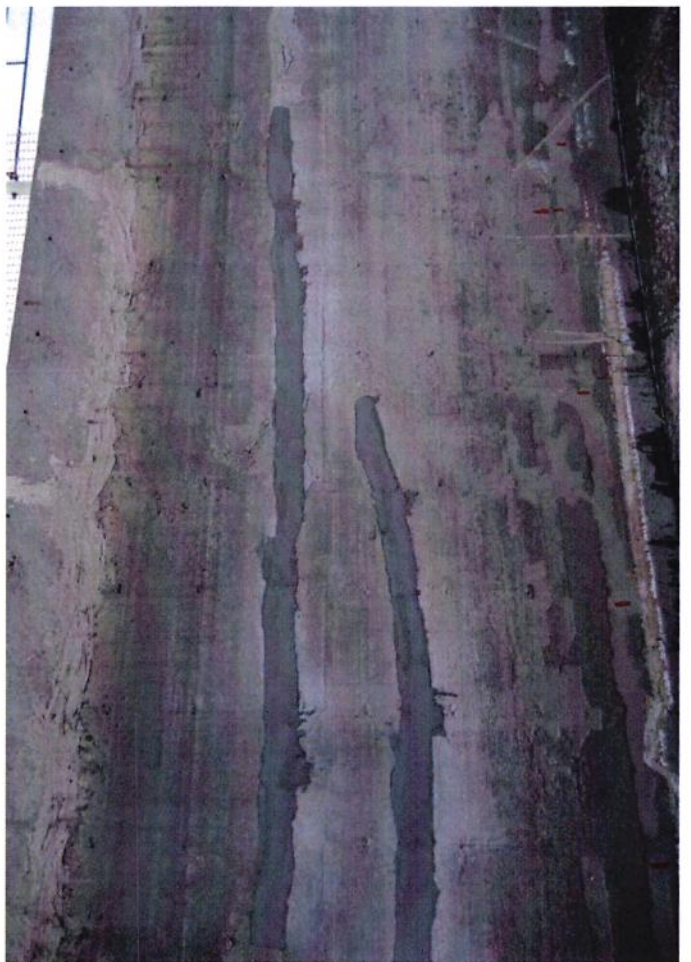
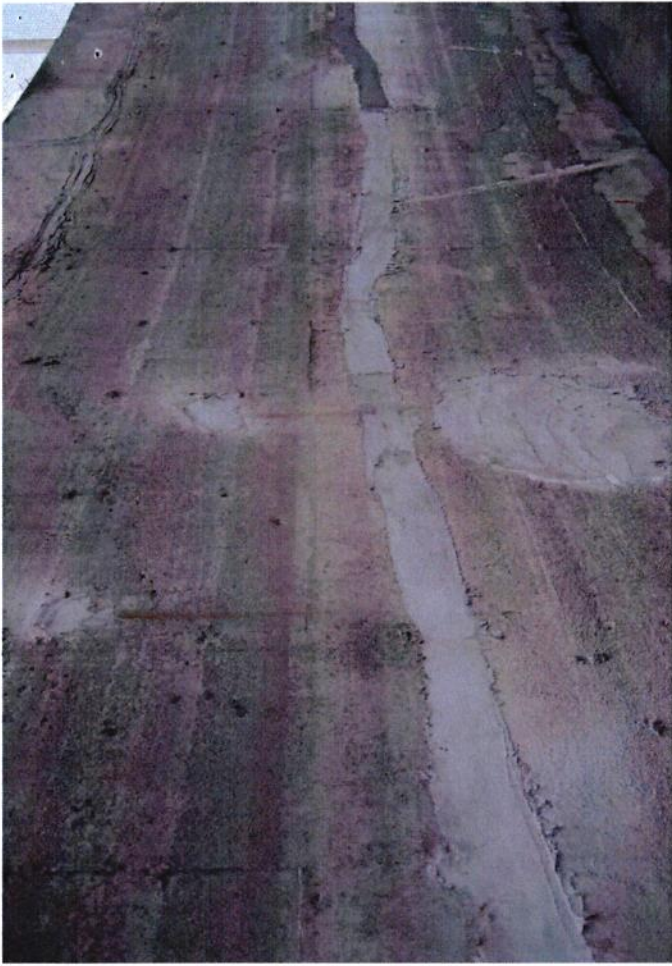
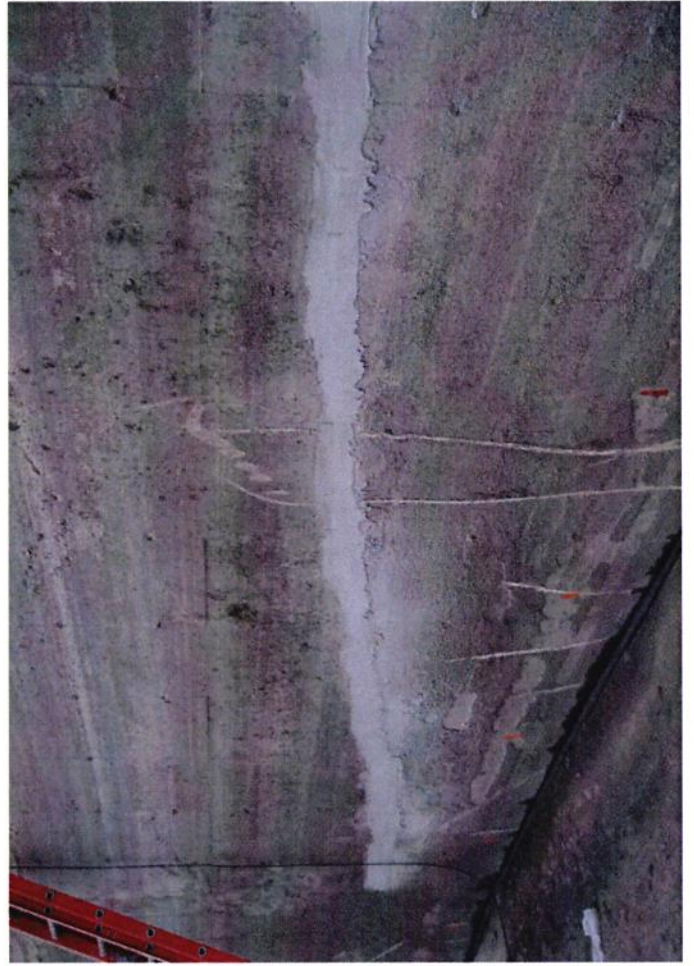
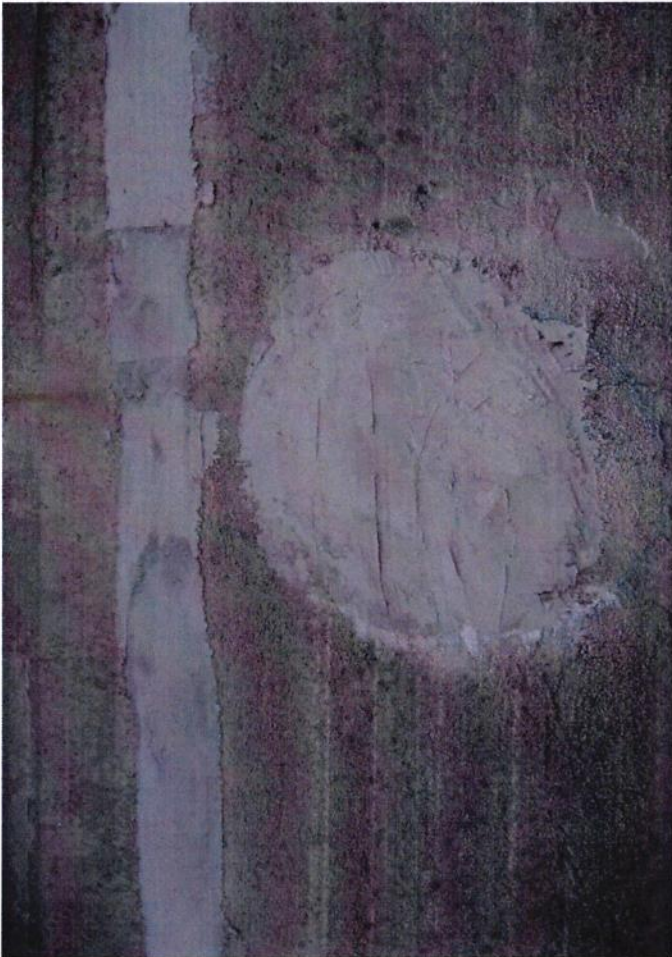
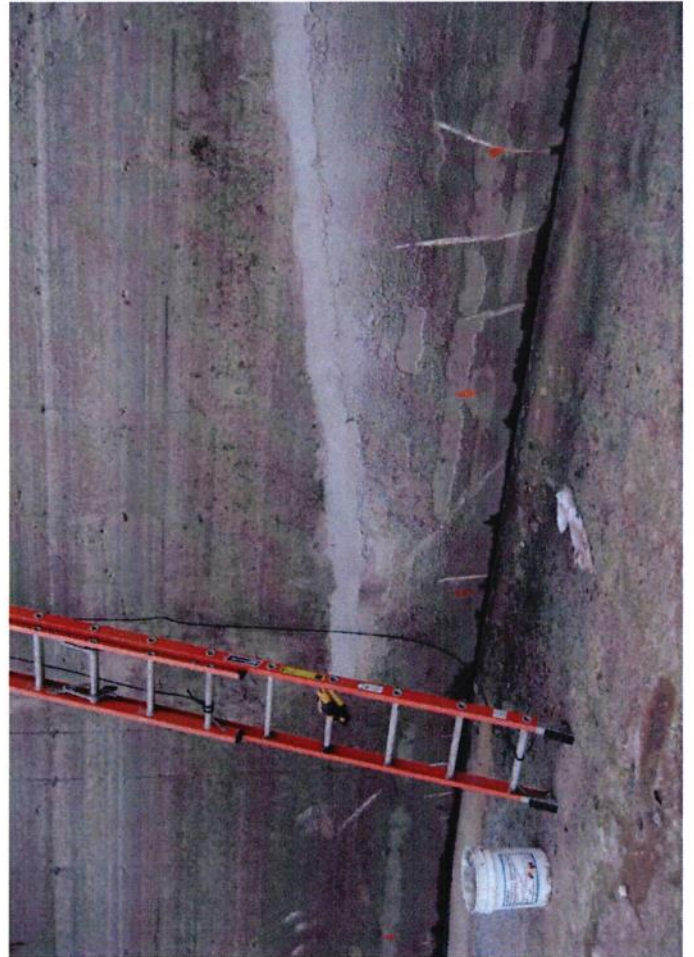
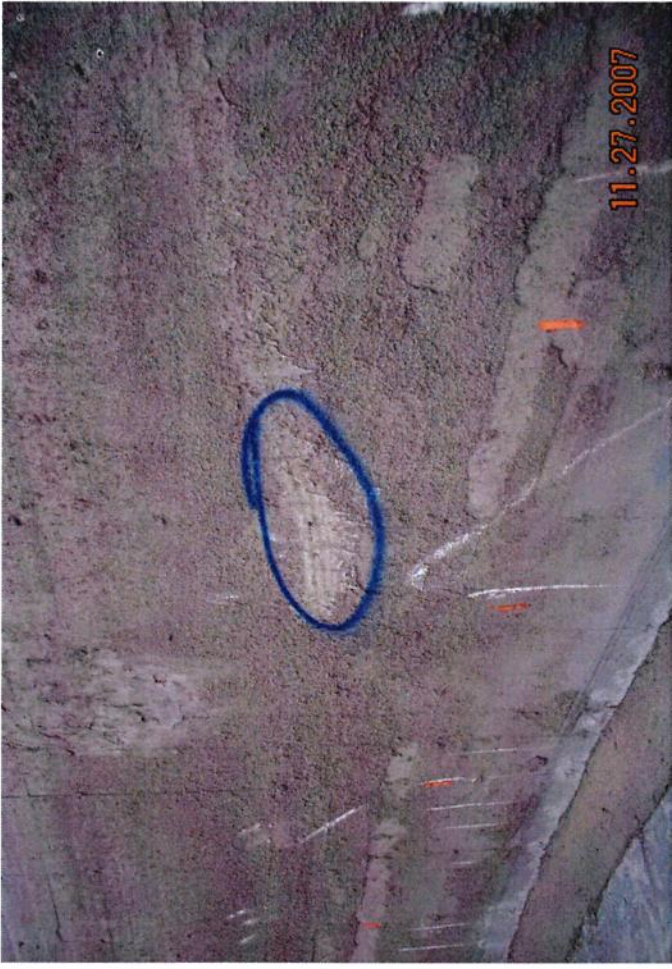
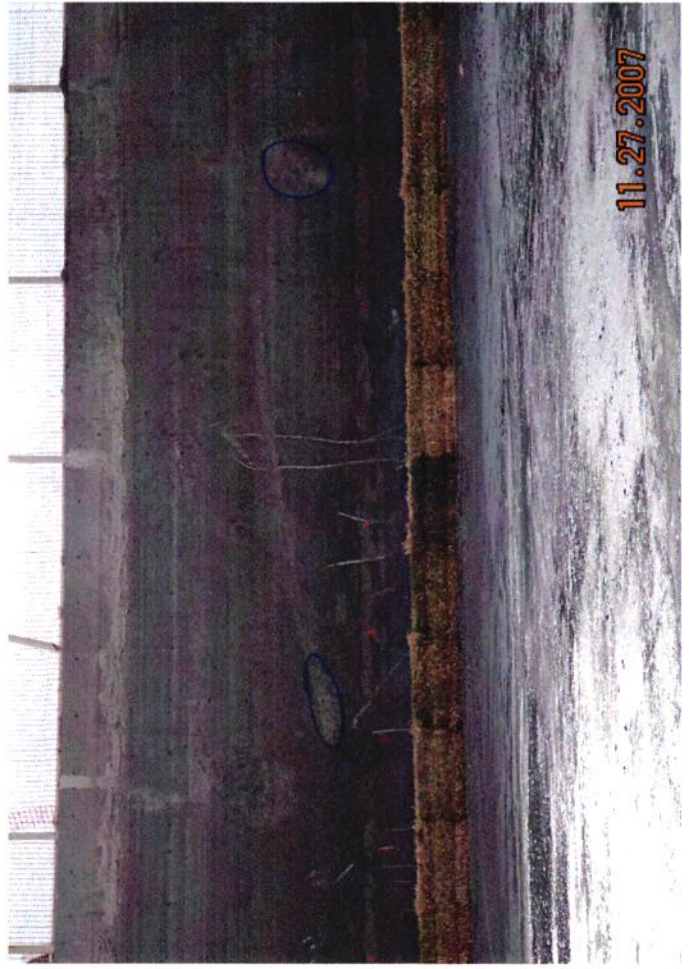
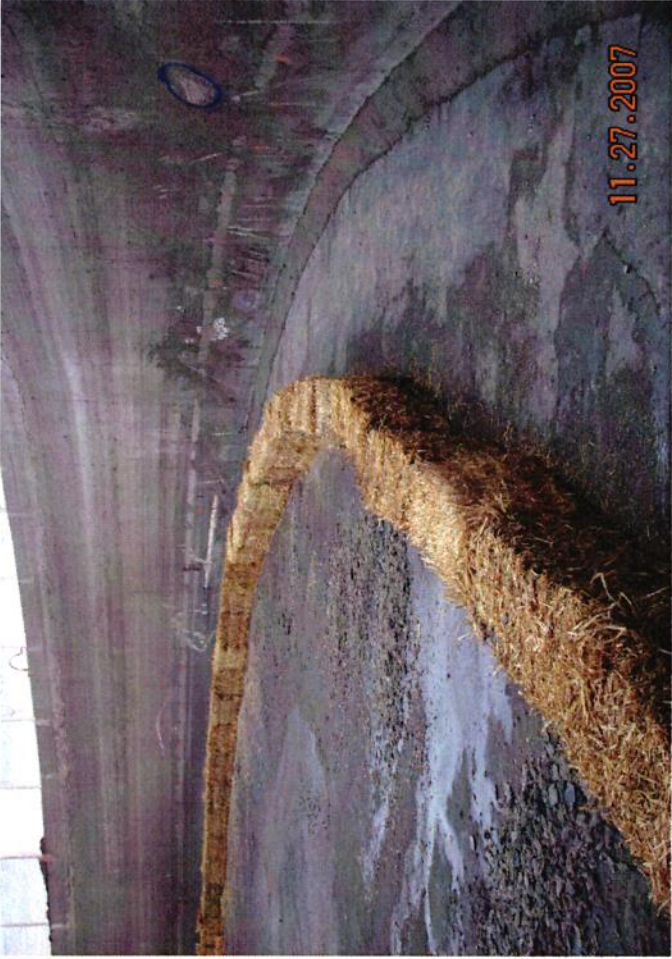
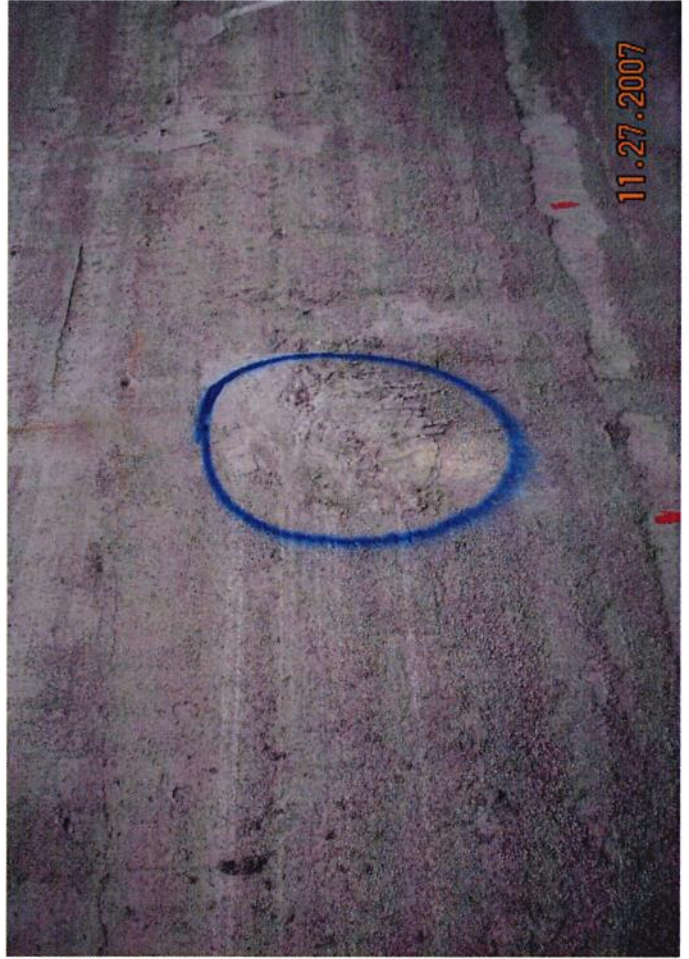
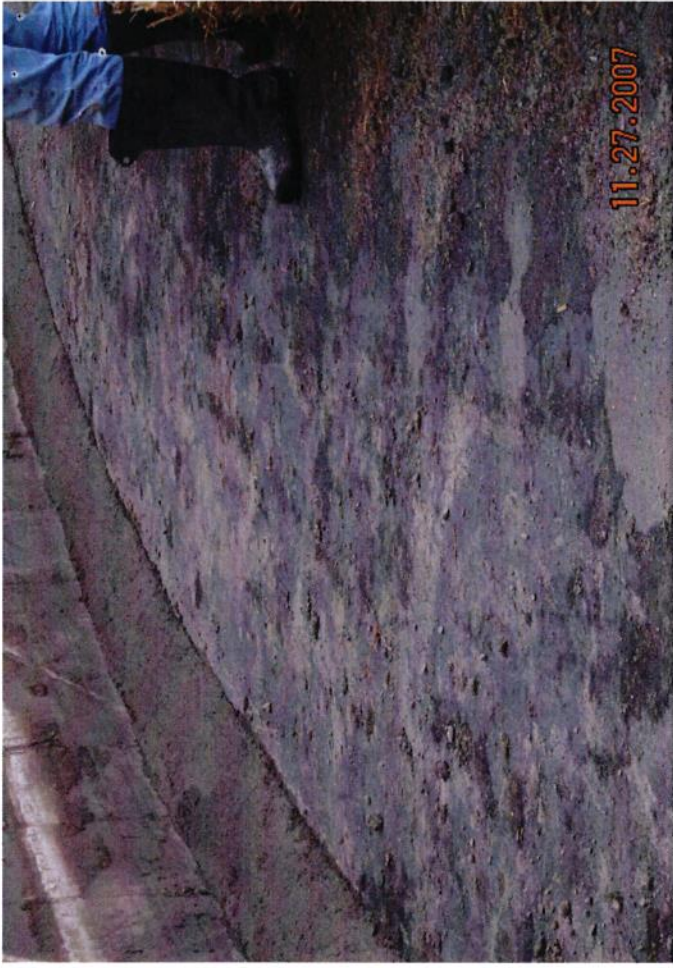
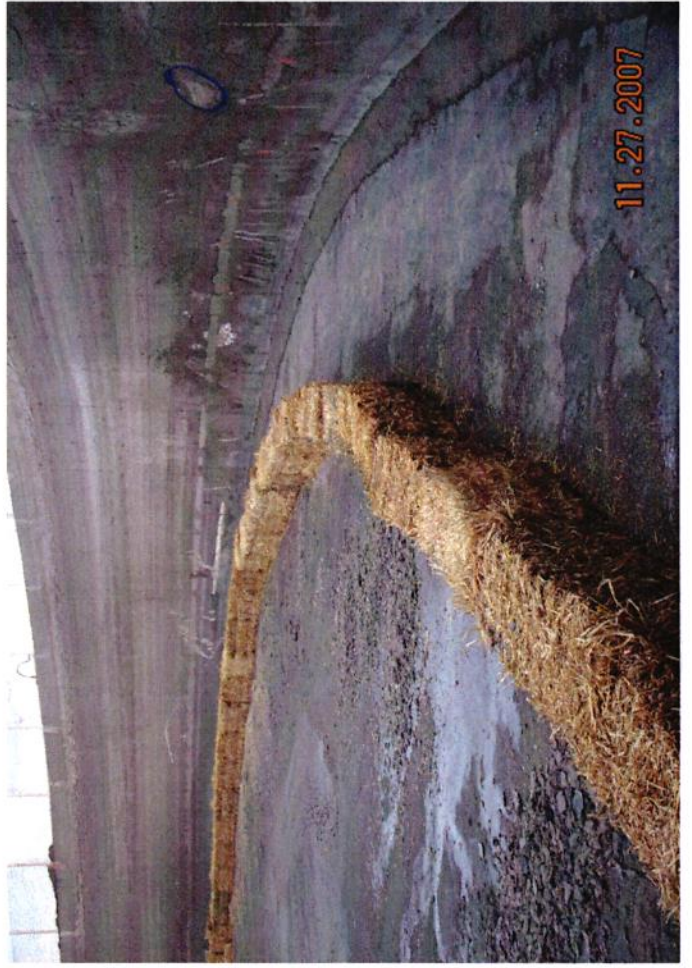
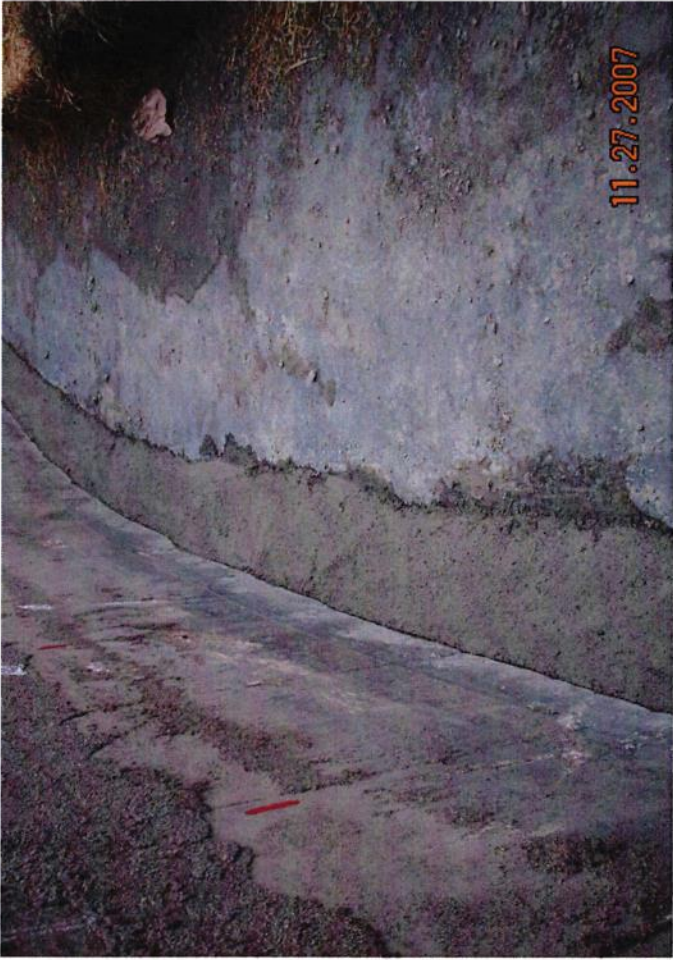
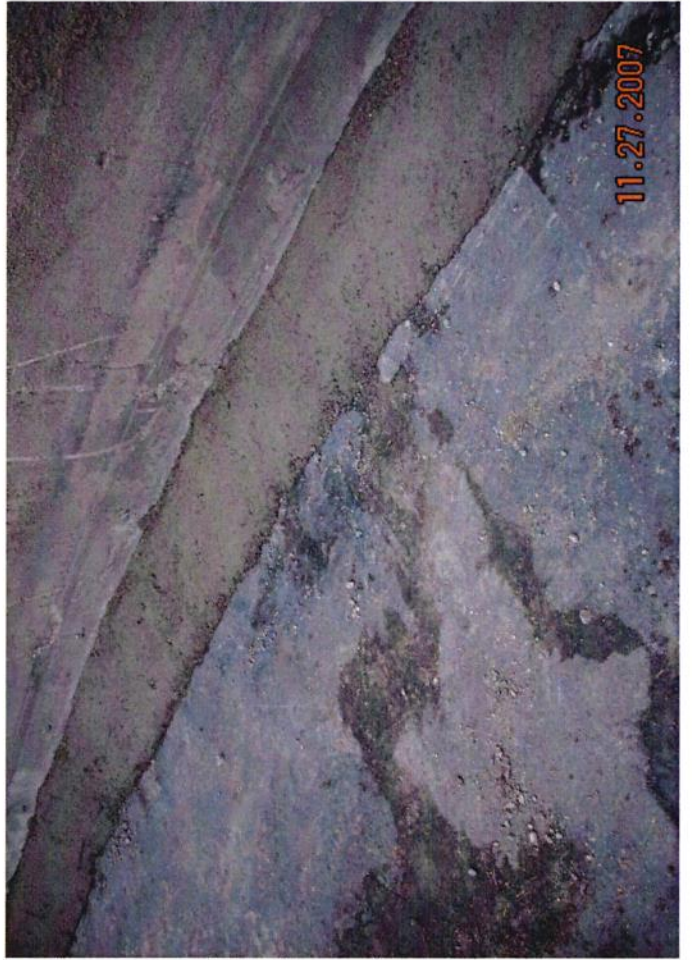
were taken of the repairs and are enclosed. The tank had been emptied and the floor power washed around the perimeter. Straw bales had been used to make a manure barrier approximately 8 feet back from the inside of the tank. Rusty Triggles and Mike Parkis had placed a concrete fillet around the entire inside perimeter of the tank. The following steps were followed:

It was during our field visit that we further reviewed the cold joint in the south portion of the tank wall. I directed that additional patching was necessary to ensure this cold joint would not leak. Two areas were marked for repair. Due to cold weather conditions, this additional patching was not completed until December 20 and 21, 2007. Rusty Tigges and Mike Parkis again performed the repairs and took additional pictures to document their work. The cold joint in the tank wall was to be chipped and ground out to remove loose material and then blown out and sealed with a non-shrink grout. They even re-patched a portion of the joint that was repaired last year to ensure no leakage.

With this letter I am certifying that the walls and floor of this tank are sound and the leakage issue with this tank has been addressed. It should be noted that it will take some time for the Chloride and Ammonia Nitrogen levels in the ground water around the tank to drop, because of the past years of seepage. However, again the environmental risk of this seepage has been minimal because the groundwater that is collected by the tile system is pumped to the surface and filtered through over 900 feet of vegetated road ditch prior to reaching waters of the State. In addition, the soils around the tank are clay soils with a low permeability. Therefore, I do not feel is necessary to monitor the groundwater for Chloride and Ammonia Nitrogen. I recommend the department accept the repairs and allow normal use of the tank.

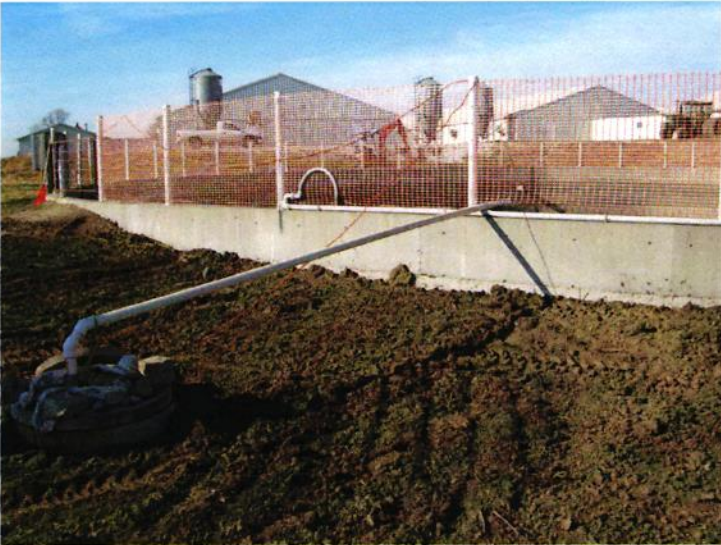
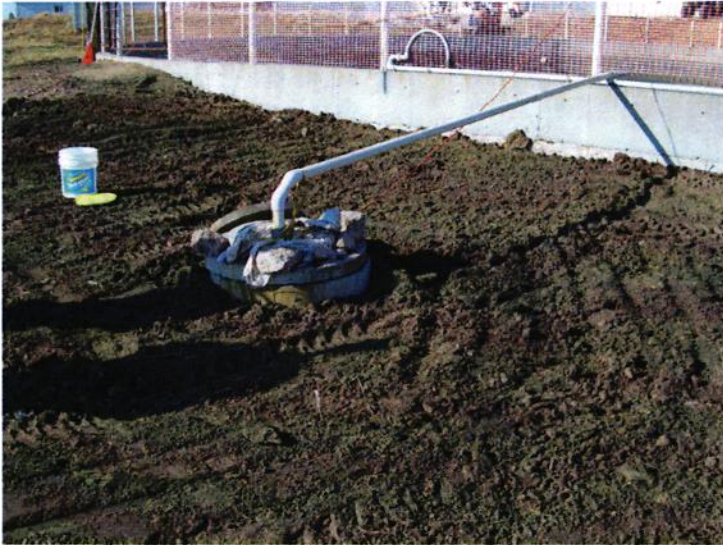
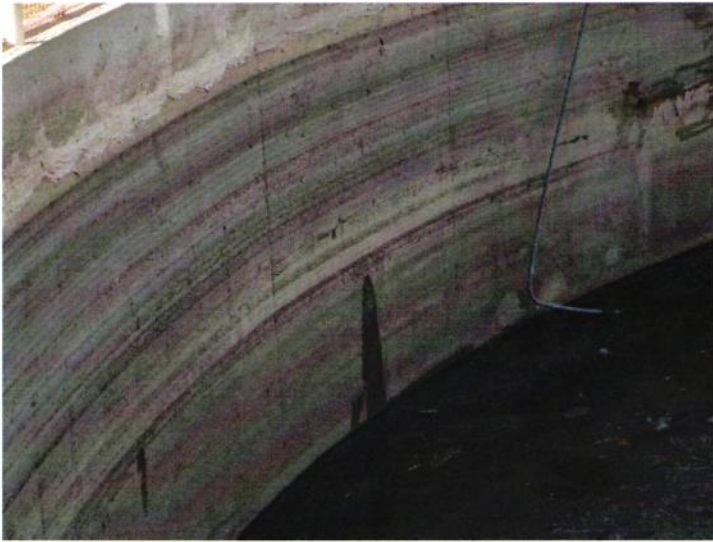
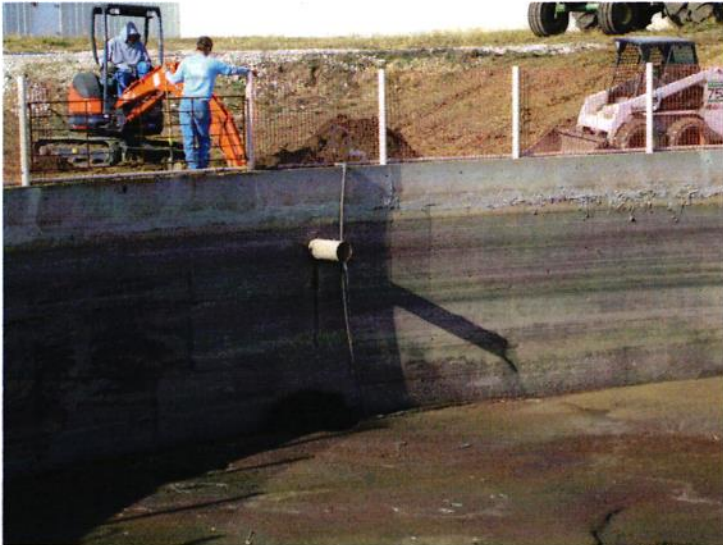
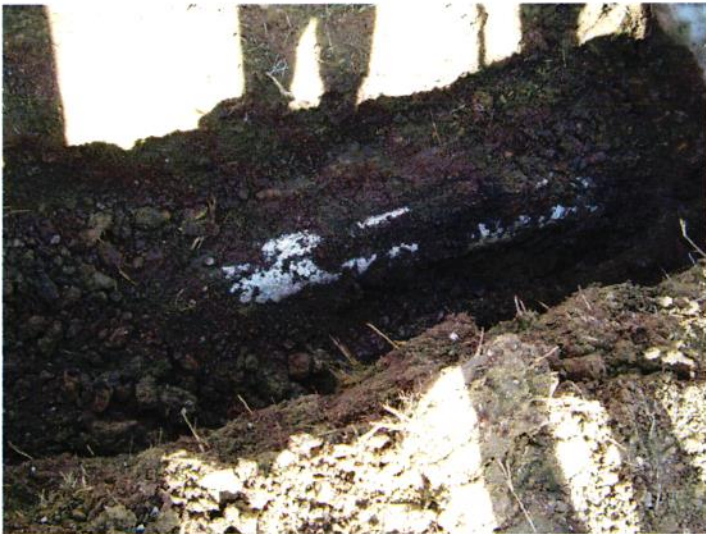
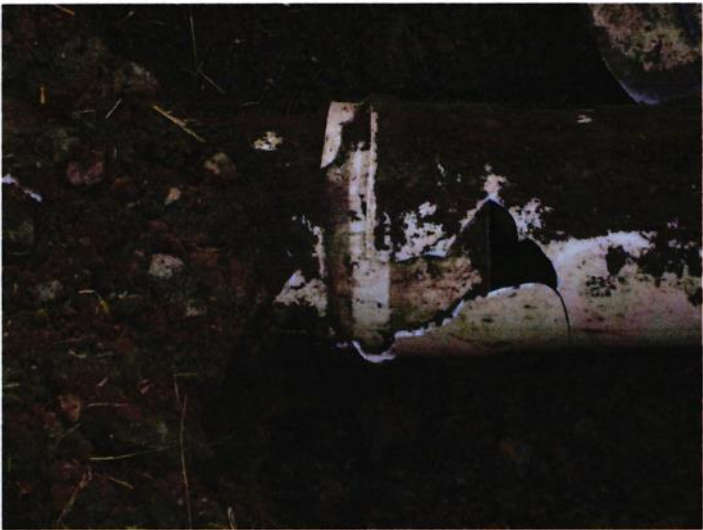
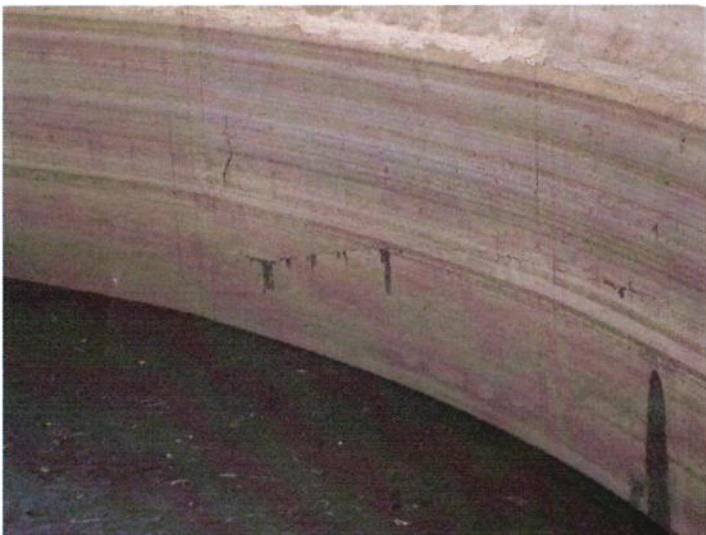
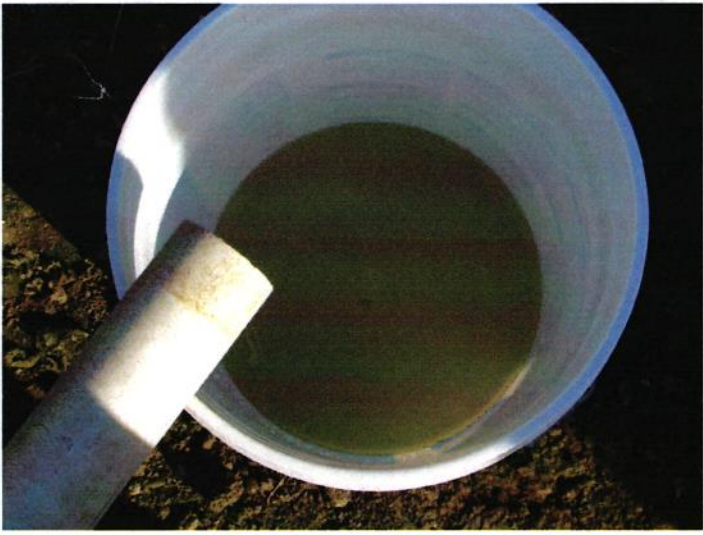
**FIELD INSPECTION**  
**11-22-06**

Kuehl & Payer, Ltd. performed an on site inspection on November 22, 2006. I arrived on site at 11:10 a.m. and pictures of this inspection are enclosed. Steve Huegerich, Facility Manager, Kevin Pietig, Site Operation Manager, and Rusty Triggles, Maintenance Foreman were on site for the inspection. We performed a visual inspection of the tank walls from the surface. A cold joint line in the concrete was noticeable in the west wall starting at the inlet pipe and extending southwest approximately 80 feet. Moisture appeared to be seeping into the tank from this joint line. In addition, there appeared to be seepage under the PVC inlet pipe. The remainder of the tank wall looks good with no signs of cracking. The cold joint line would have occurred from poor construction procedures. The placement of the concrete probably began in this area and continued clockwise around the tank. By the time the forms were filled and concrete placement returned to the beginning location the concrete in the bottom of the forms was setting up and vibration was not extended down the forms to penetrate the surface prior to addition concrete being placed over top.

As part of the inspection, the inlet pipe was excavated by Rusty Triggles exposing approximately 10 feet of the pipe. The soil along this 10 inch diameter PVC pipe was saturated for approximately 3 feet back from the wall. Beyond three (3) feet the soil was not saturated and did not smell of organics. However, roughly 6 feet back from the wall we located a bell pipe fitting in the line. The pipe was cracked and during excavation, a piece of the pipe broke out.

We believe the manure has been able to seep out of the concrete tank through voids along a cold joint in the tank wall caused by poor concrete placement. The repairs completed should address this seepage except for at the south end of the cold joint in the tank wall. Because of the wet and cold weather after Thanksgiving the additional patching did not get accomplished as planned in December. This is why this report was not submitted by January 1, 2007. Therefore, the patching of this joint from the outside of the wall should be performed this spring after the tank is pumped down below the elevation of the cold joint. We will want to inspect the patching work this spring before any backfilling is completed.

The repairs recommended included repairing the broken inlet pipe and sealing around the tank wall penetration with a non-shrink grout. The cold joint in the tank wall was to be chipped and ground out to remove loose material and then blown out and sealed with a non-shrink grout. Rusty Triggles was in charge of the performing the repairs with his plan to complete the repairs in the next two to three days. I departed the site at 12:50 p.m.

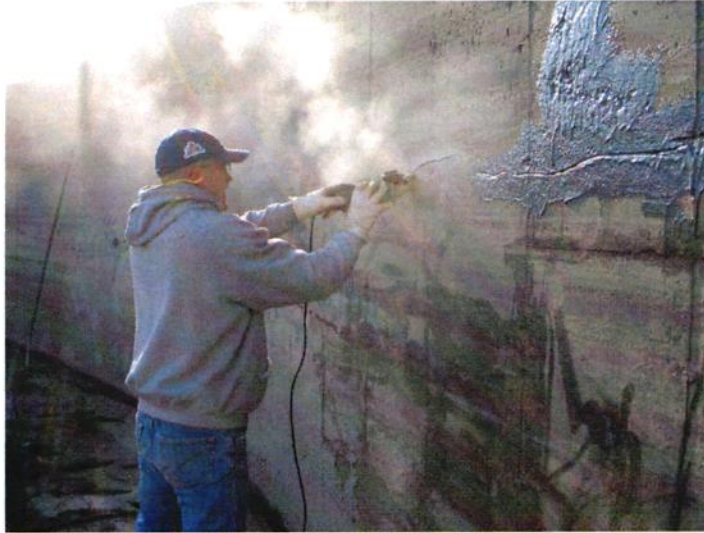
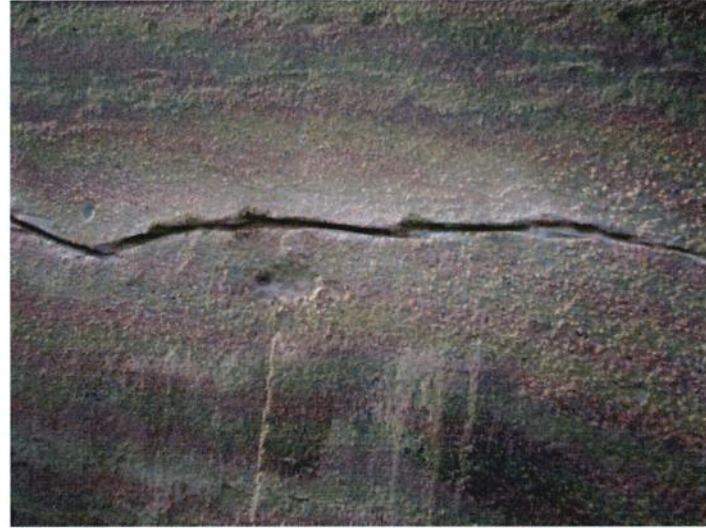
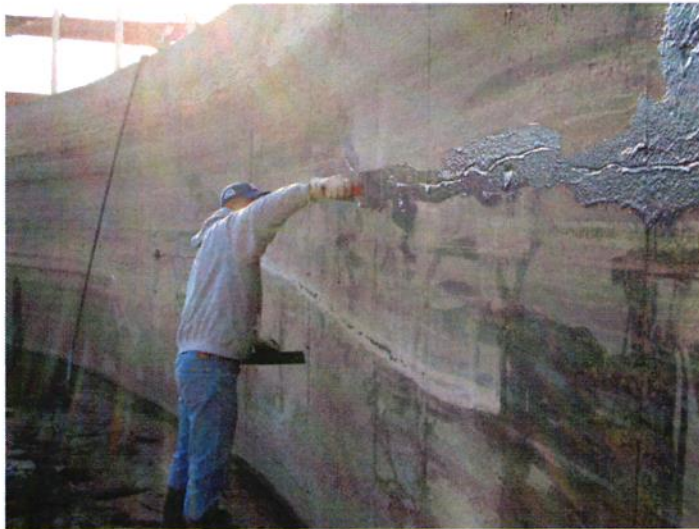
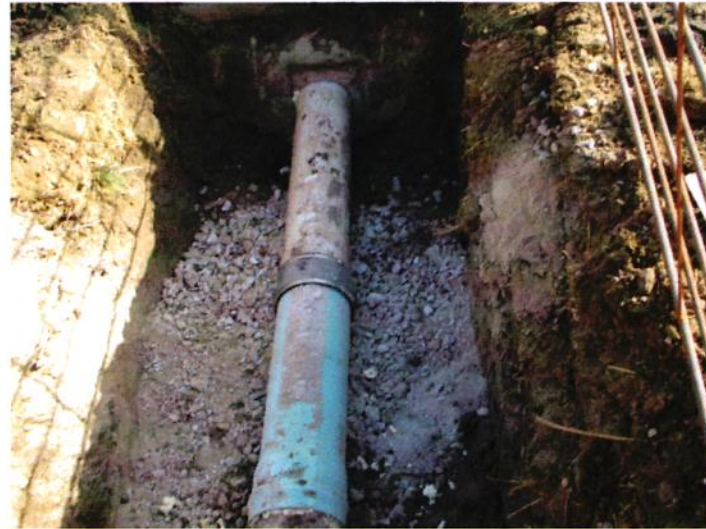
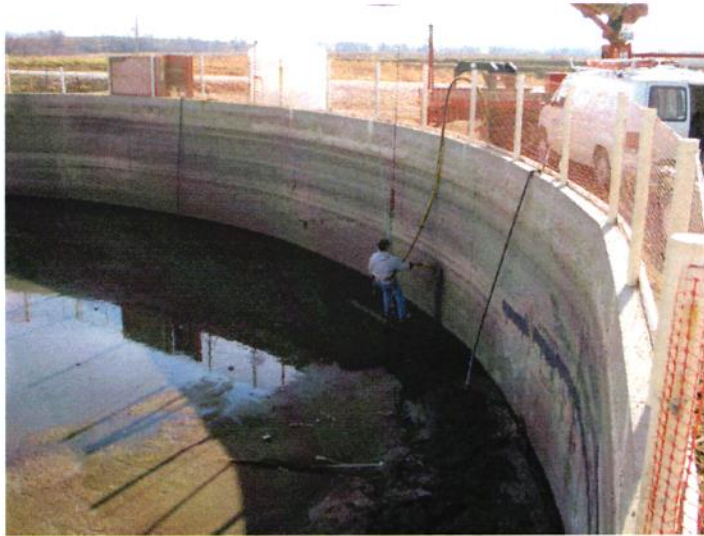
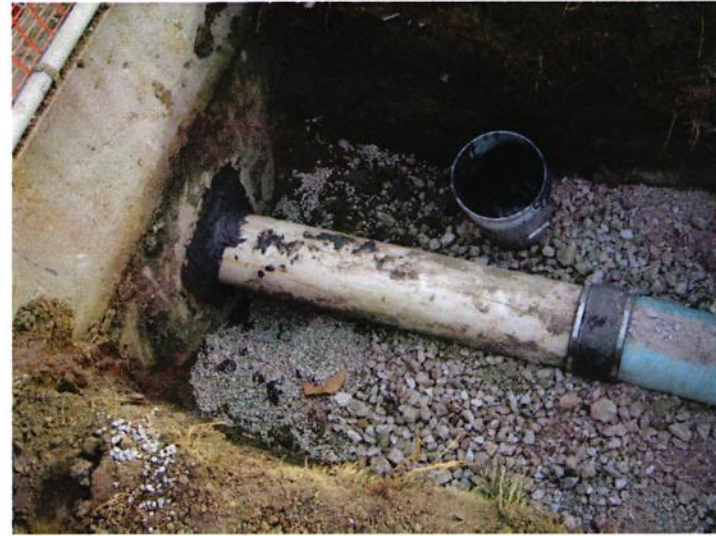
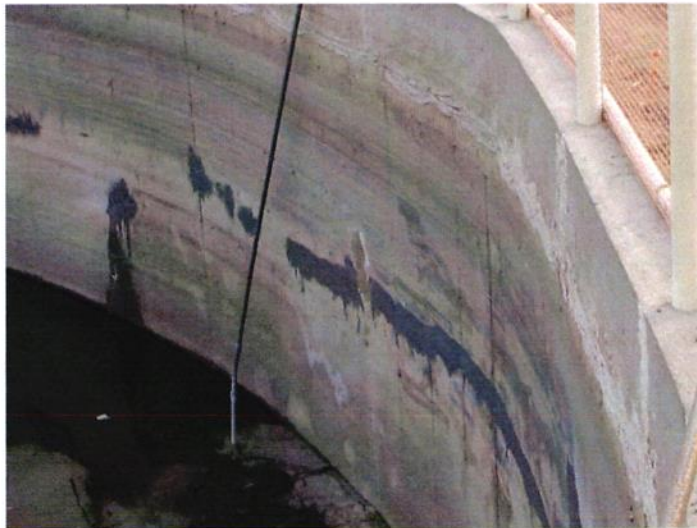
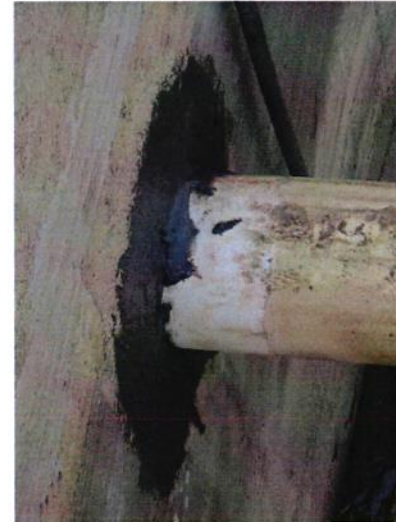
**REPAIRS BY JUERGENS PRODUCE**  
**11-23-06 AND 11-24-06**

The inlet pipe had been repaired with a new section of PVC installed by Mr. Triggles. The concrete wall at the penetration of the inlet pipe had been sand blasted clean and grout applied. The seal looked good. In addition, Mr. Triggles and his assistant had chipped, grounded and sand blasted the cold joint in the concrete. Pictures provided by Juergens Produce of the repair work show the procedures followed. The application of the grout looked good and no signs of seepage existed except for the far south end of the cold joint. Mr. Triggles explained that seepage was coming in during their patching operation and they could not get the joint to completely seal off. They had also excavated along the outside of the tank in this area and found saturated soil above the tile system and could not clean up the wall to patch from the back side due to groundwater. Because the weather was getting cold they did not want to leave the excavation open to freeze and backfilled the trench. We agreed that this area of tank was to be excavated again and the joint sealed from the back side with good clay soil used for backfill and compacted along the tank wall.

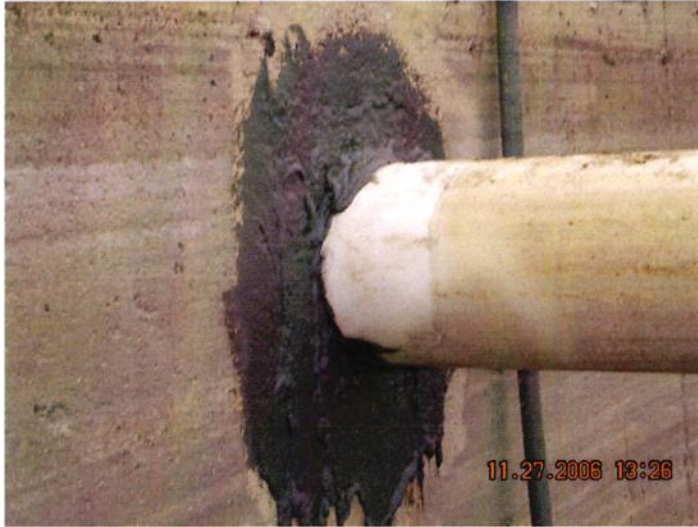
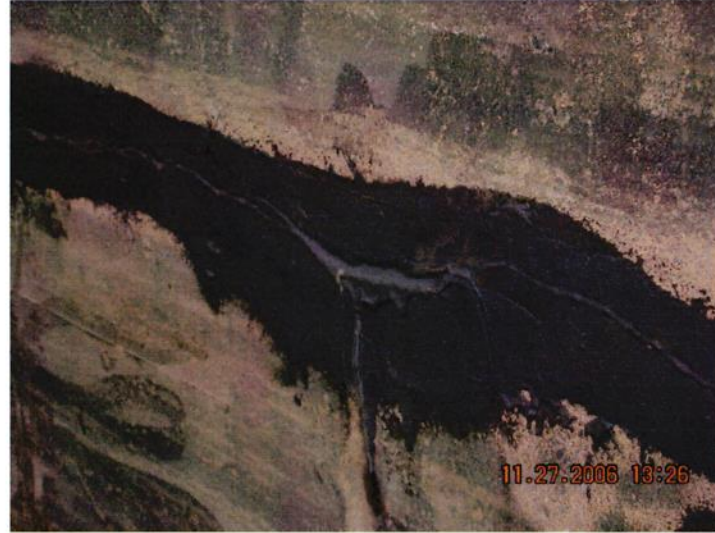
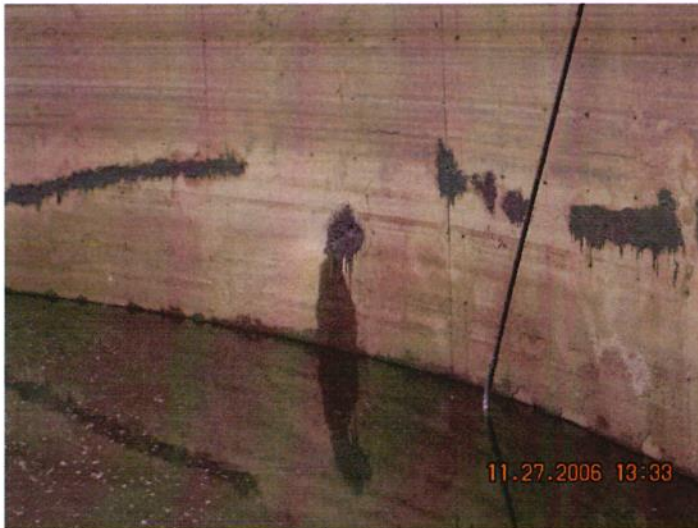
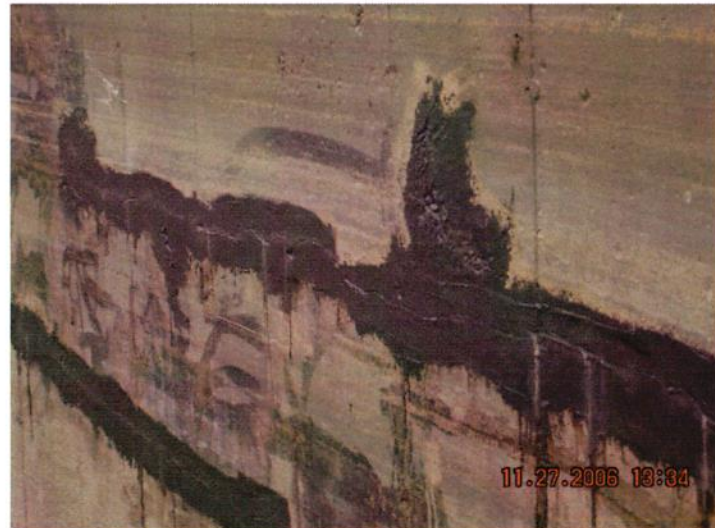
# REPAIR INSPECTION

I was contracted by Rusty Triggles on November 23, 2006, that the repairs were nearing completion. I then performed an on site inspection of the repairs on Monday, November 27, 2006. Pictures of the repairs are also enclosed. The grout use for sealing the joint is Summitville S-400, a chemical resistant 100% solids epoxy, TCA Formula AAR II HT.

It will be necessary to monitor the effectiveness of the repair work by resampling and testing of the groundwater for Chloride and Ammonia Nitrogen. We would recommend this be done three months after the last patching is completed. This will allow time for containments to flush through out the tile water. Until tests show the tank is not leaking, the discharge from the tile system should continue to be pumped back into the concrete storage tank. If leakage continues to be apparent this next summer we would recommend that the floor of the tank be inspected next fall after emptying is possible and the floor can be washed clean. However, due to the voids found along the cold joint in the tank wall we believe this to be the source of the leakage problem. A cold joint should have been less likely in the concrete work of the tank floor and due to solids in the manure and cracks that may exist in the floor would most likely fill and seal up.
