MEMO

DATE: July 27, 2022
TO: MEMO TO FILE
FROM: Jon Ryk, ES *JRM*
RE: Complaint Investigation
FOCD Complaint ID: 31314 / FOCD Staff Action ID: 162242
FACILITY: PB Leiner USA
FACILITY ID: 82-01-064

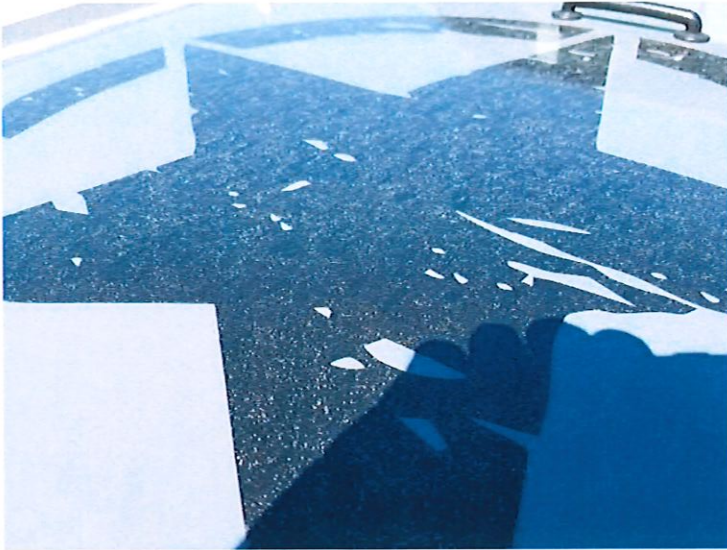
After meeting with Andy Murdock, I checked some of the darker colored vehicles in the parking area north of the facility and was able to see particulates on them. Samples obtained from prior sampling in July and August, 2022 were submitted to the State Hygienic Lab in Coralville for light microscopy analysis indicated that dust from the vehicles in the north lot included particulates that were similar to the particulates from the cartridge filters for EP-3 and 5, and to the dust from the tissue loadout.

View of dust on vehicle to the north of the PB Leiner Offices.

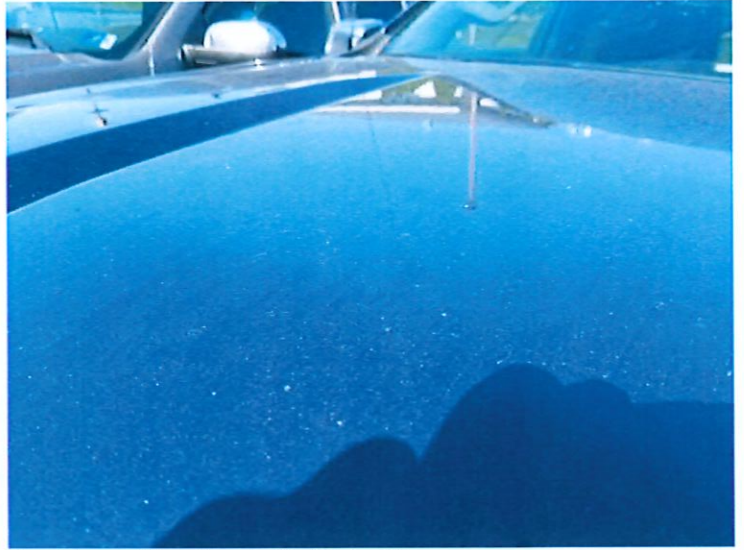
View of dust on vehicle to the north of the PB Leiner Offices.

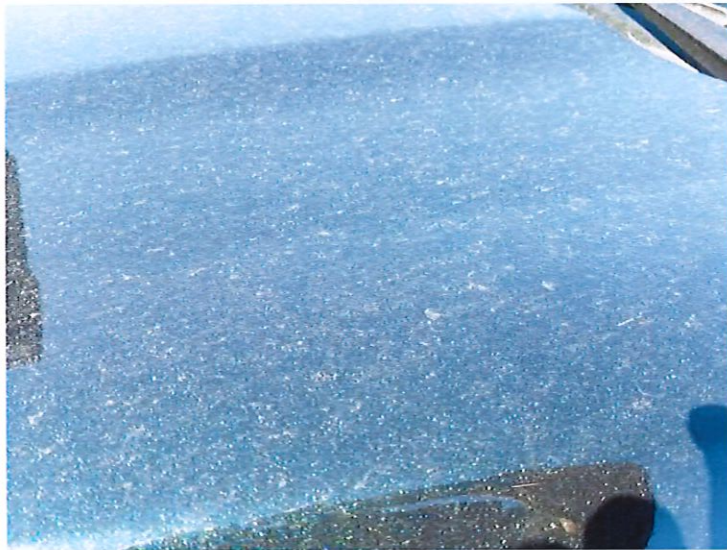
View of dust on vehicle to the north of the PB Leiner Offices.

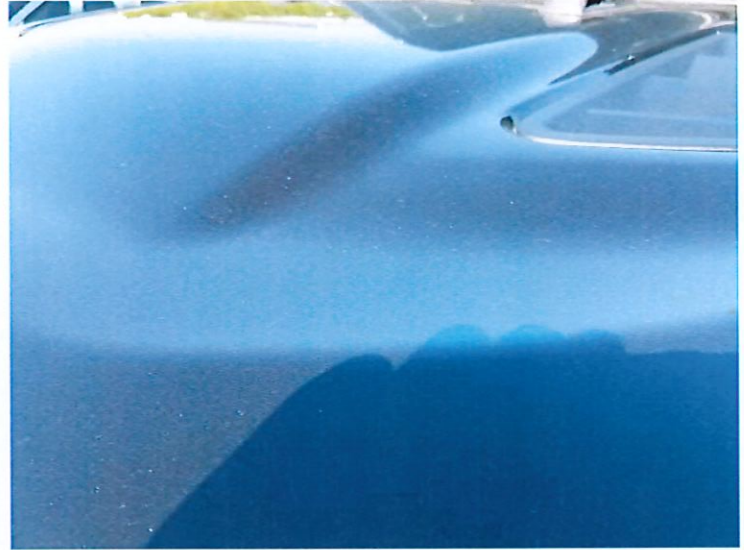
View of dust on vehicle to the north of the PB Leiner Offices.
