MEMO

Date: 9/1/21
To: Chamness SDP File
From: Brian Lee, ES

Facility: Chamness SDP, Permit # 90-SDP-10-97P-COM
RE: Derecho Mulch Fire, 8/23-27, 30/2021 visits, complaint #29884

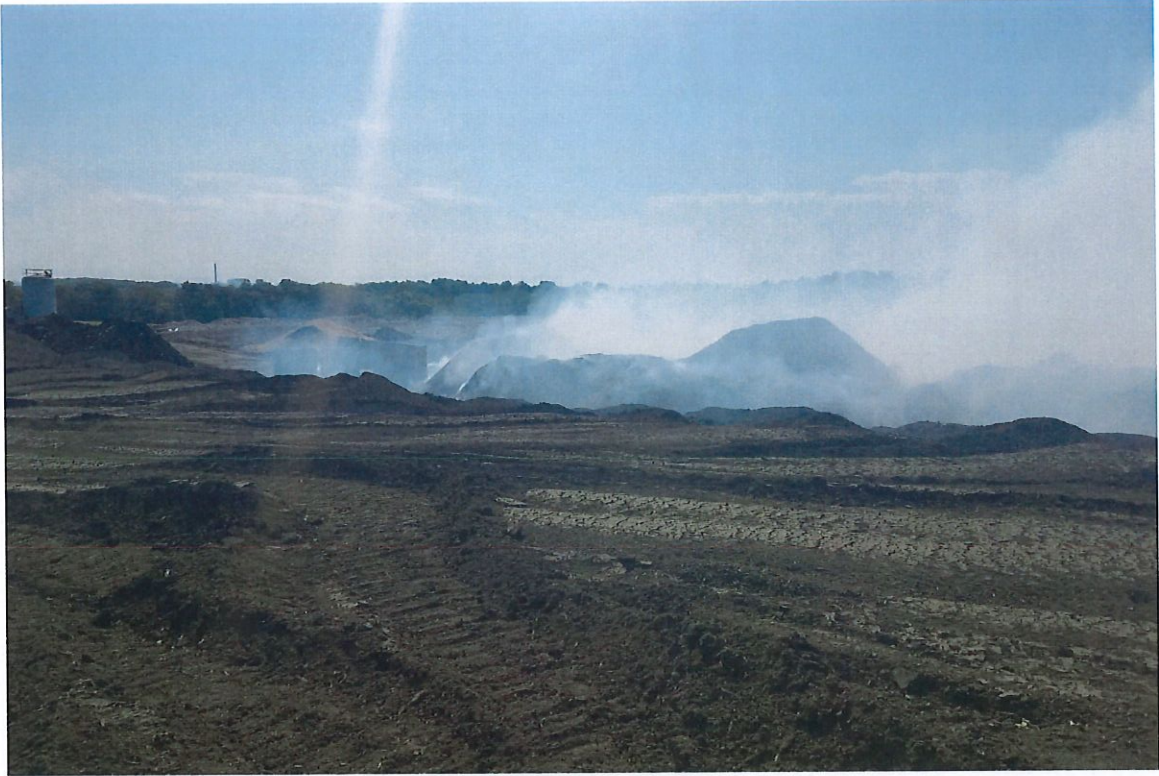
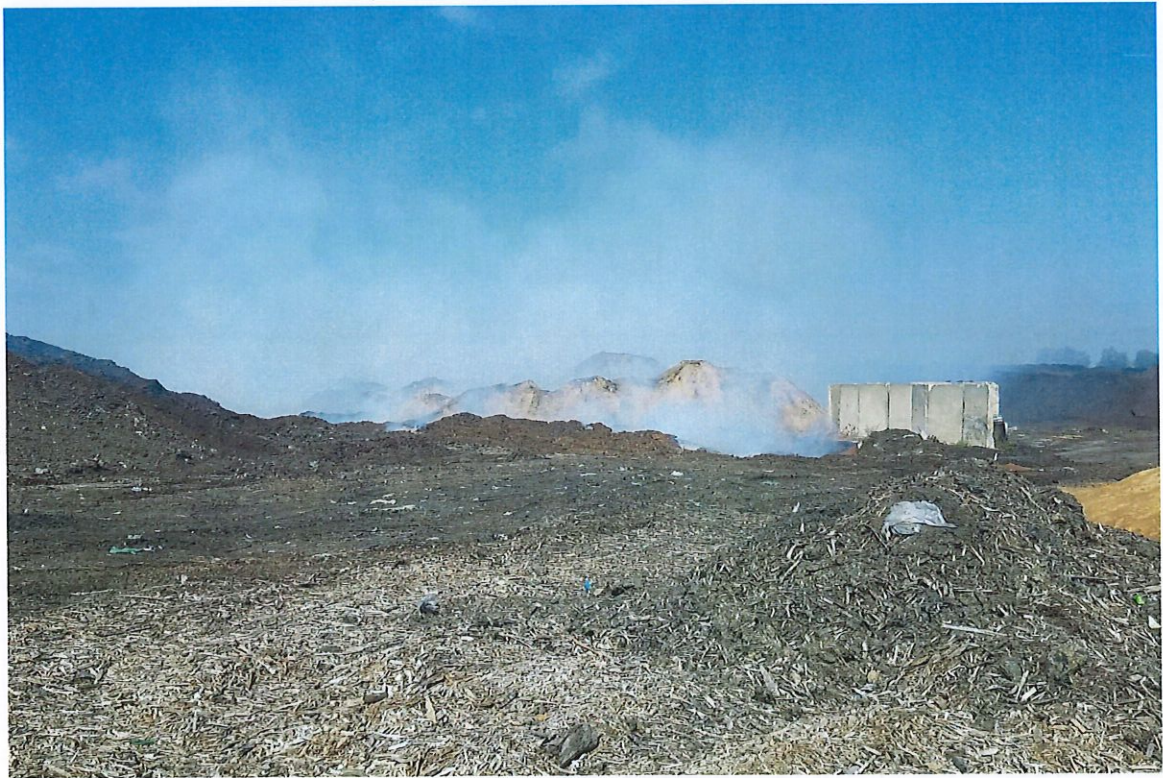
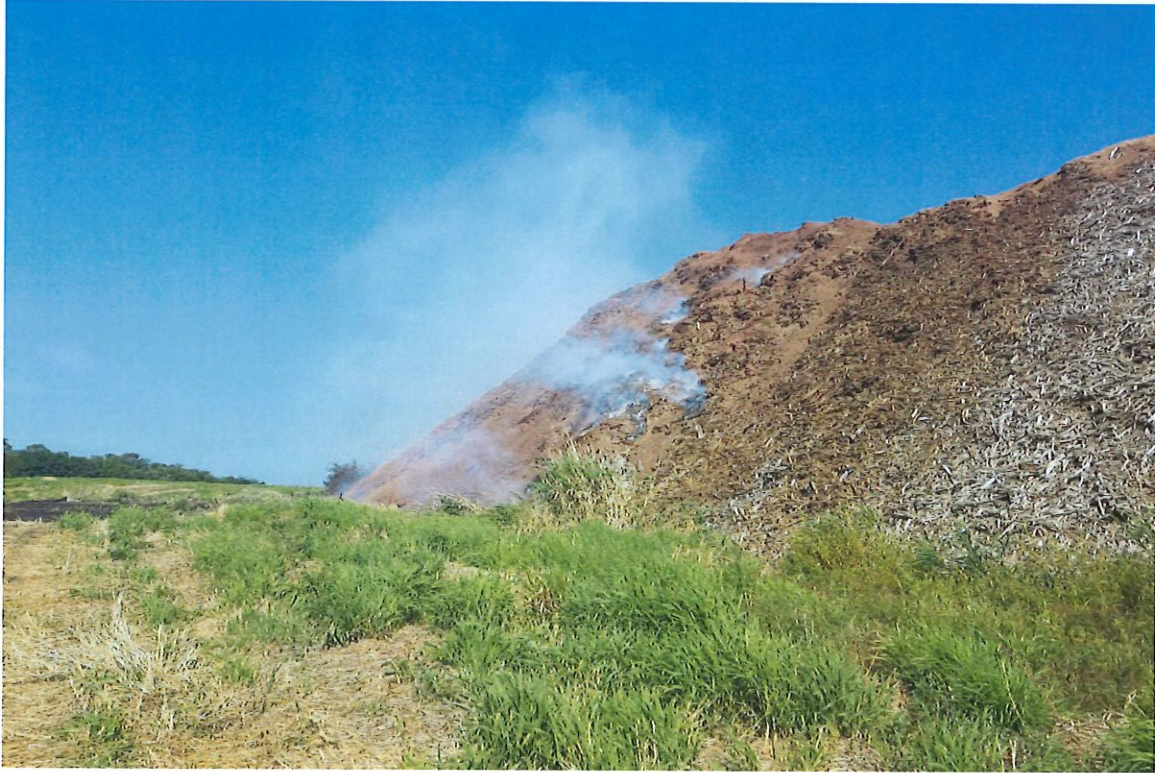
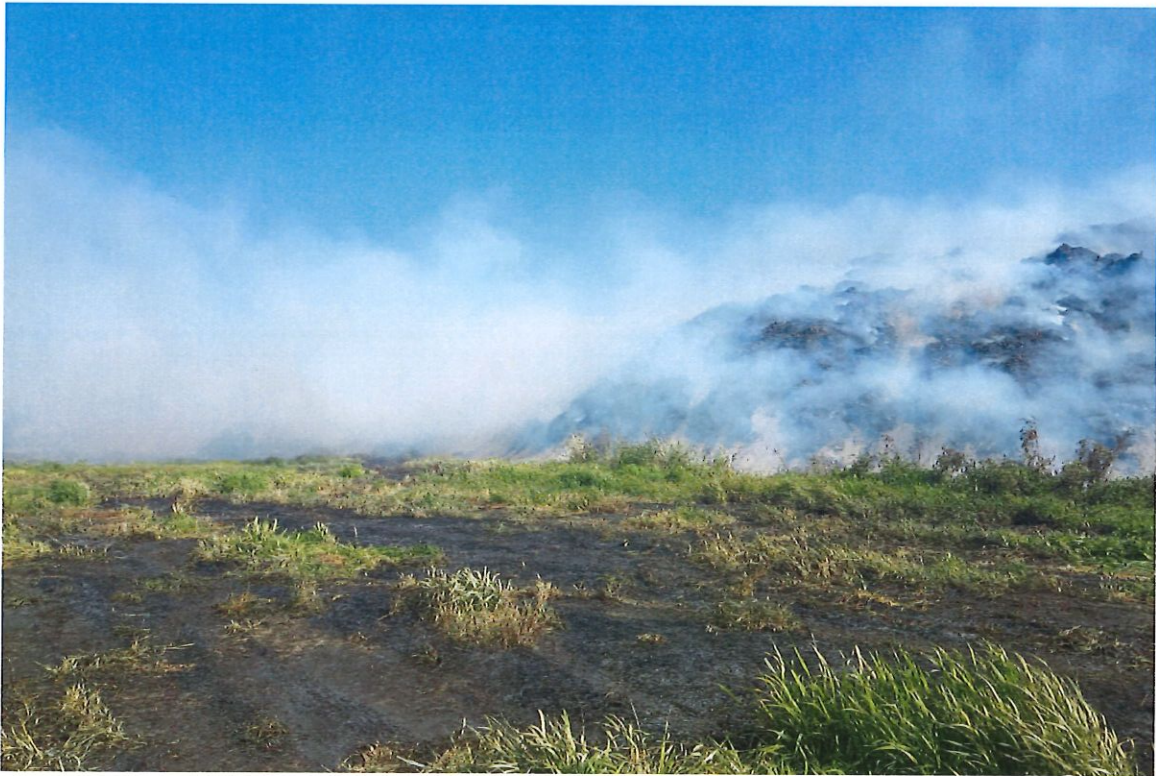
8/23/21

Wind was from the east/SE at ~5-10 mph (10:30 am). West ½ of the derecho pile had been burned and continued to smoke significantly. This included the screened compost and overs piles on top of the derecho mulch. This also included the log pile area, immediately east of the central lagoon. The fire had extended to south of the wax storage/concrete block area. The east ½ (and east facing slope) of the derecho mulch pile had not been burned at this time. Regarding on site staff, there was no activity taking place to/on the burning area. No leachate being applied and no equipment pulling the material apart. I spoke with Tyler (staff) and he indicated that the other staff had been on site overnight attempting to contain the fire with water. The (Eddyville) fire department was reportedly on site on Sunday to put out the grass fires that were south of the pile. The fire was thought to have started in the log pile area Sunday afternoon. I spoke with Richard Swan (site manager) via phone and he told me they were getting a plan together to combat the fire. We discussed getting a plan of attack implemented as soon as feasible. Gary Chamness was not on site, but reportedly had been on site earlier that day. Smoke continued to blow west/northwest from the site, towards the intersection of 160th Street (to the north) and County Road T61 (to the west). I conveyed my observations to Kurt Levetzow (DNR FO6 Supervisor).

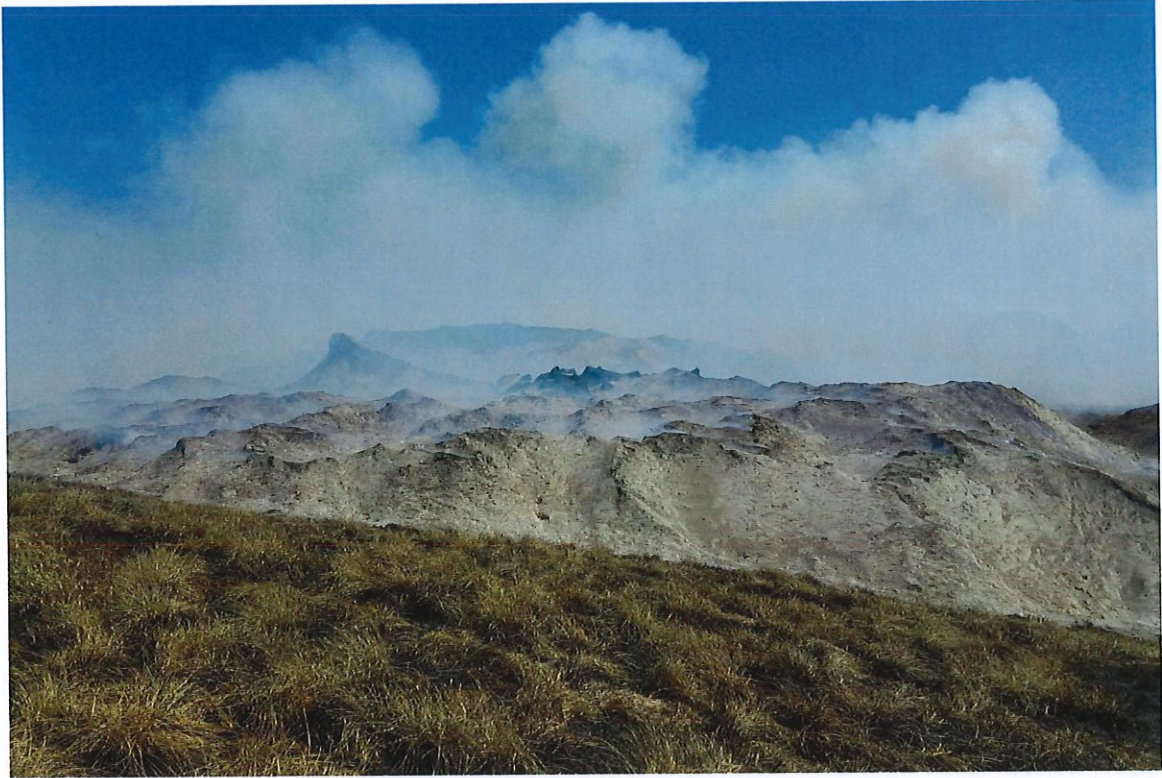
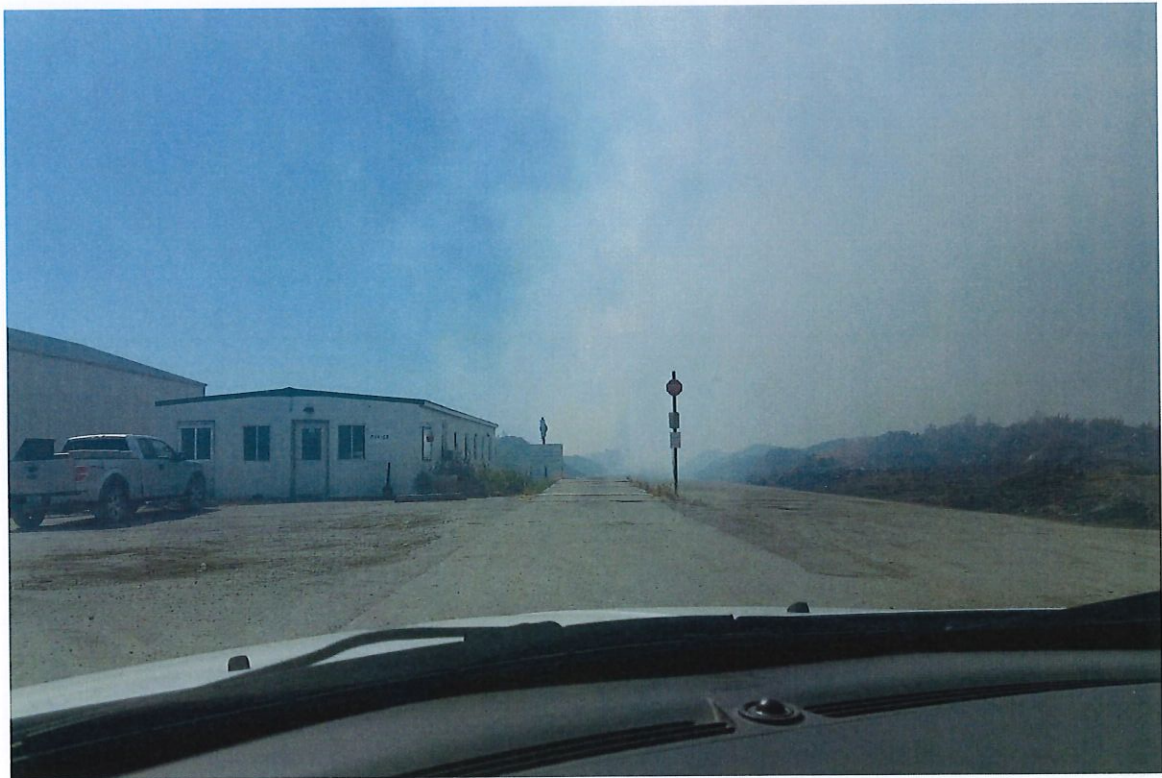
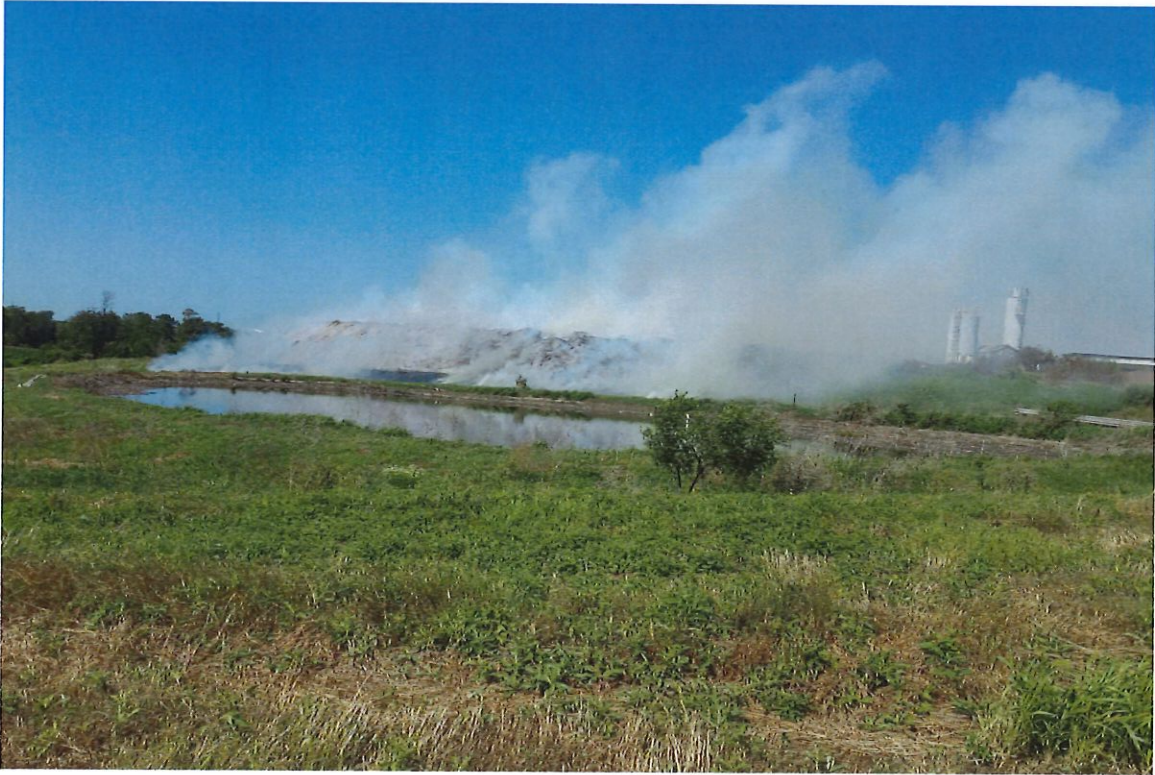
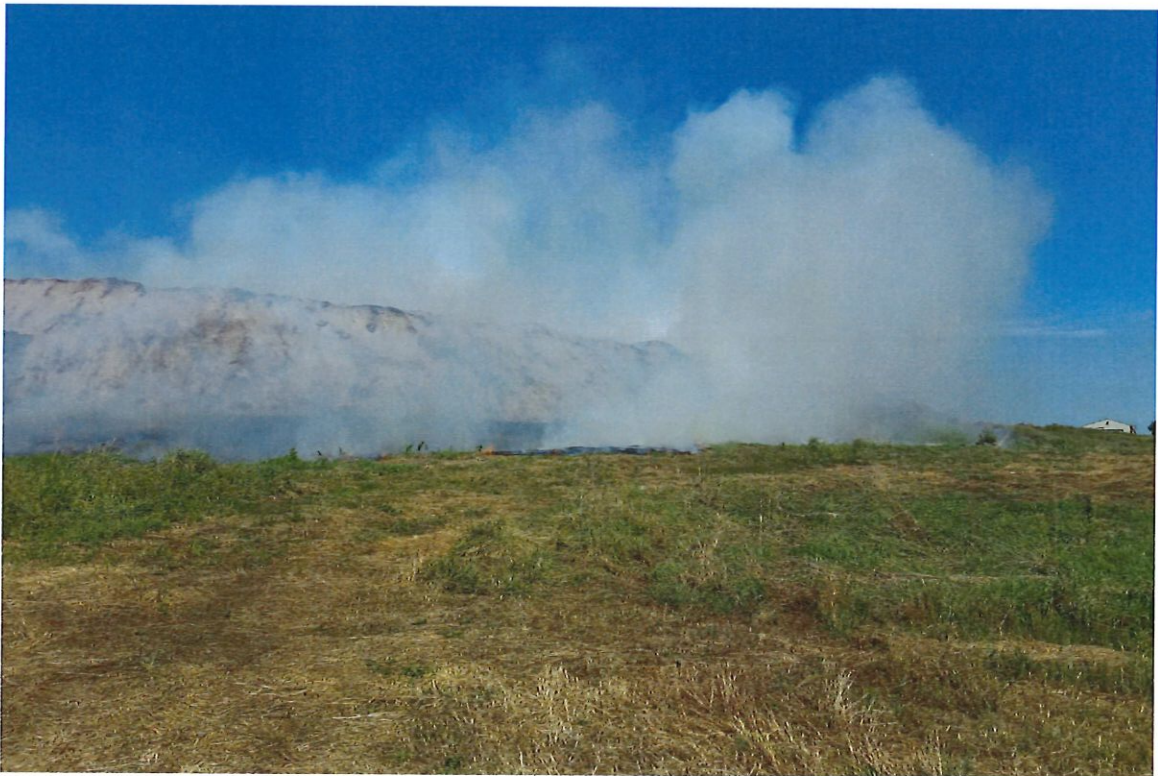
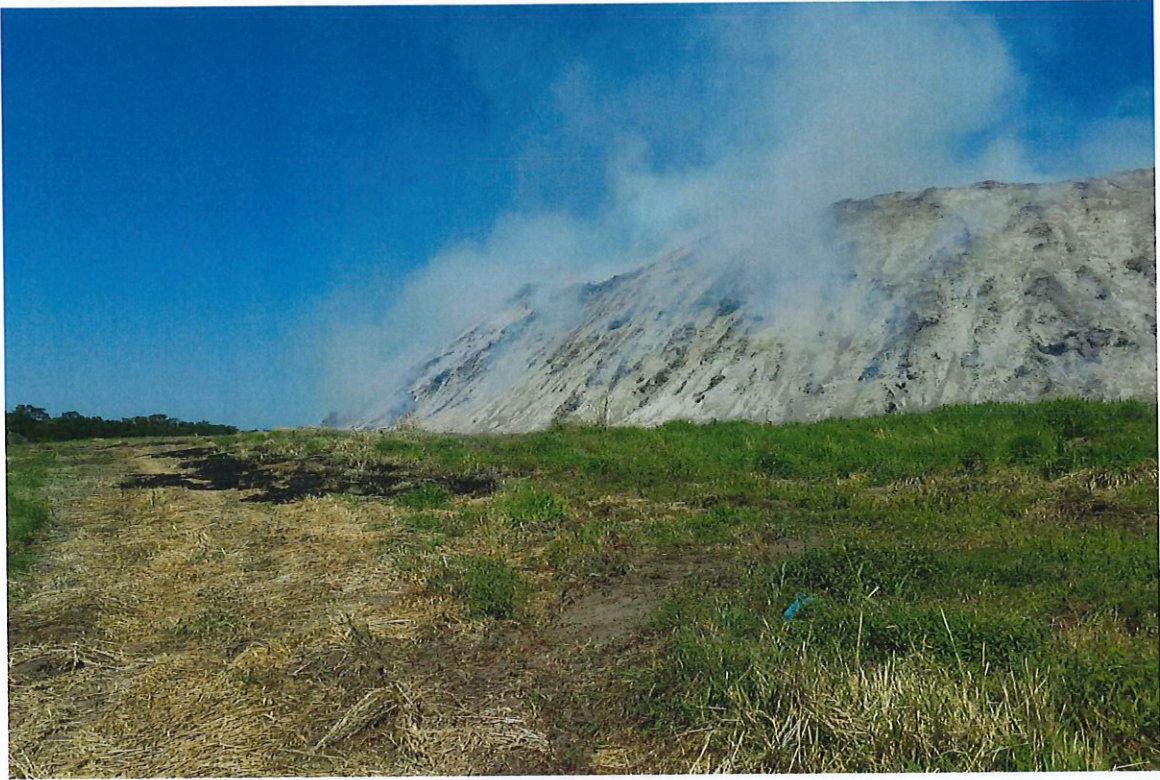
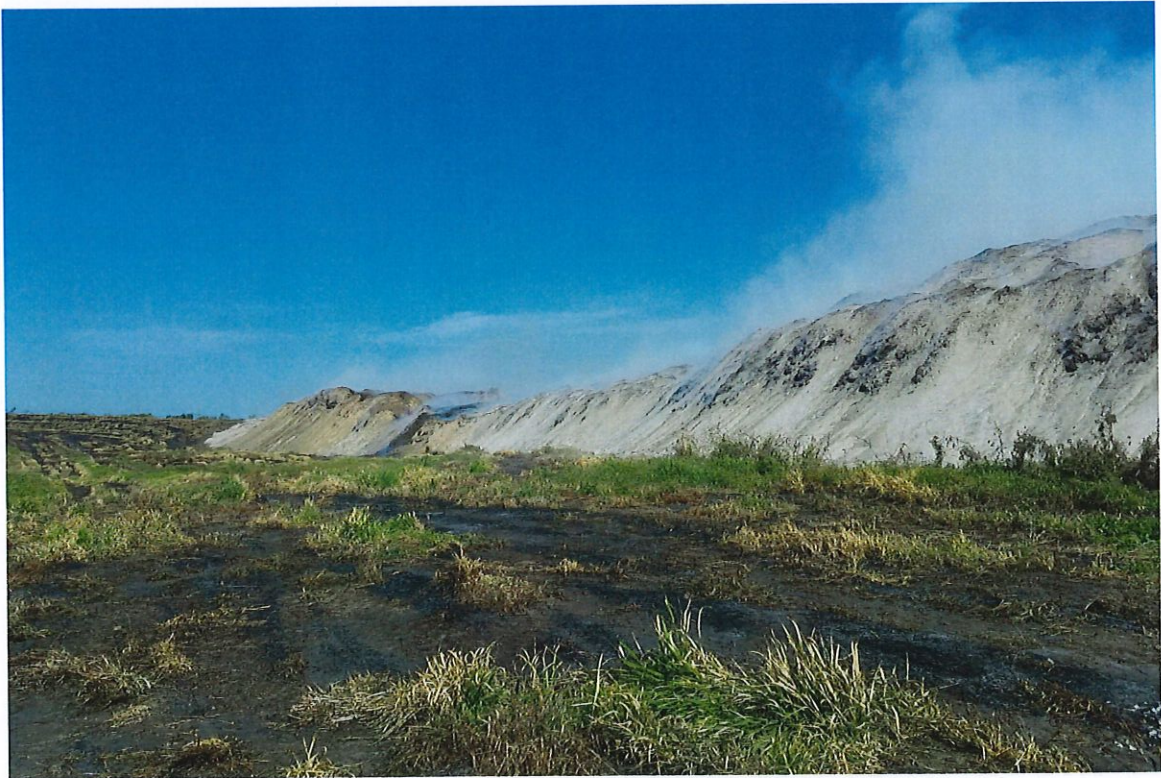
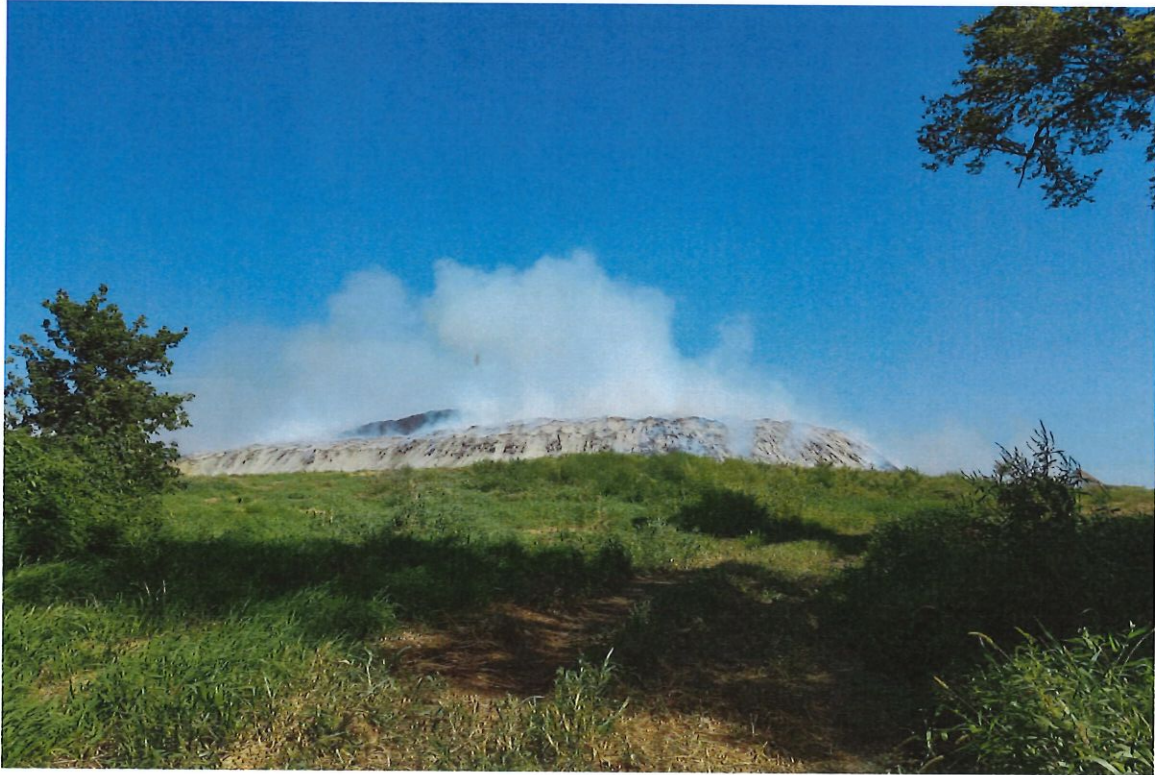
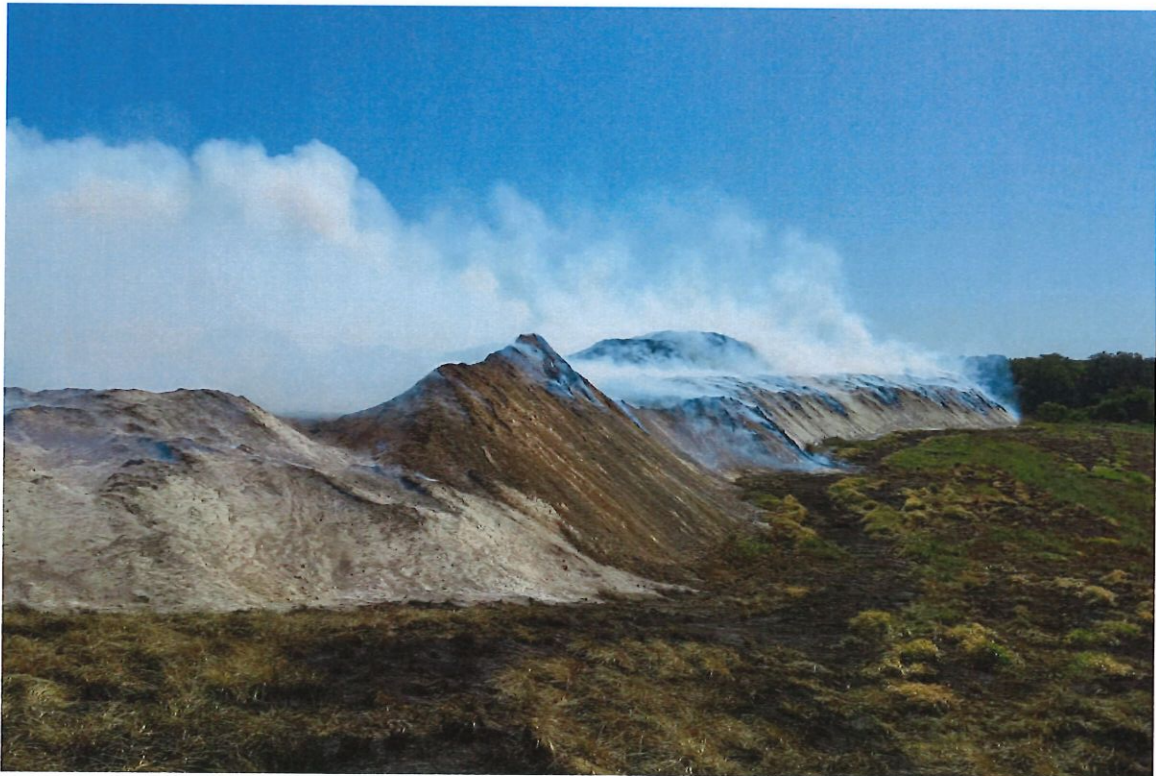
8/24/21

The smoke could be detected from many miles away. Smoke was blowing directly north into Eddyville. Wind was from the south at 10-15 mph (11:10 am). Most of the mulch pile had now either been burned or was actively burning. Most of the east slope was on fire and smoking significantly. The western upper plateau/flat portion (south of the silos) was on fire as well. The western section of the mulch pile was smoking some, but little open flame was observed. I did not observe any site activity regarding application of water or leachate to the mulch pile. I did not observe any staff/equipment separating mulch or spreading it out. Some fire had spread south into the grass area southwest of the east lagoon. No compost material on the pad was determined to be on fire at this time. Richard and Lon (staff) had reportedly left the site to retrieve a bulldozer to aid in separating the mulch. My observations were again conveyed to Kurt Levetzow.

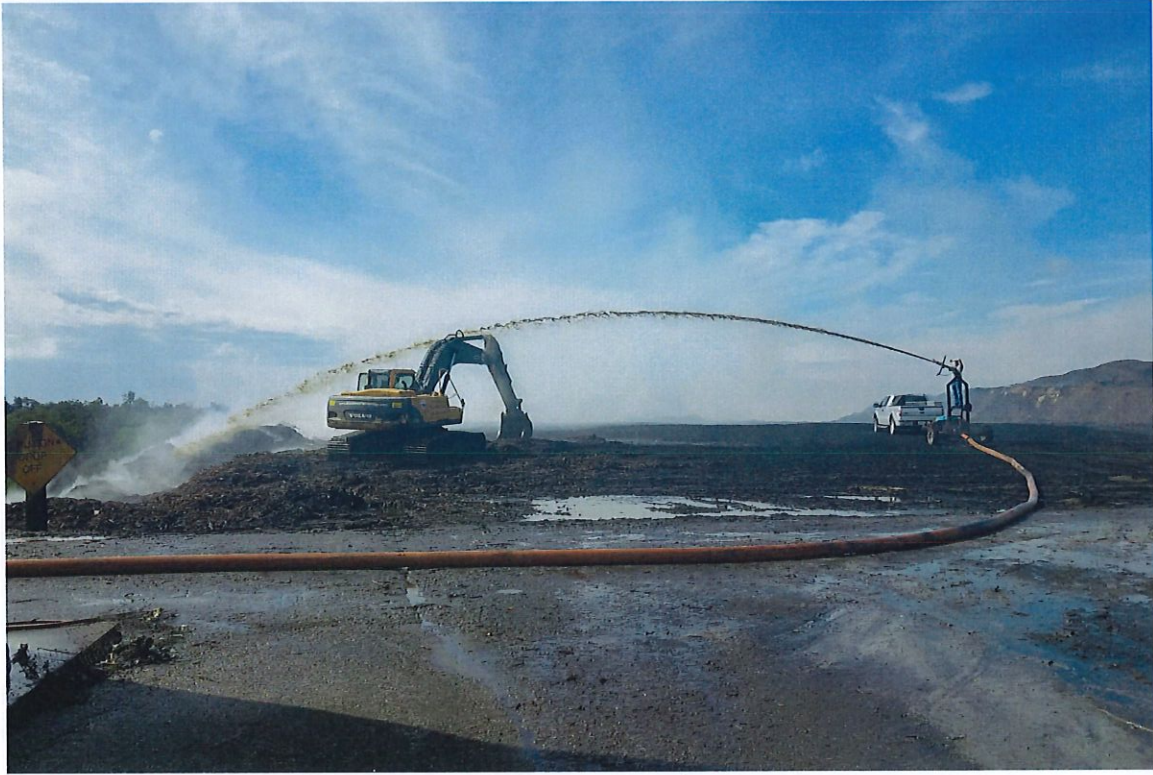
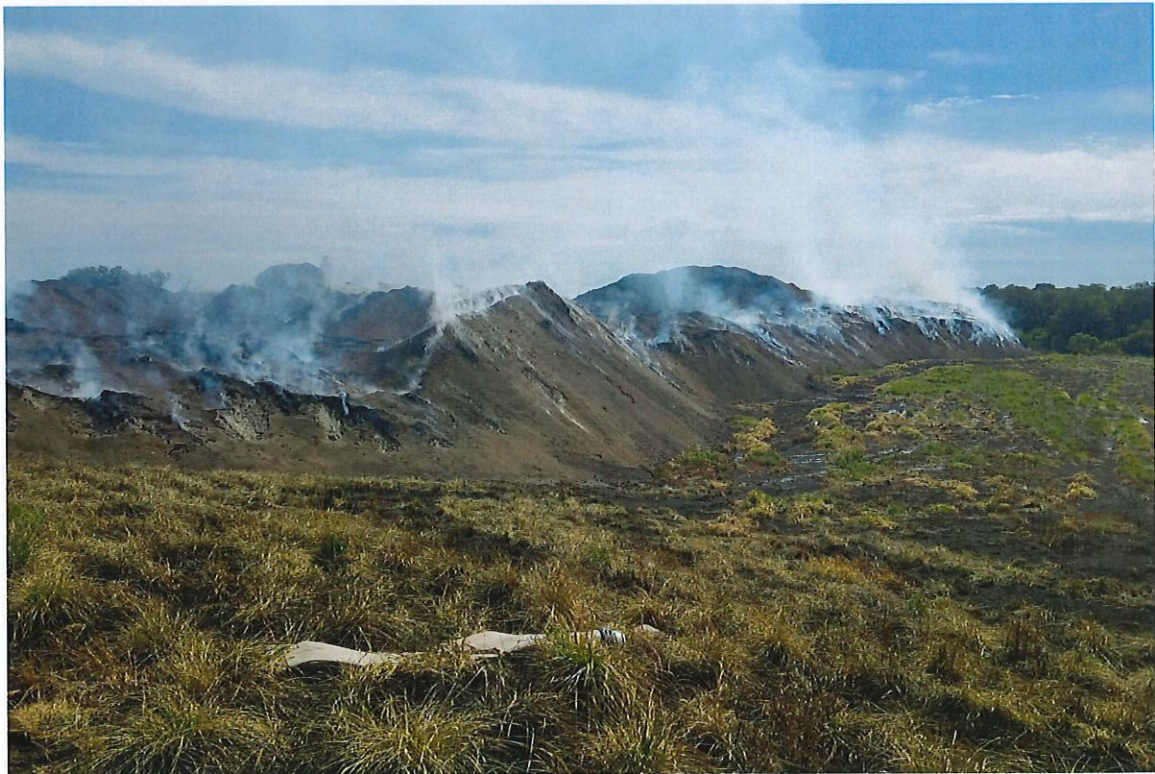
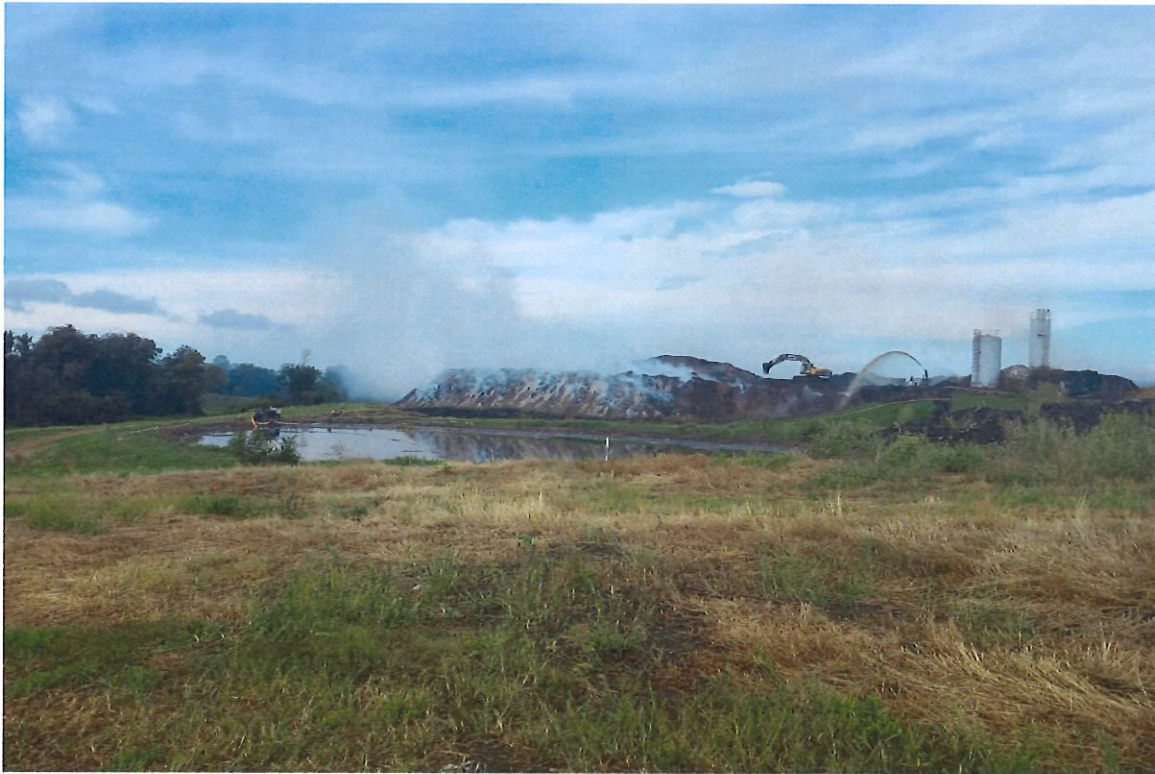
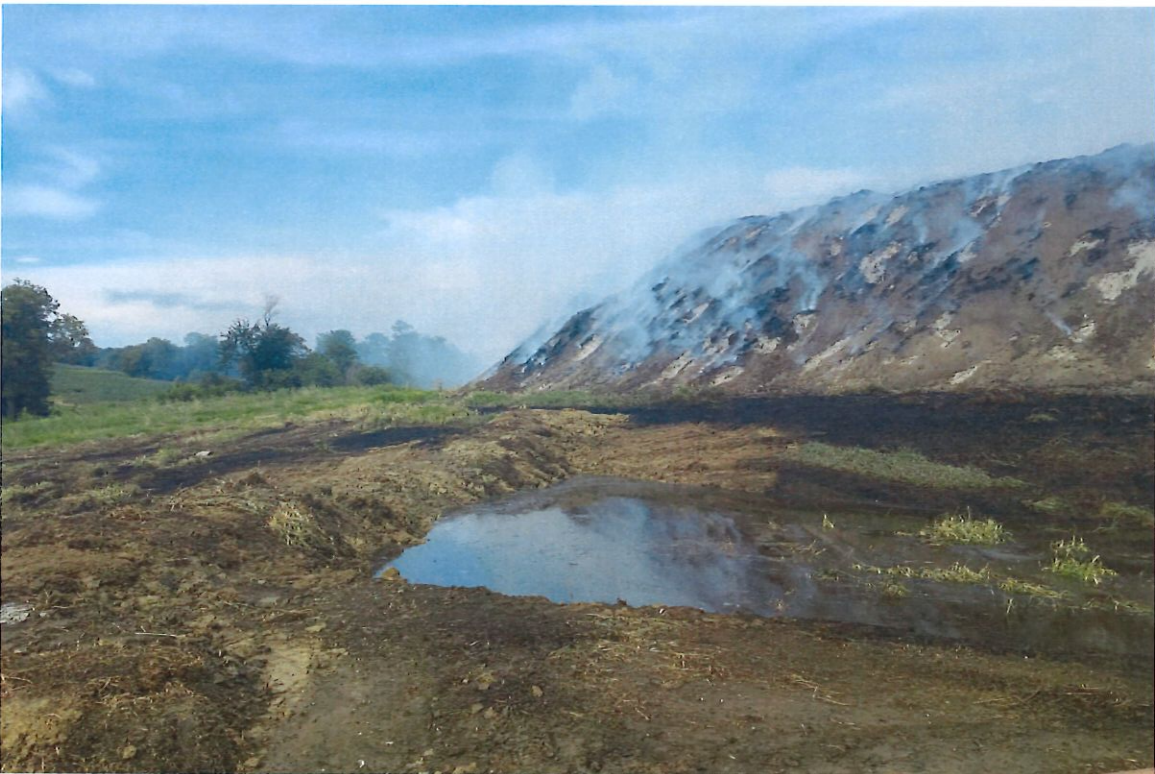
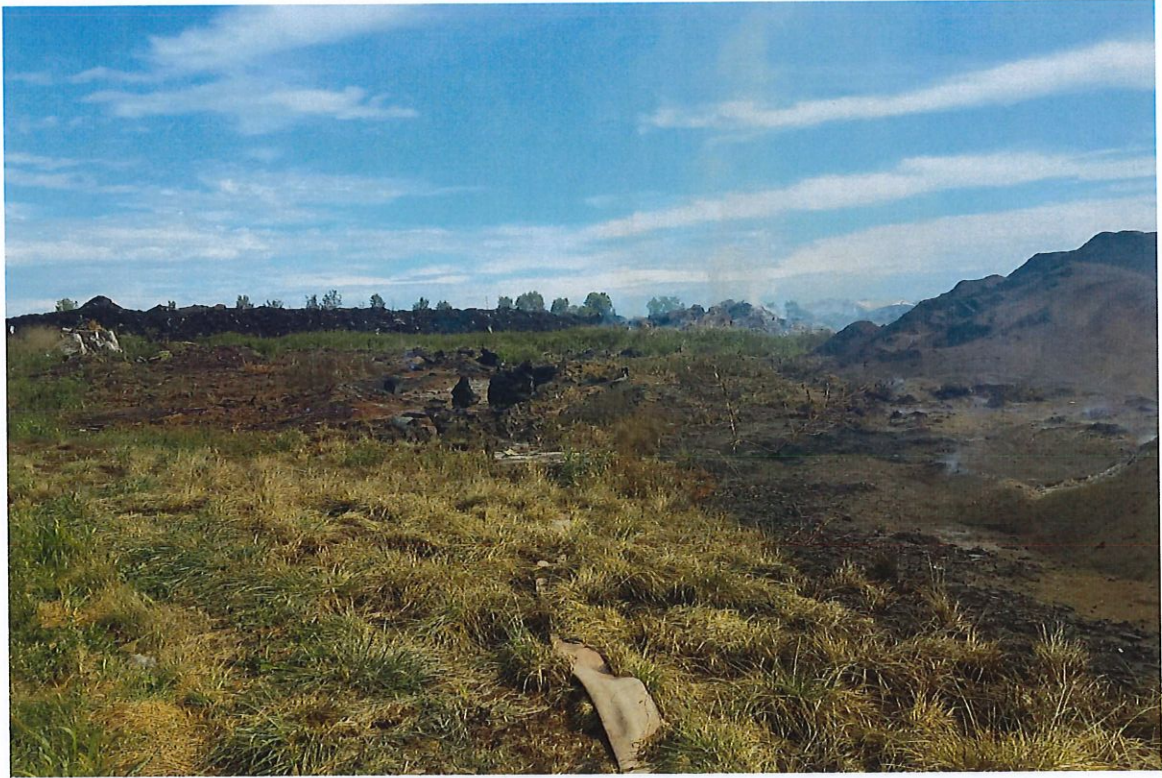
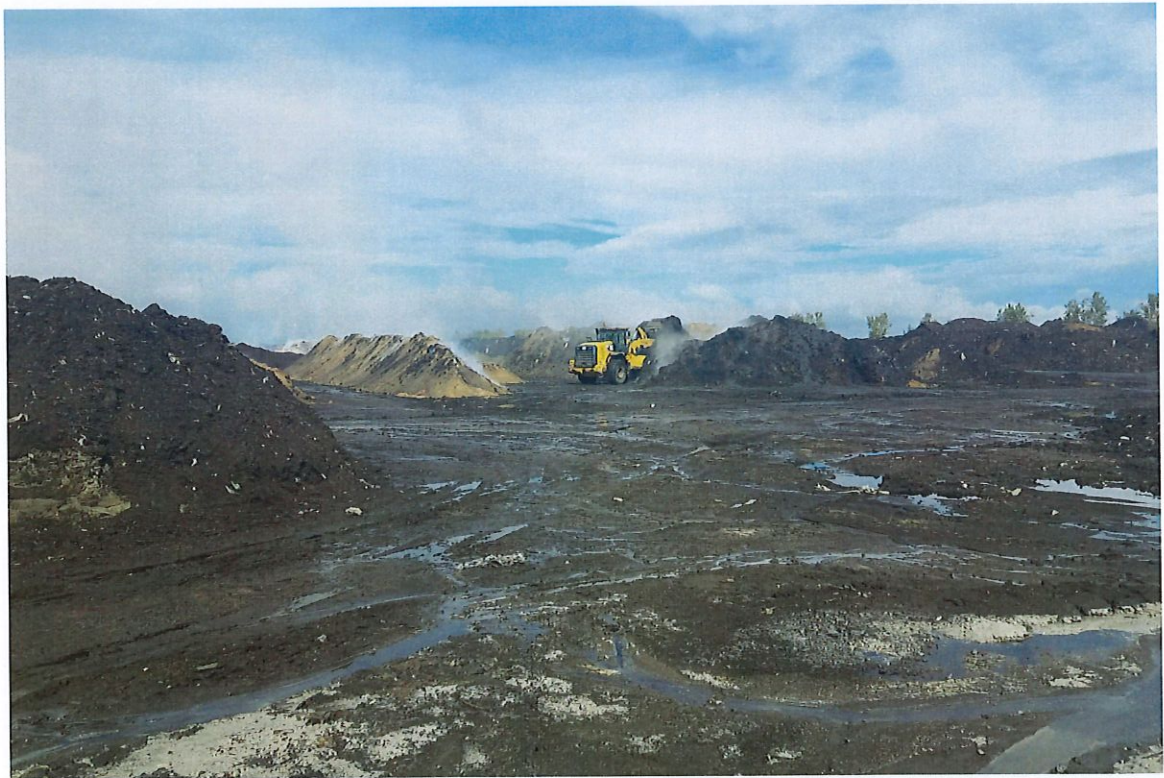
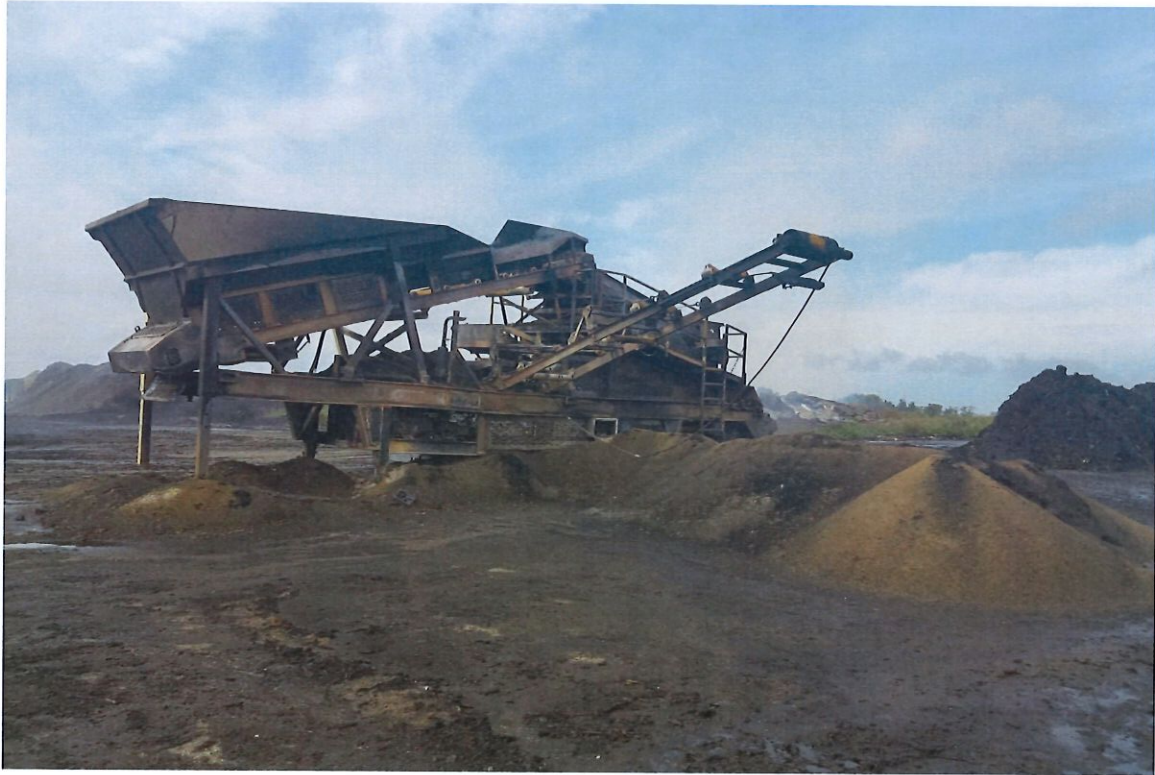
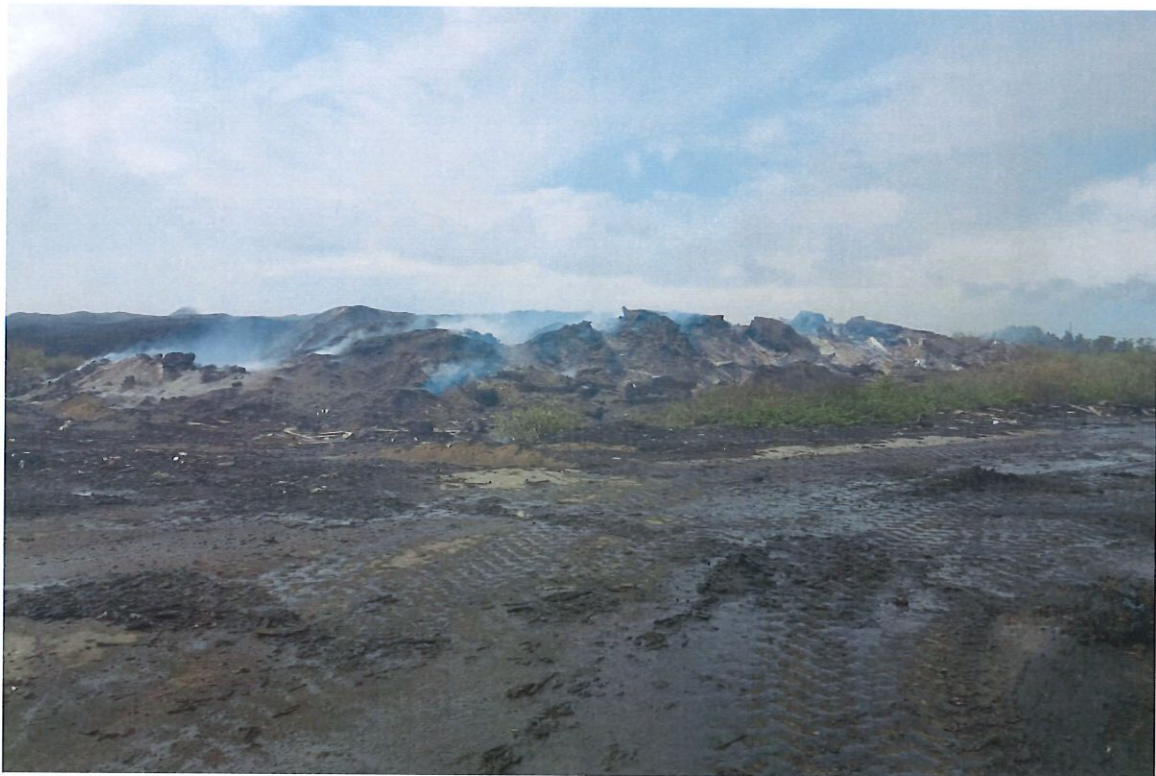
8/25/21

The smoke was less today. Approximately ½ inch of rain overnight/early morning. Wind was from the east/NE at about 5 mph (10:15 am). The bulldozer had arrived, but was sitting unutilized at the house to the southwest (Richard's House). The leachate irrigation unit was being utilized to wet down the east facing slope. Leachate from the east lagoon was being pumped up to the gun. The excavator was pulling back mulch and opening up areas that could be doused with leachate. The plateau portion was not on fire and was not smoking. The west ½ and east and south facing slopes continued to smoke/burn. The western portion of the burned mulch was not smoking as much as either of the previous 2 days. The screener unit had burned up (rubber belts/tires) and compost rows/piles on the southeast section of the pad were smoking in multiple spots. Staff was utilizing the end-loader to take wet compost slop and apply that to the smoking/burning compost on the pad. A dam had been created to contain the leachate downslope of the east facing mulch slope. That dam was built up with more soil and channels cut to drain the leachate into the east lagoon at the time of my visit. The dam and channels were effective in preventing leachate runoff. A single Chamness staff monitored the pump, hose, and dam. The bulldozer was eventually utilized create a channel at the toe of the mulch slope to guide any leachate back to the pooled/dam area. The bulldozer later pushed a large path from top of the mulch plateau down to the toe of the mulch slope. The smoke was significantly less in the area that was pushed down. This new exposed mulch appeared unburned. This pushing method was repeated multiple times up and down the slope. This was mostly achieved on the southeast/south facing slope area. The excavator continued to open up areas to be separated and doused with leachate. Early afternoon, the wind had shifted, now blowing northeast. I spoke with Karen Grimes (DNR Media) regarding a press release. I also made other observations from the pad and around the pad/facility regarding current status of compost operations and leachate management. Kurt Levetzow arrived on site about 1:00. Kayla Lyon (DNR Director) and Alex Moon (Deputy Director) arrived on site at about 1:30. Kurt and I escorted them around the site. At least 6 Chamness staff were on site and at least 4 staff were actively assisting the fire efforts. The wind shifted again, blowing north at ~5 mph in the afternoon.
