MEMO

Date: 9/1/21
To: Chamness SDP File
From: Brian Lee, ES

Facility: Chamness SDP, Permit # 90-SDP-10-97P-COM
RE: Derecho Mulch Fire, 8/23-27, 30/2021 visits, complaint #29884

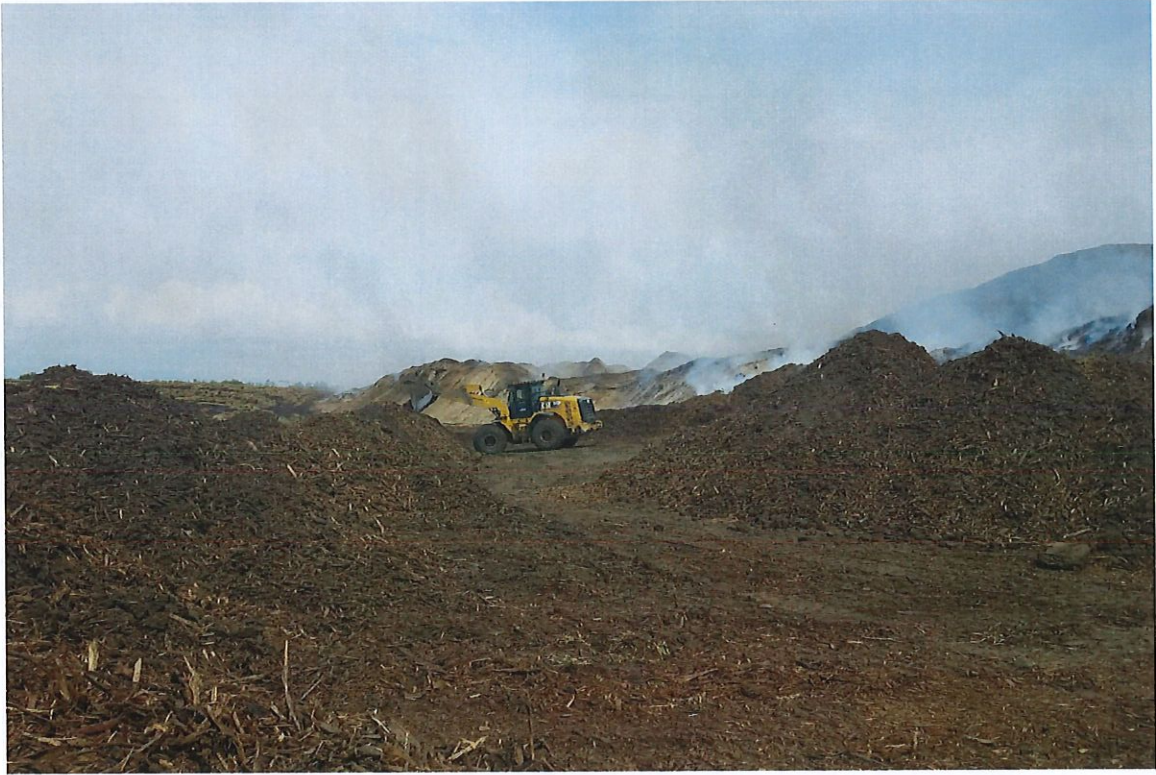
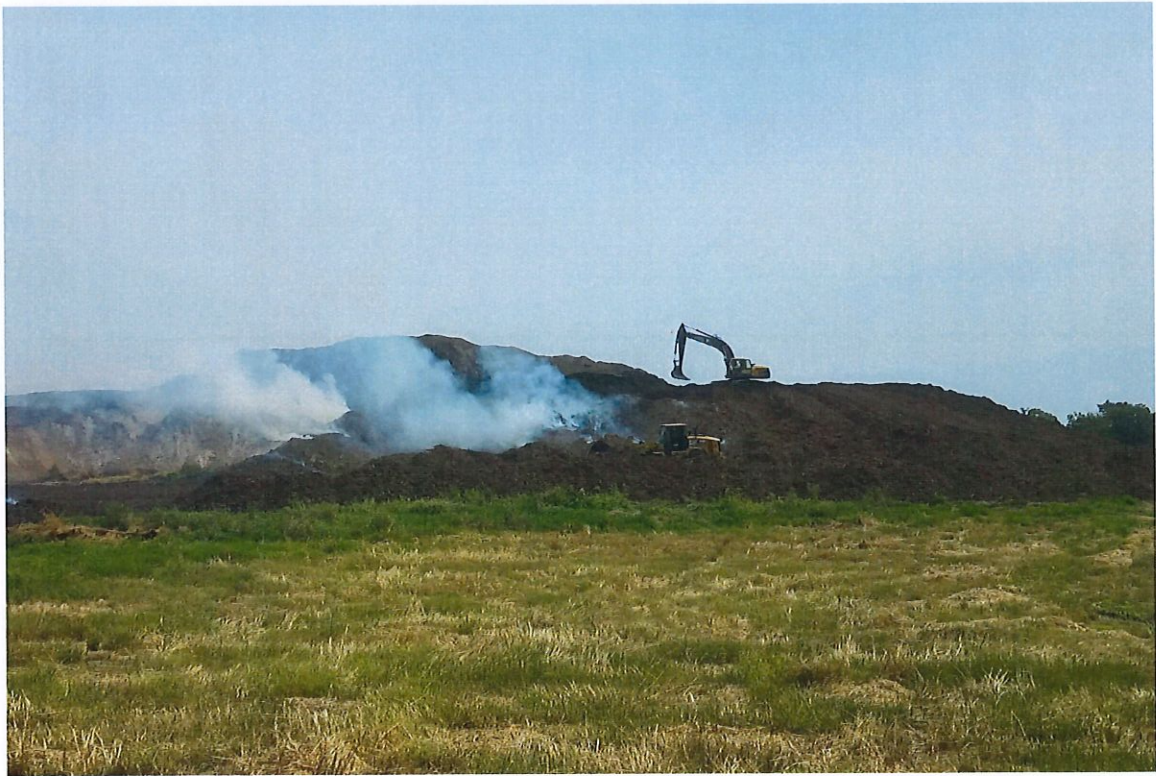
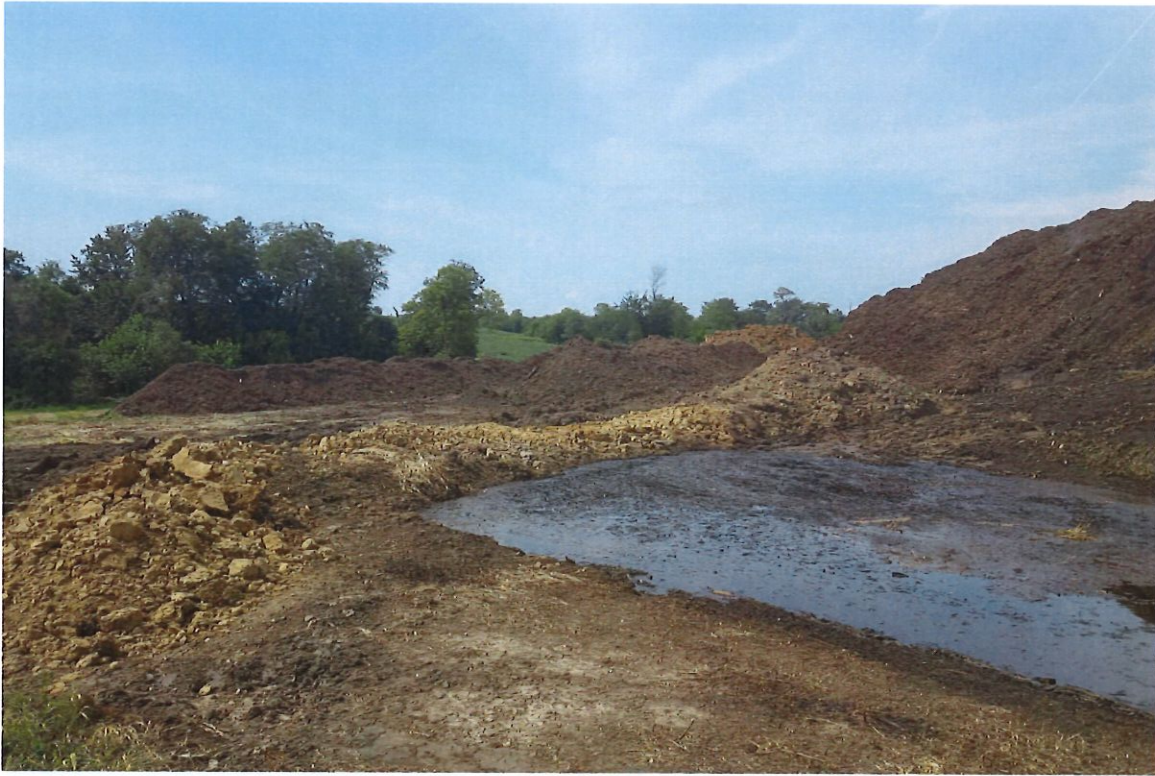
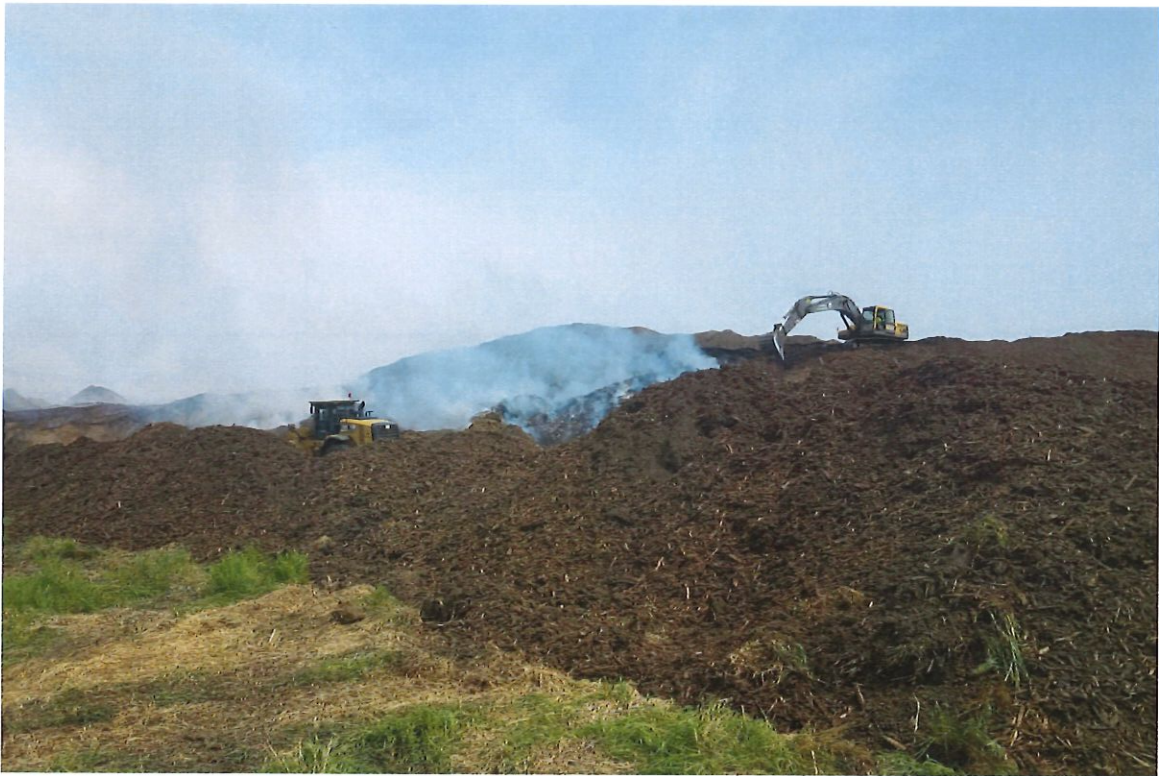
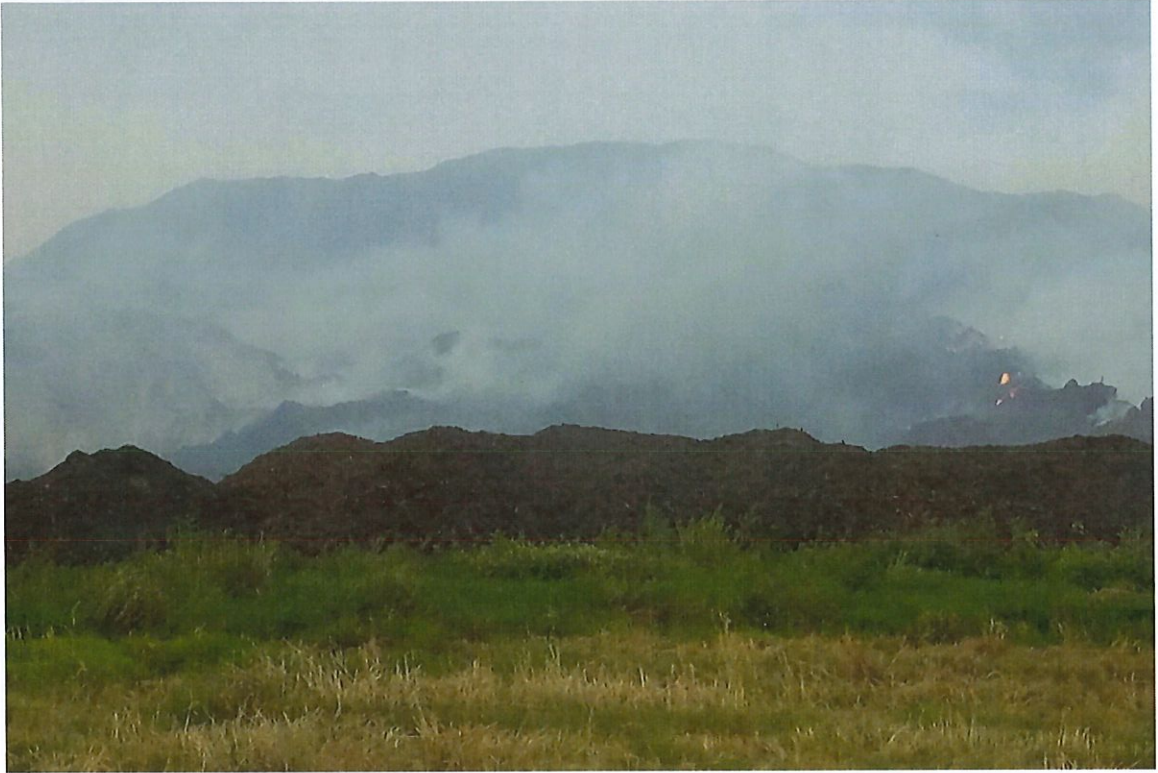
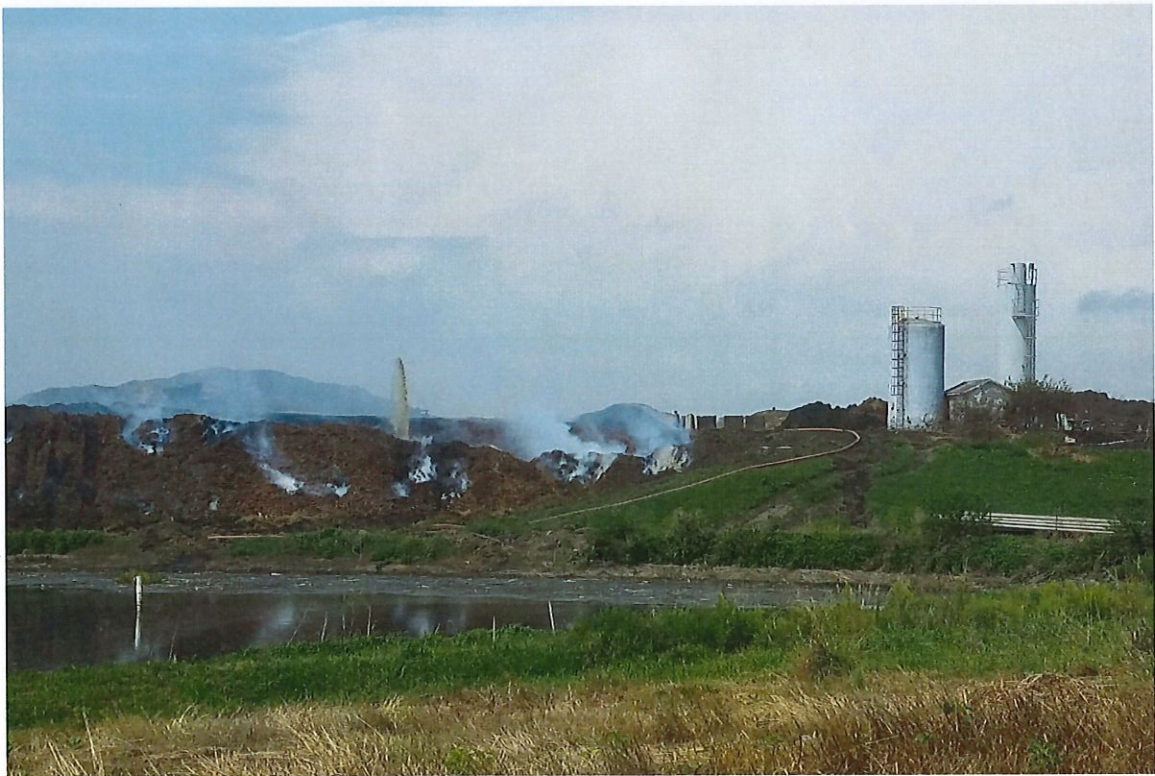
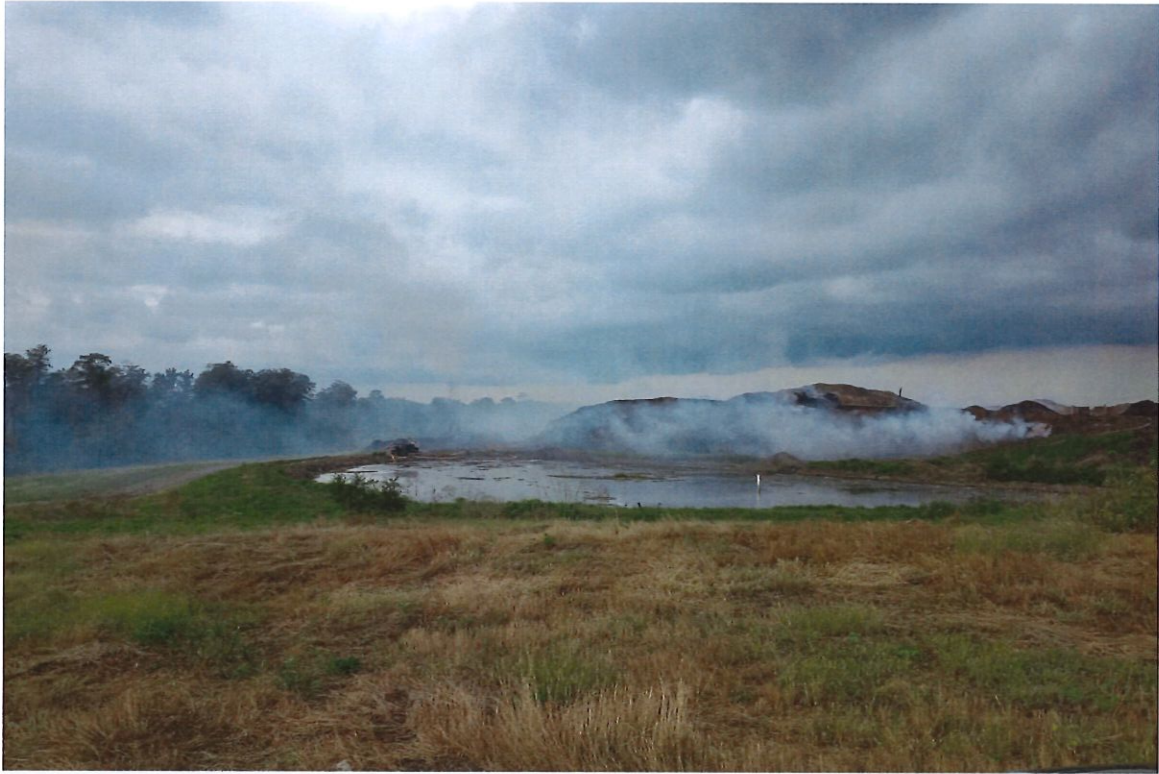
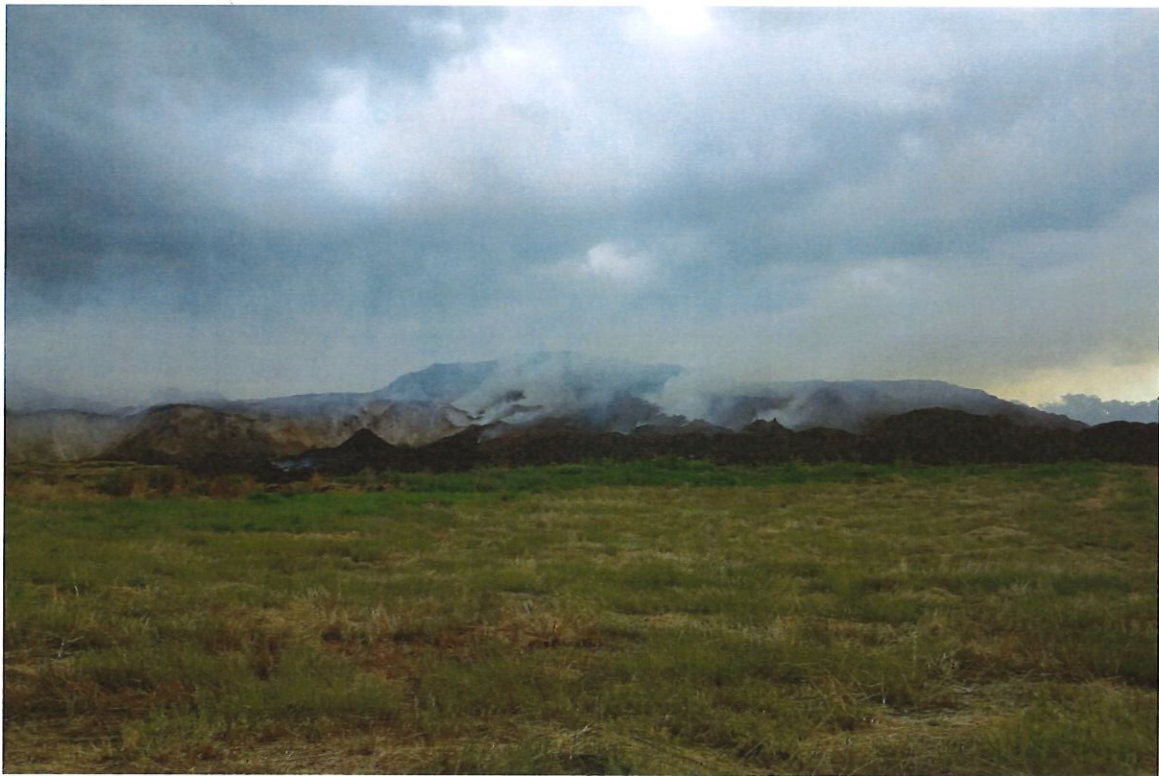
8/26/21

The smoke today was about the same as the previous day (possibly slightly less). Wind was out of the east/SE at 5-10 mph (11:45 am). Leachate continued to be applied to the east facing mulch slope via irrigation. A single Chamness staff continued to monitor the pump, hose, and dam. The east slope had pockets burning/smoking. The dam continued to hold and no leachate migration beyond the containment area was observed. A significant amount of mulch had been spread out in a couple long rows/piles along the southern edge of the pile. A ~15-foot-deep/wide hole had been dug on the southern side, past the end of the pile (uncertain sure if this was for soil use and/or leachate collection). The excavator and end-loader continued to pull part material. The bulldozer was not in operation due to an ignition switch failure (part was being retrieved reportedly). The west portion of the mulch continued to smoke, but was not flaming significantly. Very minimal smoke was detected crossing County Highway T61 (to the west). I conveyed the status to Supervisor Levetzow. After about an hour on site, wind conditions switched from the northwest at about 15 mph. A front/rain was passing through. Smoke and flame increased on the southwest portion during this intensification in wind. This was at about 1 pm and the staff had stopped for lunch. I went to the office and relayed the info to staff that the wind had switched and the flames had increased. I recommended they move the excavator on the south side as it was directly in a heavy smoke plume. Staff moved back to the south side and continued working shortly after. Flames had also increased near the wood/log storage area east of the central lagoon. A quick rain event followed, lasting about 15 minutes (maybe a couple tenths of an inch of rain). Some smoke reduction was observed at this time.

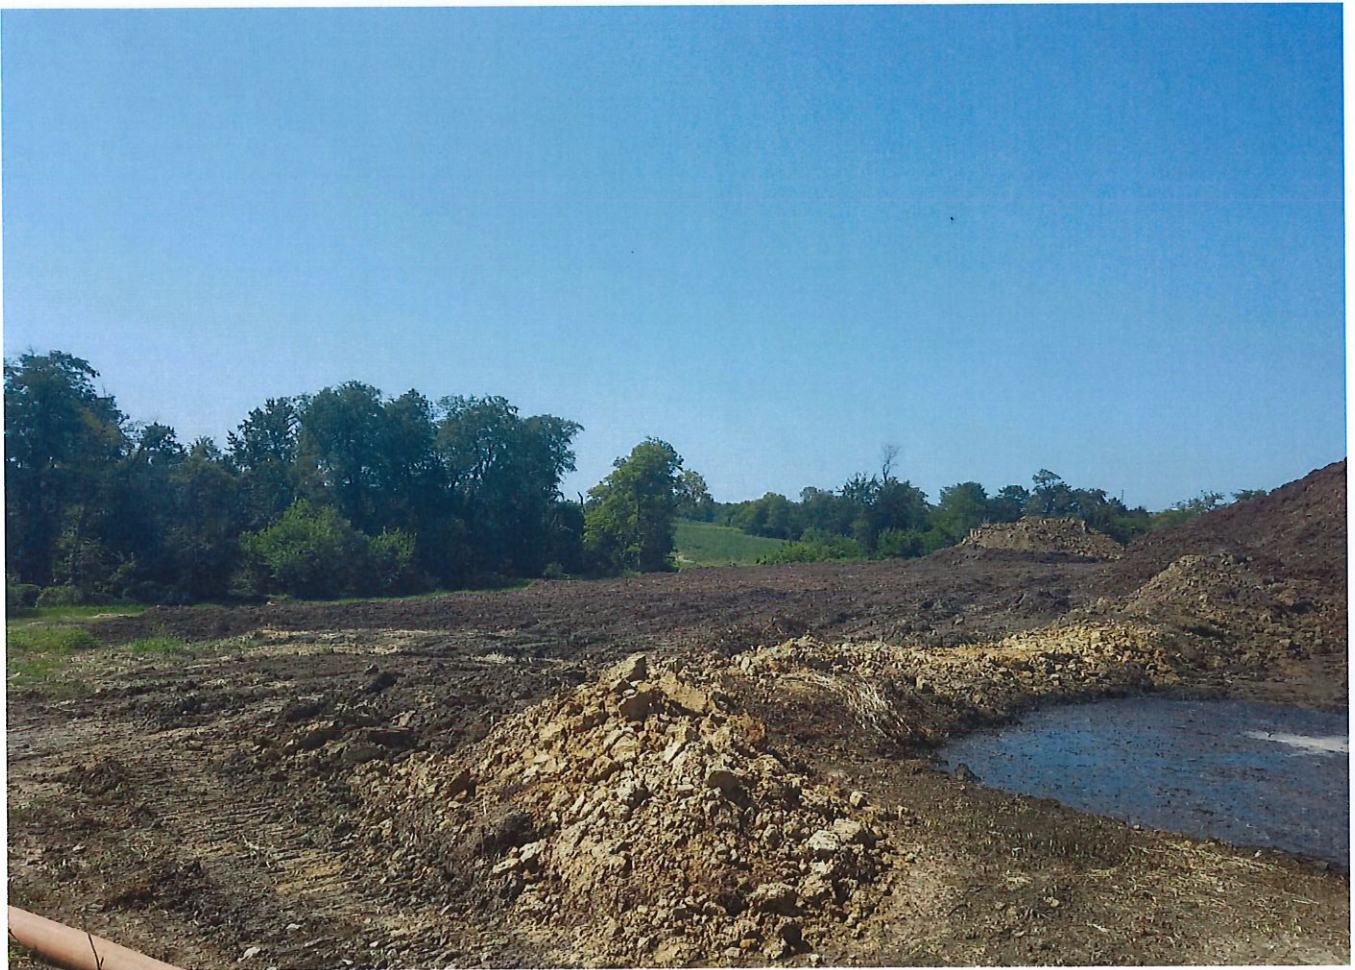
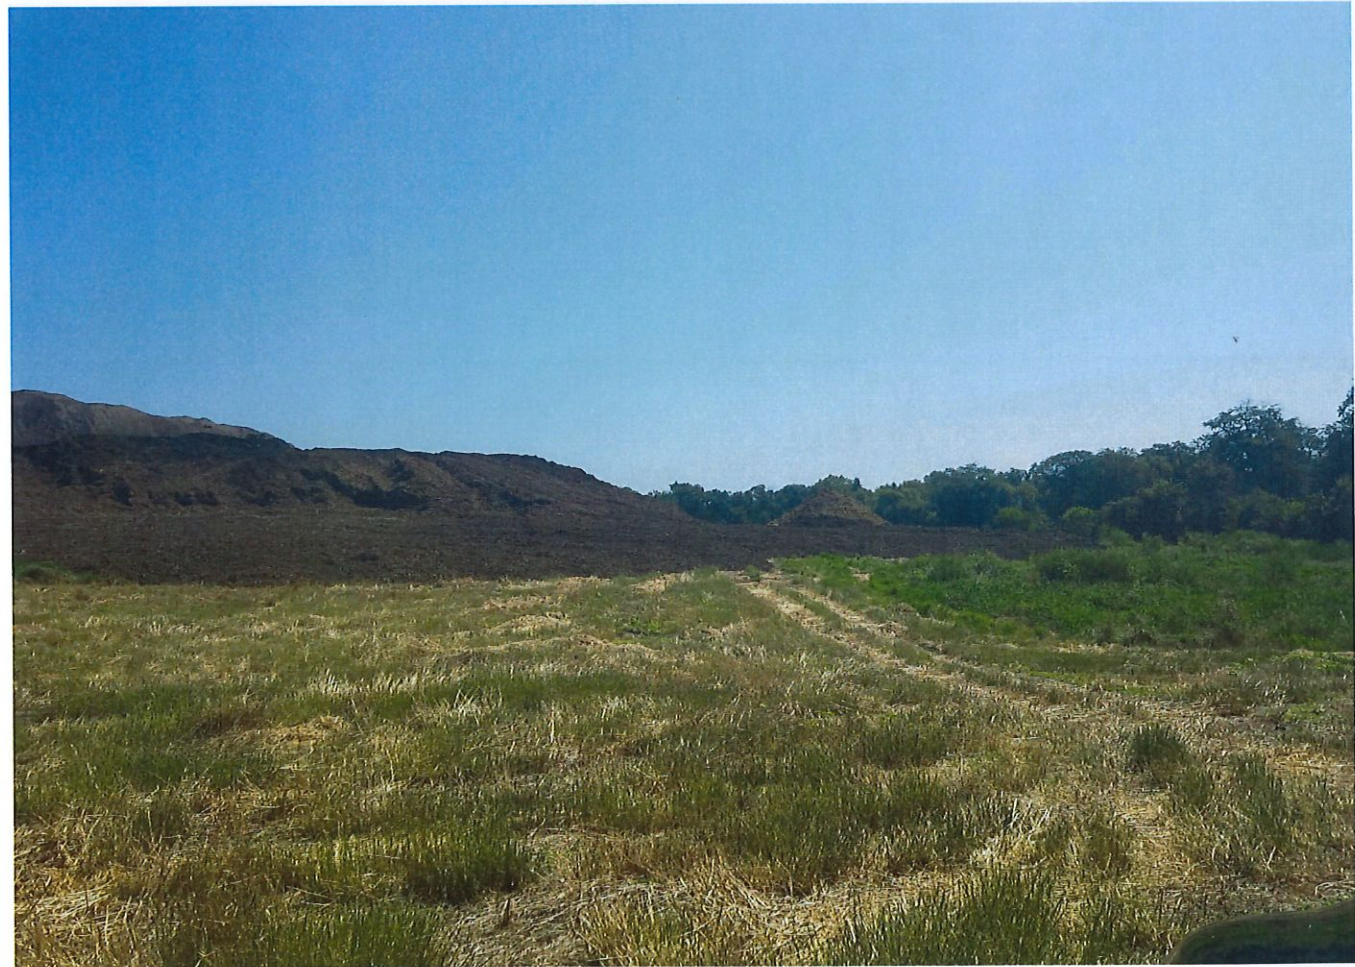
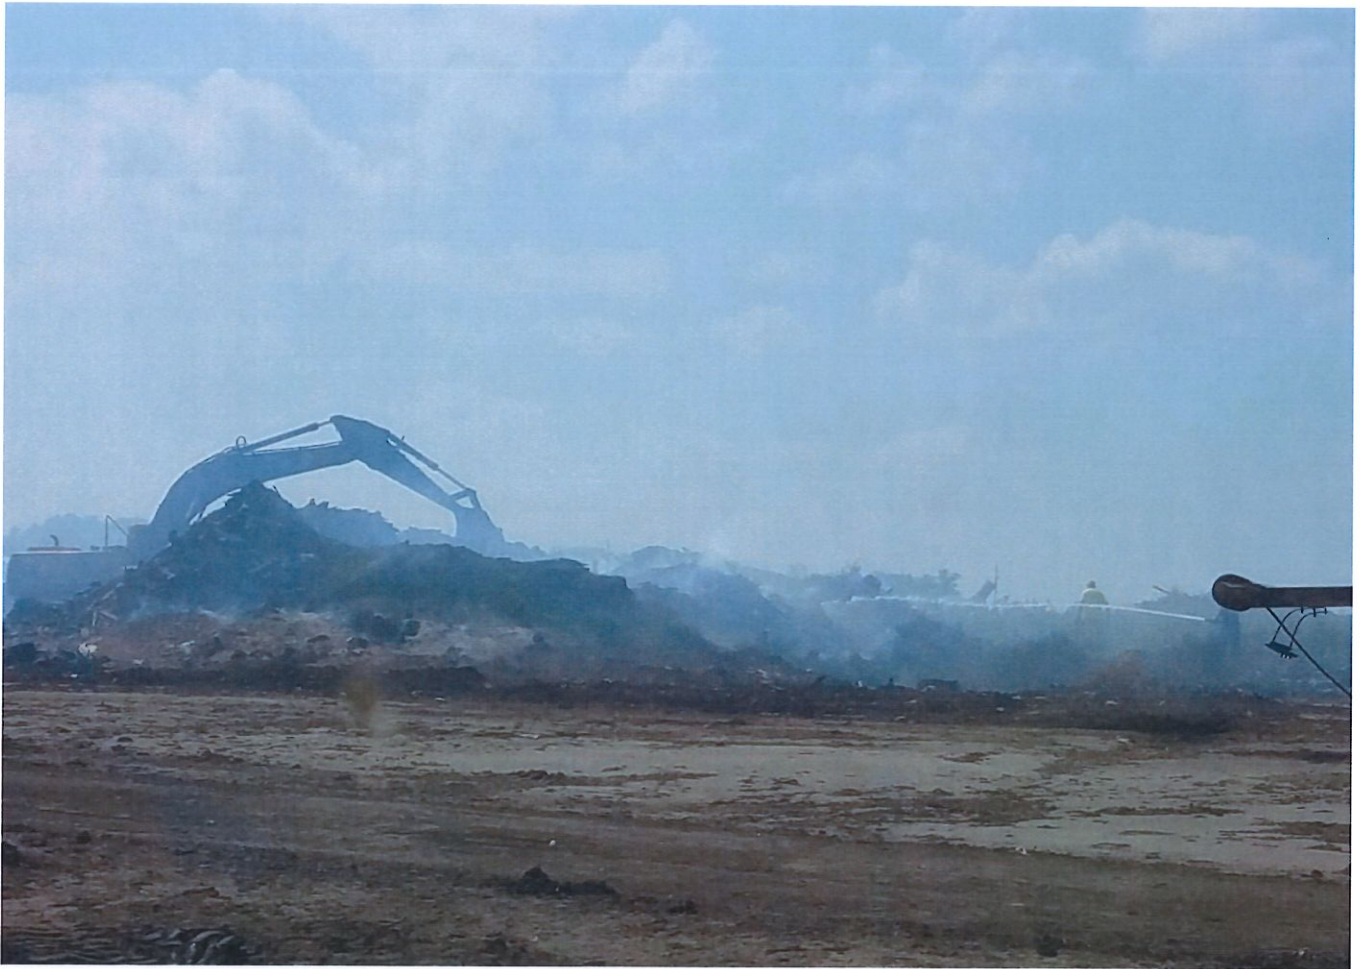
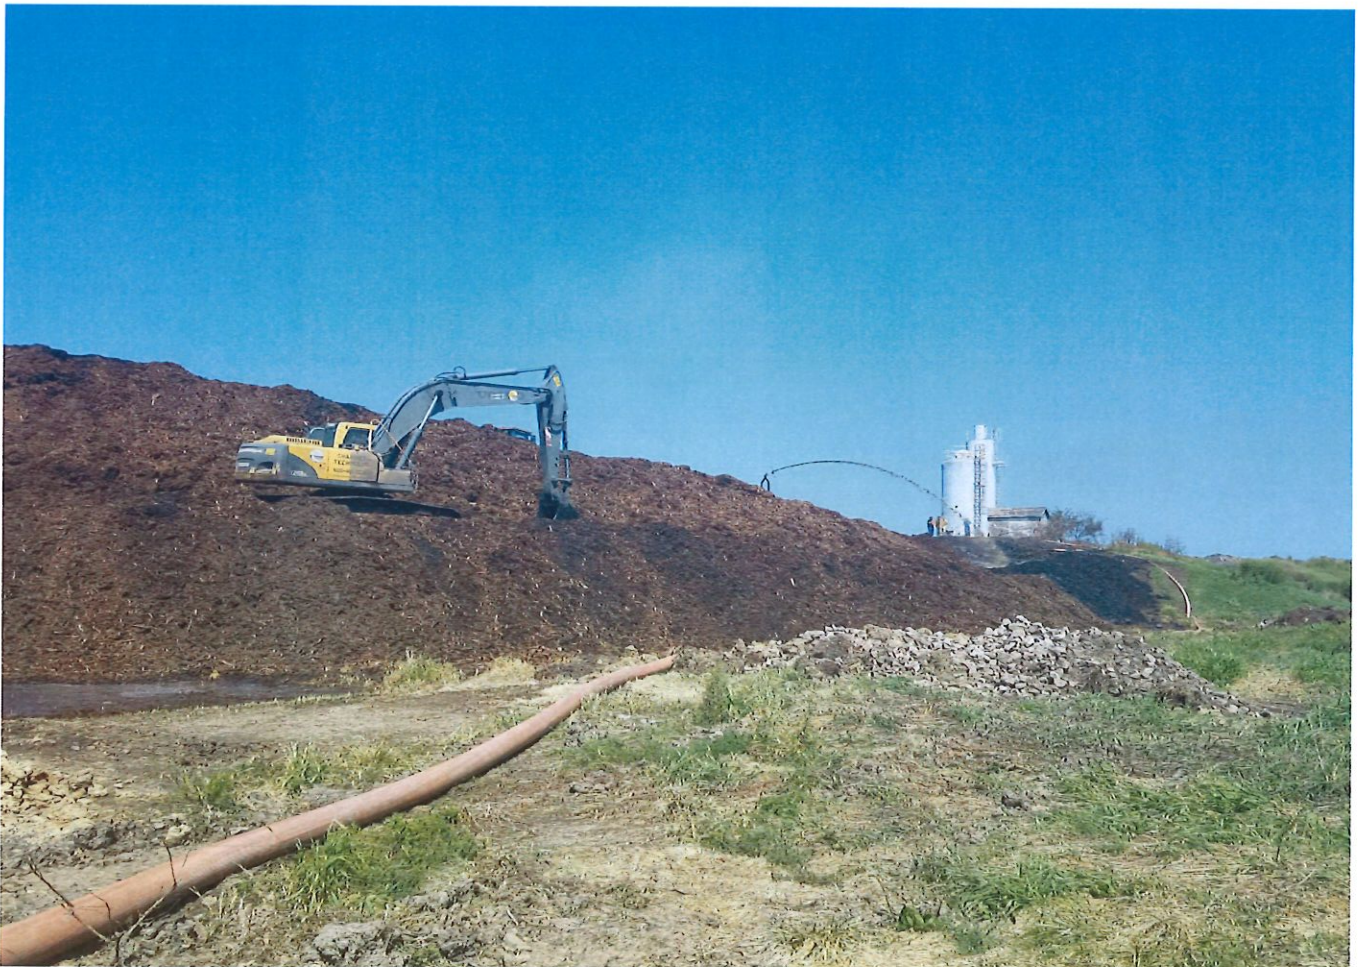
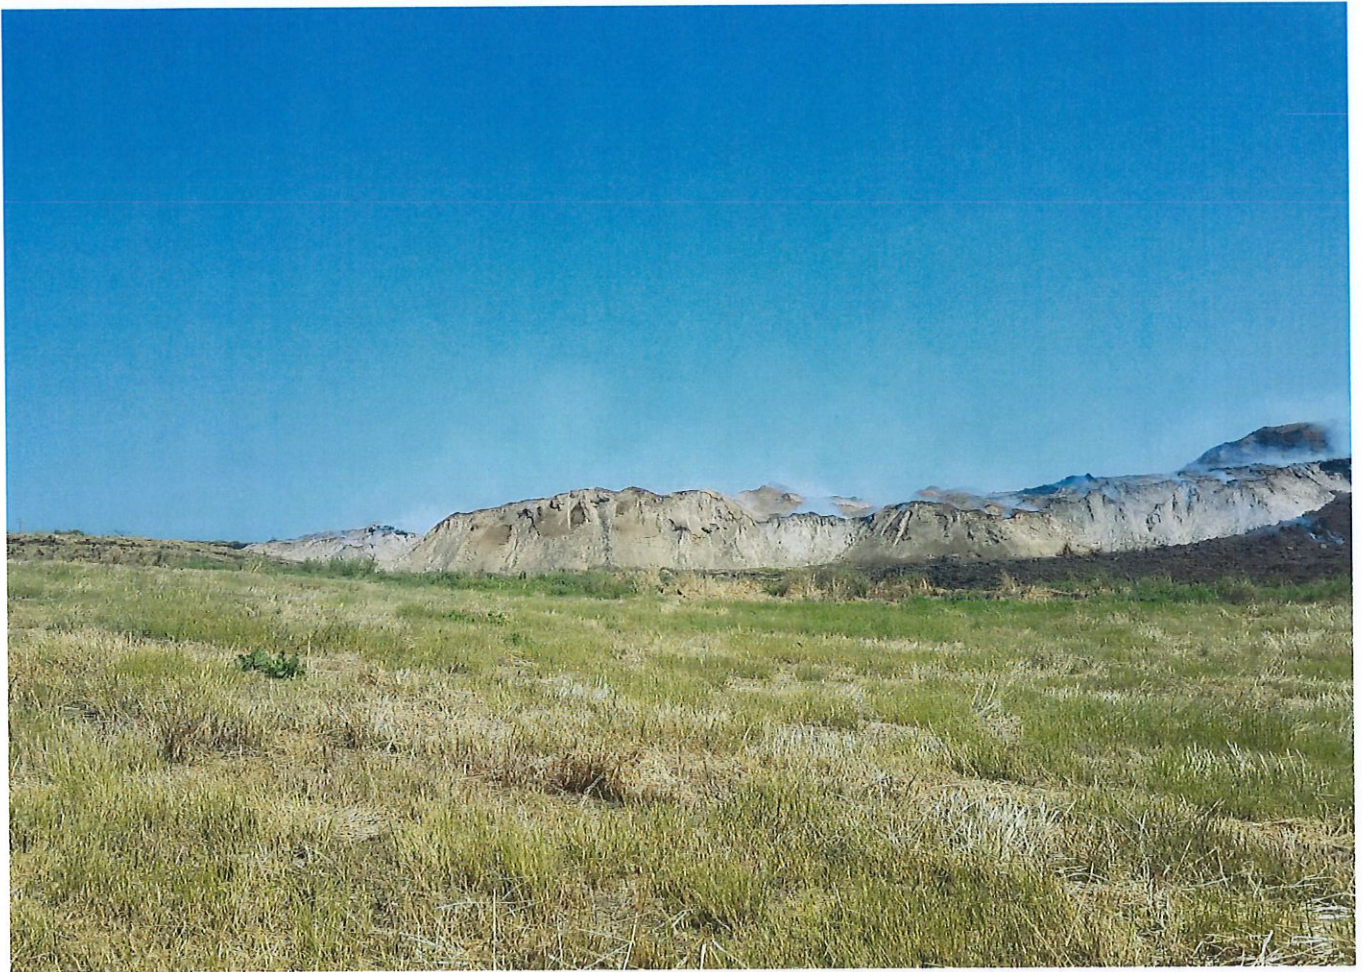
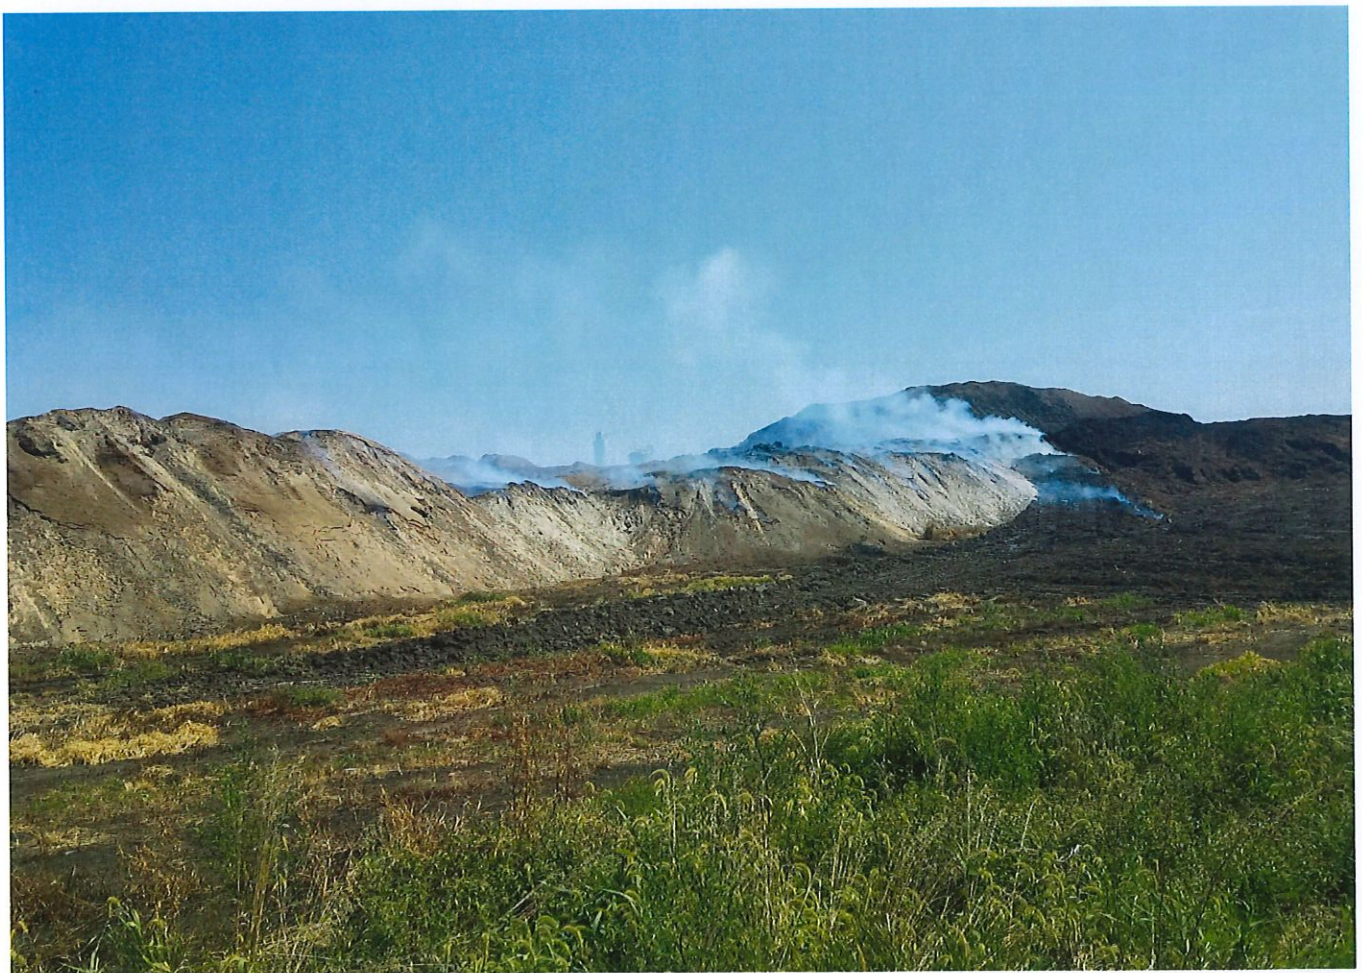
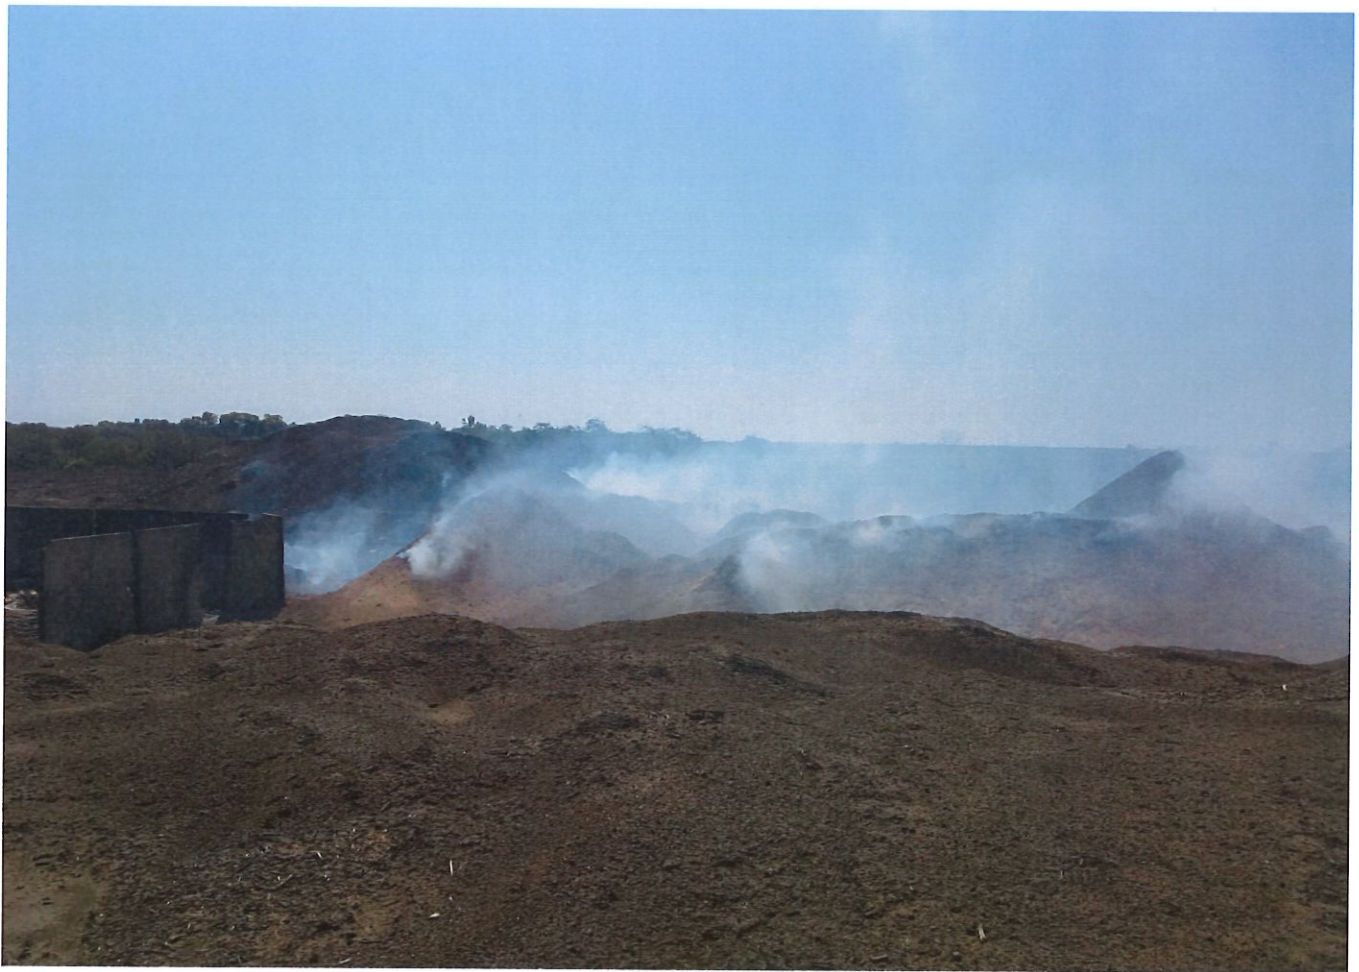
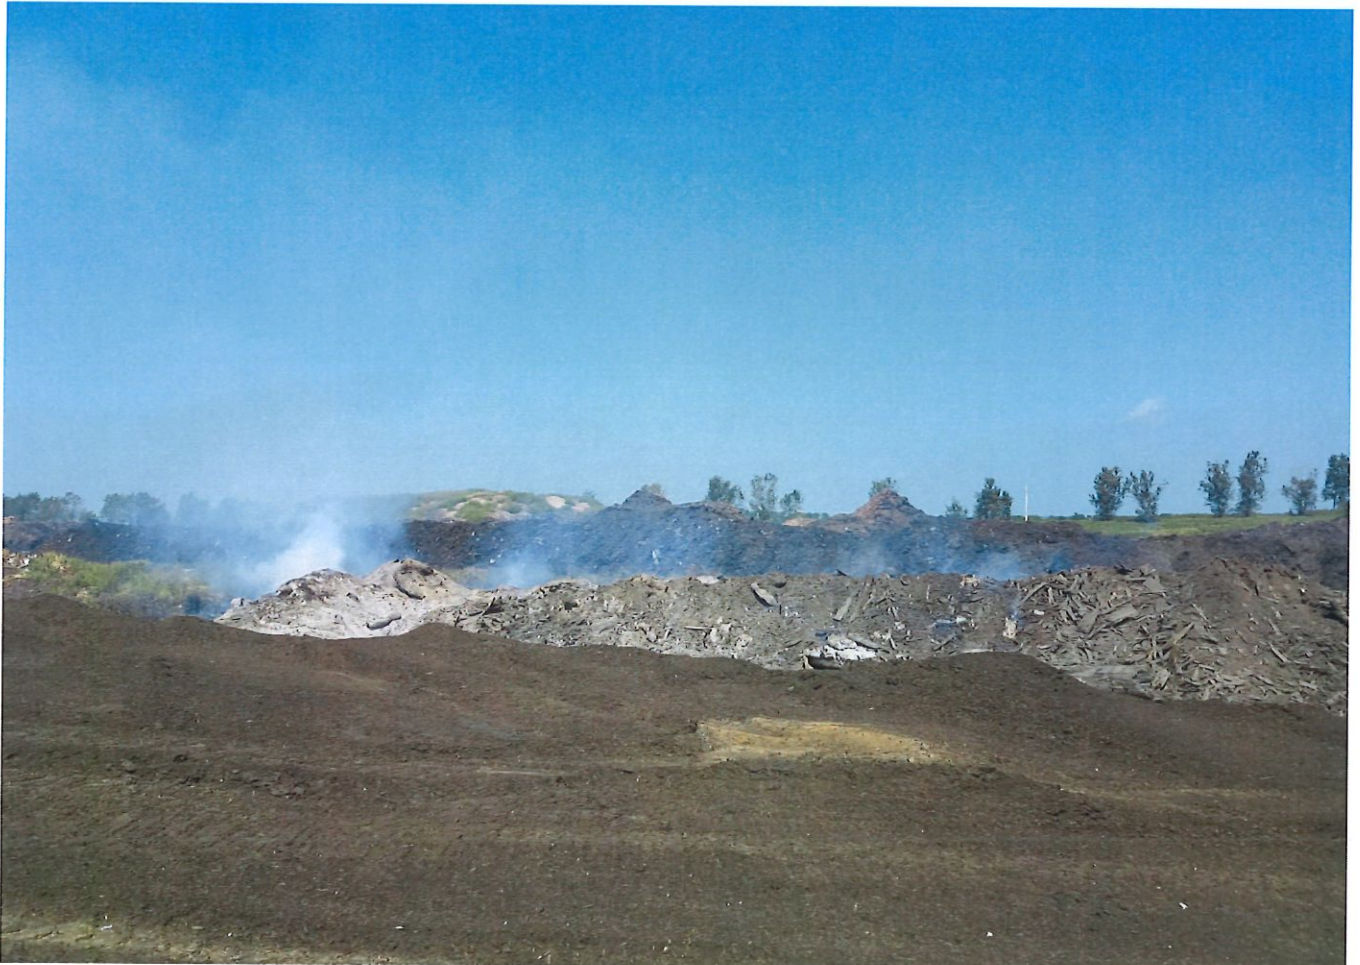
8/27

Wind was from the south/southeast at approximately 5 mph (12:00 pm). At least 6 staff were on site (5 on fire related work). The smoke was about the same as the previous day. The east slope was being worked with the excavator. A mulch terrace had been created to allow the excavator to work the slope. Leachate application continued in that same area and it now was ponded in the terrace area towards the pad. The leachate dam and recirculation process were still effective. Staff have utilized throttle control on the pump to change the arc of the leachate being applied. The eastern portion was not smoking or smoldering any longer. The mulch piles, that were pulled out over the previous days, on the south and southwest portions had been spread out. The west ½ continued to smoke somewhat, but overall smoke was less than previous days. Some hot spots on the pad were being turned and put out by the end loaders. The loaders were also utilizing wet compost mix to cover hot spots up top on the screened compost pile (western ½). The water tank was being filled in Eddyville and that water was being sprayed on the log pile and ash east of the central lagoon. Per my conversation with Richard, the ash needs to be knocked down so that equipment can get in that western area safely. Water and leachate will be utilized. Leachate use is planned to be switched to the central lagoon. Freeboard is (extremely) minimal and it is closer to the western portion. I reminded him to be able to capture and recirculate no matter where it is applied. A combination of spreading out the hot spots and covering certain areas will be implemented. Richard indicated that the east and west ½ may be separated to attempt to keep the fire from restarting on the east ½. The excavator had switched to the log pile area where water was being applied. One of the end loaders was picking up hot mulch piles on the southwest portion and spreading them out to further to the southwest. Prior to departing, I conveyed the site status to Kurt Levetzow.
