MEMO

Date: 9/1/21
To: Chamness SDP File
From: Brian Lee, ES

Facility: Chamness SDP, Permit # 90-SDP-10-97P-COM
RE: Derecho Mulch Fire, 8/23-27, 30/2021 visits, complaint #29884

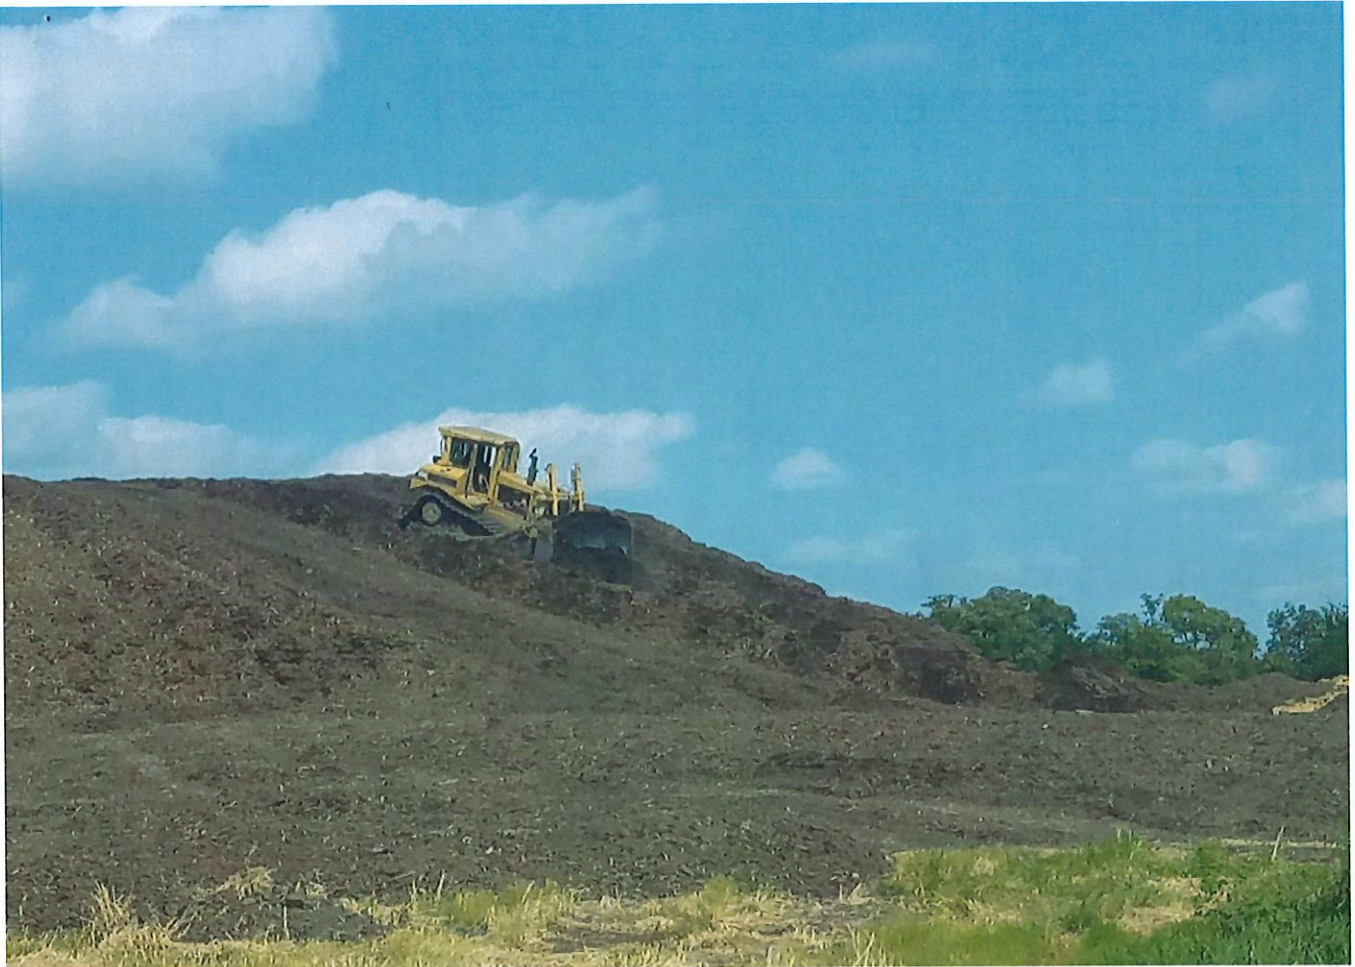
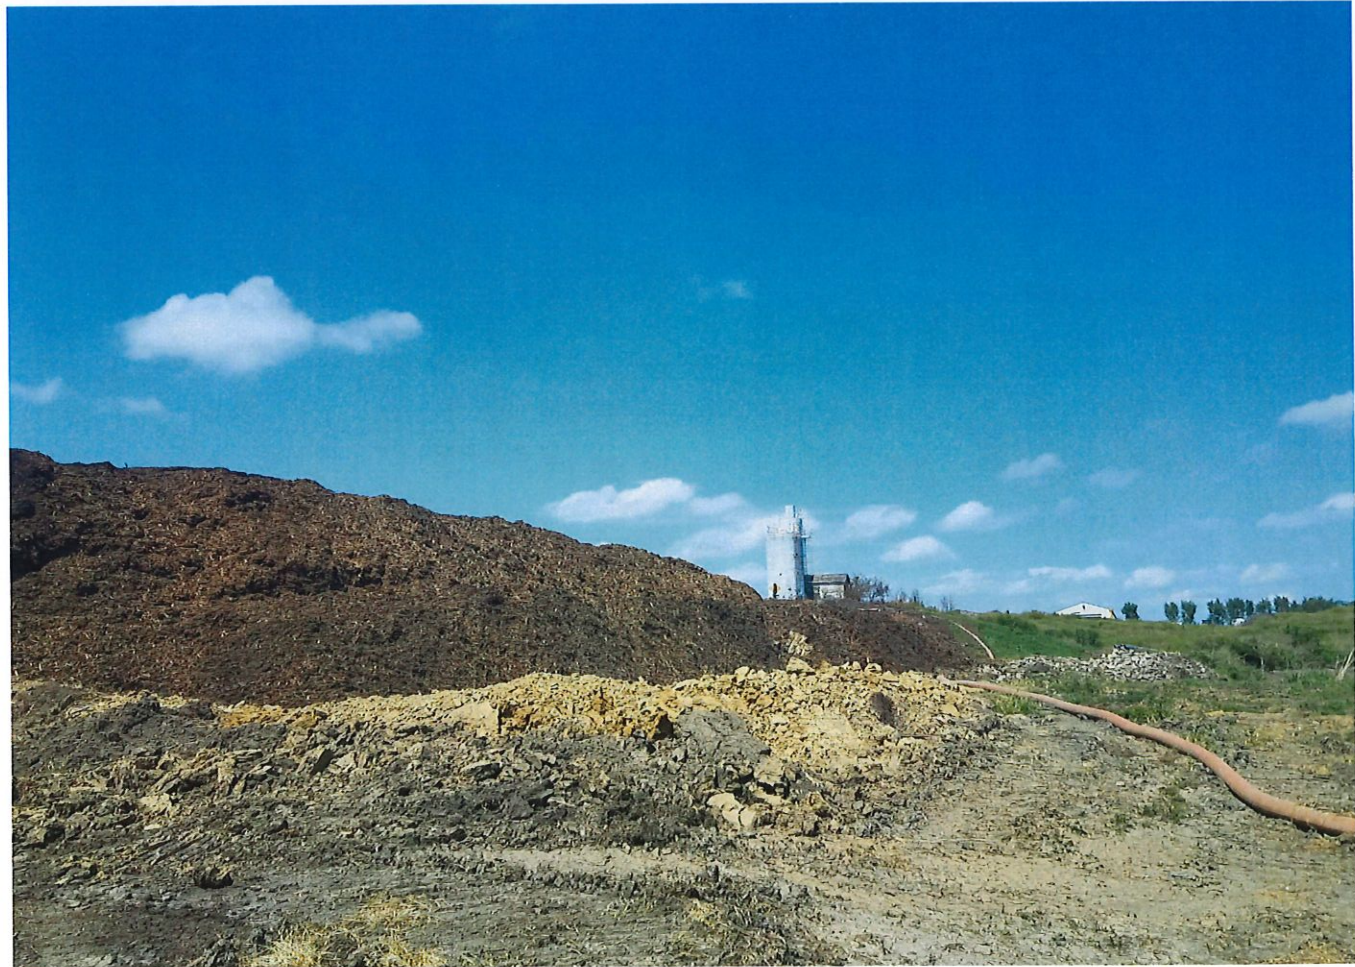
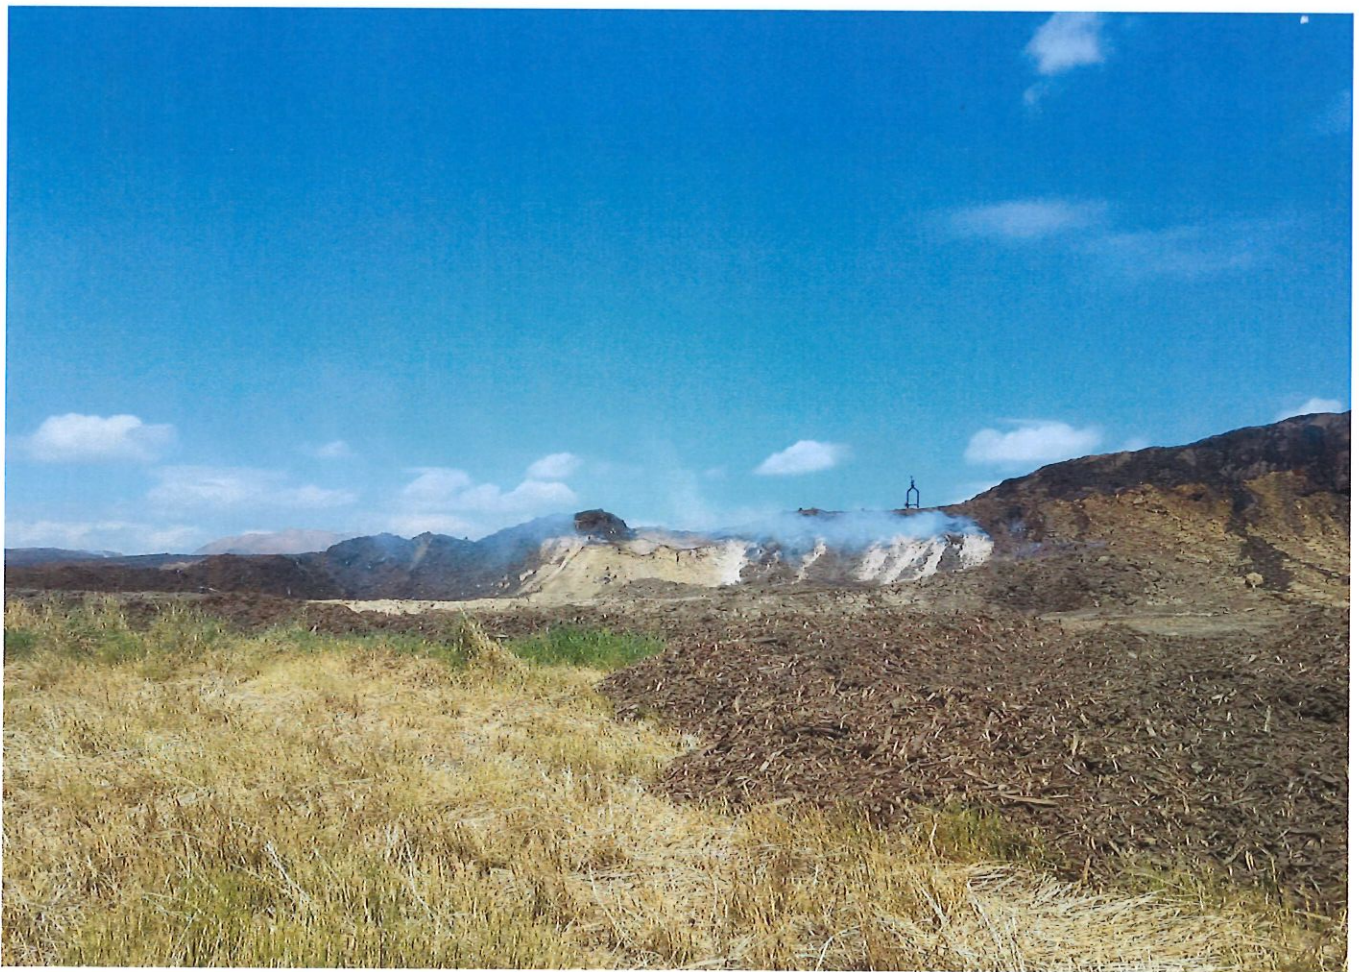
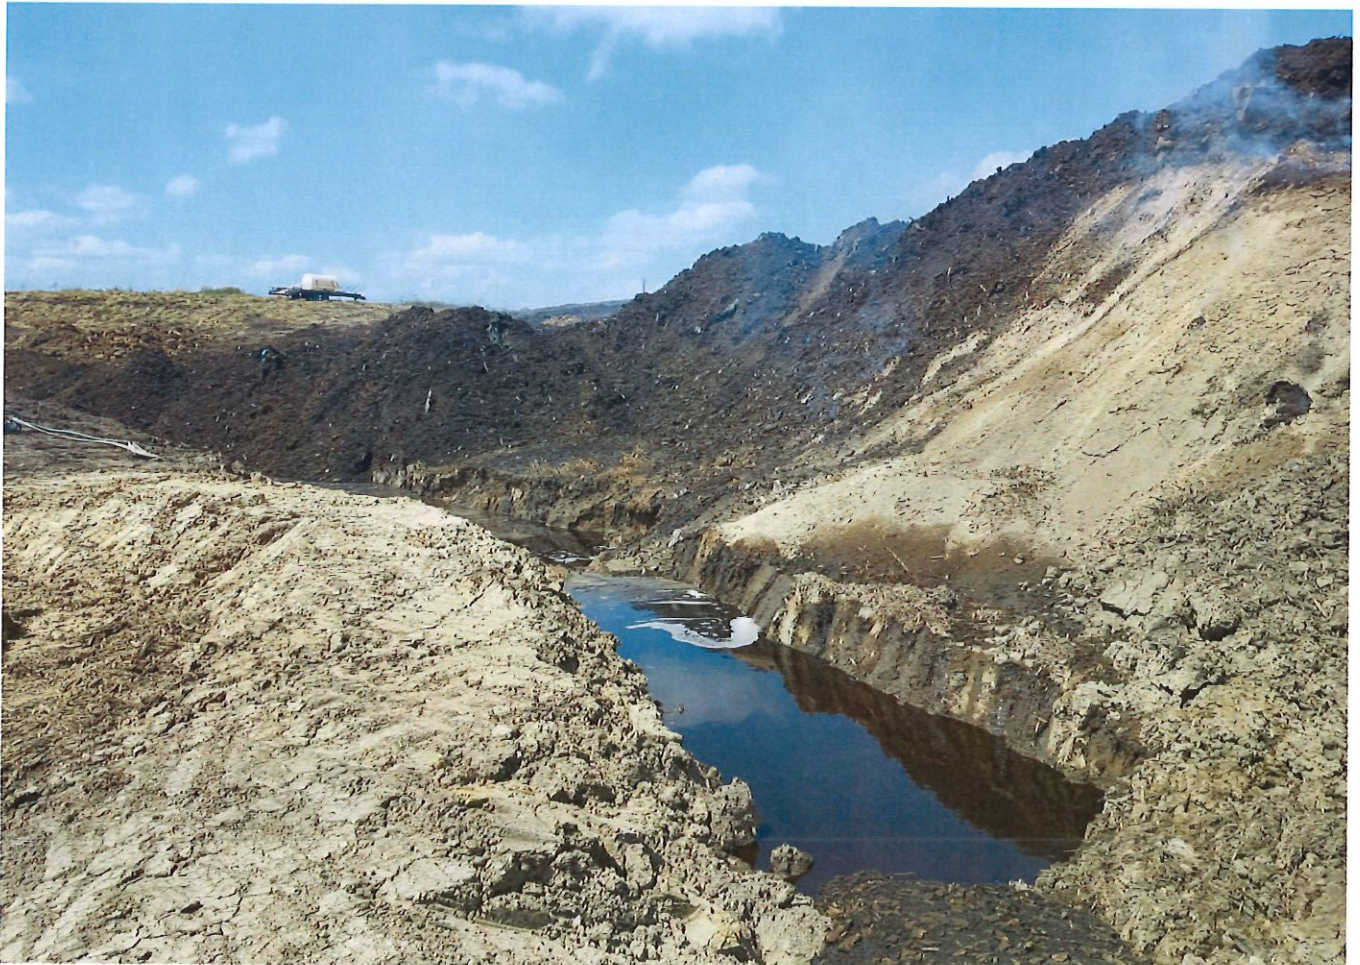
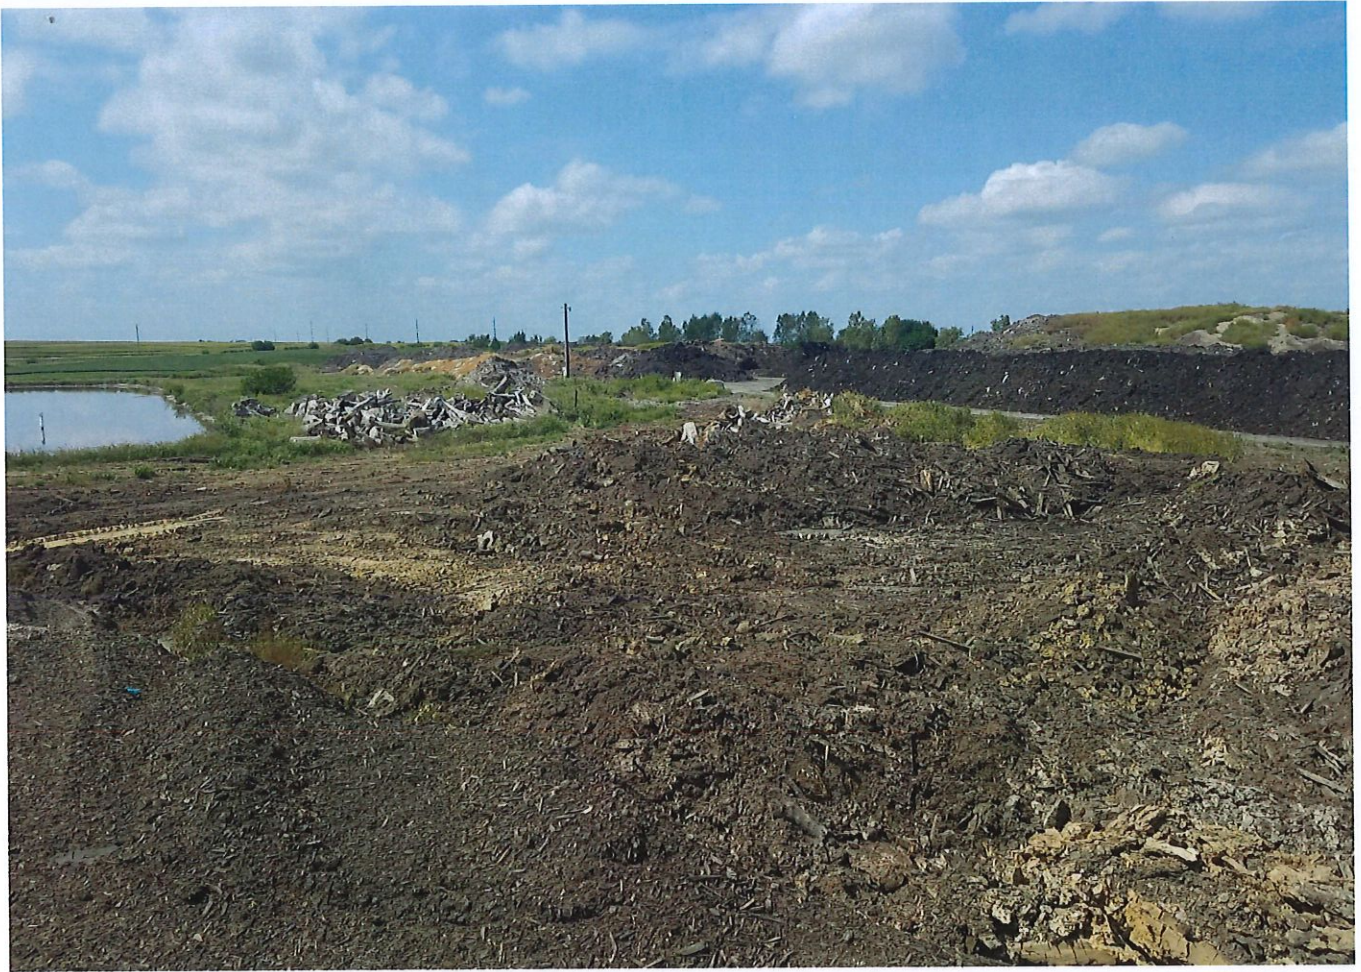
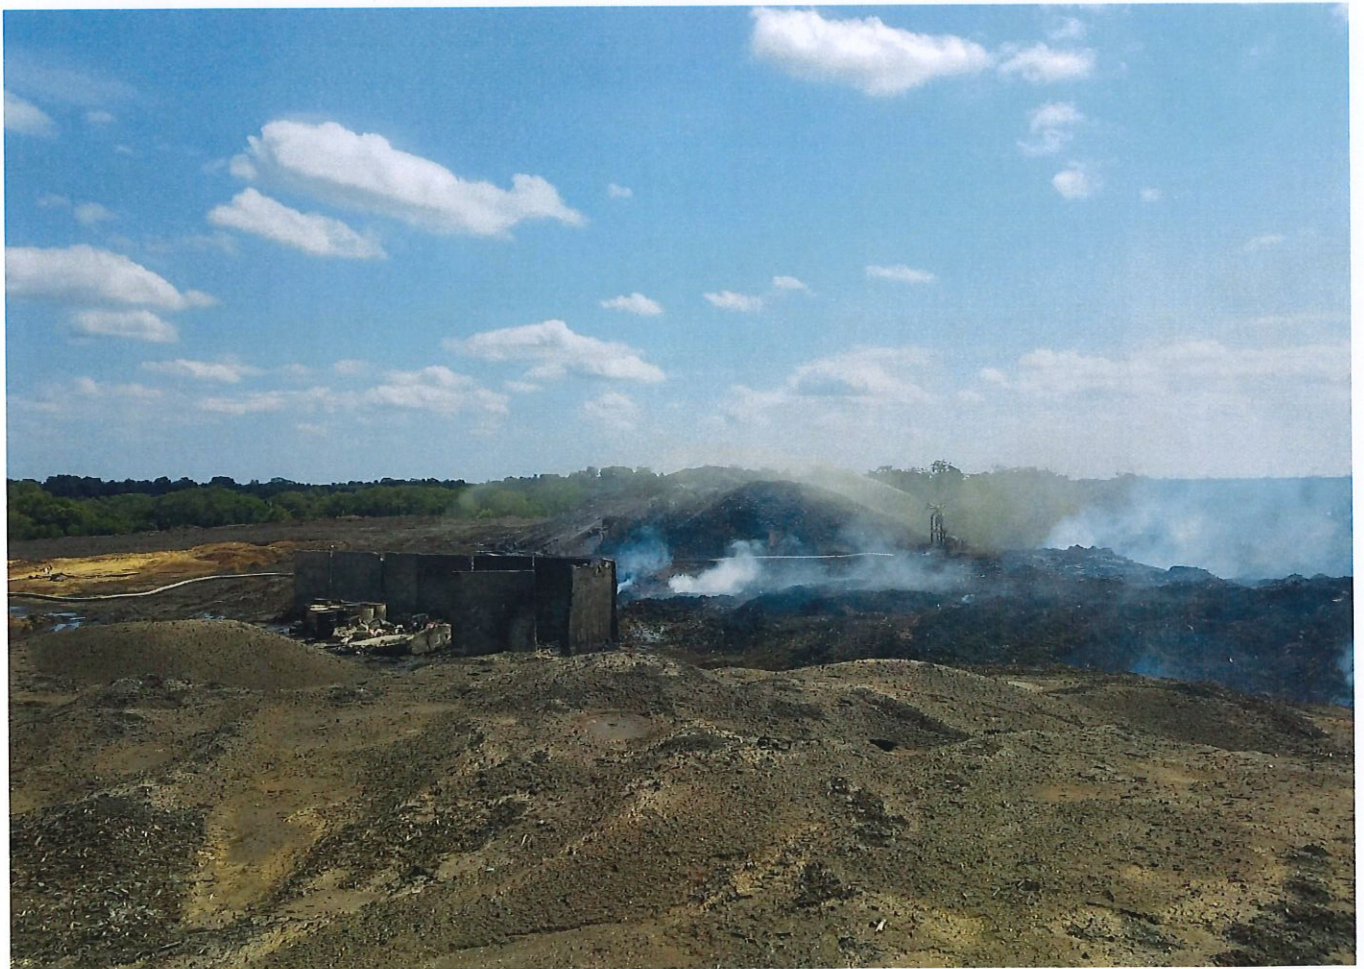
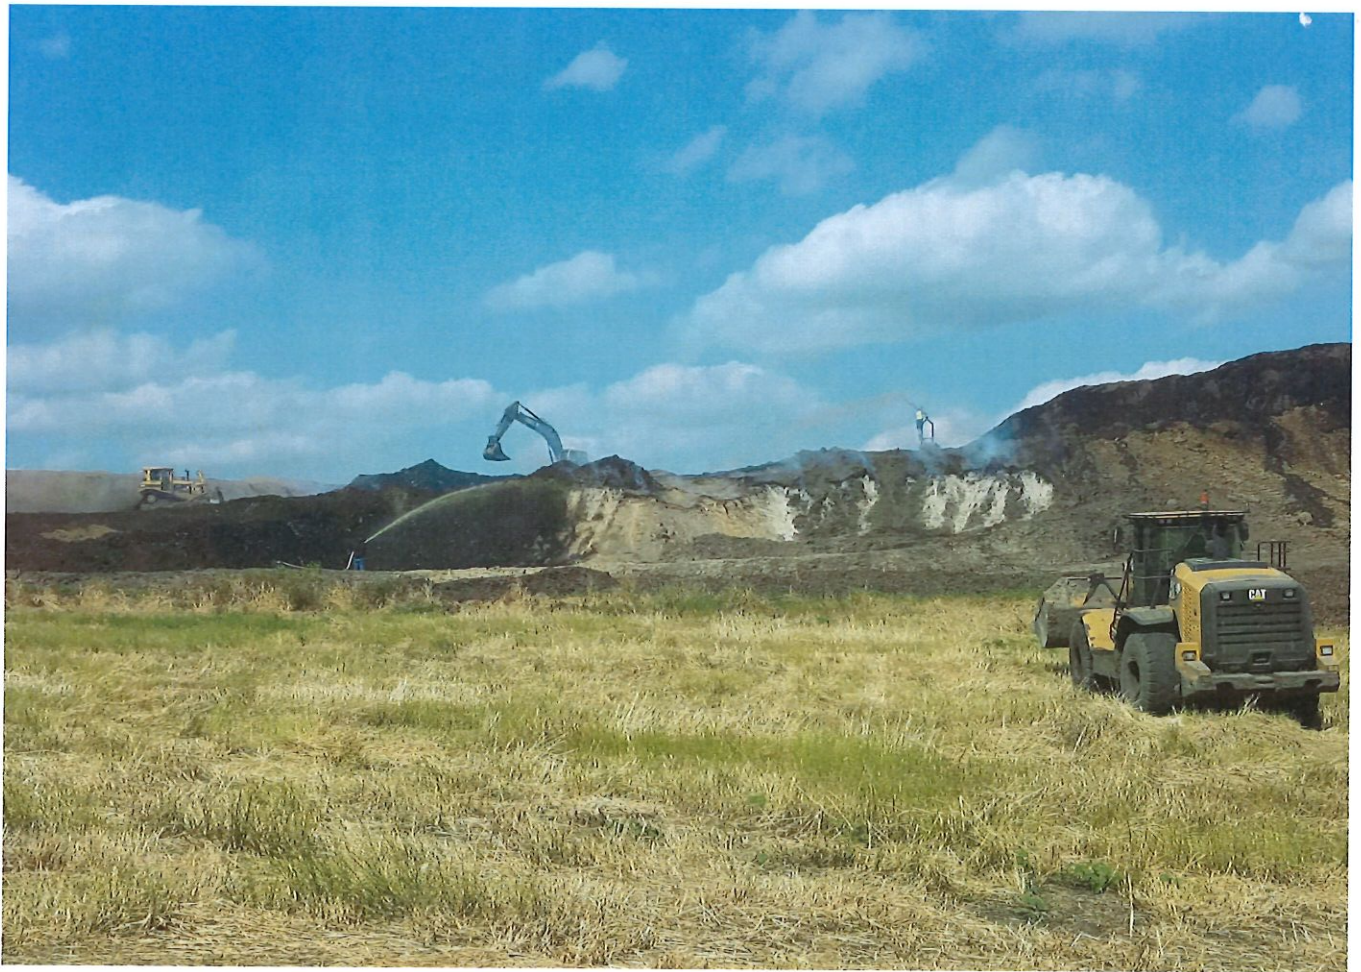
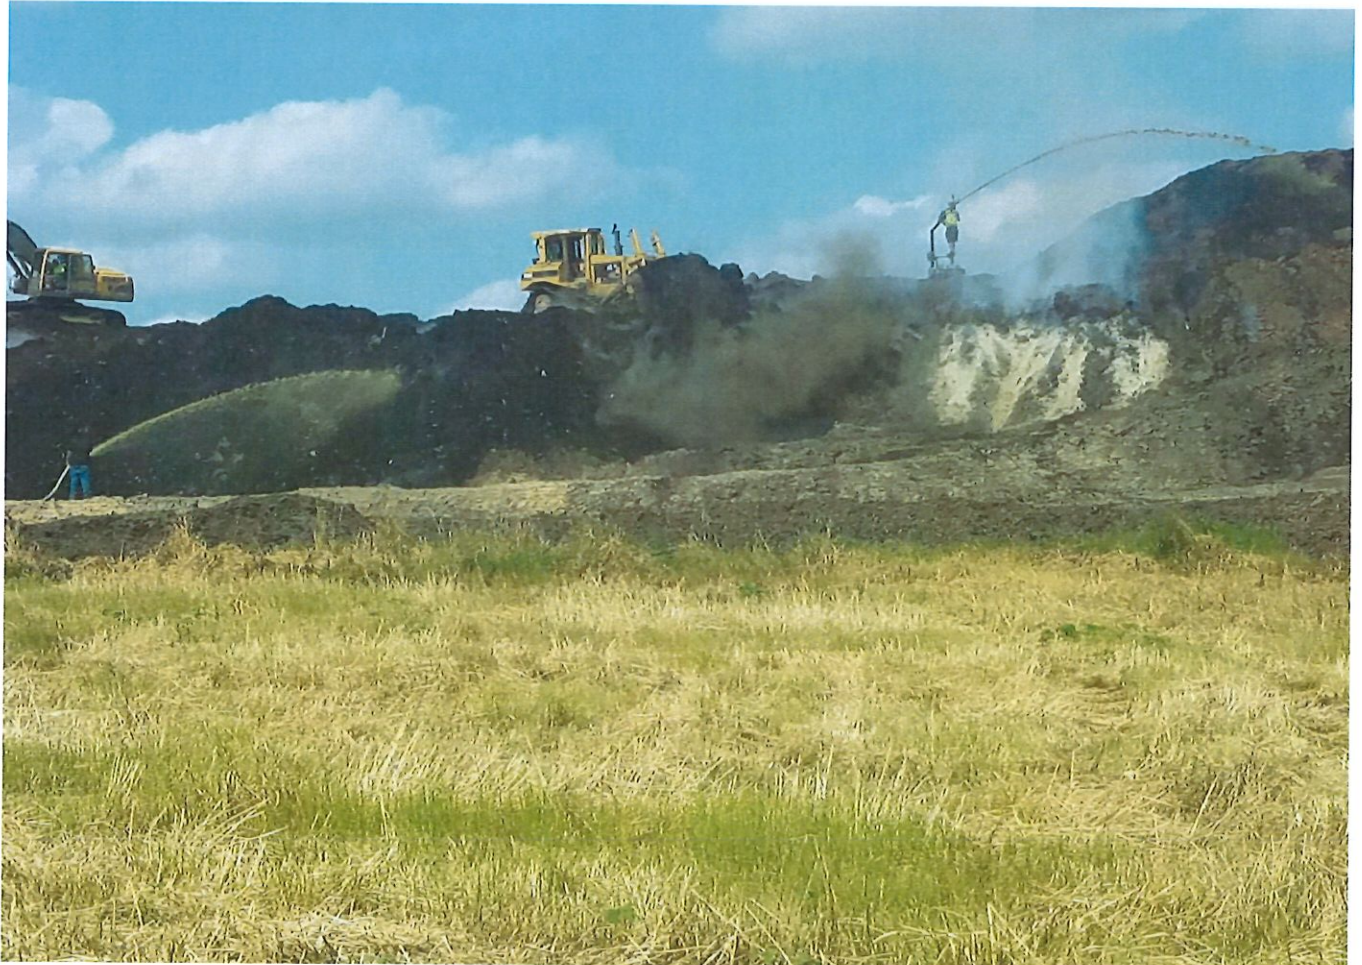
8/30

Wind was from the east at about 5 mph (1:45 pm). Leachate application was not operational, but had been moved to the southwest section. The east lagoon was still being utilized. Berms/dams had been created downslope of the leachate application area, beyond the toe of the mulch slope. Leachate was ponded and had not migrated beyond any of the structures created (no leachate migration detected at 160th crossing or at Missouri crossing either). A trash pump was in place to recirculate the leachate collected behind these new dams. The east ½ was not smoking and the log pile had been covered with soil. Overall, the smoke was less than Friday (8/27). Additional soil cover had been implemented on the southwest portion as well. The unscreened pile on top of the southwest mulch area was still smoking in a few areas. Compost rows on the pad did not appear to be smoking or smoldering. The bulldozer, end loaders, and excavator were idle at the shop as the staff were at a late lunch. The staff I spoke with indicated they had worked all weekend and got most of the fire suppressed. Leachate application (and pump monitoring) started a short time later and the other staff arrived back from lunch. I spoke with Richard and he indicated that the southwest area would be the focus. Richard estimated most of the hot spots would be covered/extinguished today. Leachate application to calm the ash was needed first, then he would be pushing through areas to spread out the material to extinguish anything burning. The whole pile of mulch is planned to be sloped and covered with soil once all the fire is out. Another berm would be created downslope of the exiting pile to contain any leachate. Leachate land application would also continue from the central lagoon once the fire is out. After I spoke with Richard, he and a couple other staff mobilized equipment to the active fire area. At least 5 staff were now working on the fire. A smoking hot spot was observed on the south side and it went from smoking to flaming up very quickly. The excavator and dozer were utilized to separate the material and push through the area. The spot appeared extinguished after a few minutes. The focus of the operation returned to the southwest portion. The bulldozer moved mulch and covered the southwest slope with unburned material as leachate was applied. Large plumes of ash rose when disturbed, but covering and pushing up non-burning/wetter mulch material in and over the areas appeared to minimize additional burning. A staff at the trash pump was applying leachate from below and the irrigation gun was utilized from above/top. The same spot on the south side flared up again about ½ hour later and the bulldozer went back and pushed a significant amount of mulch down slope to extinguish the fire. I conveyed the site status to Kurt Levetzow prior to leaving.
