DATE: September 4, 2019

FACILITY: Chamness SDP (#90-SDP-10-97P)

RE: Follow-up Solid Waste Visit (FOCD #138347)

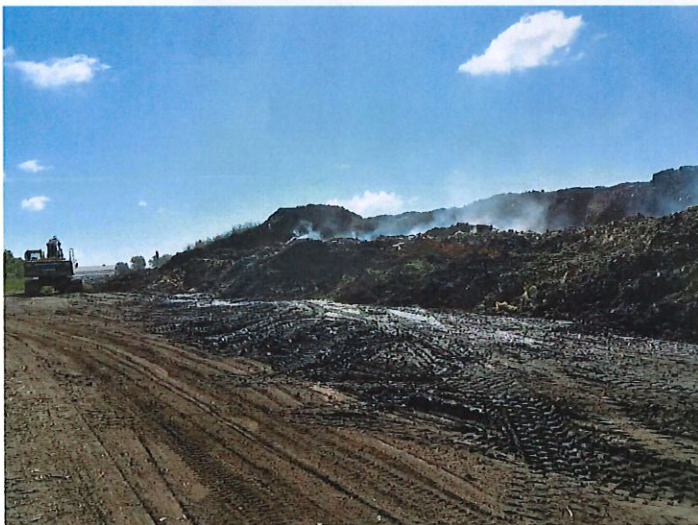
Picture 1. North central pad, looking east.

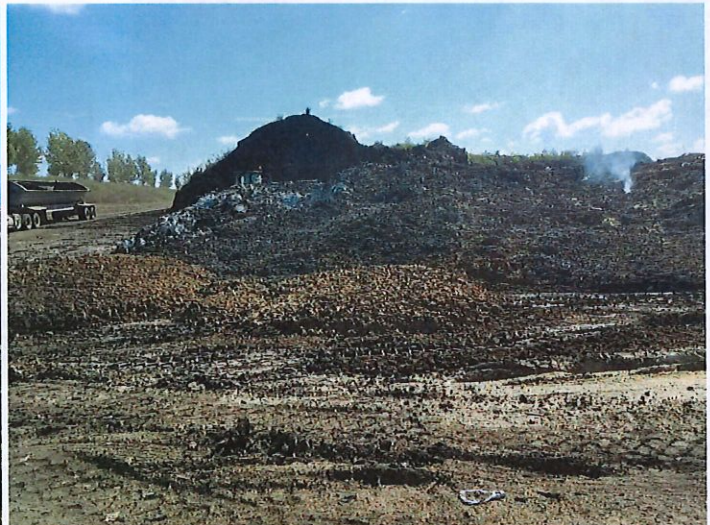
Picture 2. Northwest corner of the pad, looking east.

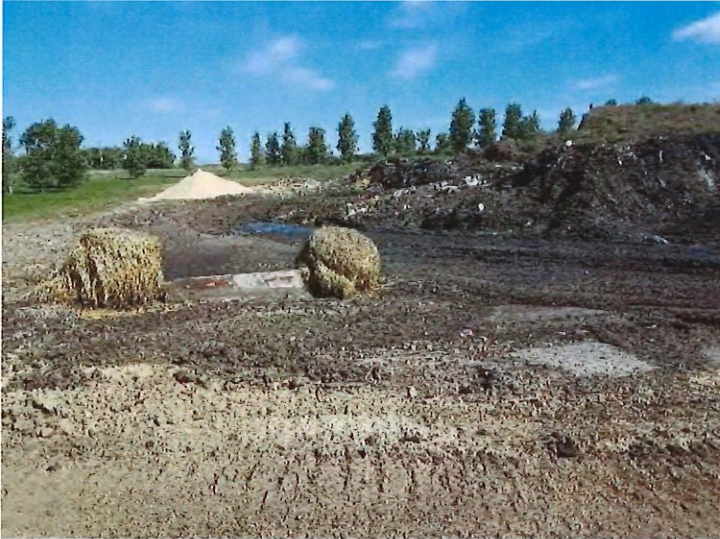
The drain from the pad to the southwest lagoon was plugged with compost material (picture 3). Earlier this year, during April/May, the berm had to be cut down to allow the leachate to reach the lagoon. No evidence of leachate discharging around the lagoon was observed. Significant compost material appeared to have reached the lagoon (Picture 4). Cured, screened compost remained off the pad on the southwest portion. Approximately 75 tons remained to be hauled out. No specific storm water controls were observed downslope of the pile. No leachate runoff was observed.

Picture 3. Southwest corner of the pad, looking north. Drain on lower left is covered/plugged with compost.

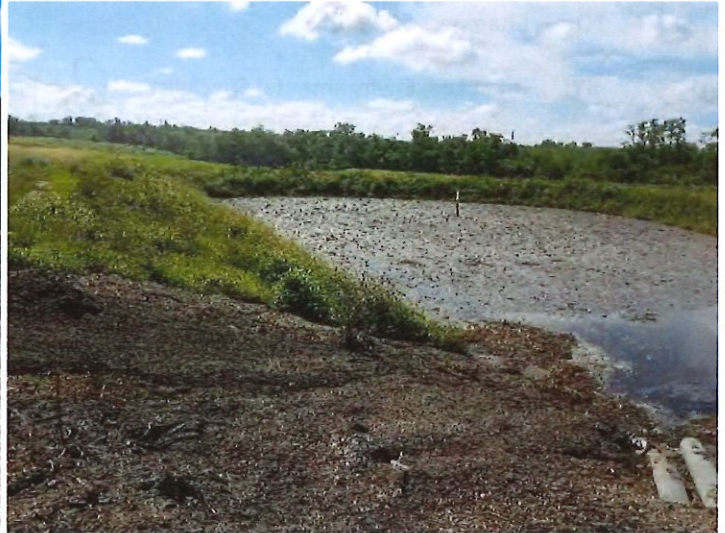
Picture 4. Southwest of pad, looking at the southwest lagoon.

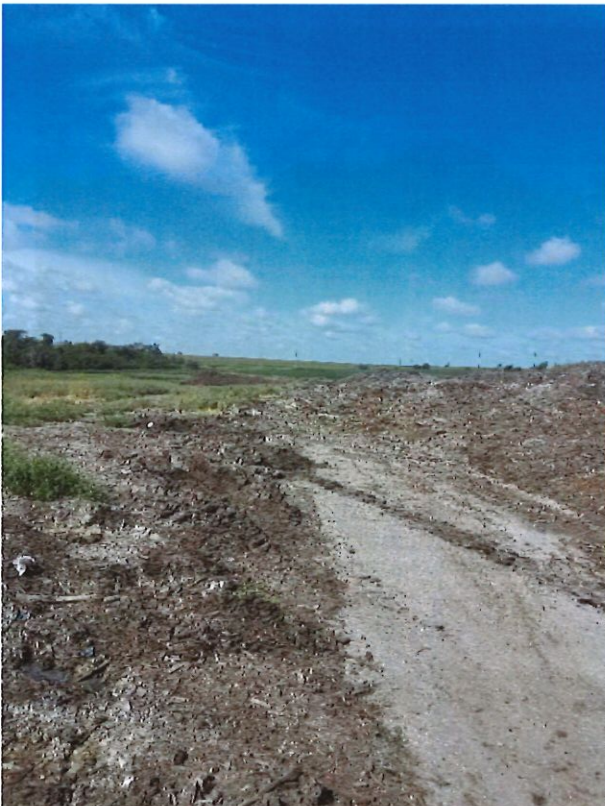
Compost was off the pad on the south-central perimeter (Picture 5). Storm water had accumulated within the compost pile in the middle of the pad. The compost was very wet and had flowed to the east. Lip balm material was stored in barrels and a few had come opened and contents were off the pad. Leachate discharge off the pad was observed at the southeast corner of the pad. Dead vegetation was observed (Picture 6). A small channel had been cut to capture some of the leachate and direct it to the east lagoon. Some leachate appeared to have previously discharged to the southwest, away from the lagoon. Some leachate was pooled in the drainageway that did not lead into the lagoon.

Picture 5. Compost off the south side of the pad, looking west.

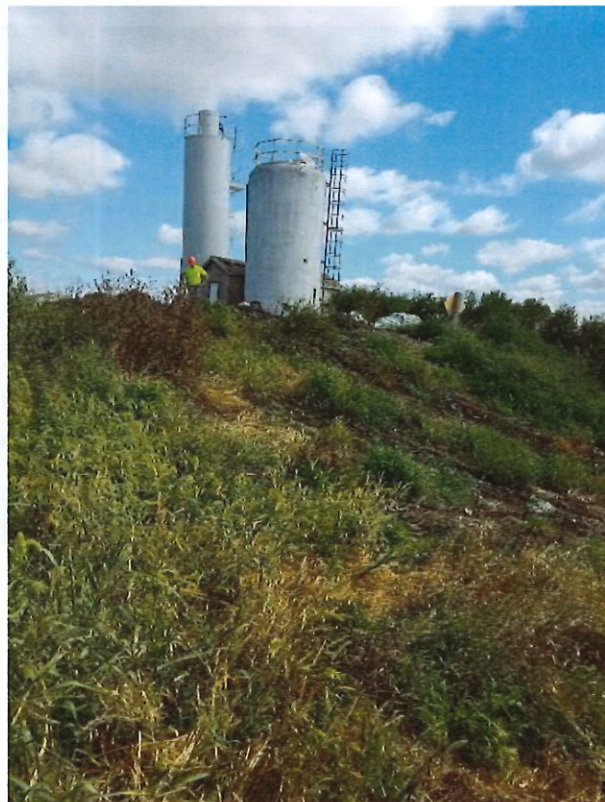
Picture 6. Dead vegetation off southeast corner of the pad, looking northeast.

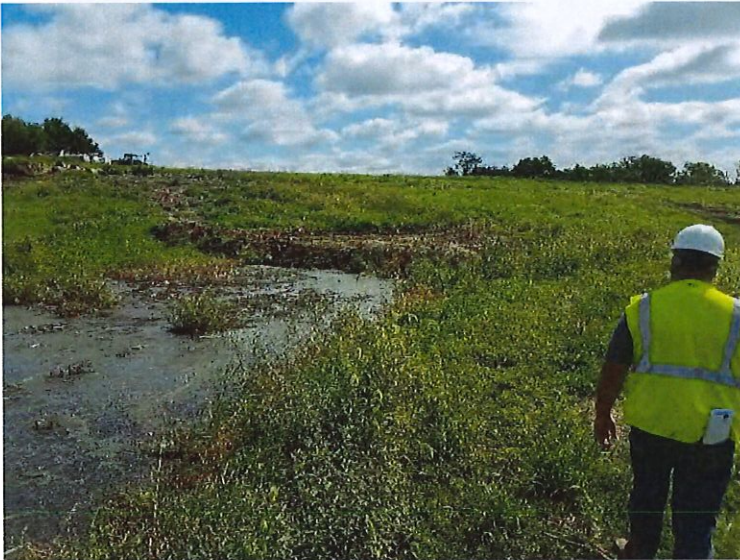
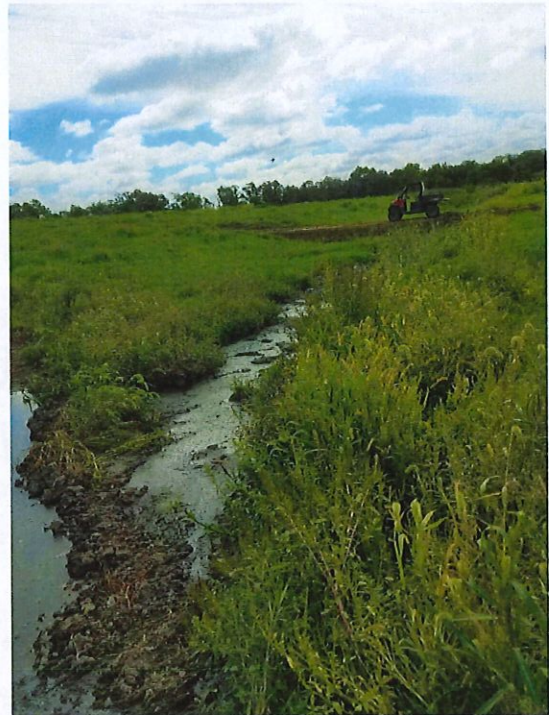
Unscreened, finished compost was being used as fill on the east end, east of the pad. Hay bale and soil berms were in place east of the east lagoon to capture runoff from that area and the east end of the pad (Pictures 7 and 8). Leachate had pooled behind the first soil berm, but had not reached or passed the second berm at the time of our visit. The wood material for grinding is stockpiled east of the main site. Additional finished compost was being used as fill in a small area a few hundred yards east of the main shop, beyond the grinding operation.

Pictures 7 & 8. Hay bale and earth berms are in place downslope of compost fill operation.

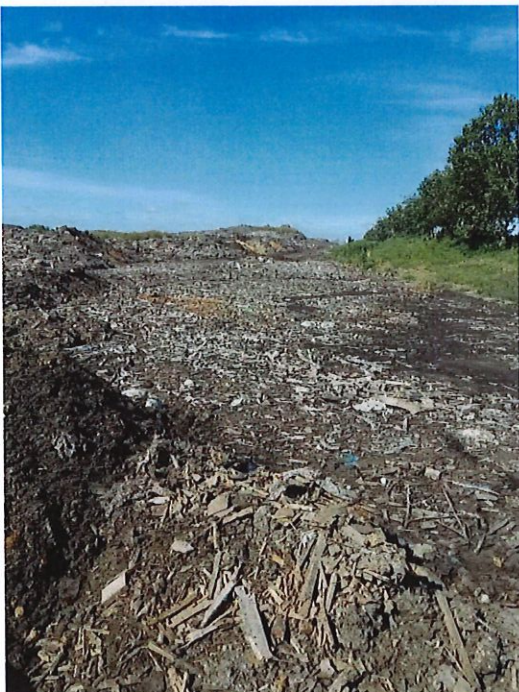
Most of the east side of the pad was covered with a soup consisting of compost and storm water (Pictures 9-11). Compost appeared to be off the east end of the pad. The drains in place were not able to function properly. One portion of the drain pipe to the east lagoon had collapsed earlier this year and has not been fixed. Staff must pump the leachate/storm water to the lagoons. Differentiating between finished compost and the current composting operation material was also difficult to determine on the east side of the pad.

Picture 9. Northeast corner of the pad, looking west.

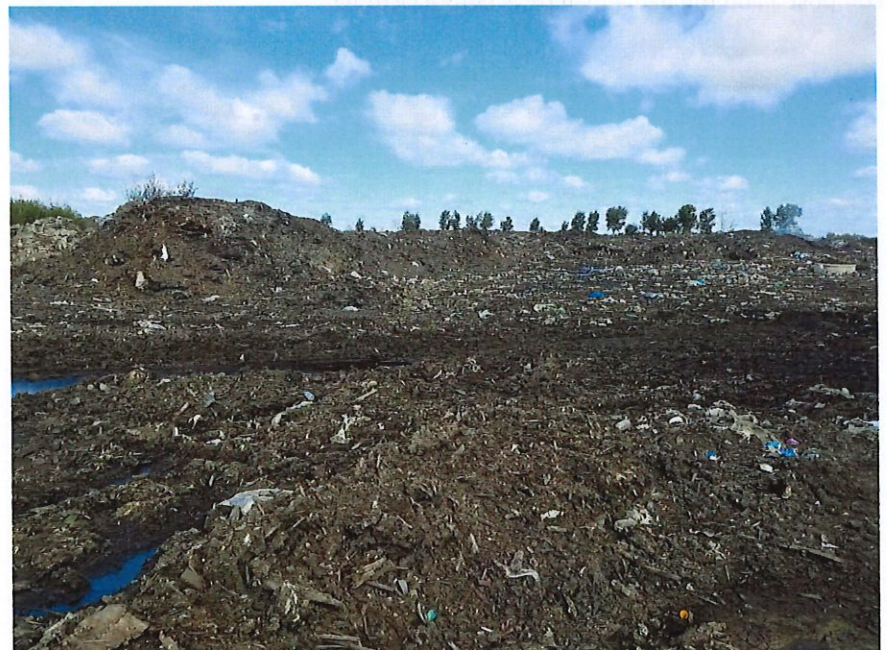
Picture 10. East end of the pad, looking north. Plugged drain is located on the right.

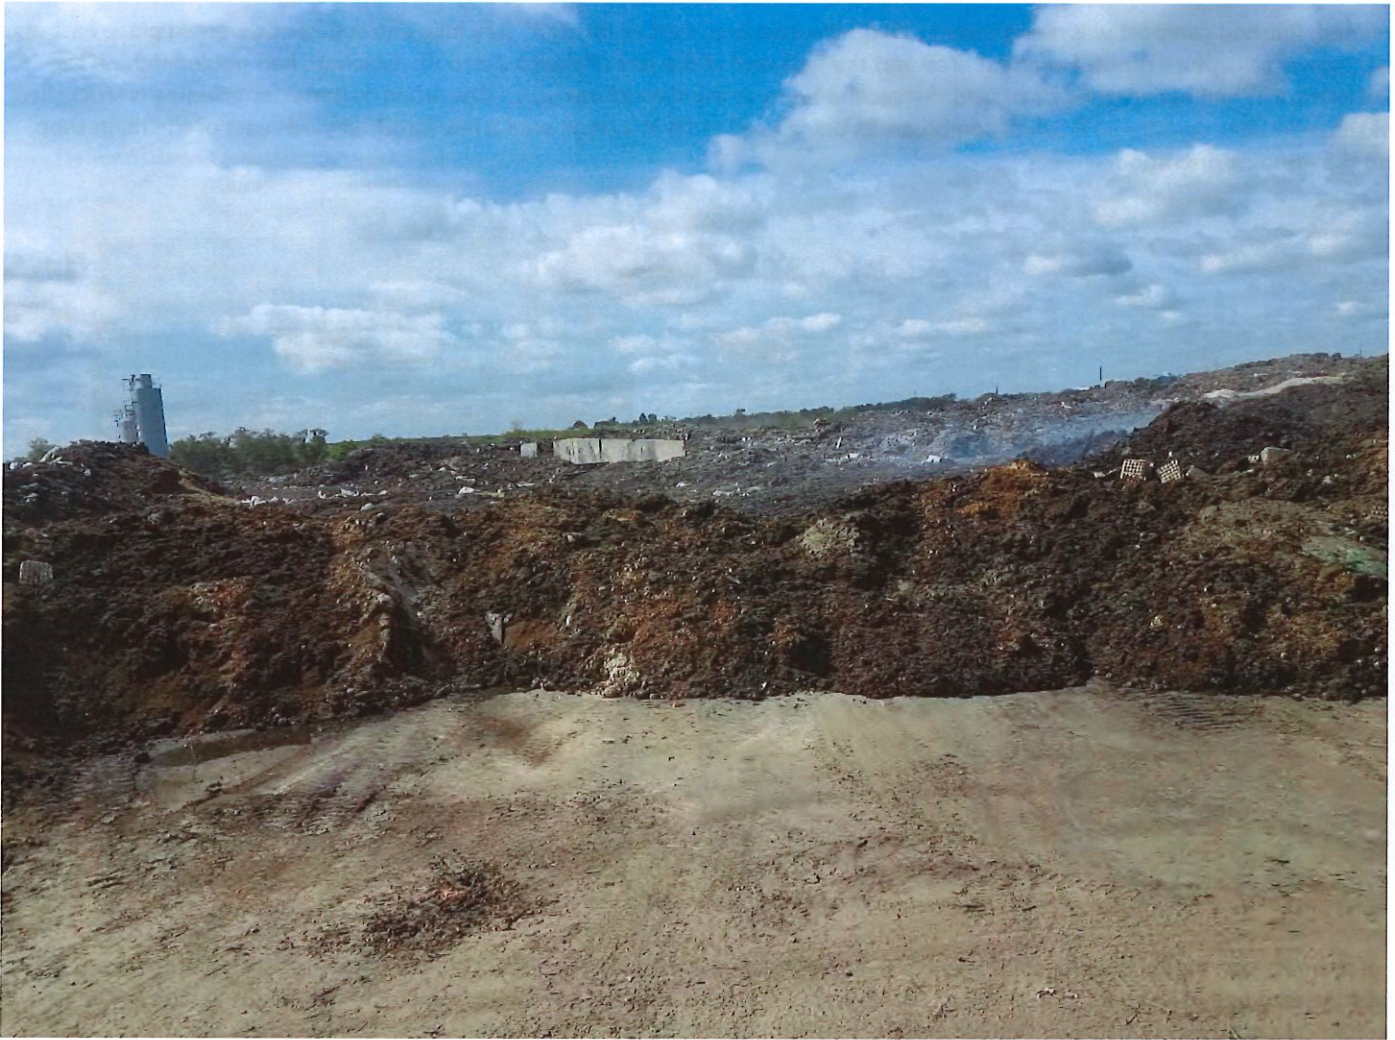
Picture 11. East end of the pad, looking south. This is typically the entry road, just south of the scale. Edge of pad is on left side of picture, running north/south.
