**IOWA DEPARTMENT OF NATURAL RESOURCES  
FIELD SERVICES AND COMPLIANCE BUREAU  
FIELD OFFICE #2 - MASON CITY IOWA**

**DATE:** July 17, 2014

**SUBJECT: Hawkeye Pride Egg Farm LLP Manure Complaint #17915**  
1275 Deer Ave, Corwith IA, Section 21, Magor Township

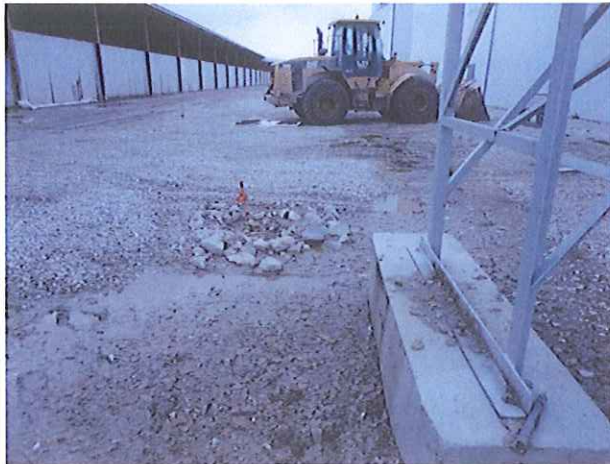
Mr. Moss directed me to what he believed were the storm drain intakes. The intakes appeared to be more of a French drain intake as they were covered with large rock. There was very wet manure; approximately two inches thick, covering a large area in the alley. There was still some discolored water standing around the drain intake location but most of the water had drained down leaving just wet manure solids. I asked Mr. Moss if he knew where the outlet was for the drains. He said he had located the outlet in an open ditch to south which leads to the storm water pond.

Storm water drain between manure building and production buildings.

I told Mr. Epting that on Saturday evening I had observed what I believed to be manure contaminated water discharging to the open ditch at the south end of the property. I asked him if this is where the storm water drains outlet and he confirmed that it was. I mentioned the location of the storm water drains between the manure containment building and the production buildings. The drains are located near if not directly under the conveyers that bring the manure from the production buildings to the manure containment building. If any manure spills off the conveyer and is not immediately cleaned up there is a risk of the manure getting into the storm water system. He told me that he was aware of the flaw in the design of the storm water drain system and he was talking to engineers about changing the location of the drains.

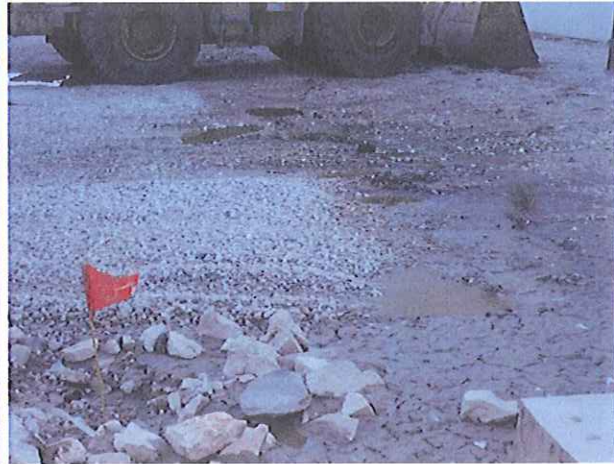
Storm water drain covered with manure.

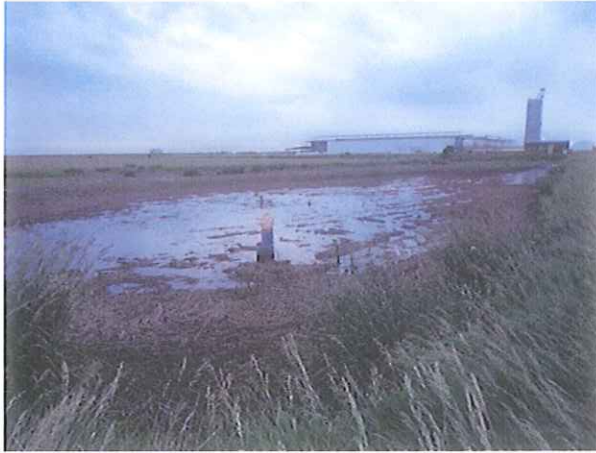
While at the storm water basin I observed an intake in the pond. The intake had a perforated stand pipe with solid collar around the bottom of the pipe. The collar appeared to be only approximately 12-18 inches tall which would not give the storm water basin much storage space before the water would discharge to the road ditch. There was no discharge from the outlet at this time.

I told Mr. Epting that on Saturday evening I had looked at the storm water basin and observed a perforated intake pipe near the southeast corner of the pond. The pipe appeared to outlet to the road ditch east of the storm water pond. I observed a short section of solid pipe, approximately 12-18 inches tall, around the bottom of the perforated pipe. I asked if that would be the depth of the holding capacity of the pond. He said that is the way the outlet for the storm water pond was designed. I questioned if this was enough holding capacity for the storm water system. He told me he would ask the engineers to look into this.

Storm water basin and outlet tube

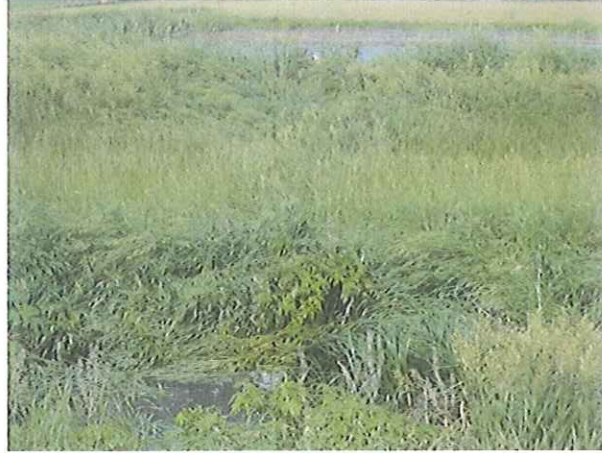
We drove to the site where the storm water discharges from the storm water basin to the road ditch and found the outlet pipe was submerged but water was bubbling up in that area indicating that the pond was discharging. We took a HACH field sample of the discharge water and found that it read  $>3.0$  mg/L ammonia. We moved approximately 50 feet upstream from the discharge pipe in the road ditch and got a sample reading of 2.5 mg/L ammonia. We moved approximately 80 feet downstream where the water from the discharge pipe was flowing in the road ditch and got a reading of 3.0 mg/L.

Storm water basin and discharge pipe

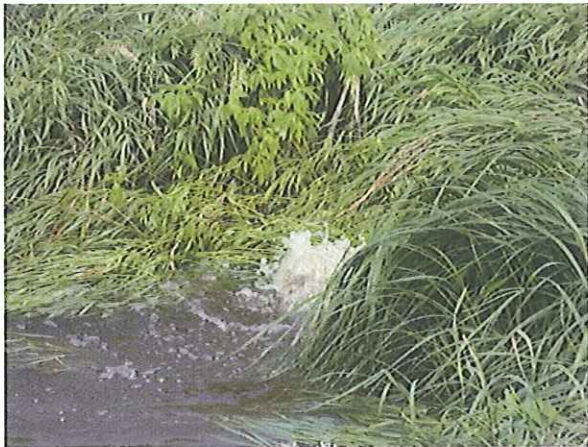
Discharge from storm water basin  
sample site #1

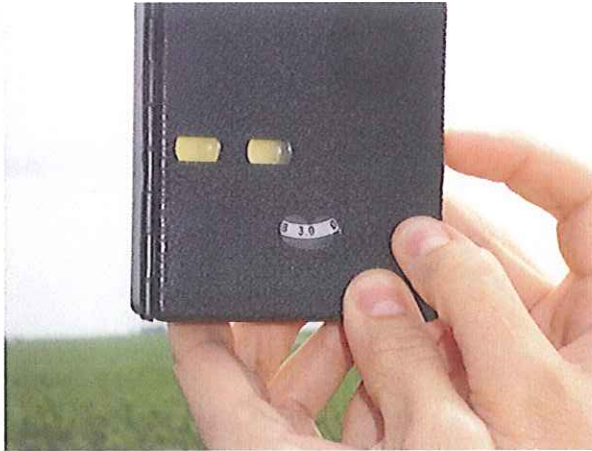
HACH sample at discharge >3.0 mg/L

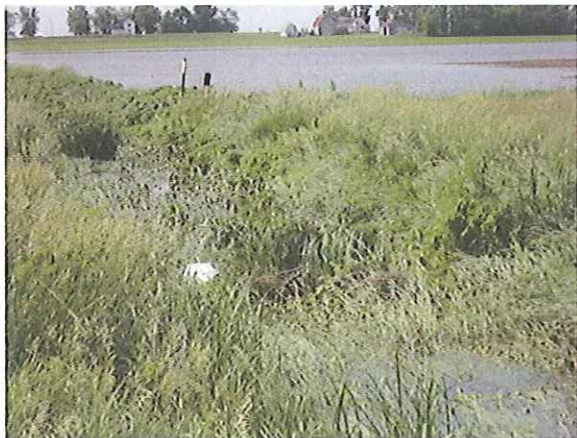
Looking south from discharge pipe

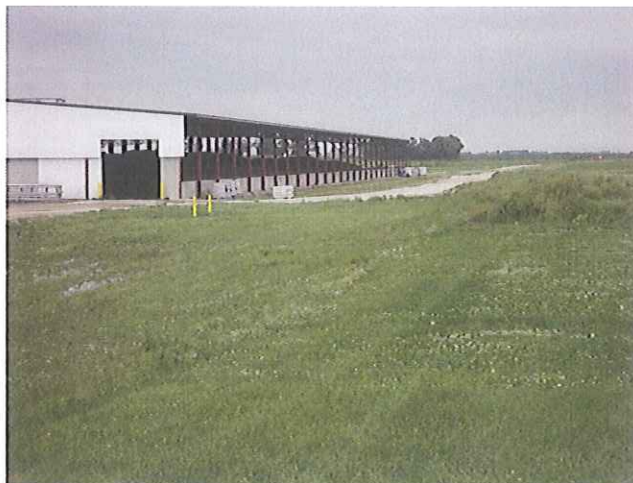
Mr. Epting was aware that someone had complained about manure being spilled over the wall of the containment building. He blamed the new manure handler/brokers for poor housekeeping procedures. He admitted that Hawkeye Pride staff had failed to clean up spilled manure on Friday June 13, 2014. He stated that usually someone from management checks to be sure that spilled manure is cleaned up before they go home but management staff had left early on Friday June 13, 2014. He said he had some of his staff cleaning up the spilled manure on Monday morning June 16, 2014.

West wall of manure containment building after clean up
