**IOWA DEPARTMENT OF NATURAL RESOURCES
FIELD SERVICES AND COMPLIANCE BUREAU
FIELD OFFICE #2 - MASON CITY IOWA**

DATE: January 20, 2021
TO: The Record
FROM: Kayla Beck *KB*
SUBJECT: Lehigh Cement Company 700 25th St NW, Mason City, Iowa
Complaint #29028 Stack Malfunctioning

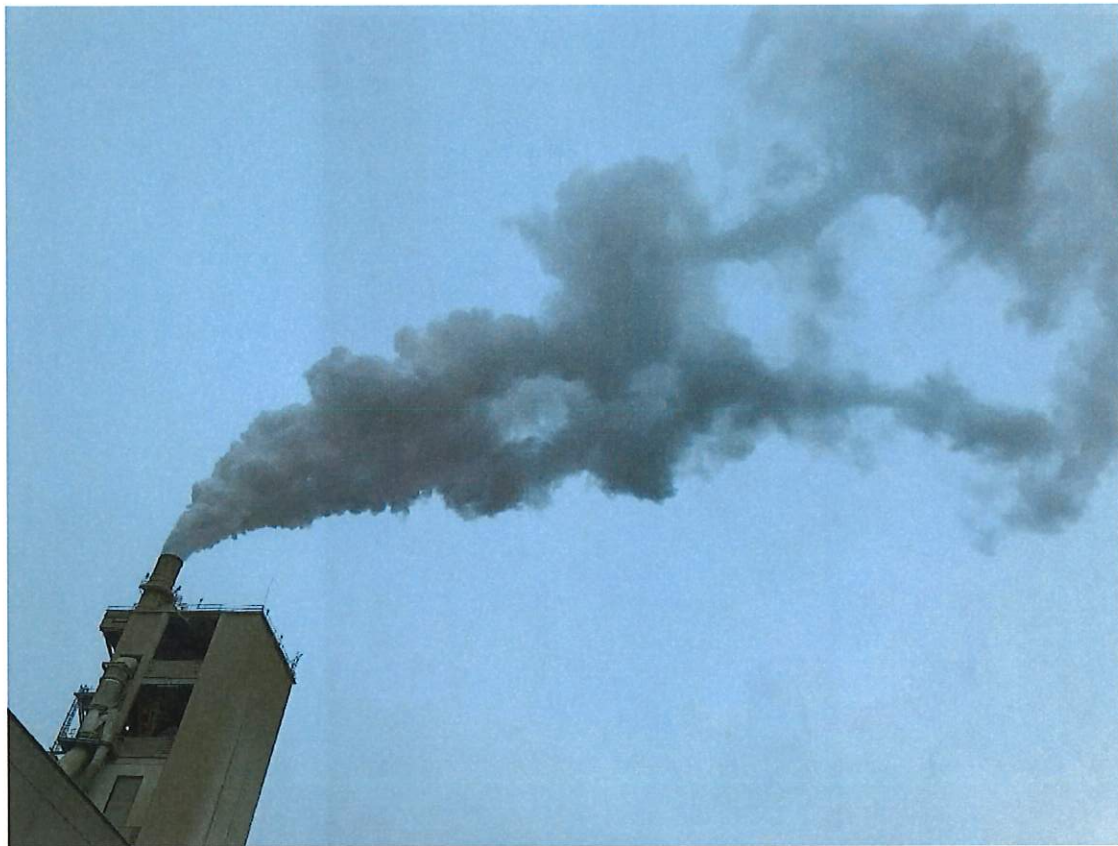
On December 14, 2020, David Knoll and I visited the facility to investigate the complaint. As we approached the facility we made visual observations of the facility's main stack (EP 25). It was clearly in operation. At the time of arrival, we did not note any visual signs of particulate matter (PM) in the emissions coming from the stack. We arrived at the main office and observed many cars were covered in varying amount of particulate matter. However, it should be noted the parking area and most of the grounds are unpaved so some amount of dirt is to be expected. Other more permanent structures such as building windows and signs had a heavier amount of larger particles with some structures being mostly coated.

Picture 3 shows the visual condition of the plume coming from the scrubber (EP-25) at the time of the investigation.

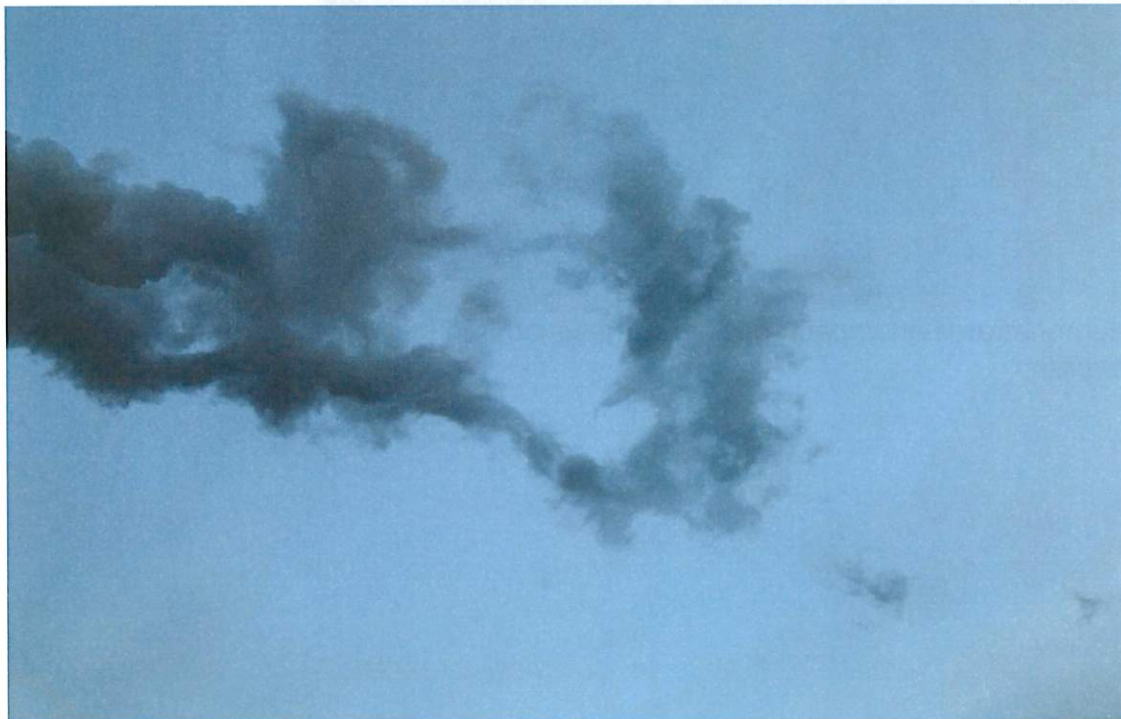
Picture 4 is a continuation of Picture 3. It demonstrates the edge of the plume captured at the same time.

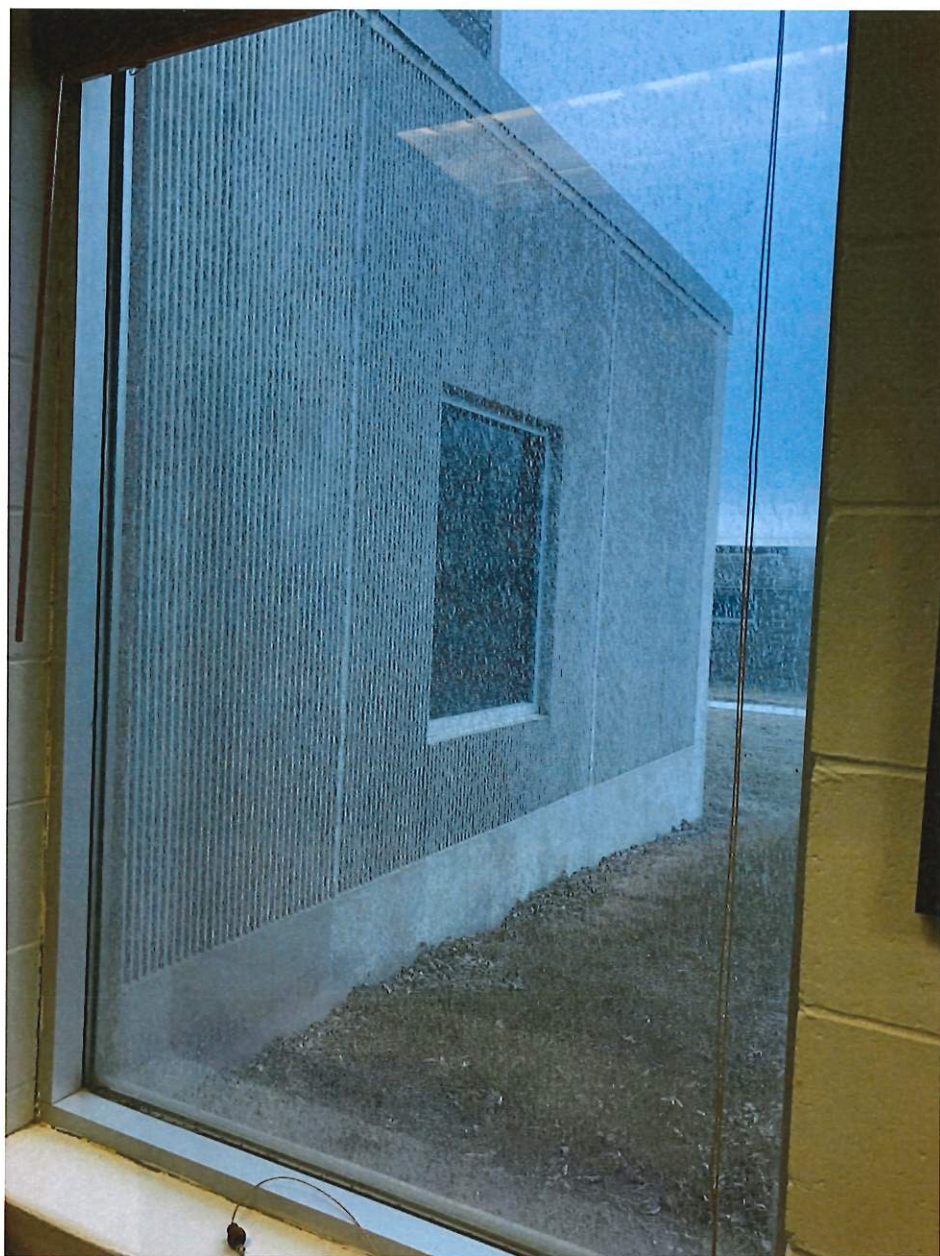
David and I entered the office and met with Michael Burkhart, Environmental Manager; Brodie Pederson, Plant Manager and Wendy Krause, MW Area Director of Environment and Sustainability. I shared with them the reason for our visit and asked if there had been any issues with the scrubber recently. Brodie confirmed that in the past few weeks the scrubber has been taken out of operation twice for incidents that resulted in employee vehicles being covered in dirty scrubber water. He stated that during the investigation into the cause of these events the facility found multiple levels of compromised demisters. These missing or malfunctioning demisters are claimed to be the cause of the events.

Brodie further explained that their maintenance team was able to fabricate temporary demister plates until the corrects parts arrived. I asked when he believed his parts would be available. Brodie stated that they were ordered and set to arrive on January 15th. David asked if the material and splattering on the windows had been caused by one of the scrubber events. Brodie agreed it was.

Picture 5 demonstrates an impacted window that is coated in dirty water droplets from the scrubber events.
