Mahaska County SLF visit 7/2/19

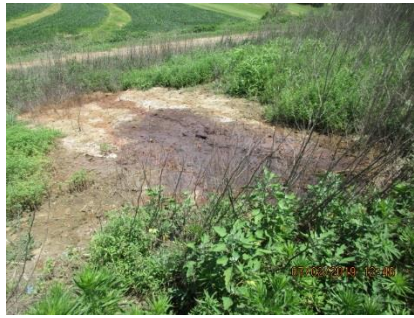
north slope leachate seepage

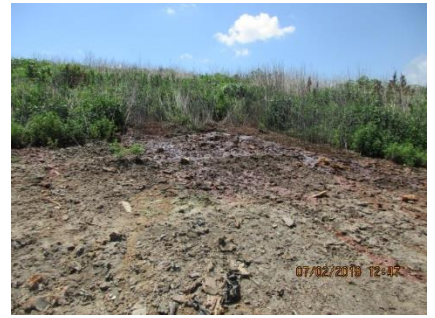
north slope leachate seepage

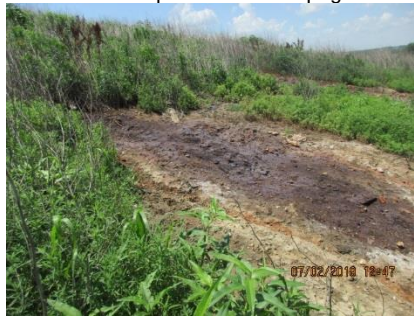
north slope leachate seepage

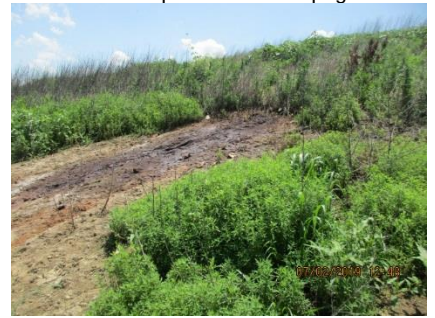
north slope leachate seepage

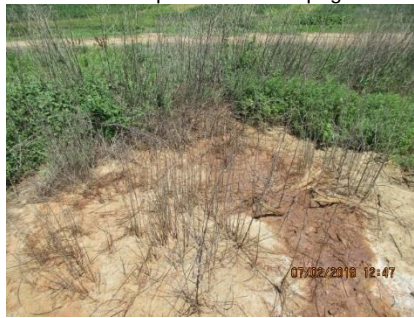
north slope leachate seepage

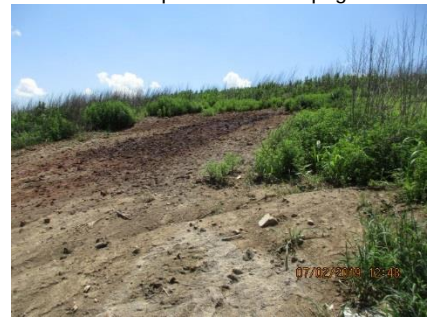
north slope leachate seepage

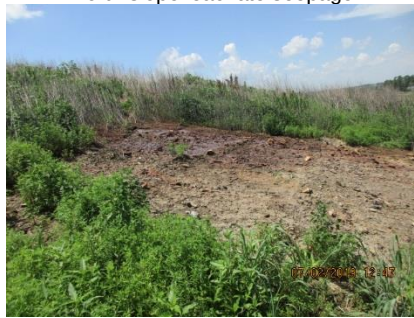
north slope leachate seepage

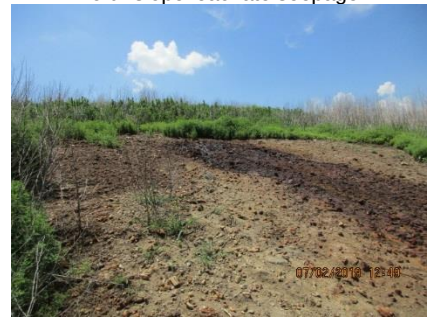
north slope leachate seepage

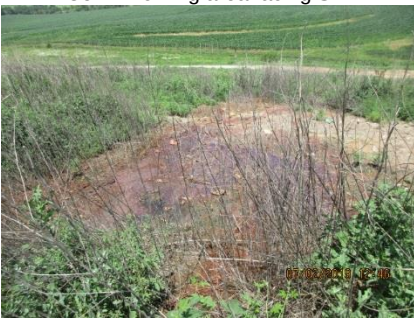
north slope leachate seepage

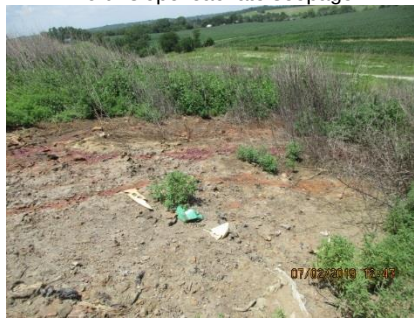
north slope leachate seepage

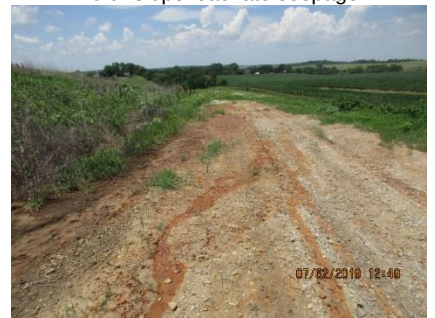
north slope leachate seepage

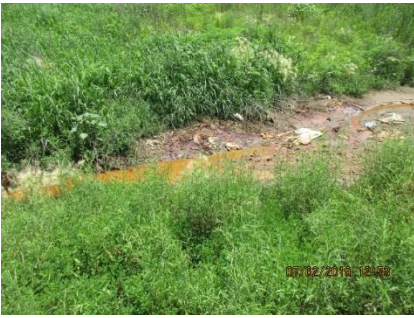
west slope leachate seepage

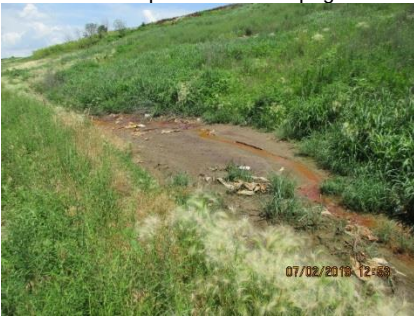
west slope leachate seepage
