SUBJECT: Notice of Violation: Construction Repair [567 IAC 113.7(6)];  
Operator Certification [567 IAC 113.8(6)j];  
Litter Collection [567 IAC 113.8(3)f]  
Mahaska County Sanitary Landfill, 2979 Highway 63, Oskaloosa, IA  
Permit No. 62-SDP-01-74P; Complaint No. 25038; ACO No. 2016-SW-01

**REPORT OF INVESTIGATION****INVESTIGATION DATE****CURRENT:** 1/8/2018**LAST:** 9/8/2017

**SUBJECT:** Mahaska County Sanitary Landfill Complaint Investigation  
2979 Highway 63, Oskaloosa, IA  
Permit No. 62-SDP-01-74P; Complaint No. 25038

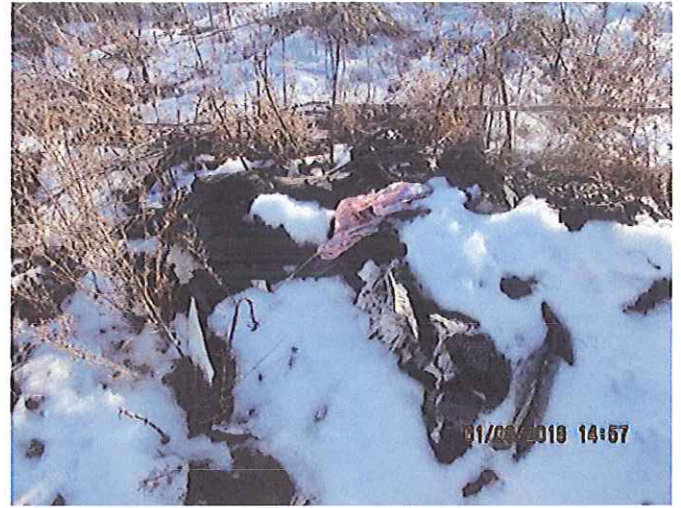
- The working face showed proper compaction and cover.
- Cover and erosion on the north filled area continued to show the need for improvement.
- A shingle pile, which I observed atop the north area during my previous inspection had not been removed.
- Significant litter was on-site. Steve Thomas' litter collection record was inadequate. This has been a recurring deficiency and is a provision of a previous administrative consent order (No. 2016-SW-01).

shingle pile on north filled area

1. The damaged liner must be properly in accordance with the approved plan and with the approval of a professional engineer. [567 IAC 113.7(6)]
2. Steve Thomas as a certified landfill operator, must comply with apply knowledge and ability in performing duties which include compliance with rules and permit conditions applicable to landfill operation. [567 IAC 113.8(6)j]
3. Collect litter daily. This includes on-site litter unless unfavorable working conditions prevent its collection. A dated record of unsafe working conditions must be maintained. [567 IAC 113.8(3)f]
4. Properly dispose of the shingle pile now located on the north filled area. [567 IAC 113.8(2)f]

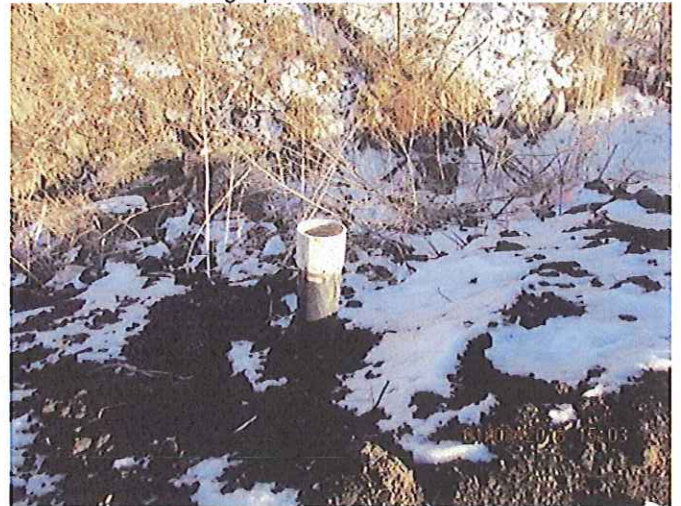
gas venting at east toe of north filled area

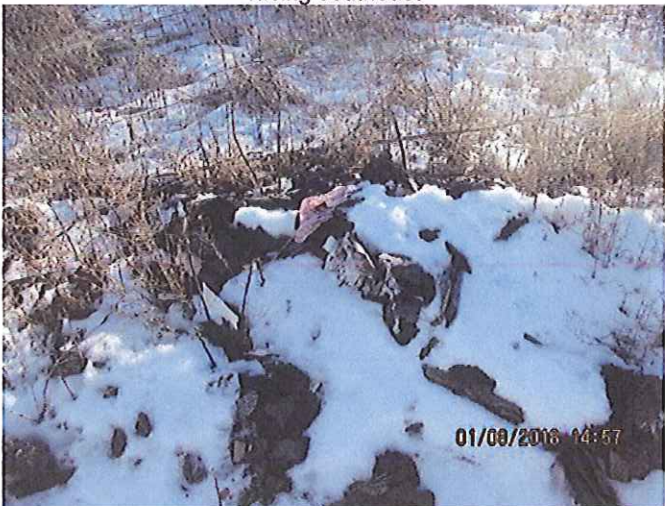
shingle pile on north filled area

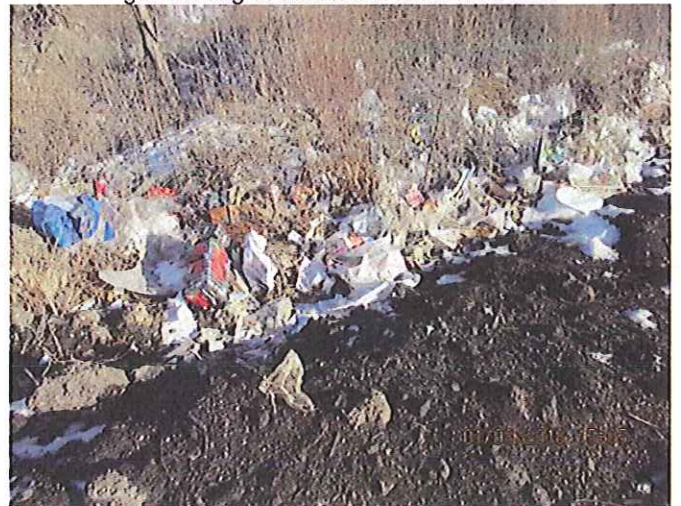
litter northeast of working face

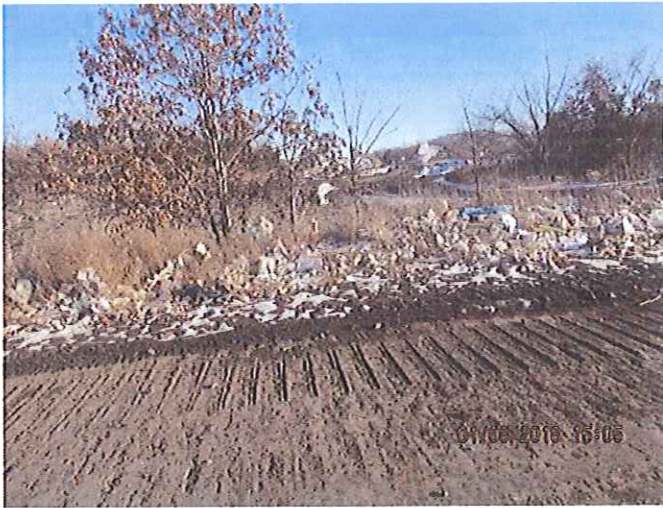
litter southeast of working area

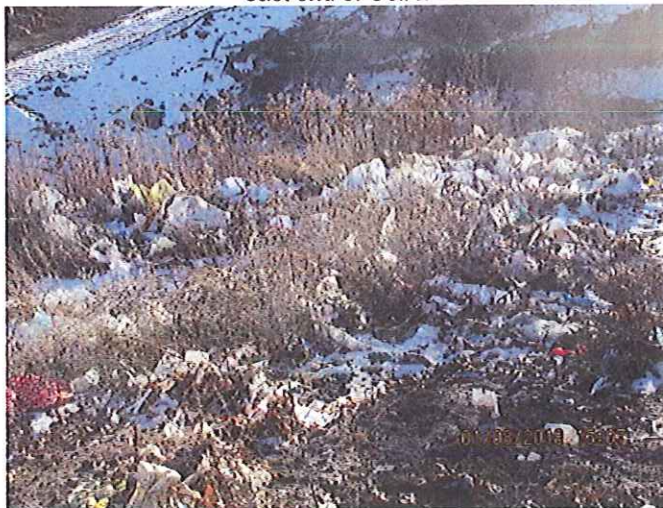
litter east of Cell 2
