**IOWA DEPARTMENT OF NATURAL RESOURCES  
FIELD SERVICES AND COMPLIANCE BUREAU  
FIELD OFFICE #2 - MASON CITY IOWA**

**DATE:** March 23, 2023

**SUBJECT:** Sulfur Odor Complaint  
NCIRSWA (SDP#94-SDP-01-75P); Webster County

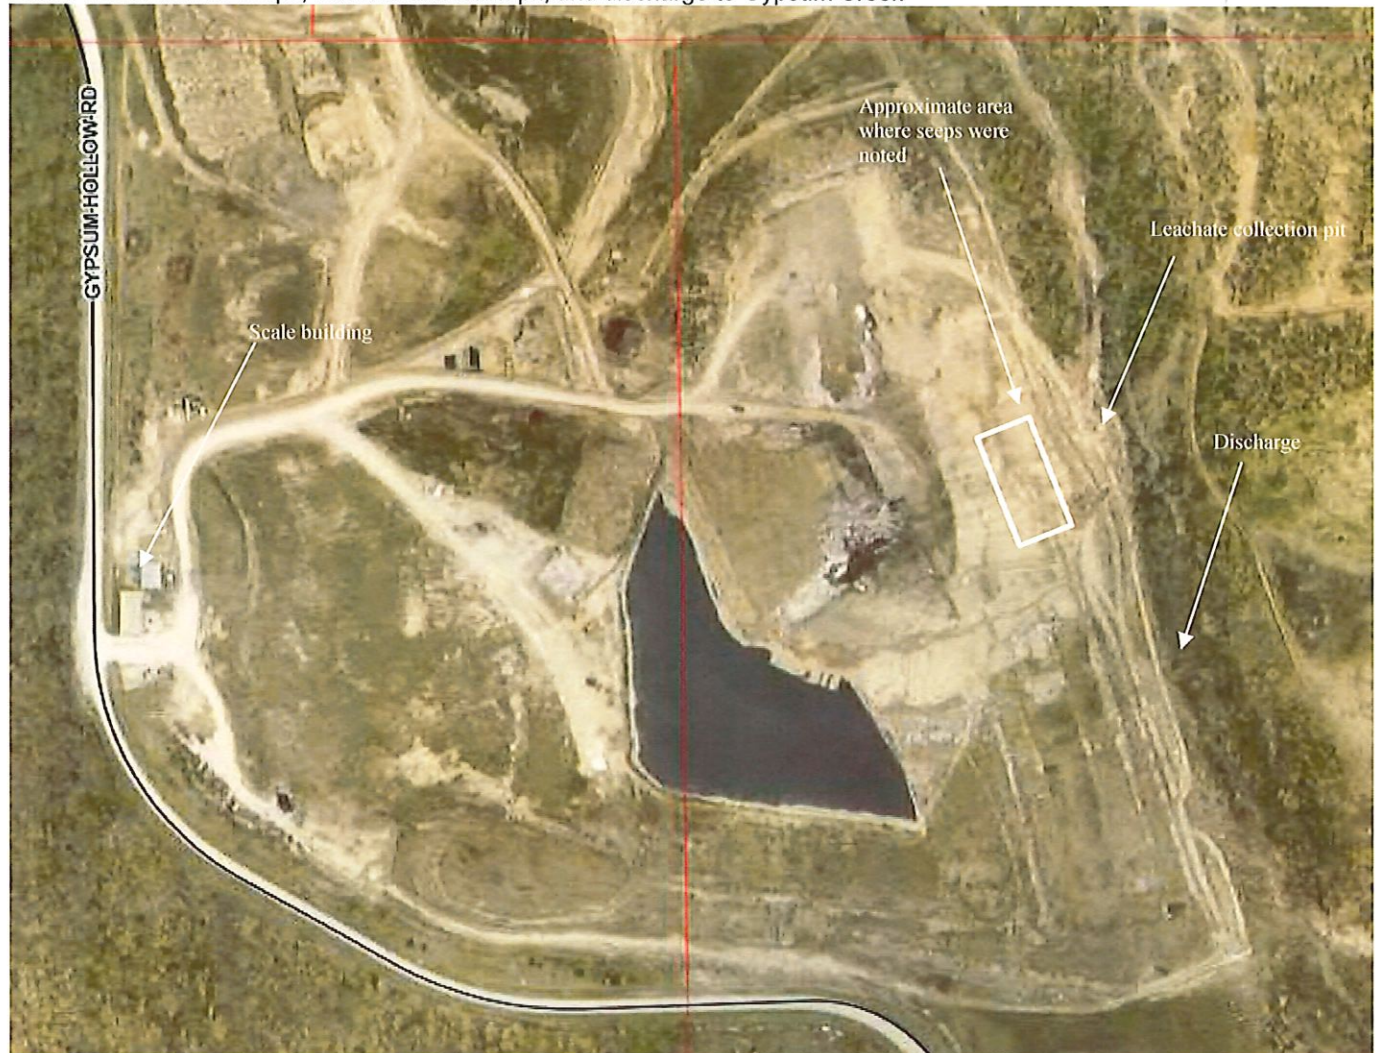
Aerial 1. Location of seeps, leachate collection pit, and discharge to Gypsum Creek

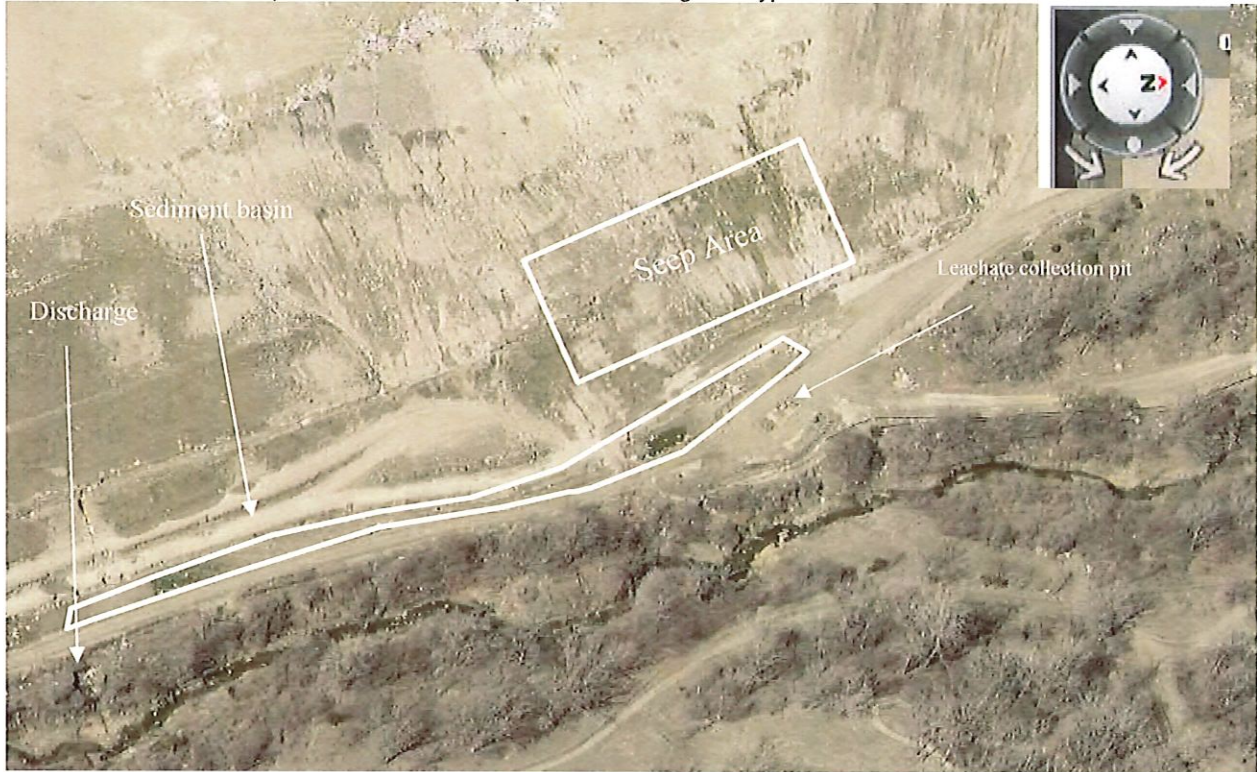
Due to the number of seeps noted on the sideslope, I wanted to observe the discharge from the sediment basin to Gypsum Creek. Mr. Myers and I walked south along the creek until we found where the sediment basin discharges to Gypsum Creek (see aerial photos and picture 4). I noted that the discharge had created a large gully. A discharge of about 5 gallons per minute was occurring at the time. The water was clear, though some foaming and bubbles were noted where the water was splashing on the ground below the outfall. No fish, alive or dead were noted in the stream. I sampled the discharge and just upstream and approximately 20 feet downstream of the discharge.

Aerial 2. Location of seeps, leachate collection pit, and discharge to Gypsum Creek

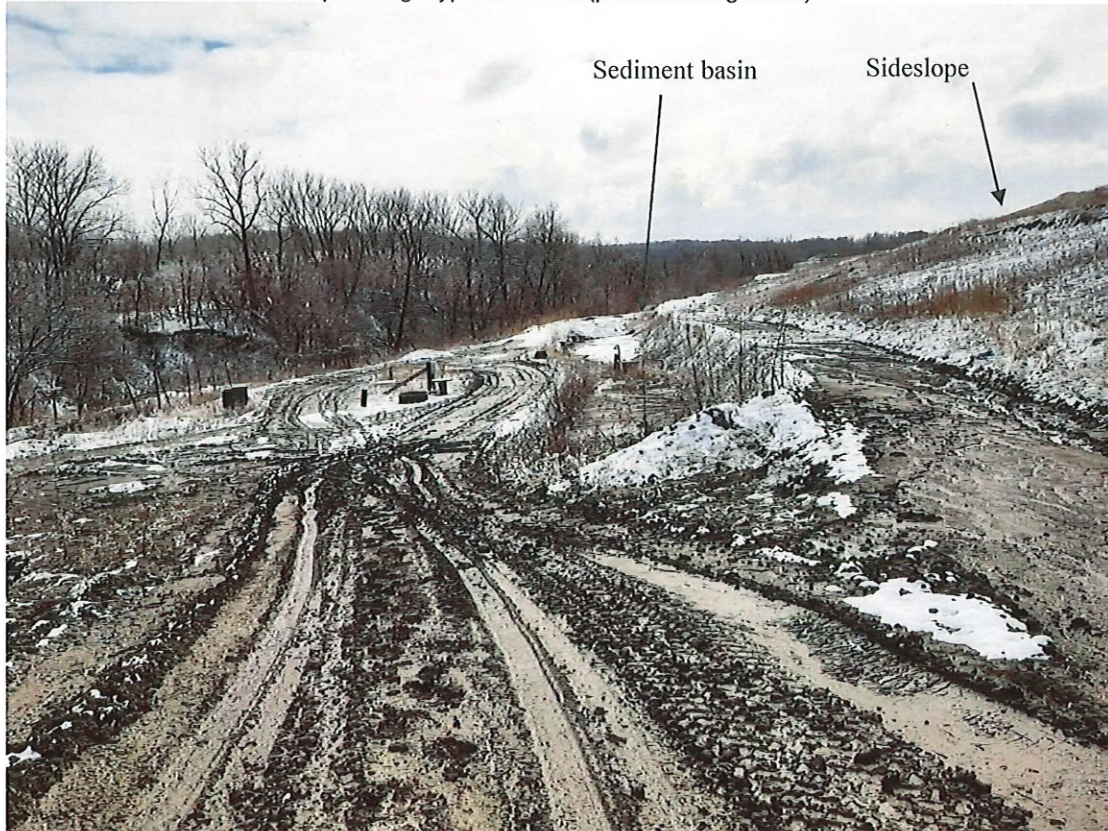
Photo 1. Leachate collection pit along Gypsum Creek (picture facing south)

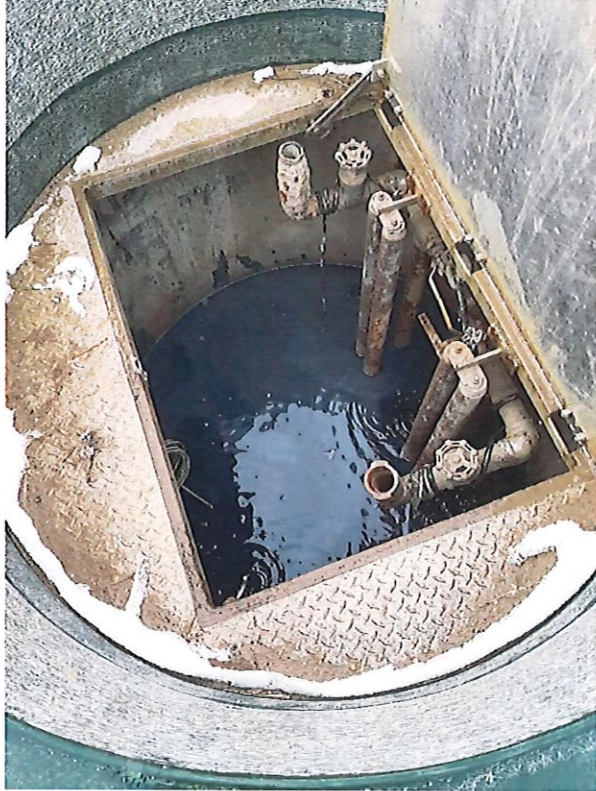
We observed that the leachate collection pit was nearly full (see picture 2). Adjacent to the leachate collection pit, there was a manhole with a slotted cover. There was a strong sulfur odor emanating from the manhole and the cover was extremely corroded, presumably due to the gases from the leachate. There was also a dead bird on the manhole. It appears that the bird landed on the manhole cover and succumbed to the gases (picture 3).

Based on my investigation, the odors are from the leachate. The landfill began recirculating the leachate in August of 2022, I believe that this activity would result in strong sulfur odors. In addition, because the leachate pumping system is currently inoperable there is more leachate than normal sitting in the leachate collection manholes, which I believe increases the odor. Lastly, it was evident at the time of my inspection that the leachate seeps were contributing to the sulfur odors. Mr. Myers understood that the leachate seeps need to be repaired as soon as possible.

Photo 2. Leachate collection pit with leachate

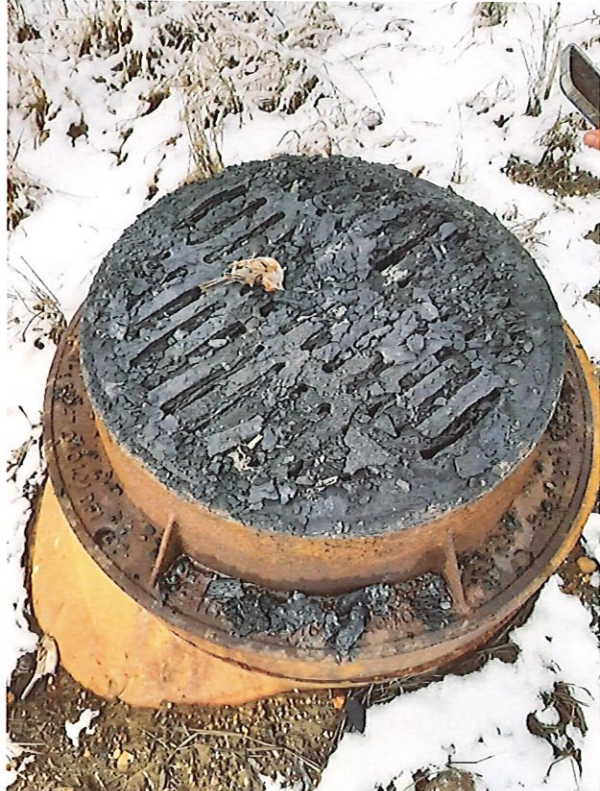
Picture 3. Corrosion and dead bird on manhole cover

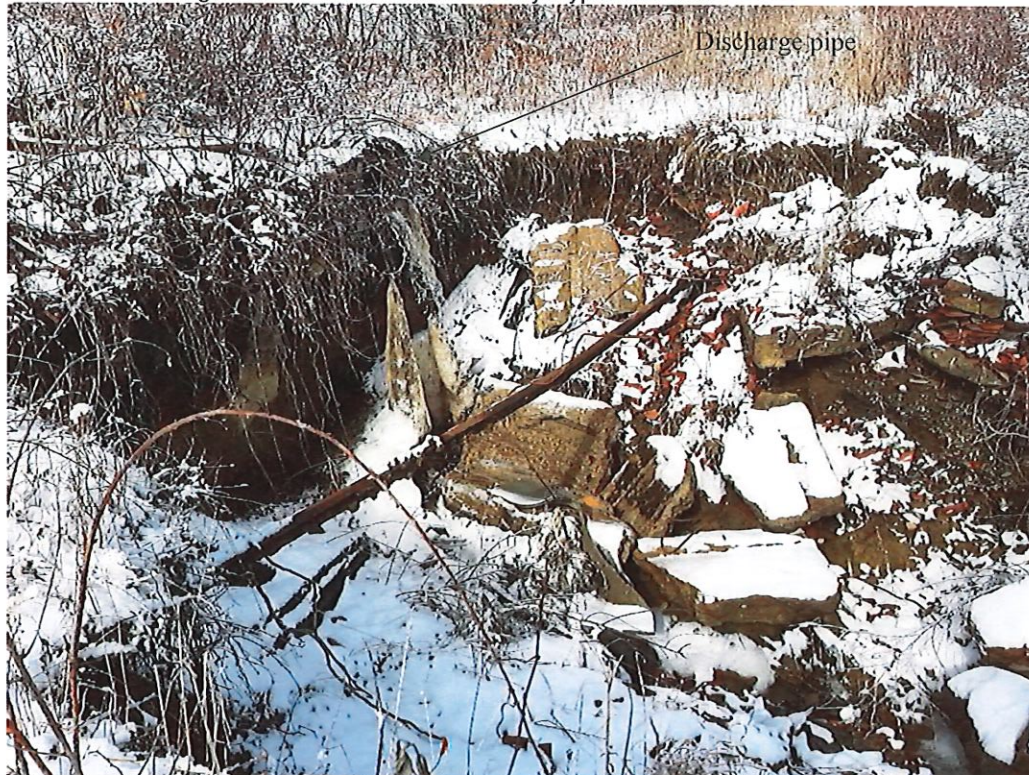
The sample results show high concentrations of total kjeldahl nitrogen, ammonia and chemical oxygen demand entering Gypsum Creek. Upstream and downstream samples show that the discharge was elevating the concentration of these pollutants in the stream (see Table 1).

The water sampling results demonstrate a violation of Iowa Code 455B.186, as the landfill is not permitted to discharge the elevated concentrations of TKN, ammonia, and COD observed in the discharge. A follow-up visit on March 15, 2023, was conducted at the landfill which also found to have a prohibited discharge. A Notice of Violation will be sent

Picture 4. Discharge from Sediment Basin to Gully/Gypsum Creek

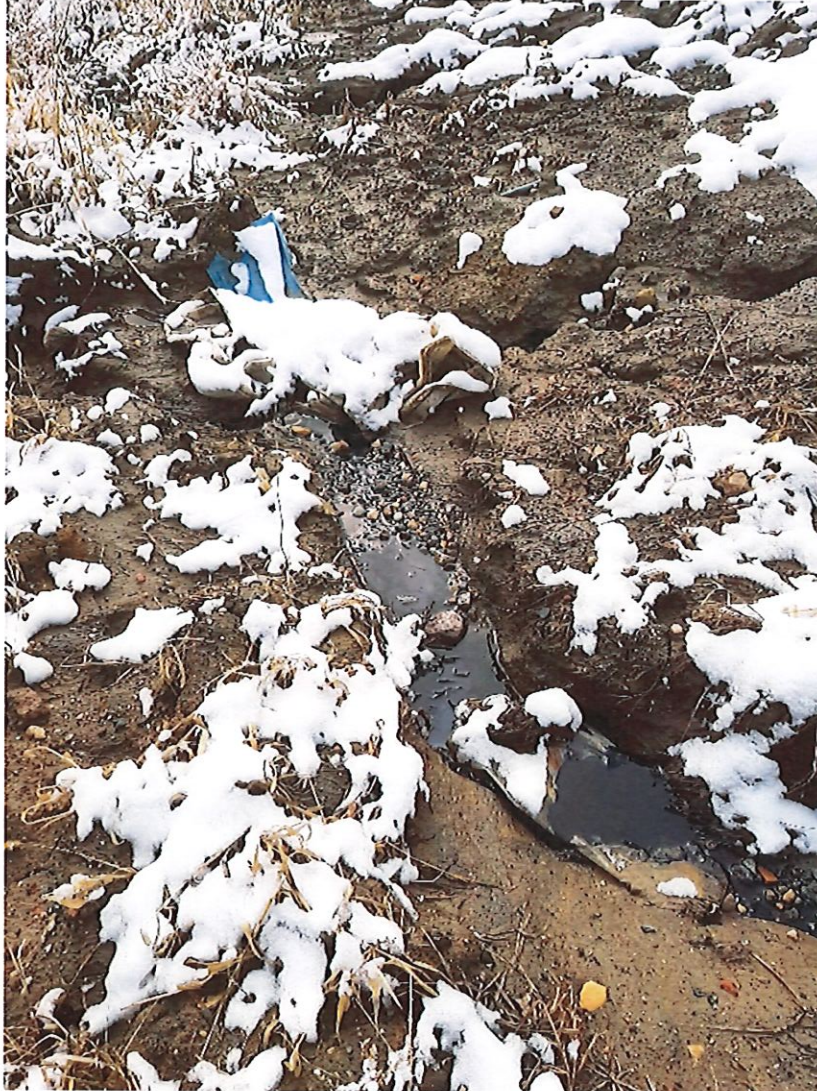
Due to wet conditions we had to walk down the side slope of the landfill to observe the leachate collection pit. While walking down the slope we noted leachate seeps that were running down the side of the hill. They were black in color and had a strong sulfur odor. It appeared that the seeps were draining into sediment basins at the bottom of the hill. Further investigating the side slope, we noted between 5 and 10 unique seeps (picture 5). Mr. Myers reported that last year staff were working in this area repairing seeps in the area and the odors were so strong that staff had to work in shifts. Mr. Myers also reported that there was a lot of waste wallboard disposed at the landfill in this area, which may give any leachate a particularly strong sulfur odor. I also noted that some garbage was exposed on the side slope.

Photo 5. Example of seep found on side slope

Mr. Myers noted that he would not be able to fix the seeps until conditions allowed for equipment operation on the sideslope. He also reported that delivery of the leachate pumps has been delayed. I informed Mr. Myers that I would let him know the results of the sampling.
