Notice of Violation: Excess Emission Oral Reporting, 567 IAC 24.1(2)
Excess Emission Written Reporting, 567 IAC 24.1(3)
Fugitive Dust - Paragraph 567 IAC 23.3(2)"c"
Stack Modification - 567 IAC 22.1(1)

RE: Air Compliance Evaluation / Complaint Investigation
Facility No. 82-01-064
Title V Permit No. N/A
Complaint ID: 31014

IOWA DEPARTMENT OF NATURAL RESOURCES
 ENVIRONMENTAL SERVICES DIVISION
 AIR QUALITY COMPLIANCE EVALUATION
 FIELD OFFICE # 6

Company Name: PB LEINER USA
Company Address: P.O. BOX 2807, DAVENPORT, IA 52809-2807
Plant Address: 7001 NORTH BRADY STREET, DAVENPORT, IA 52809
Process and/or Product Type: MANUFACTURE GELATIN

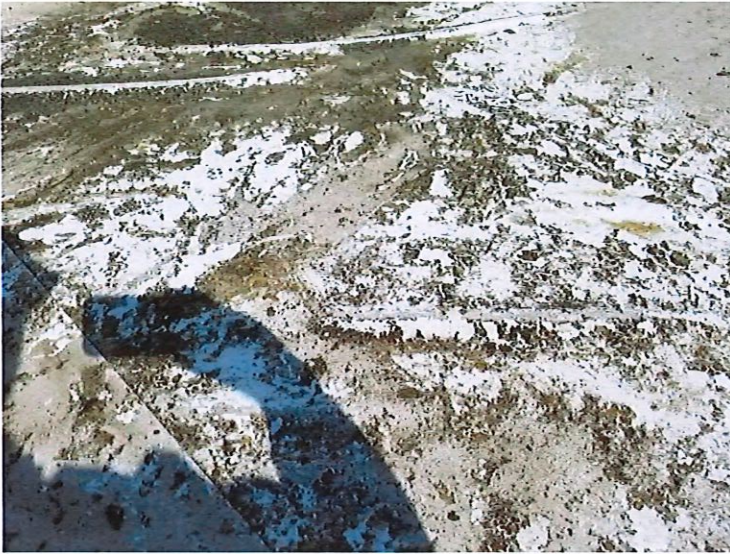
View area of roof near EP-5 showing gelatin debris on the roof

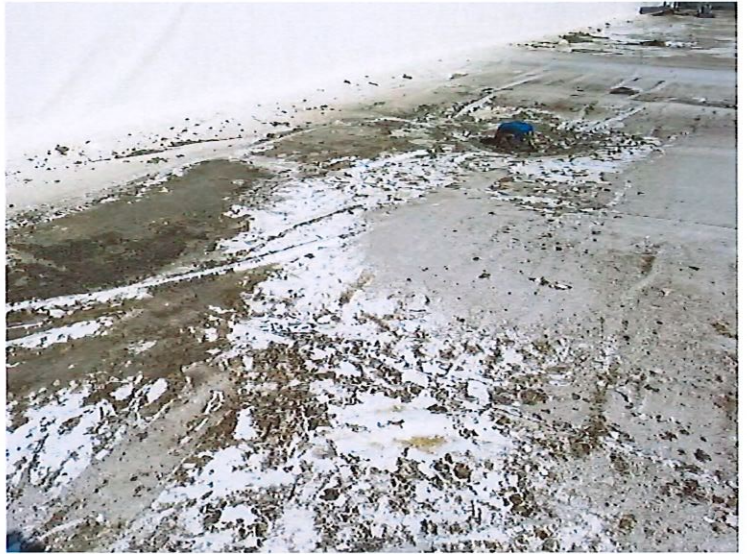
View area of roof near EP-5 showing gelatin debris on the roof.

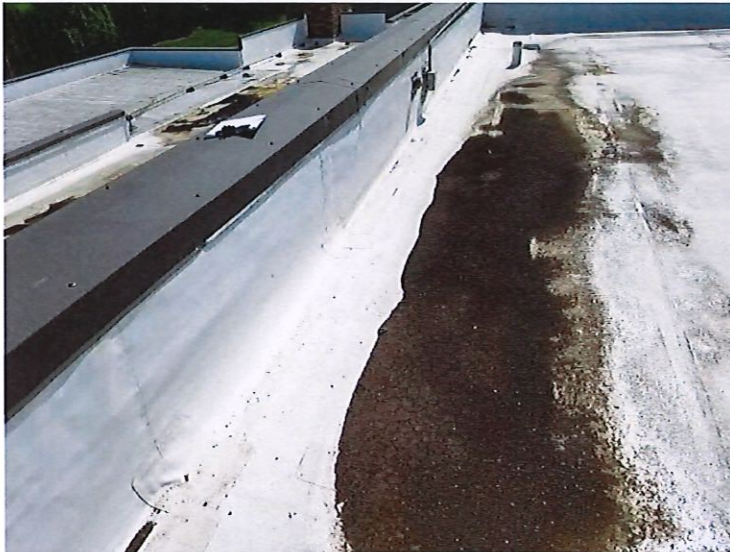
View looking east along the north edge of the roof over the Boiler Room.

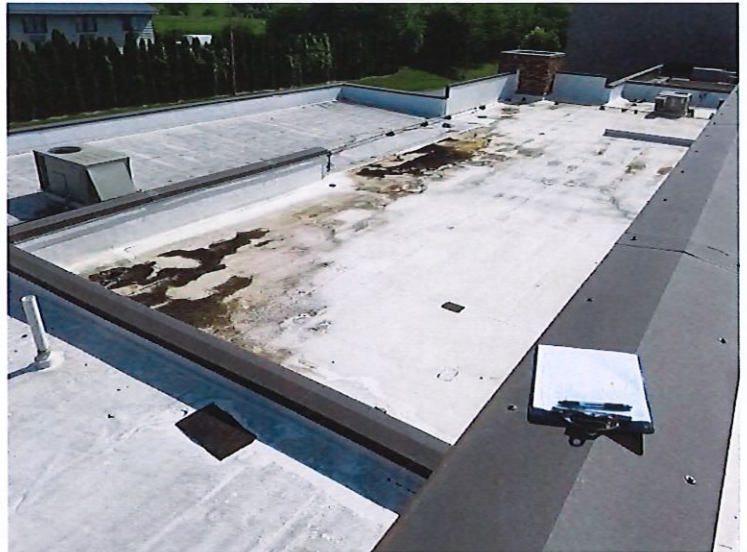
View looking northeast from the roof over the Boiler Rooms at the roof over the office area showing gelatin material on the top of the office roof.

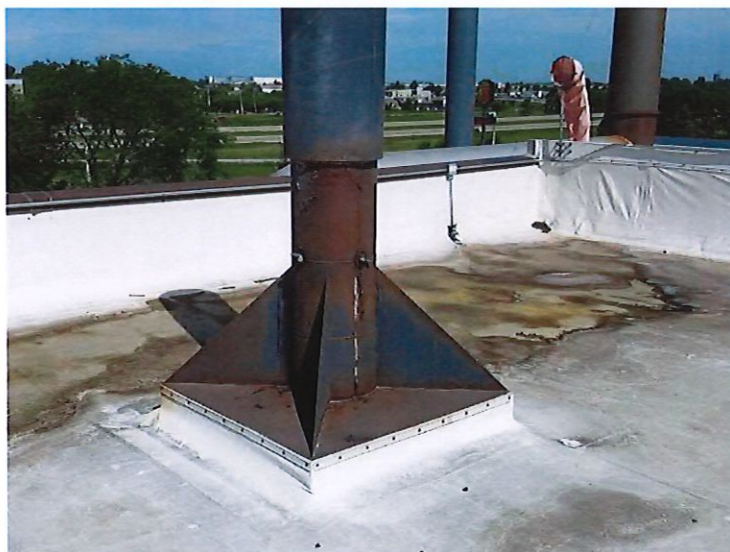
View looking northwest at area of roof around EP-12 showing gelatin material along the west edge of the roof.

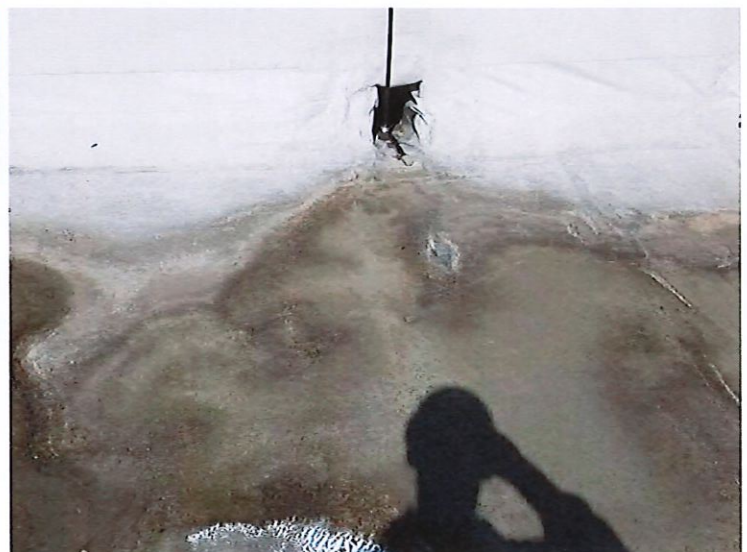
View looking west at roof drain inlet in the northwest corner of the roof near EP-12.

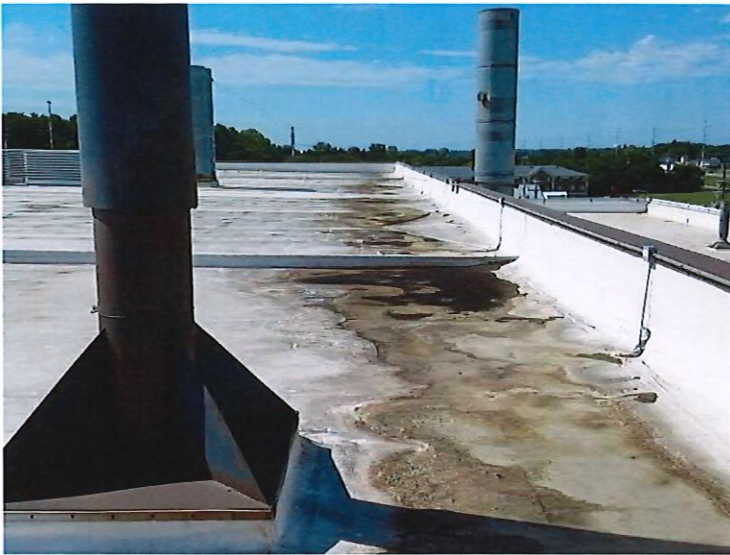
View looking south from EP-12 (left stack) along the west edge of the roofline by EP-12. EP-18 and EP-19 can be seen in the background (from left to right, respectively).

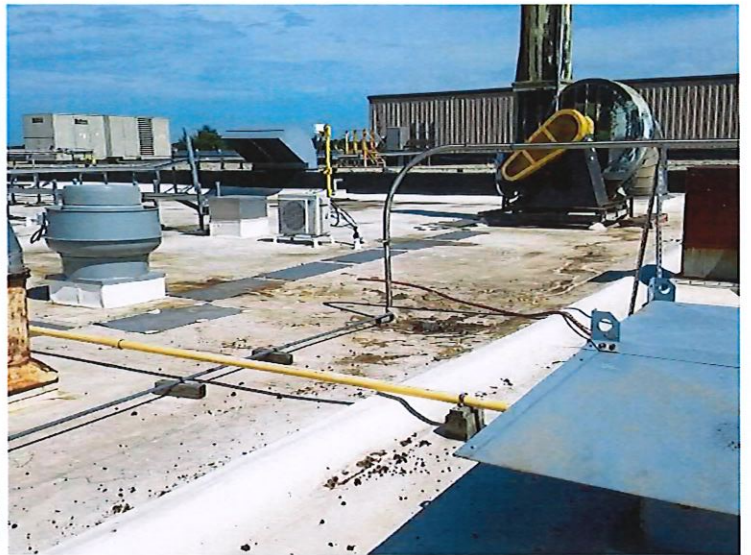
View looking north-northwest at materials on the roof near EP-6 - Old Scrubber Stack (upper right).

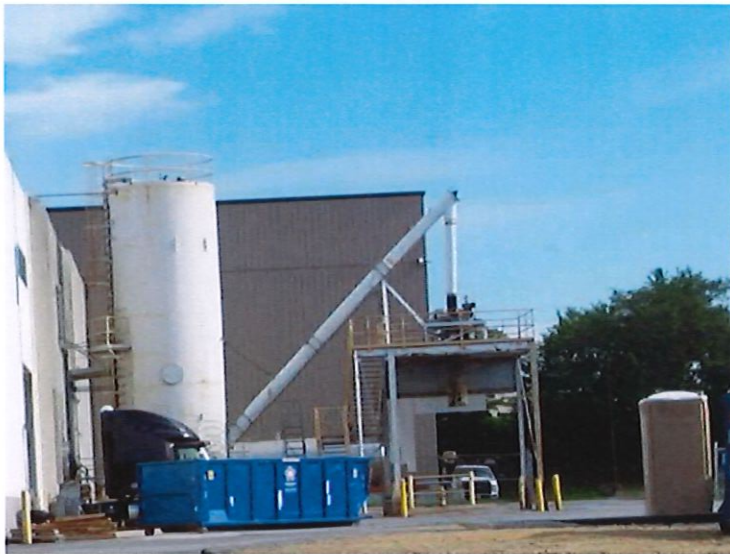
There was no tissue loadout being done on the date of my visit so I was unable to make observations of this emission point when the source is operating. However, a subsequent visit to observed the tissue loadout on August 9, 2022 revealed that the control equipment for this emission point was not functioning properly. The permit for this emission point states that any exceedance of the indicator opacity of 10% will require the owner/operator to promptly investigate the emission unit and make corrections to operations or equipment associated with the exceedance. The operator at that time indicated that they seem to have several issues with the baghouse for the tissue loadout tripping a fuse. During the initial visit on 7/22/2022 you indicated there were slatted curtains along the east and west sides of the tissue loadout bay but there were no curtains present and, according to the operator, they have not been present for about 6 months to a year.

View looking north at the tissue loadout (EP-23) from the south.

1. The repairs to the dust collector for the tissue loadout (EP-23) are complete.
2. The cleaning of the roof has been completed so that the facility can better know if there are excess emissions and be better able to identify the source.
3. The facility has developed a comprehensive operations and maintenance plan for all of the control units.

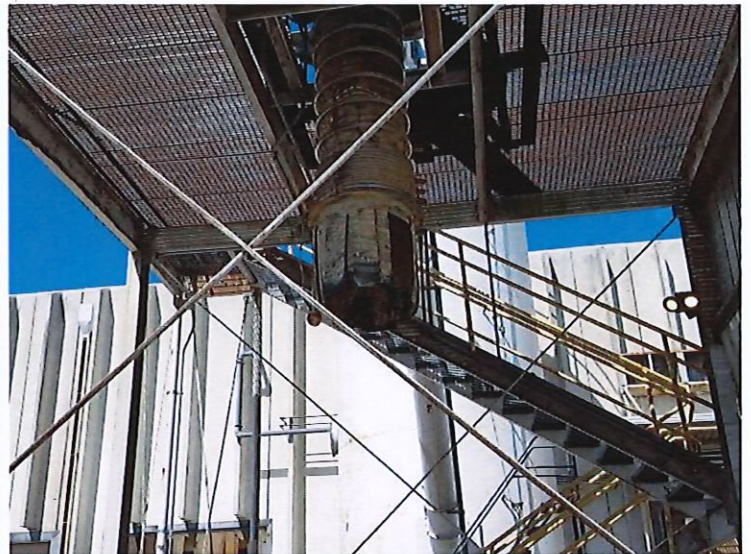
View looking up at the telescoping chute at the tissue loadout (EP-23).

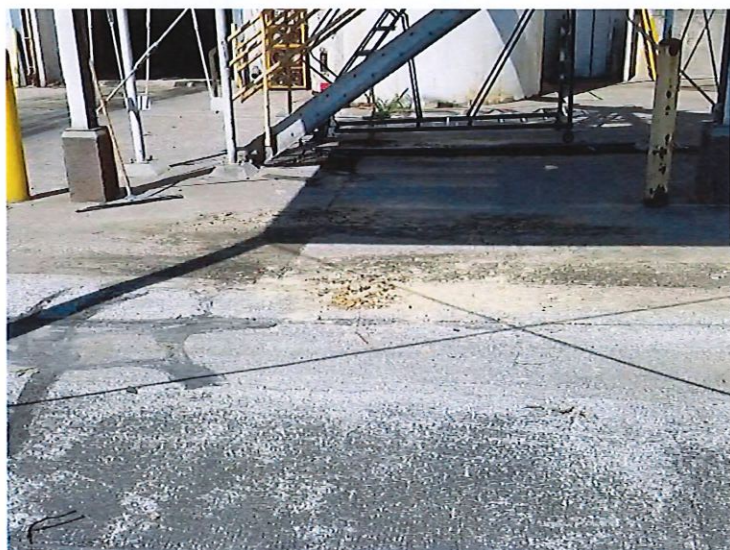
View of small pile of tissue debris located directly below the chute at the tissue loadout (EP-23).

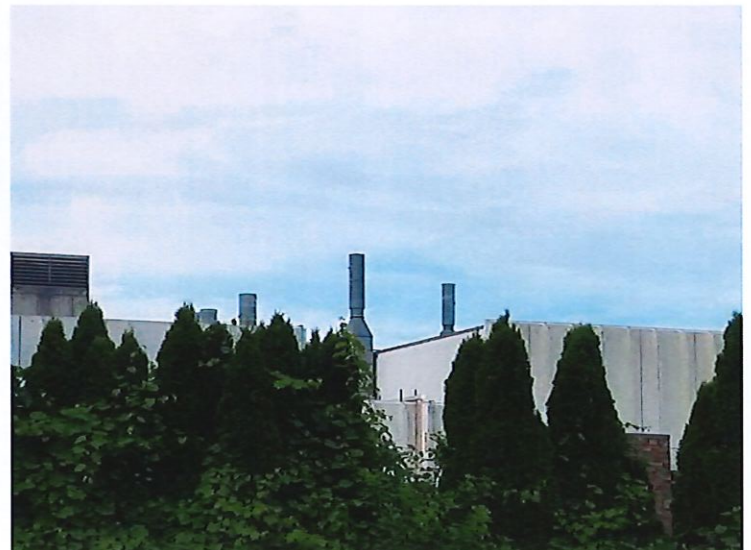
View looking south at the facility from the adjacent Super 8 facility to the north.

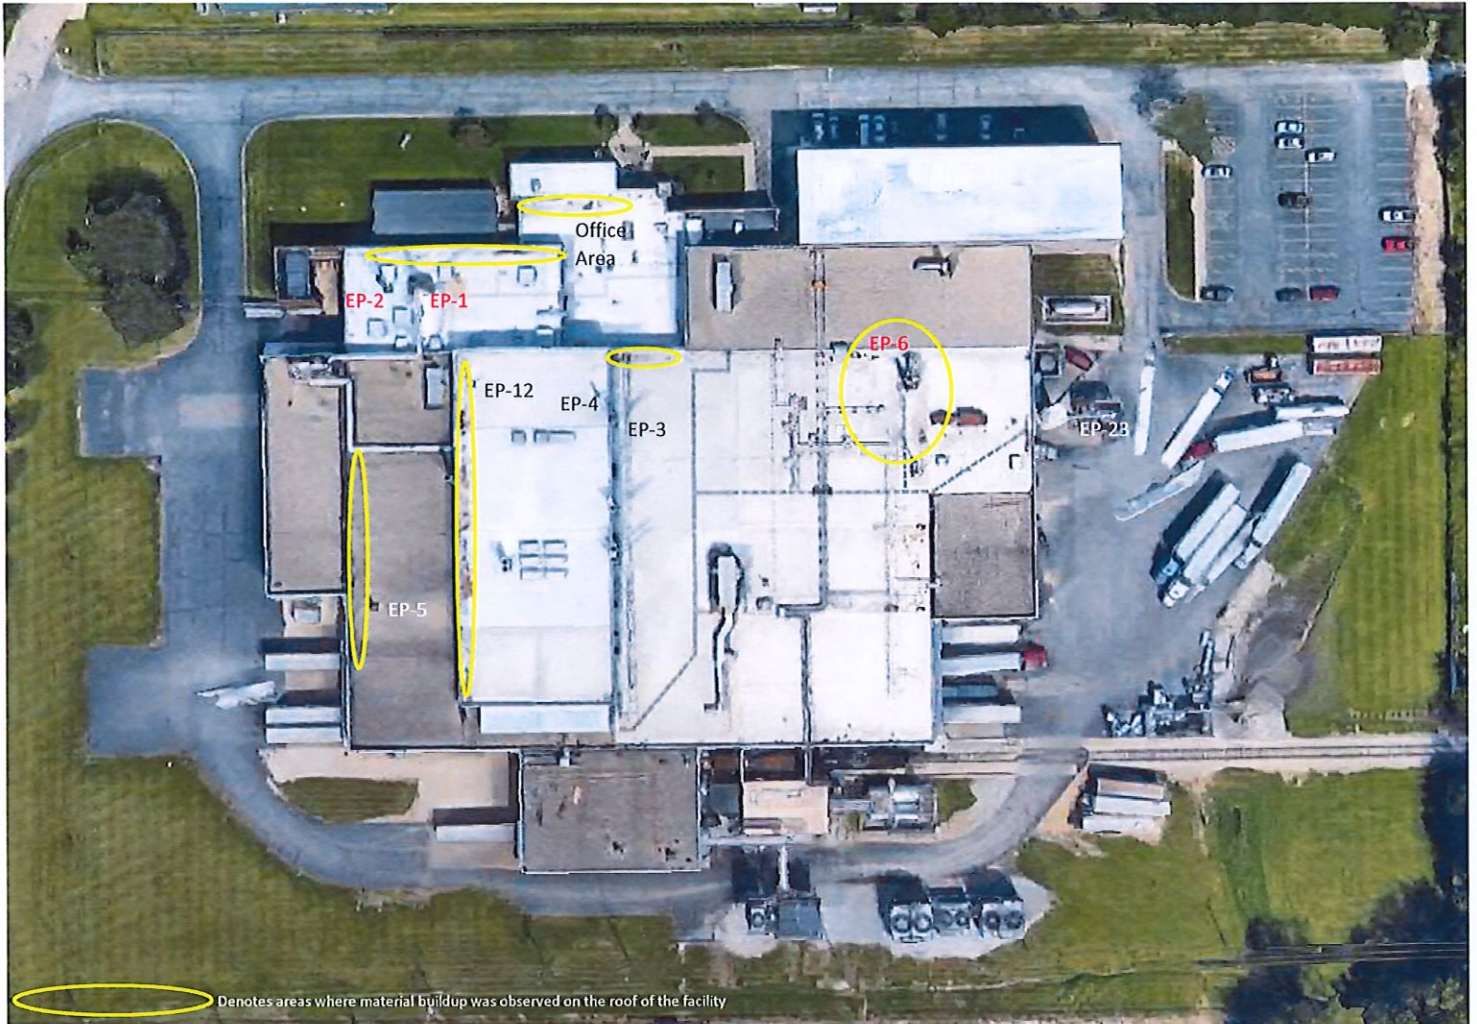
Aerial Photo of Facility

Areas with accumulations of material included the area near EP-5 and the west edge of that roofline; The area near EP-12 and the west edge of that roofline; the north edge of the roofline that has the boiler stacks (EP-1 and EP-2); The northern portion of part of the roofline for the office area; the northwest corner of the roofline to the north of the EP-3 stack; and the area of the roof near the EP-6 stack (Old Scrubber DAF Room). These areas are shown in the photos as well as the aerial photo of the facility following the photos.
