**IOWA DEPARTMENT OF NATURAL RESOURCES
FIELD SERVICES AND COMPLIANCE BUREAU
FIELD OFFICE #2 - MASON CITY IOWA**

DATE: June 22, 2020

SUBJECT: **Storm Water Complaint # 28376 Memo**
Rural Iowa Waste Management Association, 20488 M Ave, Eldora,
Hardin County

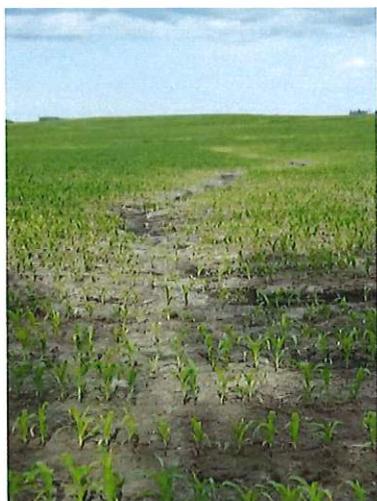
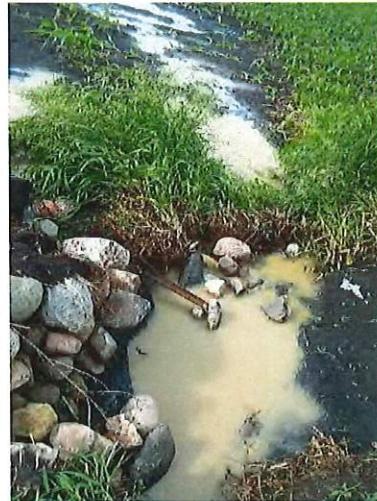
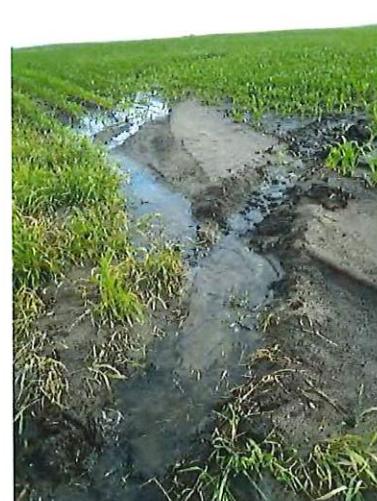
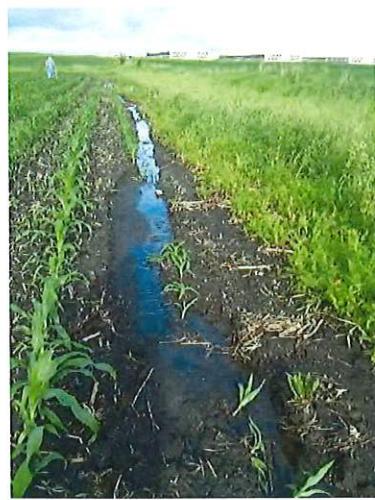
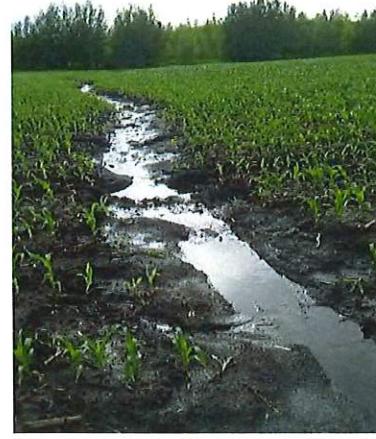
Field erosion pictures sent in by the complainant. The only reference point is in the picture with the three swine confinement buildings. That is the south border of the field. No gully was observed there the day of this investigation.

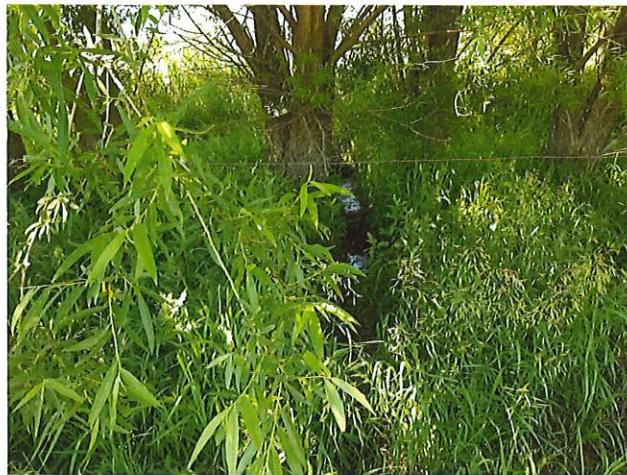
We walked out into the edge of the field where I did observe a minor gully area starting in the fence line and continued into a vegetated area in the corner of the crop field. Closer observation revealed a pipe through the berm of the settling basin that was likely causing this. I told Josh that I would recommend installing some rip rap or rerouting the outlet.

Picture of the pipe through the settling basin berm.

On Tuesday June 16, 2020, I talked to Dan Aastrup, RIWMA Manager. We discussed the settling basin in the southeast corner of the property and the possible improvements that could be made to keep the outlet from causing any erosion on the neighboring crop field. Mr. Aastrup agreed to make some improvements in that area once the ground dries out some. He will send me pictures when the improvements are completed. No further action is required at this time.

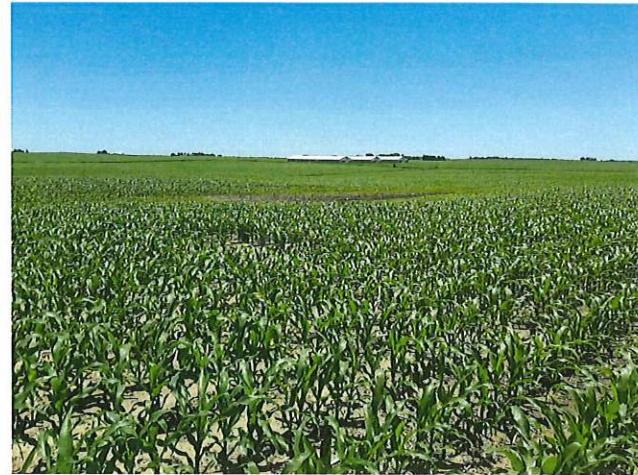
We walked north along the east fence line until we reached the top of the hill approximately half way along the east boundary. I did not observe any erosion in the crop field that was being caused by any practices being used by the landfill. I did observe some areas of the crop field where erosion was occurring due soil types and the slope of the land (6-10 percent slope in some areas verified on the USDA Web Soil Survey). These sloped areas could benefit from some improved cropping methods or conservation practices such as vegetated field borders and grassed waterways.

Gully erosion in the middle of the field in an area that has a 6-10 percent slope.

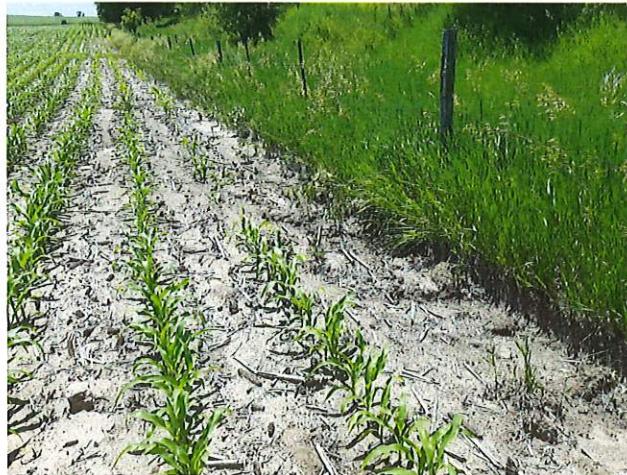
Minor erosion along the fence line between the crop field and the landfill. Very sandy sloping ground.

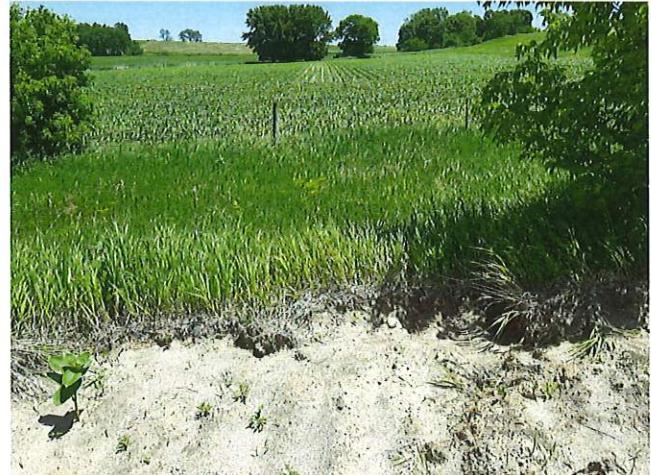
Picture shows a vegetated berm between the crop field and any disturbed area on the landfill property. The east boundary looks like this or wider for the entire length.
