**IOWA DEPARTMENT OF NATURAL RESOURCES
FIELD SERVICES AND COMPLIANCE BUREAU
FIELD OFFICE #2 - MASON CITY IOWA**

SUBJECT: Complaint ID #28376 Follow-Up Memo

Rural Iowa Waste Management Association (RIWMA) Landfill,
20488 M Avenue Eldora IA 50627

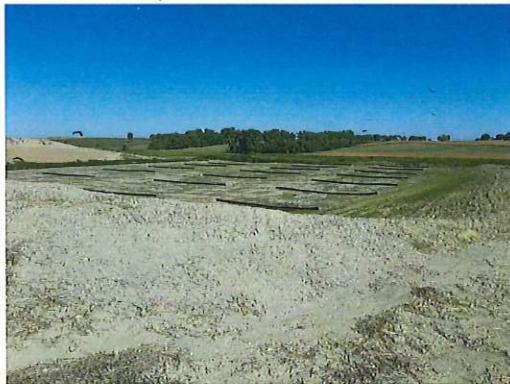
New cell constructed with silt fence installed.

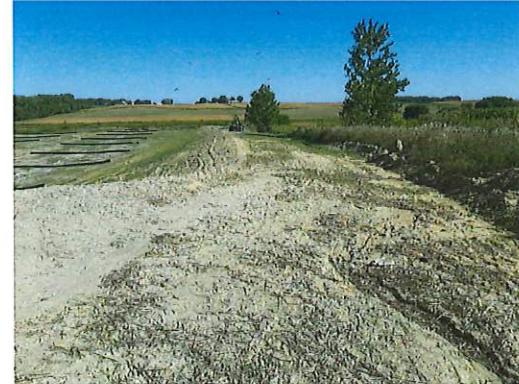
Gully erosion occurring on east berm of the new cell, no sediment leaving the site.

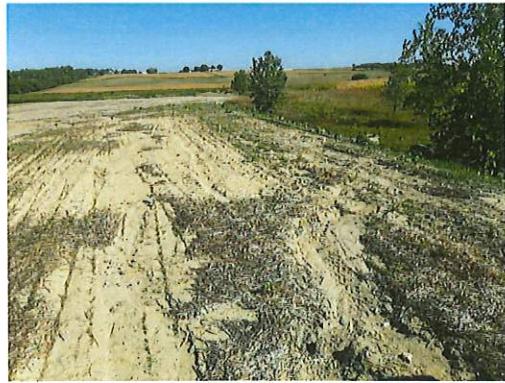
More gully erosion near east boundary.

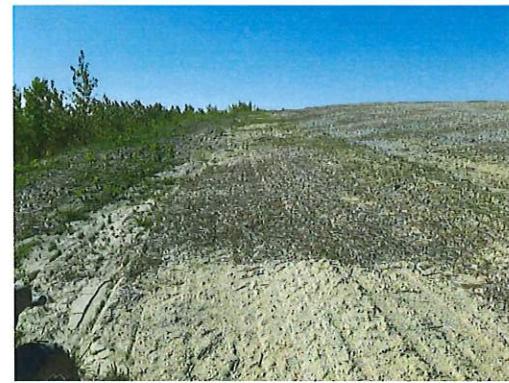
East berm looking south uphill, some vegetation has started to grow.

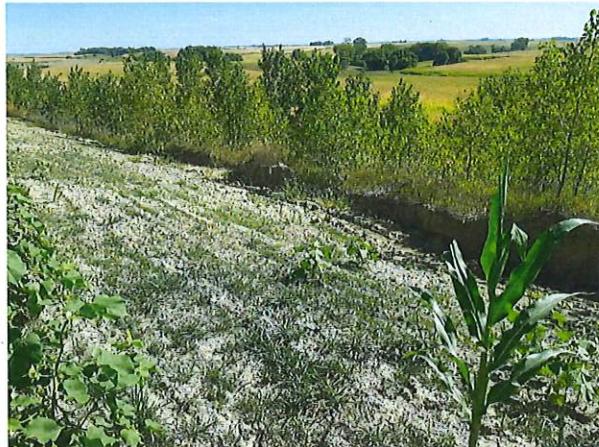
Picture taken looking northeast from east berm toward the crop field shows a cut bank with vegetation between the disturbed soil and the crop keeping sediment on the landfill property.

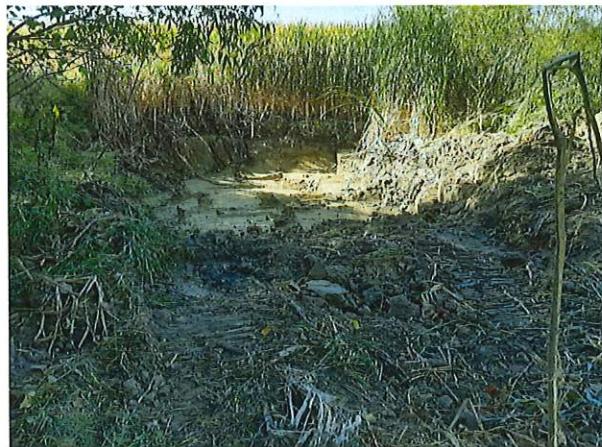
Silted-in stormwater catchment has been cleaned out.

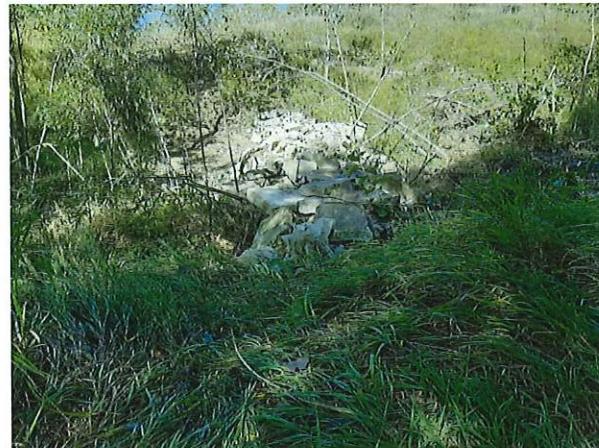
Rip rap installed in the channel leading to the storm water catchment to slow down flow and minimize sediment delivery to the catchment.

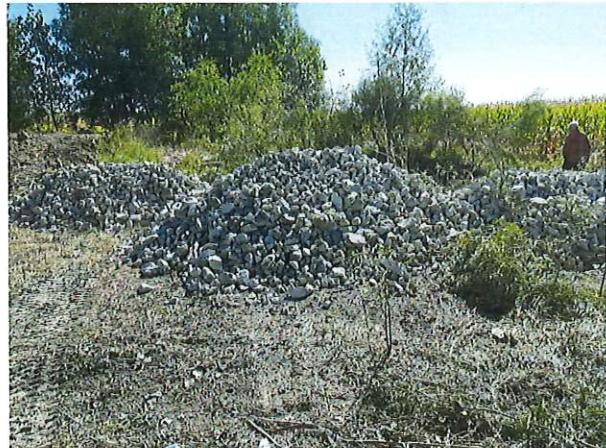
Rip rap that will be installed along south boundary and at the catchment outlet.
