**IOWA DEPARTMENT OF NATURAL RESOURCES  
FIELD SERVICES AND COMPLIANCE BUREAU  
FIELD OFFICE #2 - MASON CITY IOWA**

**DATE:**       **October 27, 2009**

**SUBJECT:**   **United Suppliers – Eldora  
Spill # 102609-KAL-1100**

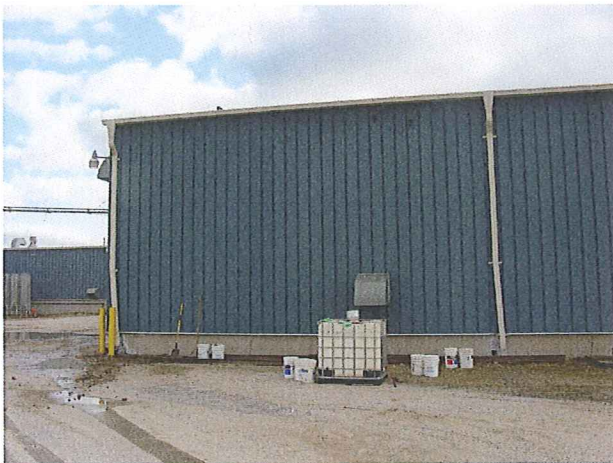
Building where spill occurred  
Note: tote of recovered product

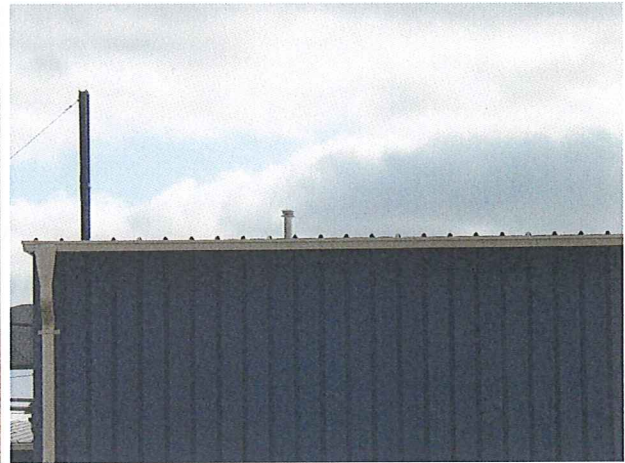
Vent on top of building (looks like a furnace vent)

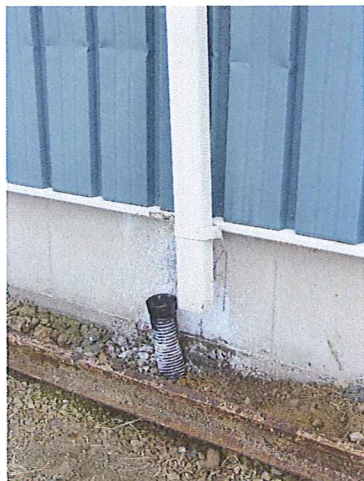
Downspout discharge to tile

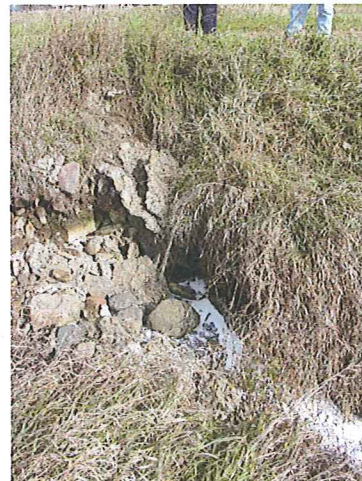
Tile outfall

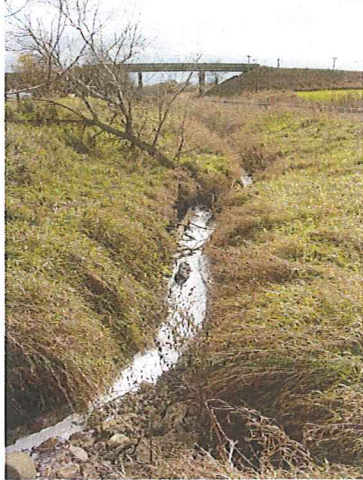
Discharge to ditch

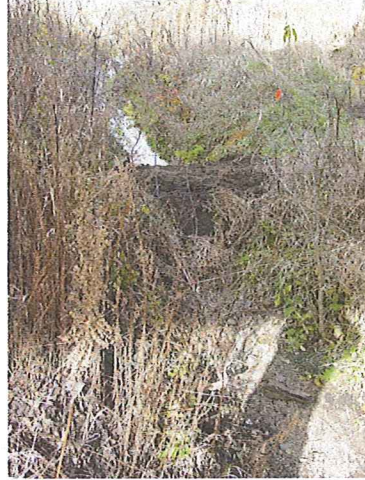
Dike to stop flow in ditch

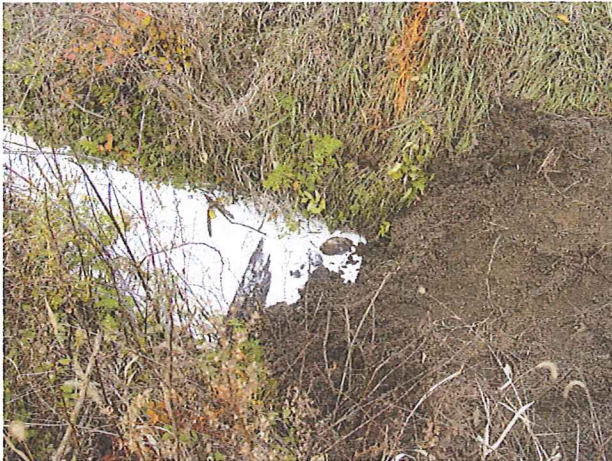
Dike stopping the flow of spilled material

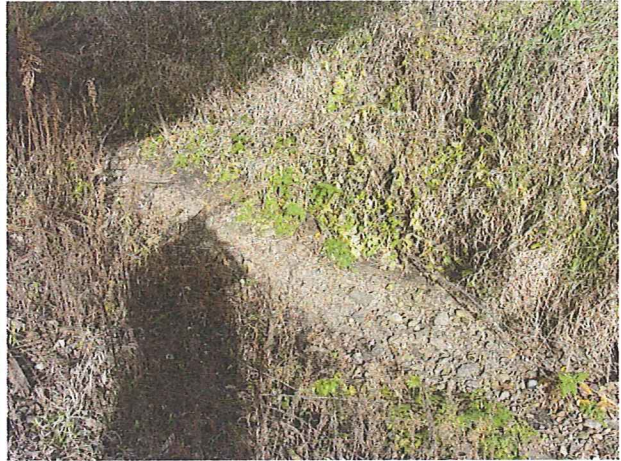
Dry ditch downstream of the dike

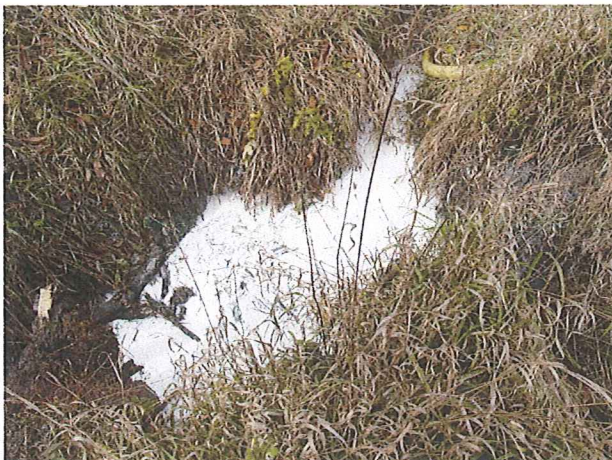
Sump area for pumping up spilled material

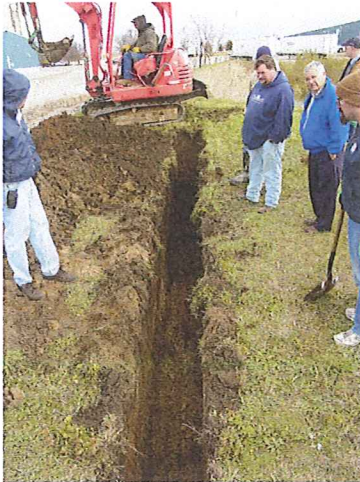
Locating the tile line closer to the building  
and plugging it

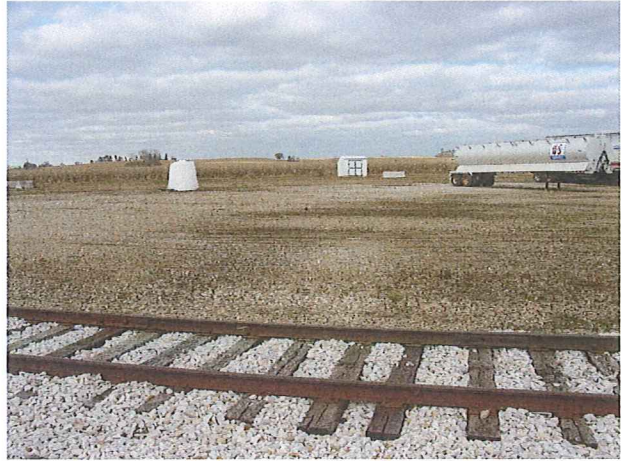
Proposed area for stockpiling soil

Soil is to be stockpiled north of the railroad tracks on the northwest corner of the facility site. Plastic will be placed on the ground and the soil will also be covered to protect it from rainfall until it can be properly land applied. The soil stockpile area is located on a portion of the plant property that drains to the facility's storm water pond. Mr. Hoyt stated that the soil would be tested to determine a proper application rate. He said that it would be applied at, or below,

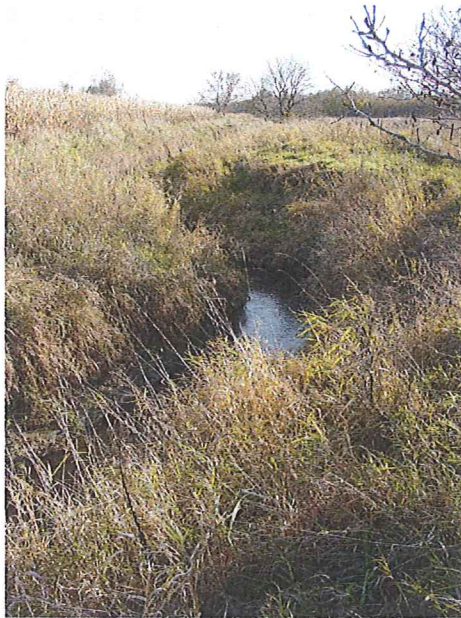
Potential receiving stream

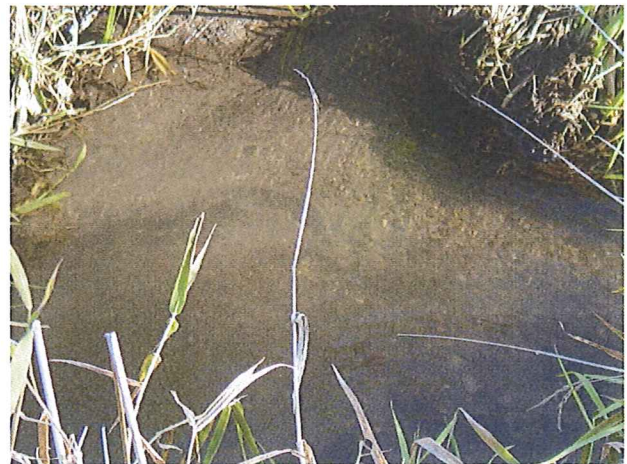
Water in stream is clear
