**IOWA DEPARTMENT OF NATURAL RESOURCES  
FIELD SERVICES AND COMPLIANCE BUREAU  
FIELD OFFICE #2 - MASON CITY IOWA**

**DATE:**       **October 30, 2009**

**SUBJECT:**   **United Suppliers – Eldora**  
                  **Spill # 102609-KAL-1100**

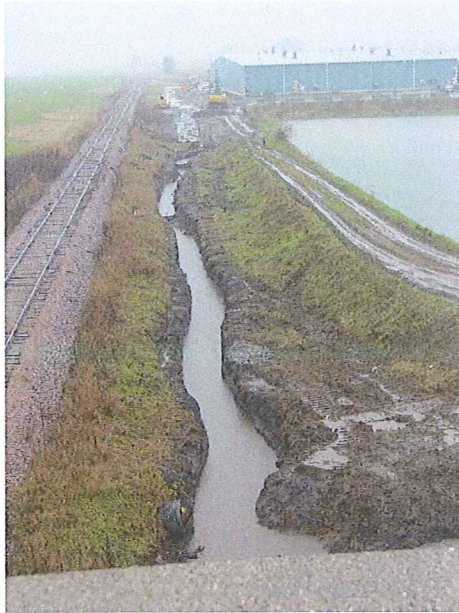
The ditch has been completely dug out from the point of the old tile outfall to where the spill was stopped with the dikes. It has been raining and the ditch has now filled in with runoff water. A series of silt fences had been installed to control soil erosion. The tile line itself has been removed from the old outfall point to a point about halfway along the west side of the building.

Ditch cleaned out from old tile outfall to where the spill had been stopped.

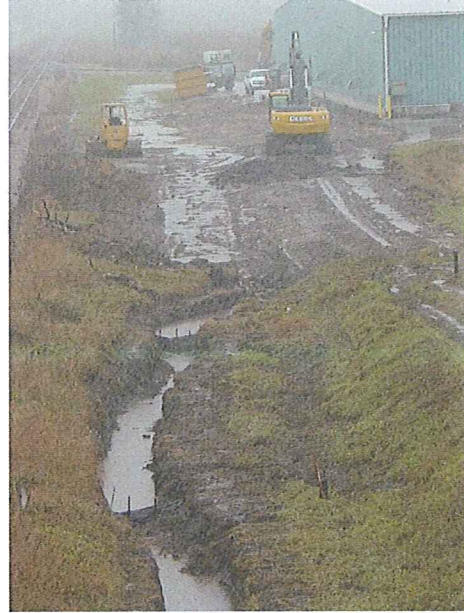
Upper end of ditch showing silt fences and the area where removal of the tile was occurring. Note: water was diverted around the west side of the work site.

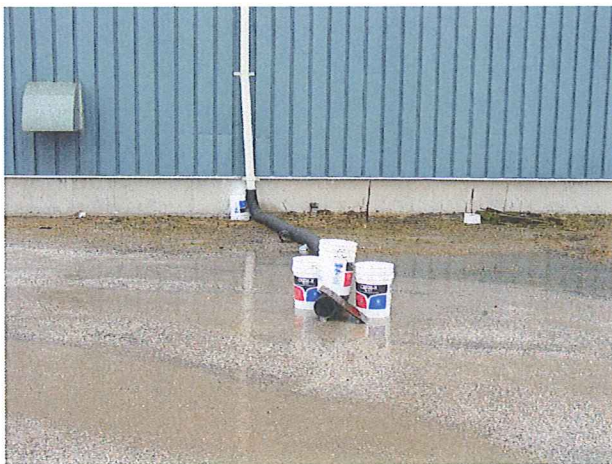
Tile intake plugged with bucket (background). Solid tile now diverting water away from the building and tile intake.

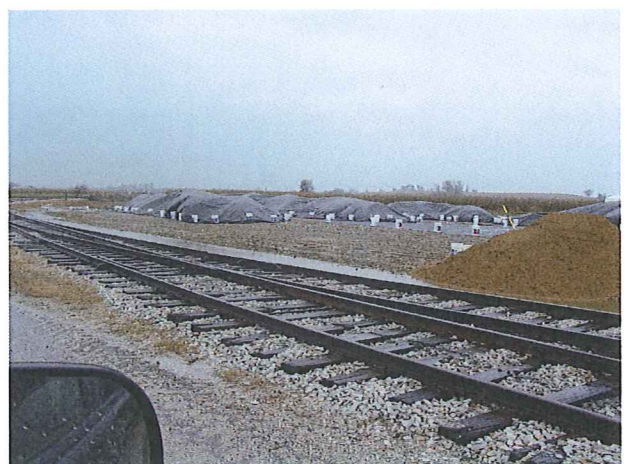
Gerhke Excavating had been removing the tile line by removing the clean soil from above the tile and using this soil to refill the trench after the tile and contaminated soil had been removed. The contaminated soil was being placed inside plastic silage tubes. Six mil plastic sheeting had been placed on the ground first, then the soil filled tubes and then everything had been covered with another layer of plastic.

Soil stockpile area showing that the contaminated soil is contained and protected from the weather.
