SUBJECT: Complaint Investigation, Complaint No. 33602, Staff Action No. 175731, Adair County

### Report of Investigation

**RE:**      Complaint Investigation, Complaint No. 33602, Staff Action No. 175731, Adair County

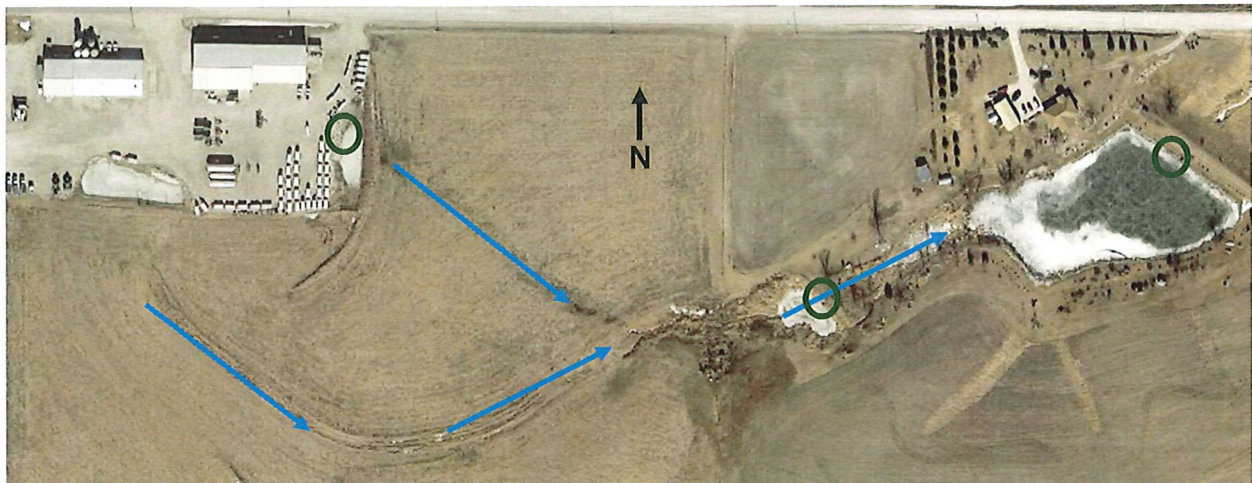
Figure #1: Location of ponds with flow direction and location samples were taken

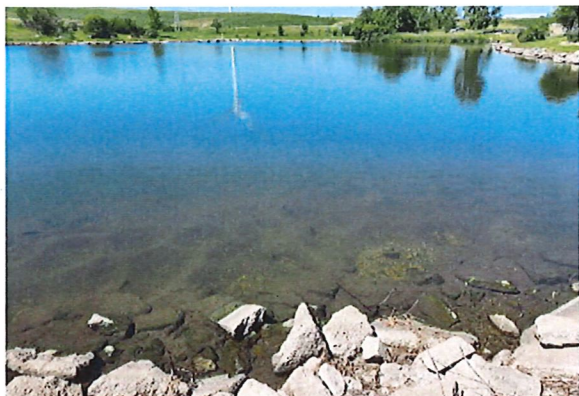
Photo #1: View of east pond looking west with clear water and fish present

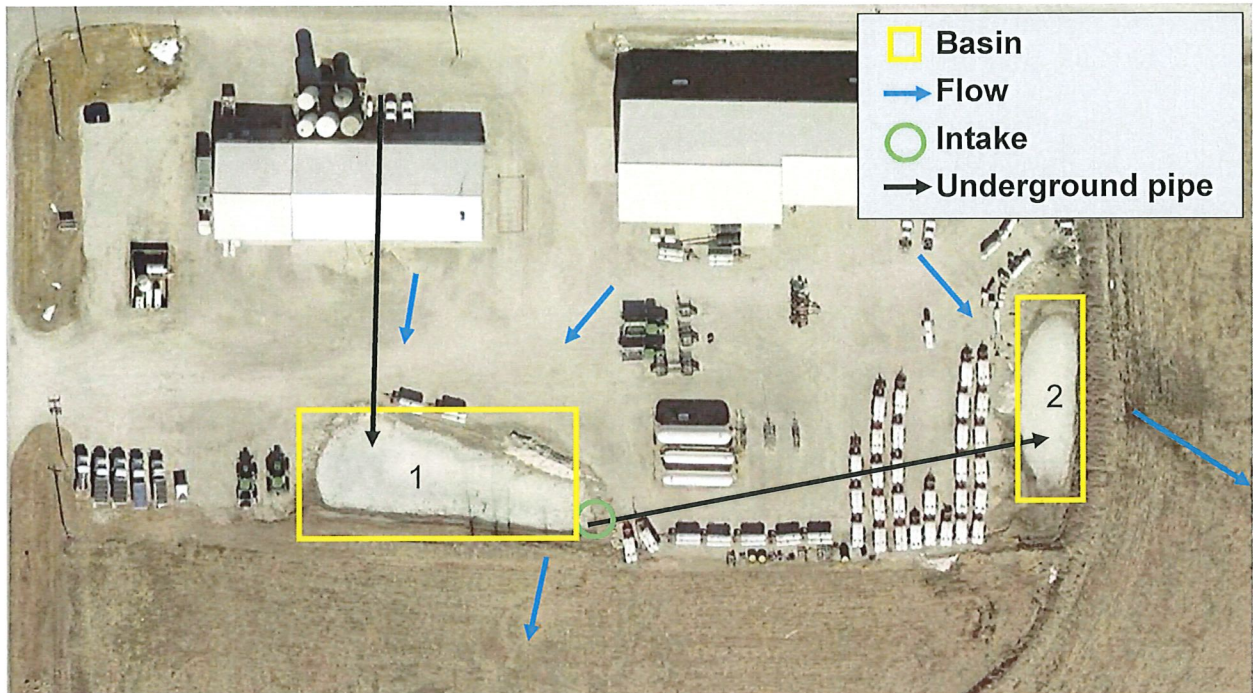
Figure #2: Overview of Agriland facility with direction of flow and basin locations

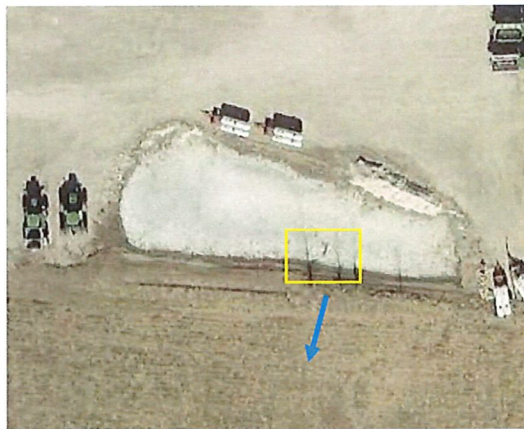
We observed several empty chemical totes located around the western retention basin and the water was green in color. A stormwater inlet pipe is located on the northern side of the basin and was not flowing at the time of this investigation. On the southern berm of the basin we located an area of dead grass from the top to the bottom of the berm. Within the area of dead grass were signs of some trenching and erosion indicating the potential for the basin to overflow or evidence that it has overflowed before. Liquid levels were not at the high-water mark at this time. The photos below document the western basin.

Figure #3: West basin with area of concern and direction of flow

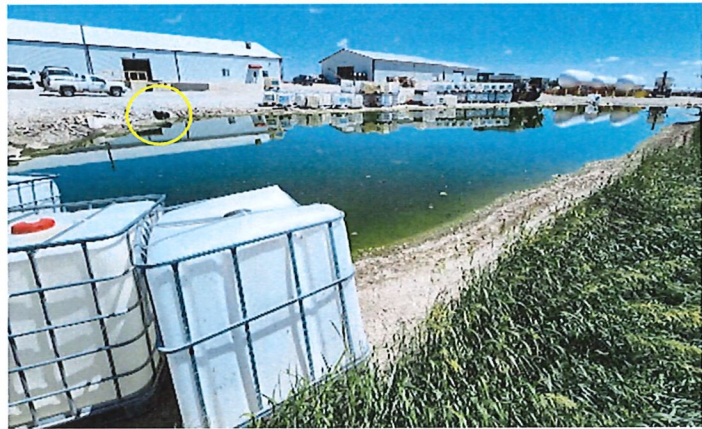
Photo #2: West pond looking east with inlet pipe present

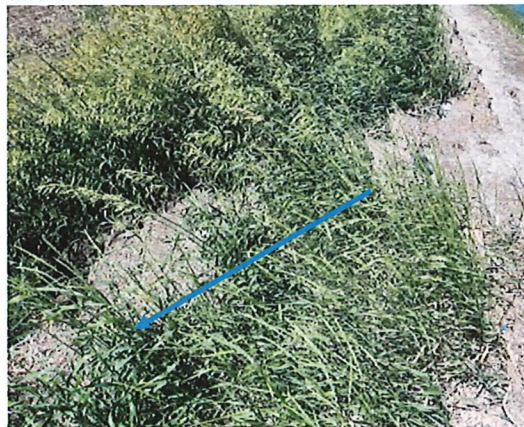
While no water quality violations were noted, there are deficiencies in stormwater controls at your site. It appears as though the western basin has overflowed at some point. Additionally, the intake associated with the basin appears to have been designed as a managed intake with a cap over the pipe to regulate when flow to the secondary basin can occur. At the time of our inspection the cap was present but water was actively flowing around the cap and through the tile to the second basin. This should be modified so no further flow can occur without active management. Also, please evaluate the elevation of the intake pipe to ensure it is placed at the correct grade. This will help ensure the basin does not overflow the berms.

Photo #3: South side of basin with evidence of overflow on berm and dead grass present

Please ensure repairs to the basins are made, including a plan for dewatering the eastern most basin. Please contact me by **July 15, 2024**, documenting repairs were made.

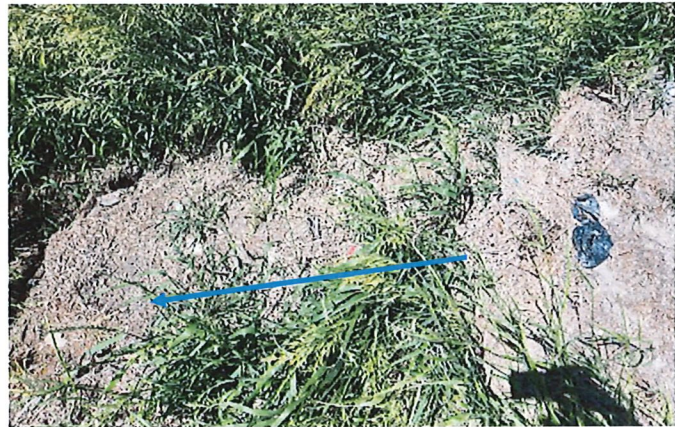
Photo #4: South side of basin with evidence of overflow on berm and dead grass present

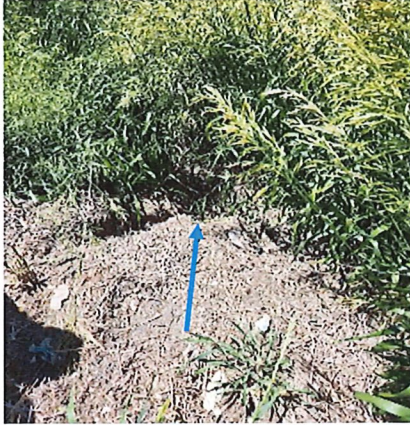
Photo #5: Looking south down the retention basin berm showing erosion and dead grass present

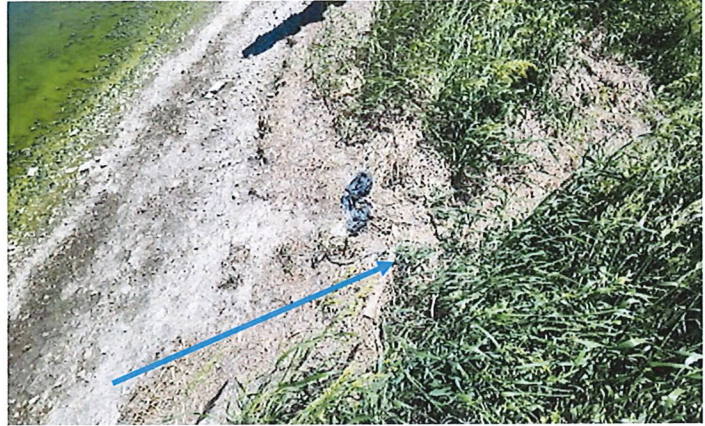
Photo #6: Looking east at area of dead grass along south berm

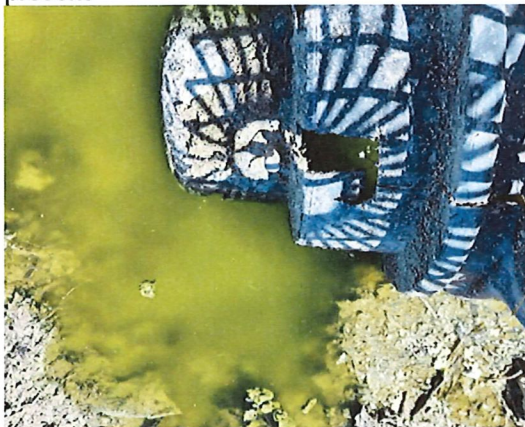
Photo #7: Tile intake to east retention basin with hole in cap present

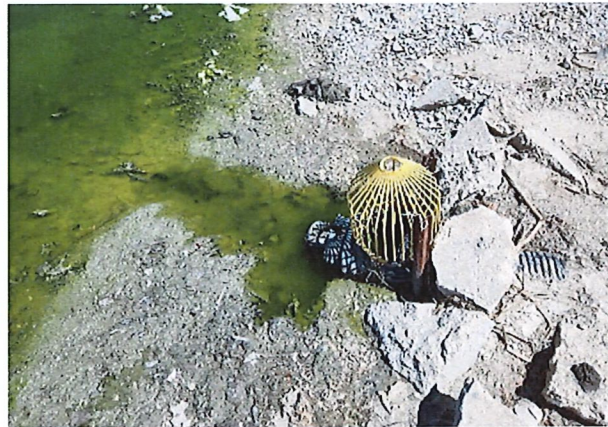
Photo #8: Tile intake to east retention basin

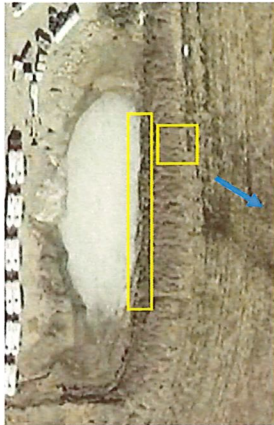
We then inspected the eastern basin. We observed green water flowing through the tube from the west basin. On the eastern berm several animal burrows were noted on the west side of the berm itself and near the waterline of the berm. On the east side of the berm holes were again noted in the berm wall and an area of flow appeared to be coming out of one of the holes but was not flowing at this time. This basin is not equipped with a tile line to discharge the basin and must physically be dewatered. However, evidence that the basin had overflowed was observed. We took another field test and noted ammonia levels of  $\approx 250$  mg/L. The photos below document the eastern basin.

**Figure #4: Eastern basin with areas of concern and direction of flow**

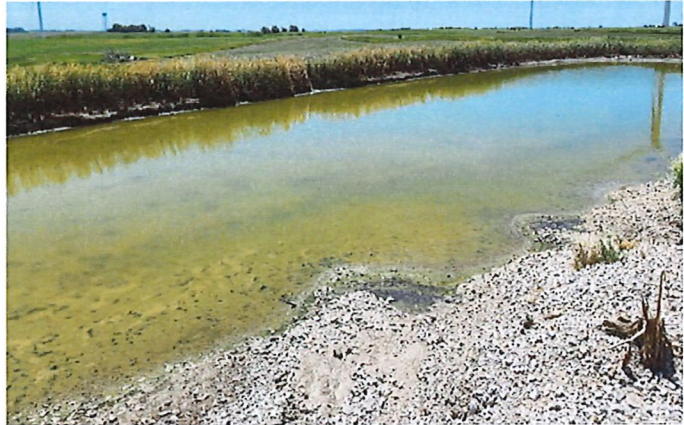
**Photo #: Eastern retention basin**

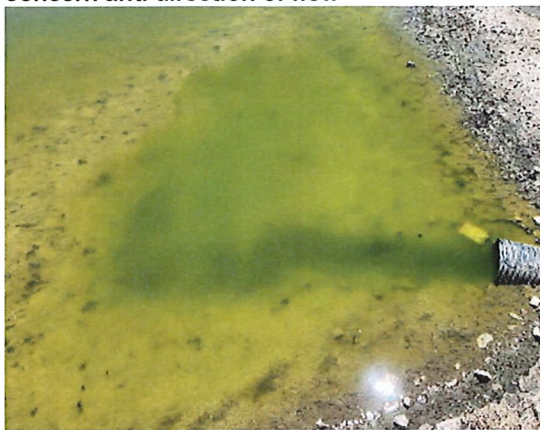
**Photo #: Inlet pipe from primary retention basin with green water flowing in**

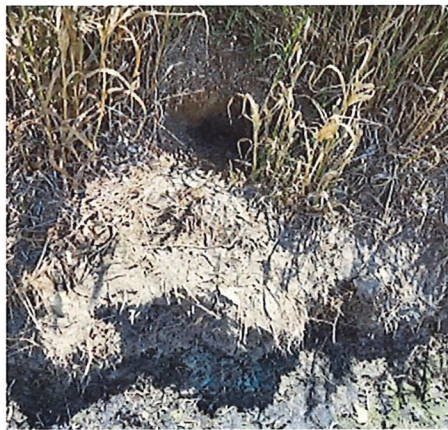
**Photo #: Animal burrow just above waterline of basin**

The east retention basin is designed to be dewatered when needed. However, although the area has received 9 inches of precipitation during the course of the last 3 months, Mr. Miller stated he has never needed to dewater the basin. During this investigation we observed signs of trenching indicating that the basin has overflowed. Measures must be taken to ensure an overflow does not occur. Additionally, the basin has several animal burrows on the east and west side of the berm. These should be filled to ensure a berm failure does not occur.

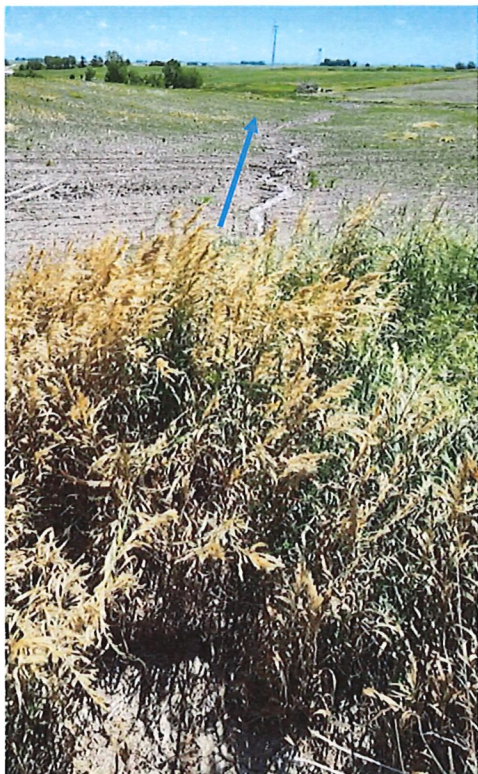
Photo #: Looking east from eastern berm with dry trench present

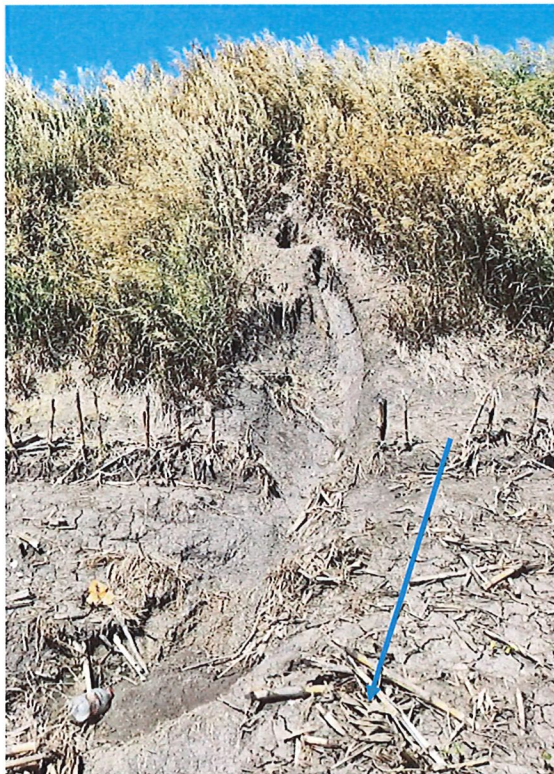
Photo #: Animal burrow on east side of east berm with area of flow coming out of it
