**MEMORANDUM**

**RE:** Agriland FS - Canby Facility Visit  
1608 160th Street, Casey, Iowa  
Adair County, Prussia Township, Section 5  
HSI Number 052311-MAC-1145

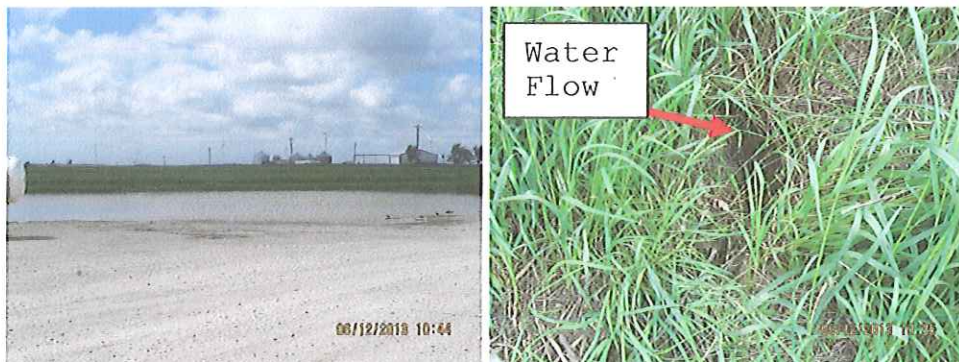
Wilken and Mr. Scholl inspected the facility. It was observed that the earthen secondary containment structure contained a large amount of liquid. However, it was not overflowing. There was no evidence that the structure had overflowed. Wilken observed water flowing from the base of the south side of the earthen structure. It appears water is working its way through the south earthen wall of the structure. Wilken informed Mr. Scholl that the water will likely continue eroding the south earthen wall of the structure. Wilken recommended that the damage to the basin wall be repaired immediately before the condition worsens.

Wilken spoke with Mr. Scholl via telephone on June 14, 2013 and reminded him that the leak in the south basin wall should be repaired as quickly as possible. Wilken asked Mr. Scholl to keep the department updated on any repairs.

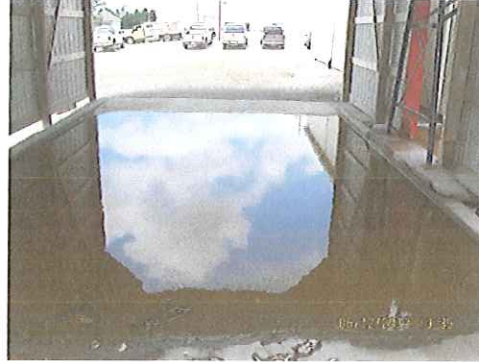
It was observed that the concrete loading pad on the south side of the dry fertilizer building was completely full of liquid even though a structure was built over the loading pad. Wilken advised Mr. Scholl to pump the liquid out of the loading pad and properly dispose of such. Wilken reminded Mr. Scholl that the loading pad cannot adequately contain spills if it is full of liquid. Wilken reminded Mr. Scholl that liquid in loading pads such as this often contain ammonia laden water.

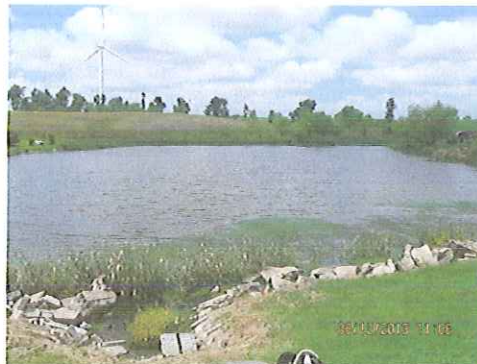
Wilken subsequently met with Ms. Janet Crees (owner of the private pond). During our last visit, the Crees' pond was almost completely covered in a thick algae mat. The pond exhibited improvement during this visit. Ms. Crees was reminded that the department can restock the pond whenever the Crees are ready to do so.
