REPORT OF RCRA COMPLIANCE EVALUATION INSPECTION

LINWOOD MINING & MINERALS CORPORATION

401 East Front Street
Davenport, Iowa 52804
(563) 324-1931

February 23, 2022

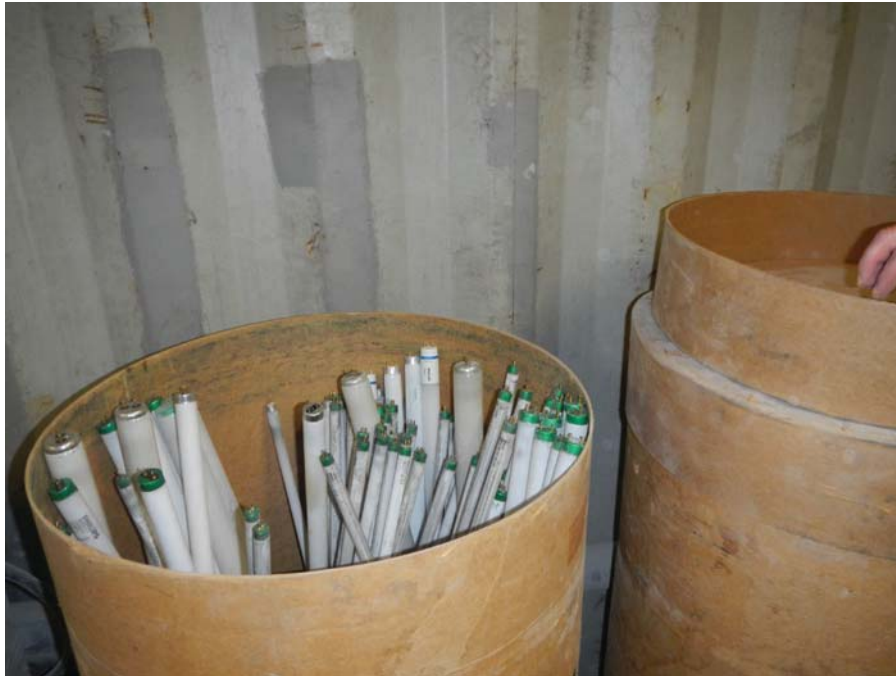
I observed the universal waste accumulation area located in the electrical/tan steel conex container located directly east of the steel maintenance building. There were two closed 4-foot round fiberboard universal waste lamp accumulation containers. I had Mr. Osland open the containers and the round 4-foot fiberboard container on the left was storing approximately 60 spent 4-foot fluorescent & LED lamps. The round 4-foot fiberboard container on the right was storing 7 spent 4-foot fluorescent/LED lamps and 9 or 10 HID lamps. Several HID lamps are shown broken at the bottom of the container. Neither of the containers were dated or labeled as universal waste lamps (attachment 4 photos 1 - 3). I asked Mr. Osland how long the universal waste lamps had been in storage and he stated he did not know for sure. Mr. Osland stated that he could not remember how long it had been since he had transported the waste lamps to the Scott County landfill, but thought it been well over a year ago. I informed Mr. Osland that the containers must be labeled as universal waste and dated when the first lamp is added to the container or have a tracking system such as a log to track the length of time the universal waste lamps have been accumulating. I did not leave NOPF for this issue at the time of the inspection. However, it may be added upon further review. I also informed Mr. Osland that the universal waste lamps cannot be stored for longer than one year. Furthermore, I informed Mr. Osland that broken lamps are considered to be hazardous waste and must be managed as such to minimize a release to include being stored in an impermeable container such as a plastic or metal container and not in a fiberboard container.

Compliance Evaluation Inspection	DESCRIPTION	Photo of two round fiberboard containers located in the “electrical/tan” steel building storing spent lamps. The left container has approximately 60 spent fluorescent & led lamps. The containers are not dated or labeled as universal waste lamps.	1
	PHOTOGRAPHER		Date
Direction: Northwest		Trevor Urban	02/23/22

NOPF 2 – Failure to immediately clean up the broken HID lamps and manage them to minimize a release of mercury is in violation of 40 CFR 273.13(d)(2).

NOPF 3 – Failure to manage the 4-foot universal waste lamps and HID lamps in a container that is labeled with the words “Used Lamps”, “Waste Lamps”, or “Universal Waste Lamps” is in violation of 40 CFR 273.14(e).

NOPF 4 – Storing the 4-foot universal waste lamps and HID lamps for greater than one year is in violation of 40 CFR 273.15(a).

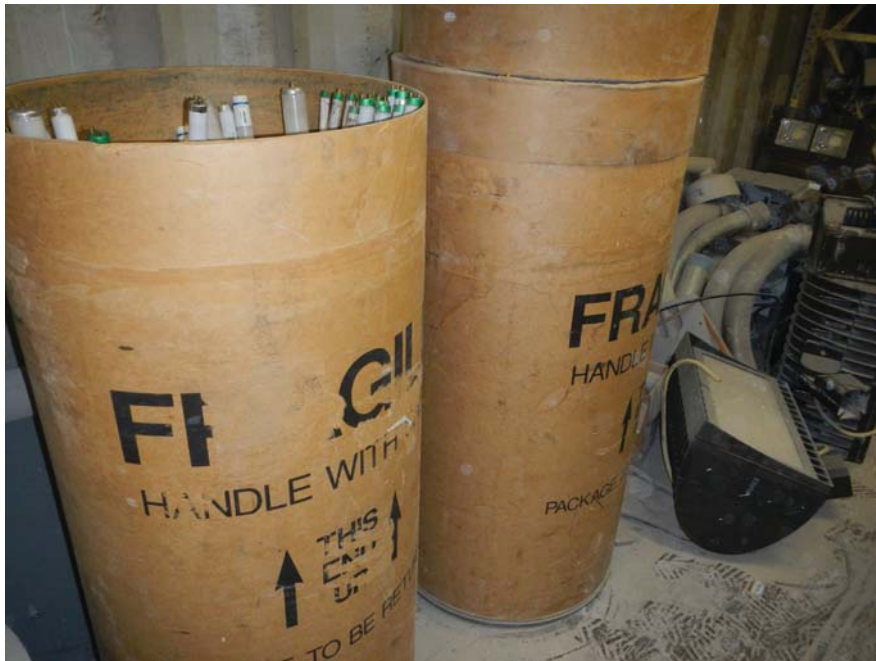
Compliance Evaluation Inspection	DESCRIPTION	Same as photo 1, of the two round fiberboard containers located in the electrical/tan steel building storing spent lamps. The left container has approximately 60 spent fluorescent & led lamps. The containers are not dated or labeled as universal waste lamps.	2
	PHOTOGRAPHER		Date
Direction: Northwest		Trevor Urban	02/23/22

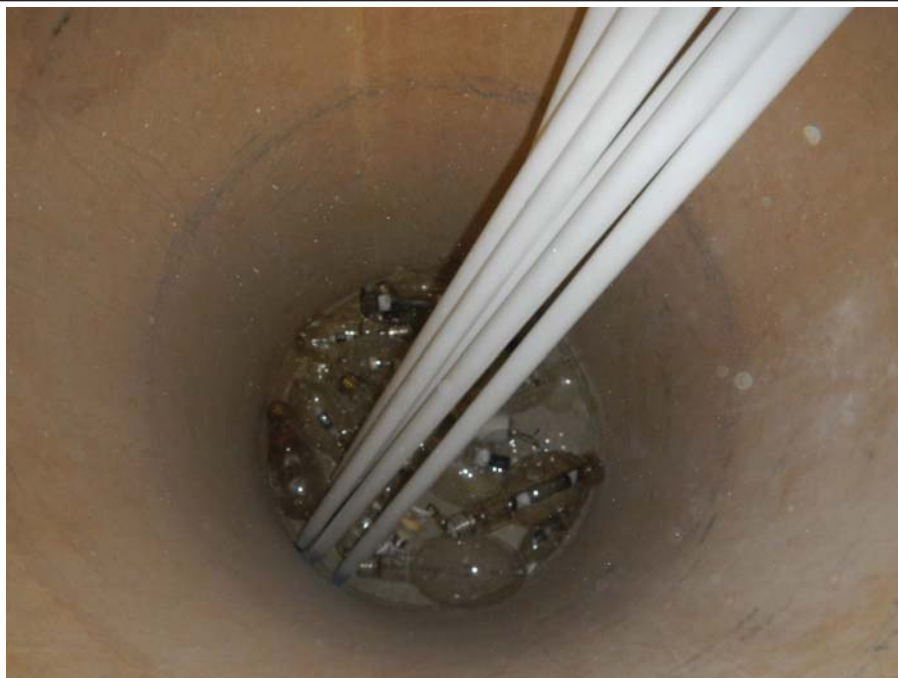
Compliance Evaluation Inspection	DESCRIPTION	Photo of the round fiberboard container shown in photos 1 & 2 on the right located in the electrical/tan steel building storing 7 spent fluorescent/led lamps and 9 or 10 HID lamps. Several HID lamps are shown broken at the bottom of the container.	3
	PHOTOGRAPHER		Date
Direction: West		Trevor Urban	02/23/22

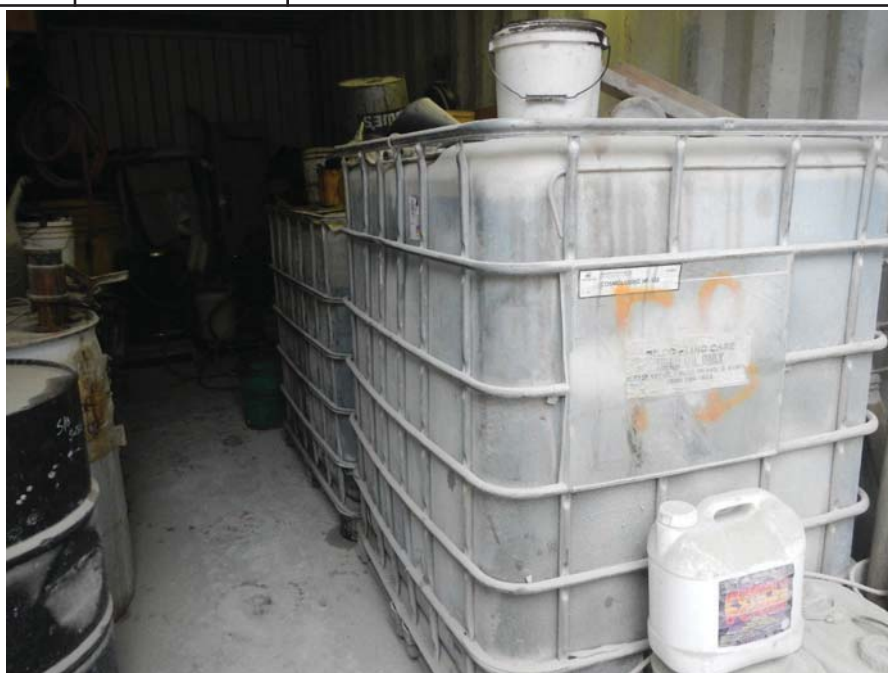
I observed a 275-gallon and 330-gallon tote of used oil being accumulated in the blue steel conex container near the facility office/directly south of the maintenance building (attachment 4 photo 4). The 330-gallon tote was full and 275-gallon tote was $\frac{3}{4}$ full of used oil. Both totes were labeled as “Used Oil”. I observed a 1,000-gallon red steel tank accumulating used oil in the mobile equipment maintenance shop located underground in the mine (attachment 4 photo 9). The tank was less than half full and was labeled as used oil. Mr. Osland stated that large pans on wheels (shown in photo 9) are used to collect the used oil from large equipment during servicing and that they are immediately emptied into the red used oil storage tank. I also observed a black 55-gallon steel container of used oil being accumulated in the oil/lubrication building on the north/Quarry side of the facility (attachment 4 photo 7). The 55-gallon container was $\frac{1}{2}$ full of used oil and was not labeled. I informed Mr. Osland that the 55-gallon container accumulating used oil located in the oil/lubrication building on the north/Quarry side of the facility must be label as “Used Oil”.

Compliance Evaluation Inspection	DESCRIPTION	Photo of two square totes located in the “maintenance/blue” steel building storing used oil. The two containers are both nearly full and labeled as “Used Oil”. An aerosol can puncturing unit is shown on the left. The remaining containers held product oils.	4
	PHOTOGRAPHER		Date
Direction: East		Trevor Urban	02/23/22

NOPF 1 – Failure to label used oil accumulation containers as “Used Oil” is in violation of 40 CFR 279.22(c)(1).

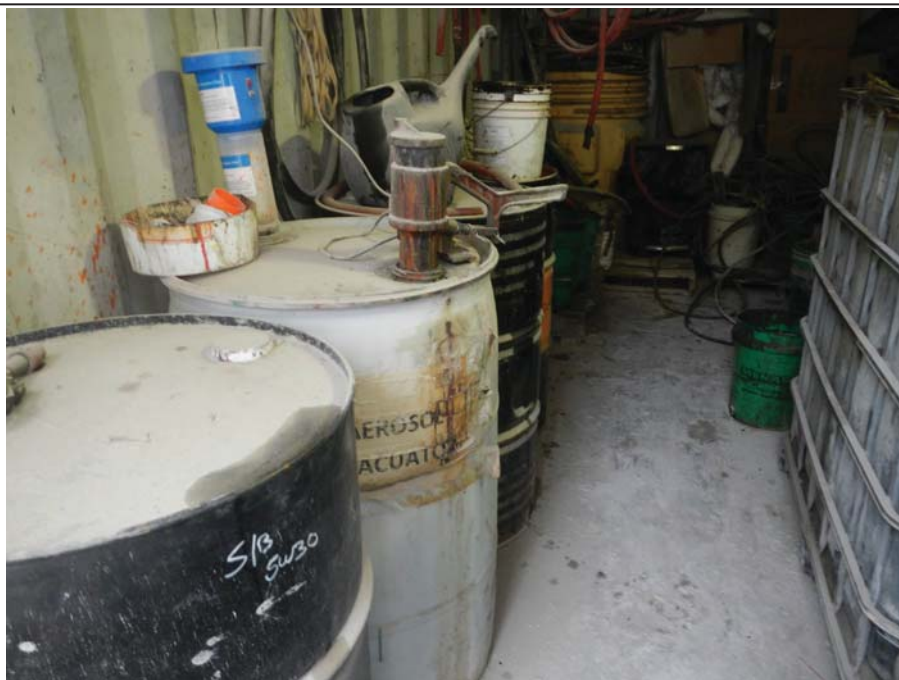
Compliance Evaluation Inspection	DESCRIPTION	Close up of the aerosol can puncturing unit shown in photo 4 located in the maintenance/blue steel building. The white 55-gallon plastic container was less than ¼ full, closed and labeled as “Aerosol Evacuation”.	5
	PHOTOGRAPHER	Trevor Urban	Date 02/23/22

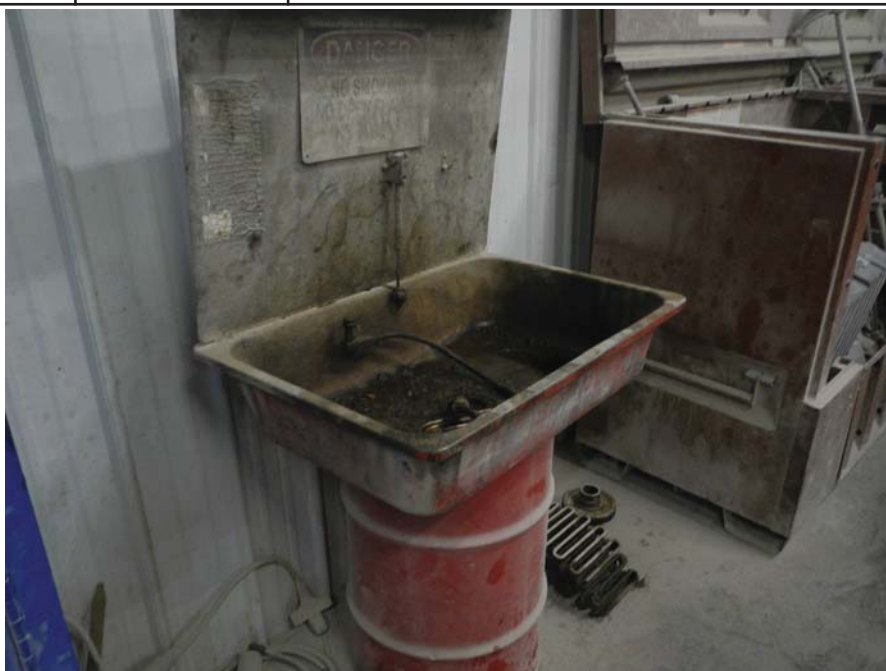
Compliance Evaluation Inspection	DESCRIPTION	Photo of a parts washer located in the maintenance shop that is located directly west of the electrical/tan steel building. The parts washer sets on top of a red 33-gallon container and is serviced on an eight-week schedule by RILCO Lubricants & Services.	6
	PHOTOGRAPHER	Trevor Urban	Date 02/23/22

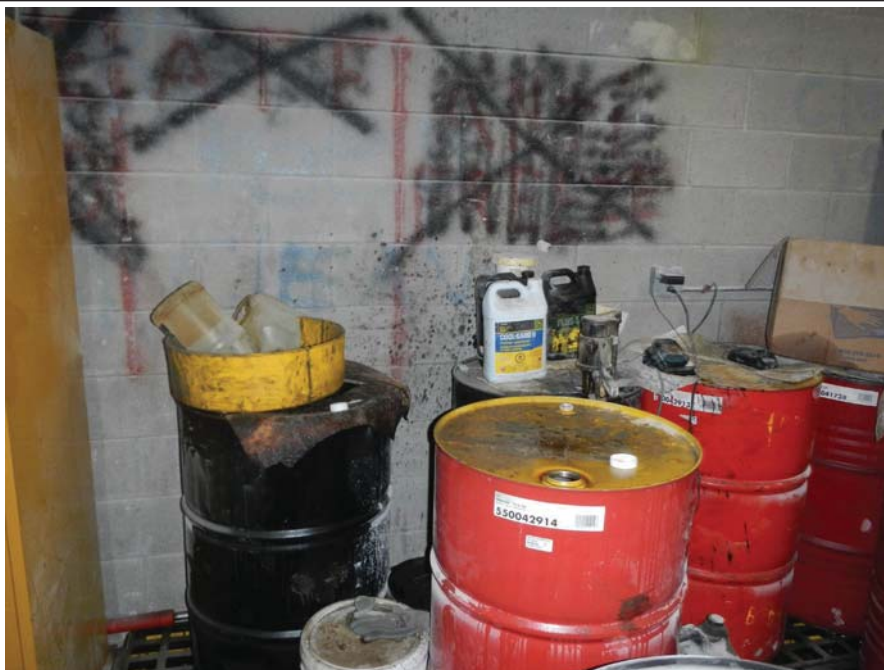
Compliance Evaluation Inspection	DESCRIPTION	Photo of several 55-gallon containers of oil products located in the oil/lubrication building on the north/Quarry side of the facility, (north of Hwy 22). The black 55-gallon container on the left was half full of used oil and was not labeled as "Used Oil".	7
	PHOTOGRAPHER	Trevor Urban	Date
Direction: North			02/23/22

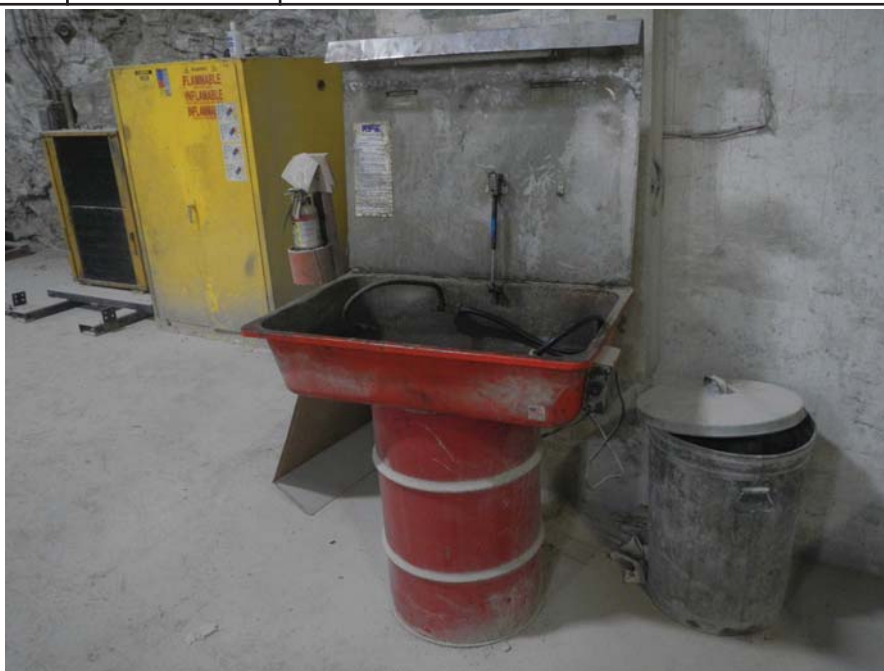
Compliance Evaluation Inspection	DESCRIPTION	Photo of a parts washer located in the mobile equipment maintenance shop located underground in the mine. The parts washer sets on top of a red 33-gallon container and is serviced on an eight-week schedule by RILCO Lubricants & Services.	8
	PHOTOGRAPHER	Trevor Urban	Date
Direction: Underground			02/23/22

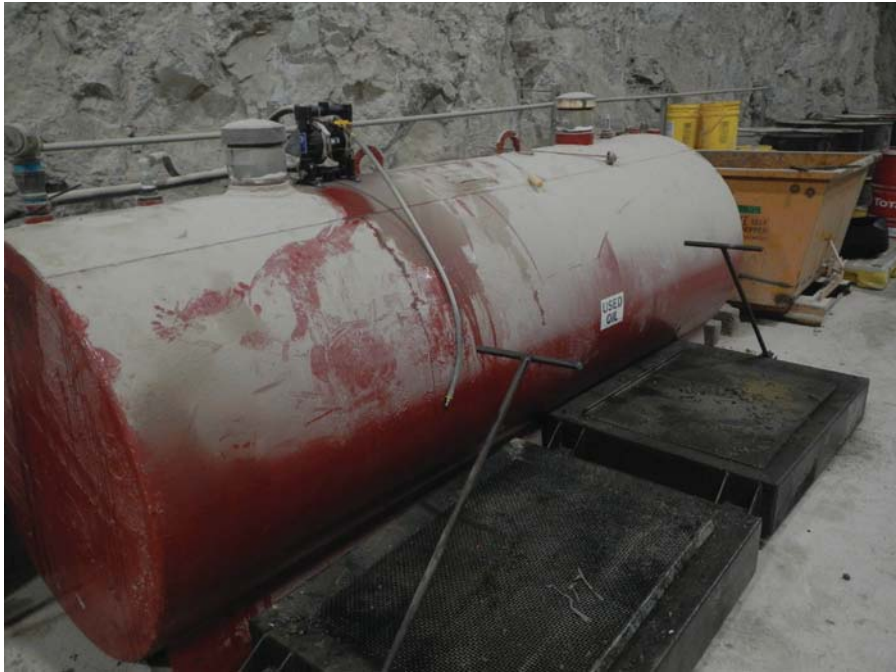
Compliance Evaluation Inspection	DESCRIPTION	Photo of a used oil collection tank and drain pans located in the mobile equipment maintenance shop located underground in the mine. The tank is labeled as "Used Oil". A bin for the collection of used oil filters is shown on the right of the used oil tank.	9
	PHOTOGRAPHER	Trevor Urban	Date
Direction: West			02/23/22

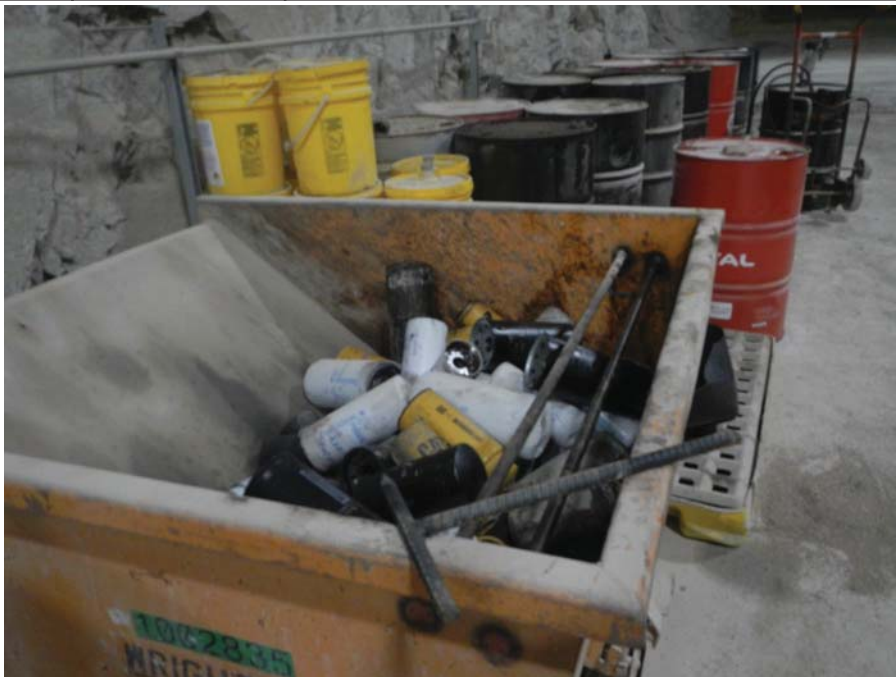
Compliance Evaluation Inspection	DESCRIPTION	Photo of the used oil filter collection bin (shown in photo #9) in the mobile equipment maintenance shop located underground in the mine. All filters were punctured and are managed as scrap metal. The remaining containers shown held product oils.	10
	PHOTOGRAPHER	Trevor Urban	Date
Direction:			02/23/22
