December 7, 2023

**RE: RESPONSE TO IDNR LETTER DATED NOVEMBER 2, 2023
REVIEW OF SEMI-ANNUAL INSEPCION – FALL 2023
POWESHIEK COUNTY SANITARY LANDFILL
IDNR PERMIT #79-SDP-01-73P**

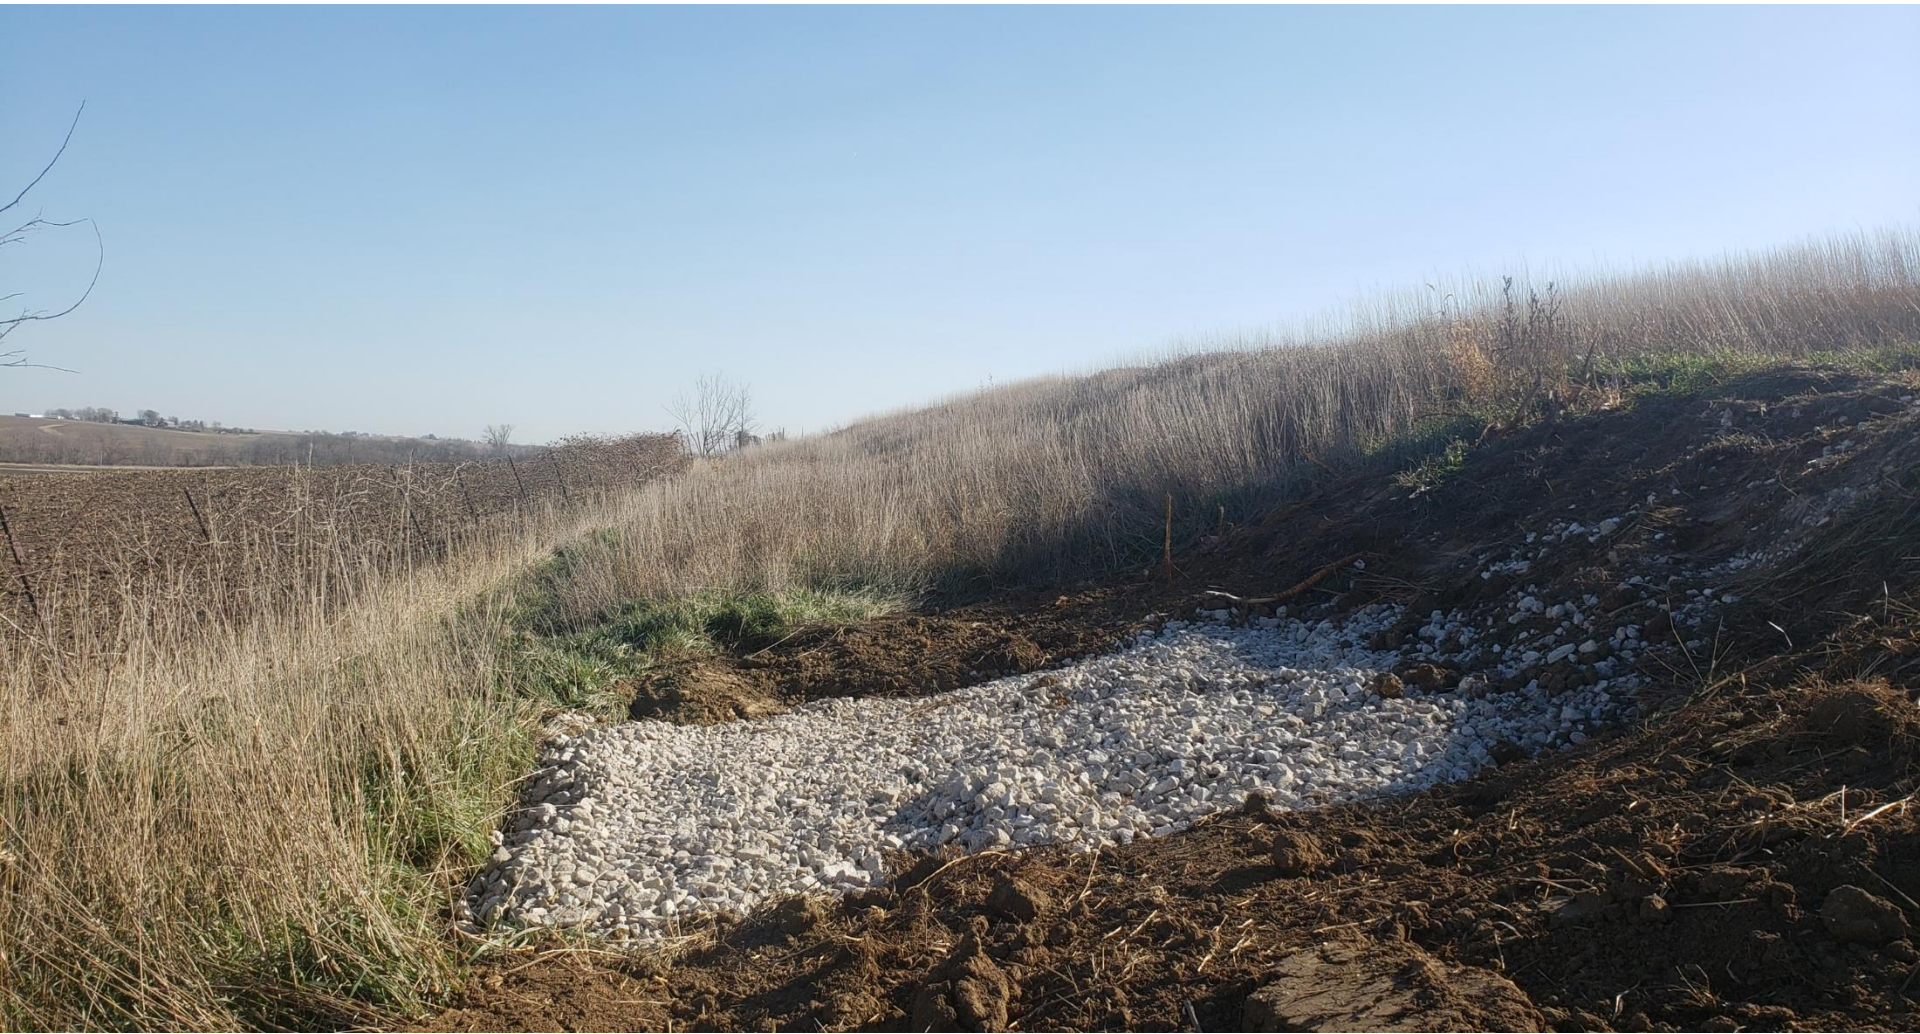
The north repair area was approximately 12' by 12'. The south repair area was approximately 15' by 15'. Photos of the repair areas are included in Attachment A. The repair areas will be reviewed during future semi-annual inspections with observations included in each report.

Photo 1: North seep repair area, looking east

- Approximately 2' of soil was removed from each area. No waste was encountered during the excavation.
- A geotextile filter fabric was placed on the base of the excavation.
- Clean erosion stone was placed on the geotextile filter fabric.
- Excess soil was either spread adjacent to the repair areas to promote vegetative growth or hauled to the soil stockpile at the end of the access road.
- The areas were repaired during November, 2023. Due to the late date of the work, areas disturbed during the repairs will be seeded next Spring during the IDOT recommended Spring seeding period (March 1 – May 31).

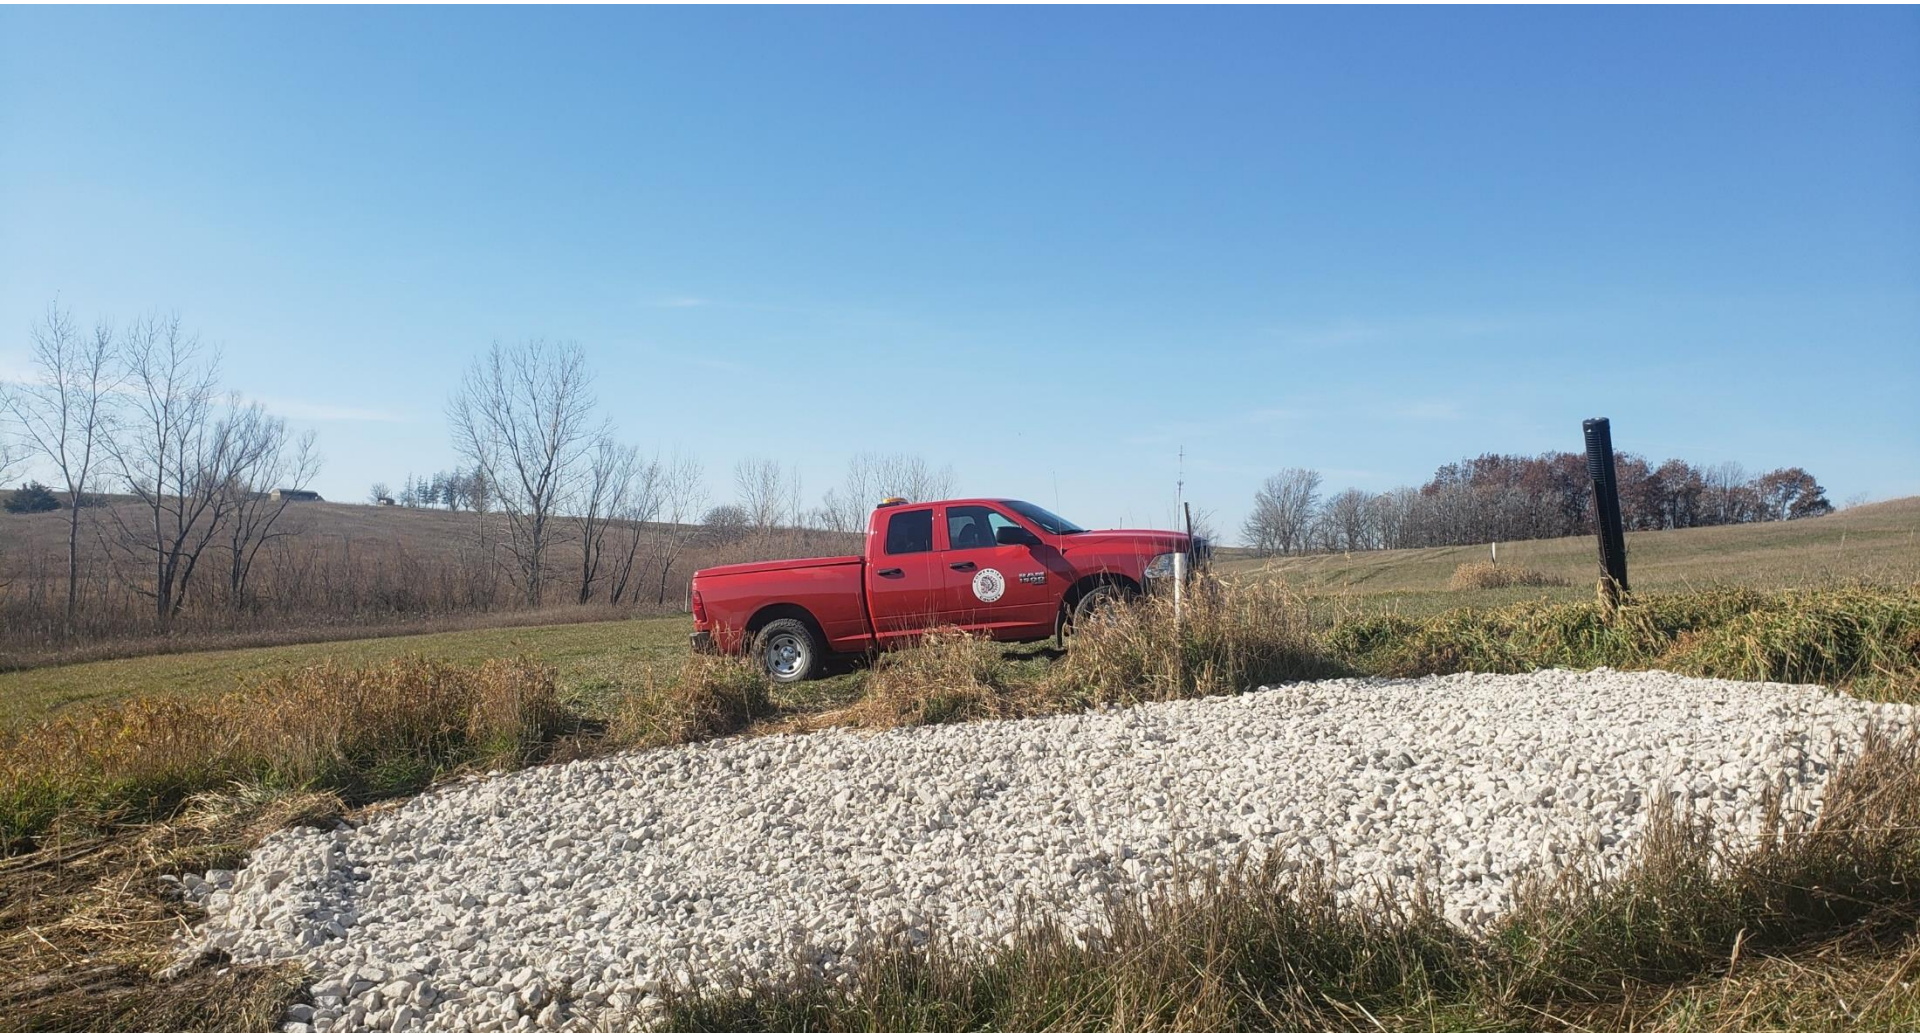
Photo 2: South seep repair area, looking west
