**RE: SEMI-ANNUAL INSPECTION – SPRING, 2024
AMES/STORY ENVIRONMENTAL LANDFILL
IDNR PERMIT NO. 85-SDP-13-91
HLW P.N. 6004-24A.750**

SITE PLAN
 SPRING 2024 INSPECTION
 AMES/STORY ENVIRONMENTAL LANDFILL
 AMES, IOWA

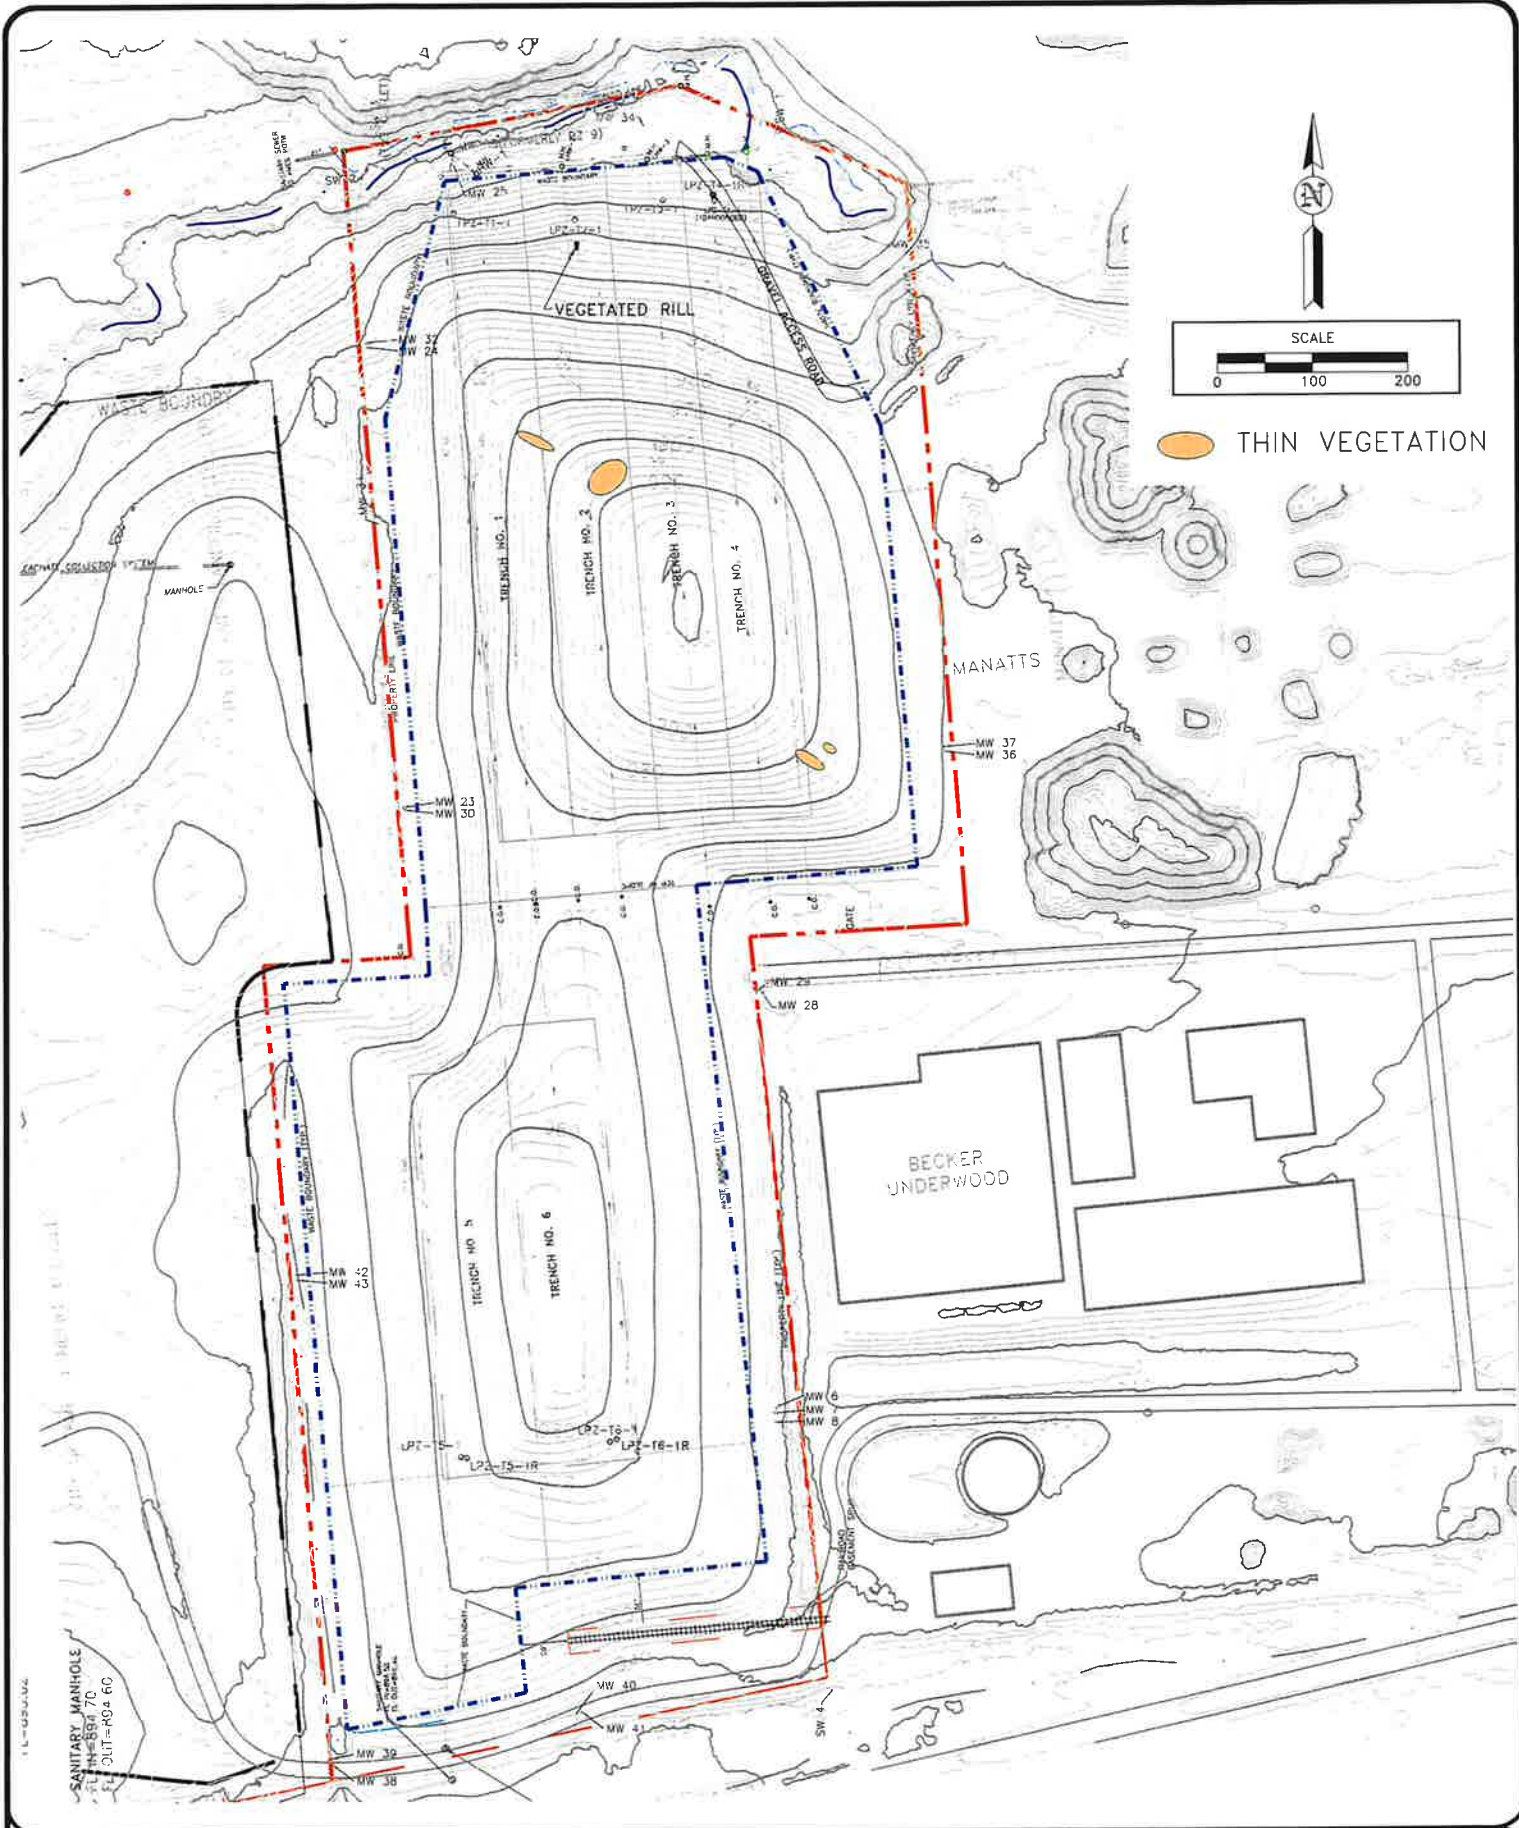
FIGURE:		1
REVISION	NO.	DATE
DRAWN JGH	PROJECT NO. 6004-10A	DATE 3/25/24

Vegetation is in excellent condition on the majority of the north half with the exception of a few areas where thin vegetation was noted during this inspection. The approximate location of these areas are shown on the attached figure. The areas do not appear to have changed appreciably over those noted during past inspections and may possibly start to fill back in if normal precipitation patterns return in 2024.

No erosion was noted on cap with the exception of near LPZ-T2-1 (note the location of the erosion was inadvertently referred to as adjacent to LPZ-T1-1 in the Fall, 2023 inspection report). A rill has formed near LPZ-T2-1; however, the rill is well vegetated and based on the condition of vegetation in this area, the rill does not appear to be active. No waste is exposed in the rill. The approximate location of the vegetated rill is shown on the attached figure.

1. Continue to monitor condition of vegetation, focusing on the areas with thin vegetation noted during this inspection, and reseed and control weeds as necessary.
2. Continue to monitor leachate levels in LPZ-T5-1R and discuss in the 2024 Annual Water Quality Report (AWQR).
3. Monitor the vegetated rill near LPZ-T2-1. Continue to monitor the remainder of the cap for erosion rills and repair as needed.
4. Continue to monitor bank erosion near MW-35 – if erosion appears to threaten the integrity of the well install bank stabilization to protect the MW.
5. Continue to remove trees from landfill cap as needed.
