March 27, 2024

RE: SEMI-ANNUAL INSPECTION – SPRING 2024 POWESHIEK COUNTY SLF CLOSURE PERMIT NO. 79-SDP-1-73C HLW P.N. 6011-23A.750

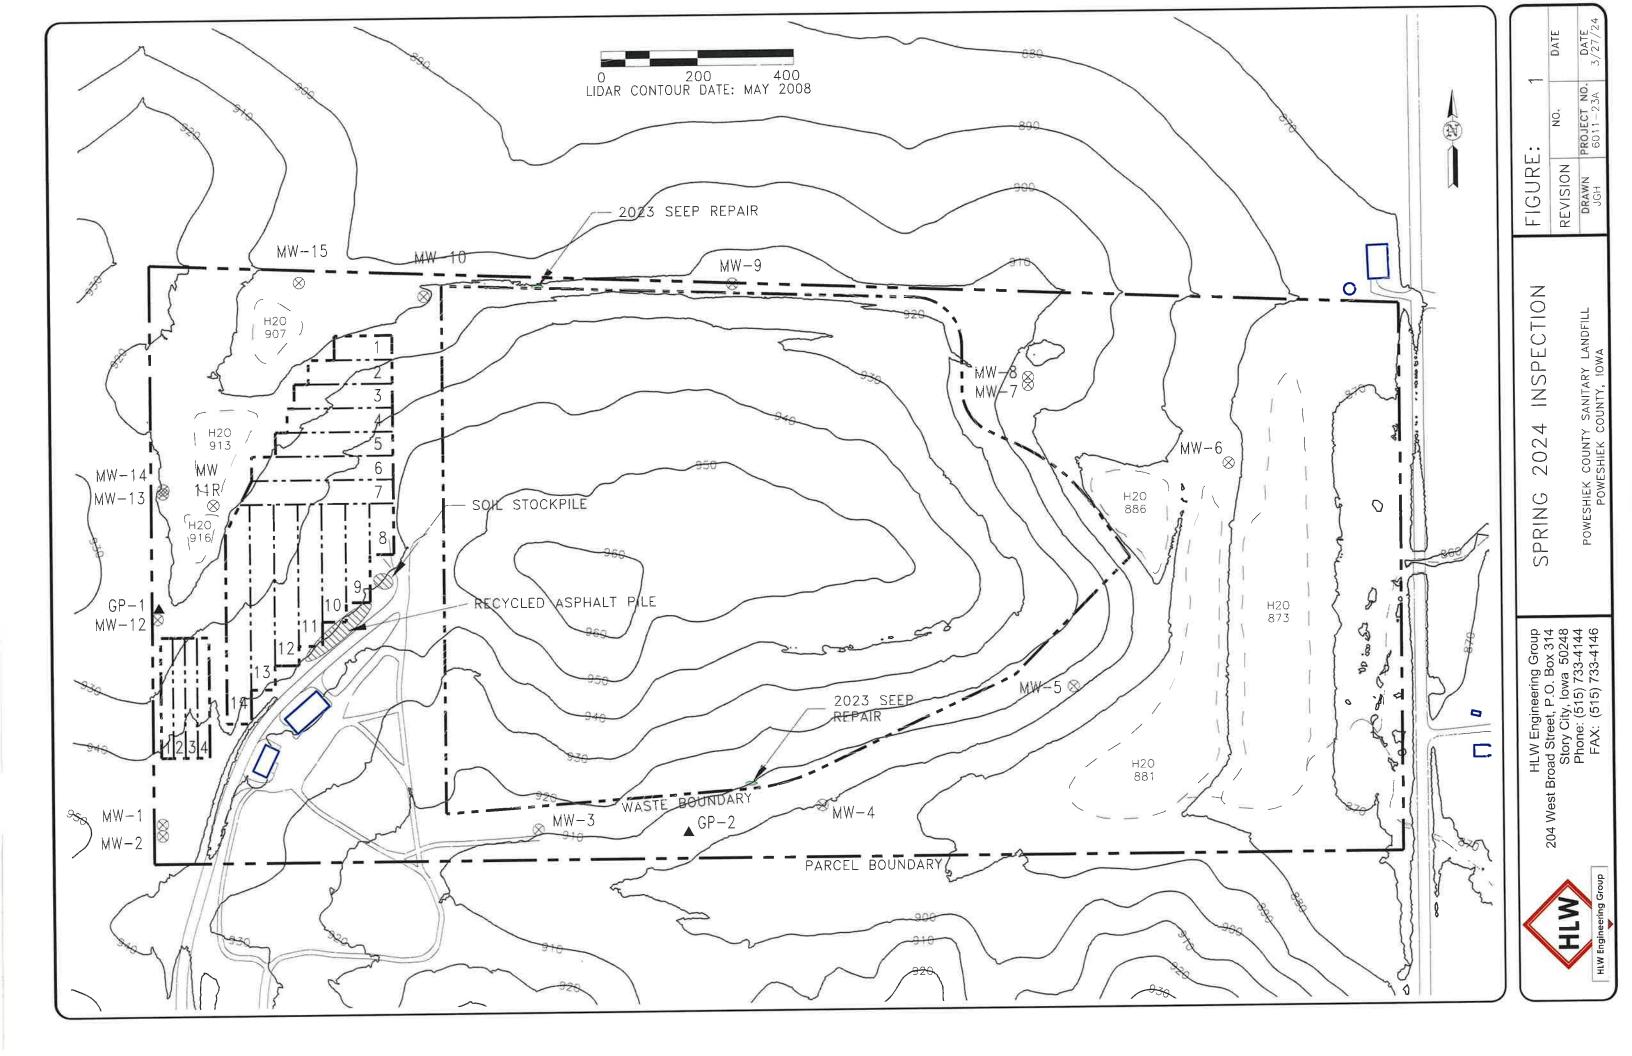
County staff previously stockpiled soil at the end of the access road at the approximate location shown on Figure 1. The soil is available for use in future repairs at the landfill if necessary. As noted during past correspondence, a portion of the original stockpile

A temporary stockpile of recycled asphalt has been placed along the access road to the west of the soil stockpile. This stockpile appears to outside of the waste boundary to the east but may infringe on the south side of Trenches 9-11. The approximate location of the temporary stockpile is shown on Figure 1. Mr. Brehm reported that this stockpile would be utilized by a Contractor on a county road improvement project and would be removed this year.

As documented in the December 7, 2023 letter (Doc #108401), two (2) potential seep areas were repaired by County staff in November, 2023. Figure 1 is attached illustrating the referenced repair areas.

The areas of repair were observed during this inspection. At the time of inspection vegetation had not established on the disturbed soil areas adjacent to the rock and fabric repair areas.

Review of the north repair area indicated that the perimeter of the repair was dry and no moisture was observed.

Review of the south repair area indicated that the south side (downslope side) of the repair was moist but that there was no flow.

- 1. Remove the temporary asphalt stockpile during 2024.
- 2. Continue to monitor the soil stockpile.
- 3. Continue to monitor the repaired seep areas.
- 4. Continue to remove trees from the cap and terrace letdown ditch.
- 5. Continue to monitor settled areas for signs of ponding or drainage issues.
- 6. Continue to monitor the terrace channels for evidence of ponding or overtopping. Regrade terrace channels to eliminate ponding as necessary.
- 7. Continue to monitor vegetation and erosion and repair as necessary.
- 8. Continue to monitor diversion and drainage systems and repair as necessary.
