April 15, 2024

RE: ANNUAL INSPECTION – 2024 BREMER COUNTY SANITARY LANDFILL IDNR PERMIT #09-SDP-01-75C – CLOSED HLW PN 6035

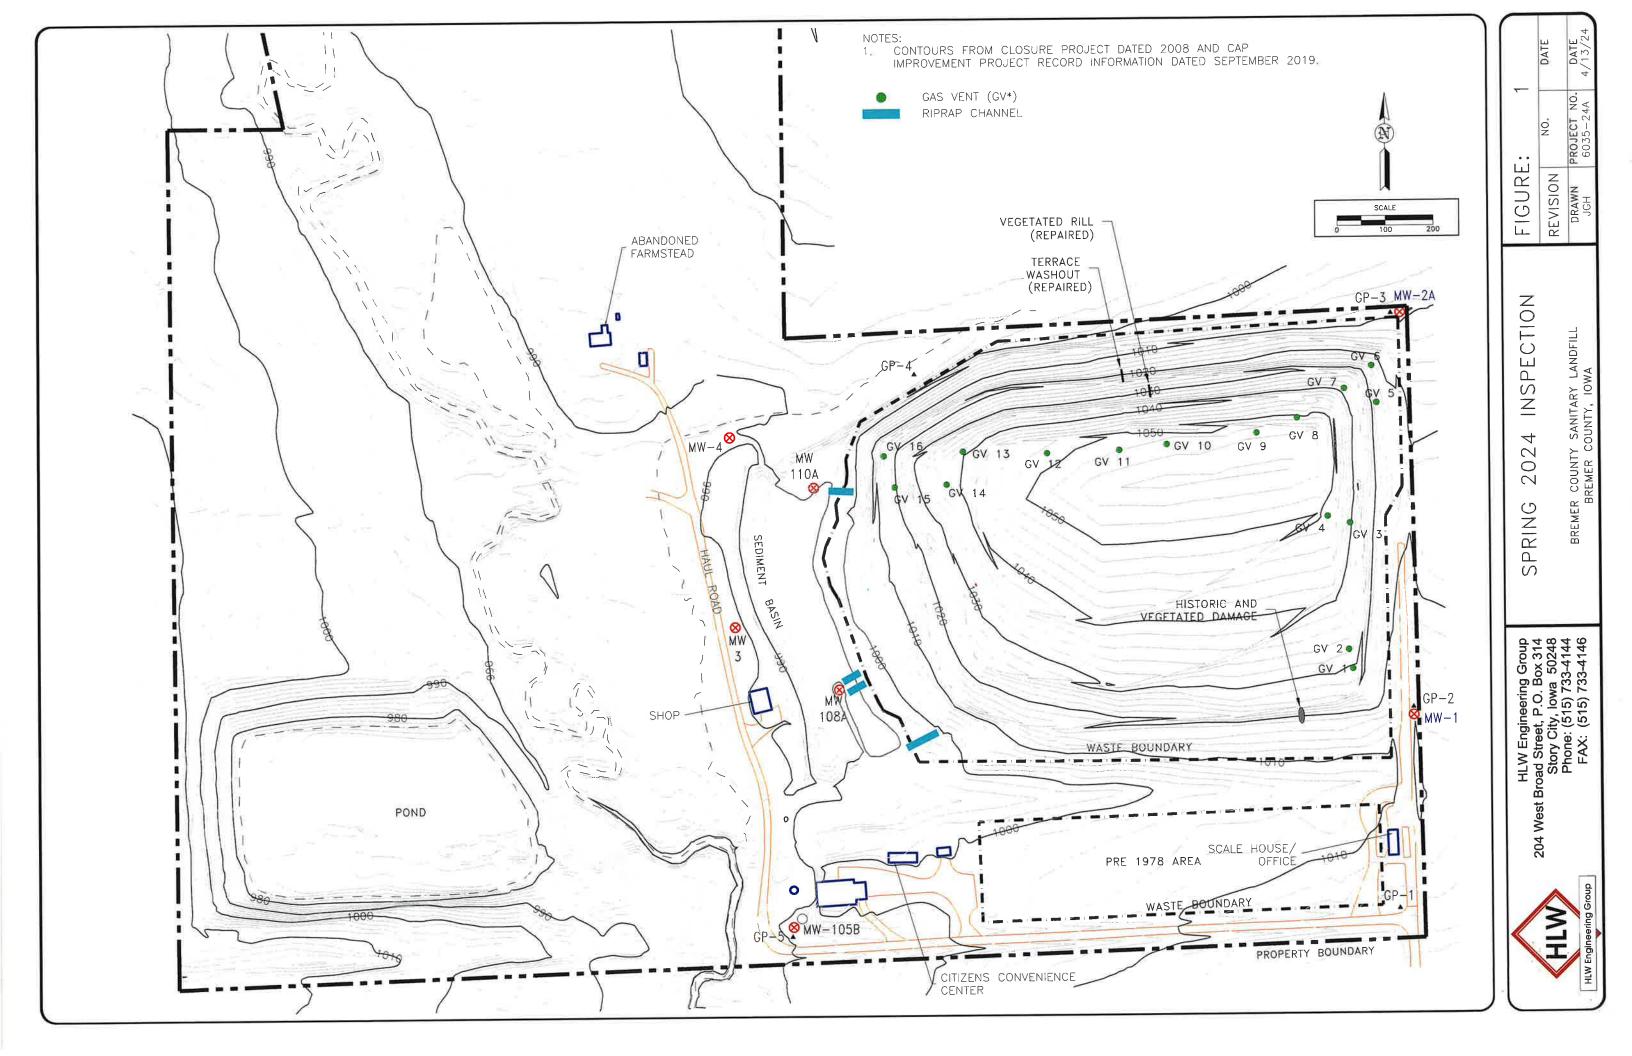
- 7. The diversion and drainage systems are maintained and are in generally good condition. Review of the area of the former terrace washout near the intake of the second terrace (from the toe of slope) on the north slope was inspected. The washout and the intake were repaired in 2023. Improvements were also made to the terraces above and the terrace below the repaired washout. Areas repaired in 2023 were seeded and the vegetation is emerging. The locations of the repairs are shown on the attached figure.

A project to install gas vents through the cap in areas where stressed vegetation was noted during past inspections was completed in May, 2022. Sixteen gas vents were drilled through the cap into the waste mass. Each vent was backfilled with clean river rock and a perforated pipe with wind turbine vent on top was installed in the rock to aid in gas removal from the waste mass. A Construction Certification Report was submitted to IDNR on July 15, 2022 (Doc #103616). Erosion was also repaired during this project. The locations of the vents and the erosion repairs are shown on the attached figure.
