April 29, 2024

Spring 2024 Semi-Annual Engineering Inspection
Viking Pump Foundry Sand Landfill
Permit No. 7-SDP-12-89P-FSL

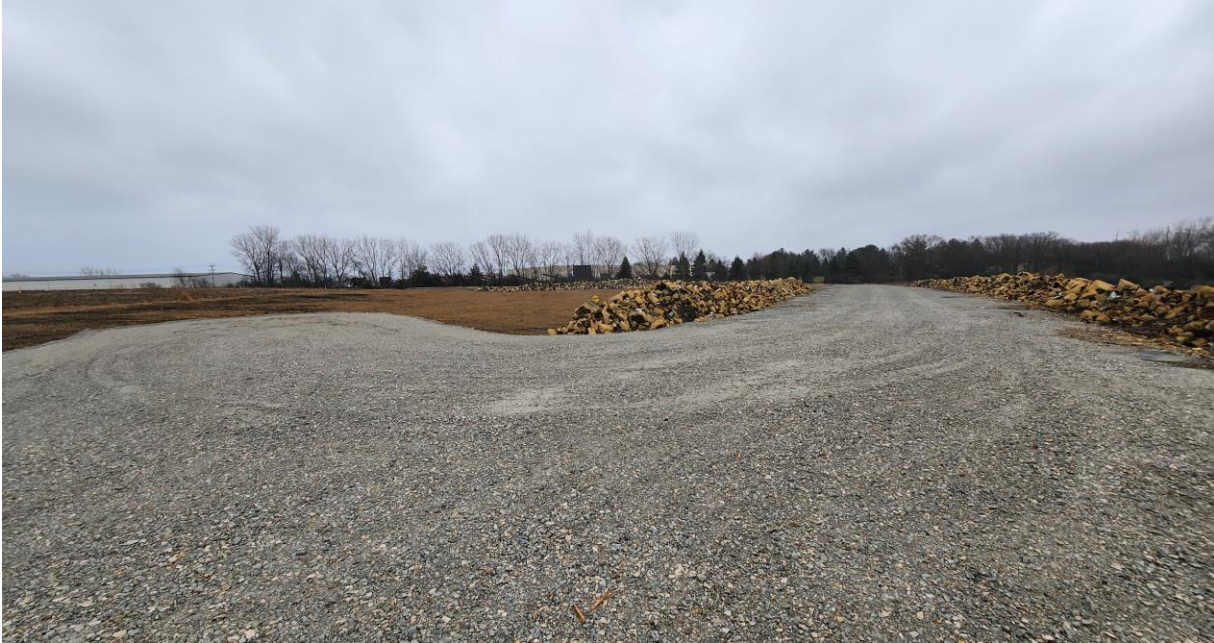
The landfill access road was reconstructed since the previous inspection. The reconstructed road included an underlying geogrid and gravel. The new roadway extends in two directions into the landfill providing improved access across the site and facilitating distribution of blocks for crushing. The access road may be extended or modified in the future as filling proceeds.

Photo 1. View of new access road from the west edge of the road, looking toward the entrance (southeast). Staged blocks placed on either side of the access road.

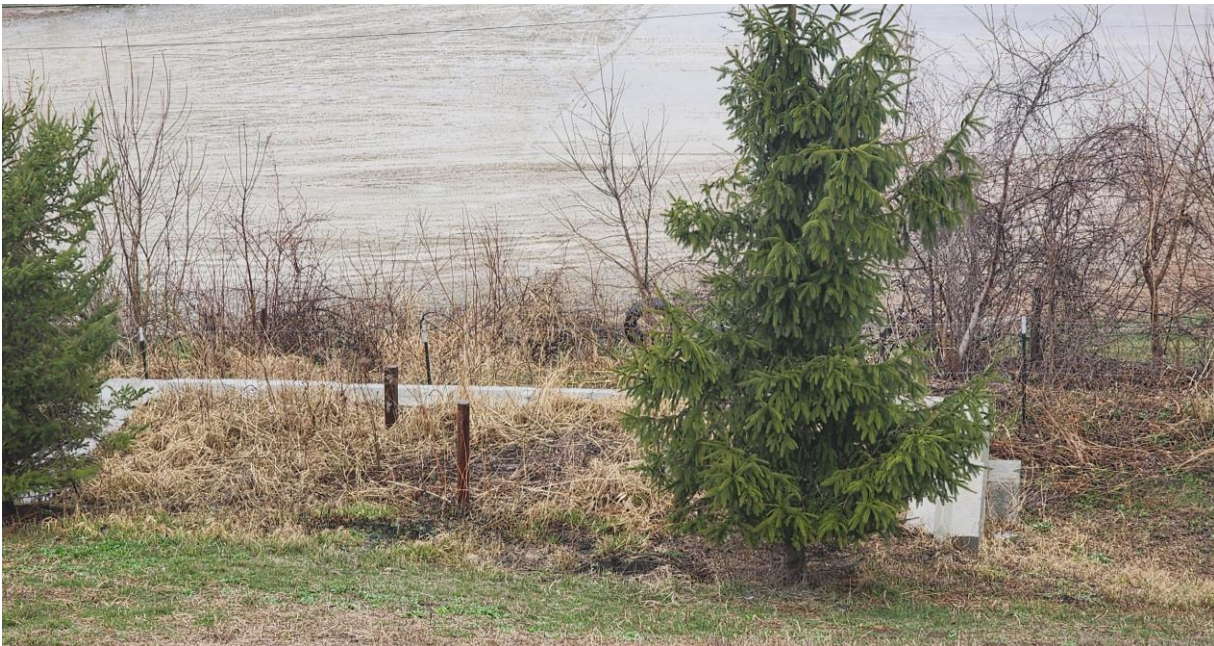
The retaining wall around the area of MW-8 and MW-13 was previously upgraded. The fill behind the wall was overgrown at the last inspection, and additional maintenance was requested. Since then, the overgrowth has been cleared and the wells are easily accessible.

Photo 2. Area of new retaining wall around MW-8 and MW-13 on north side of landfill. Overgrown brush observed in October 2023 is now cleared.

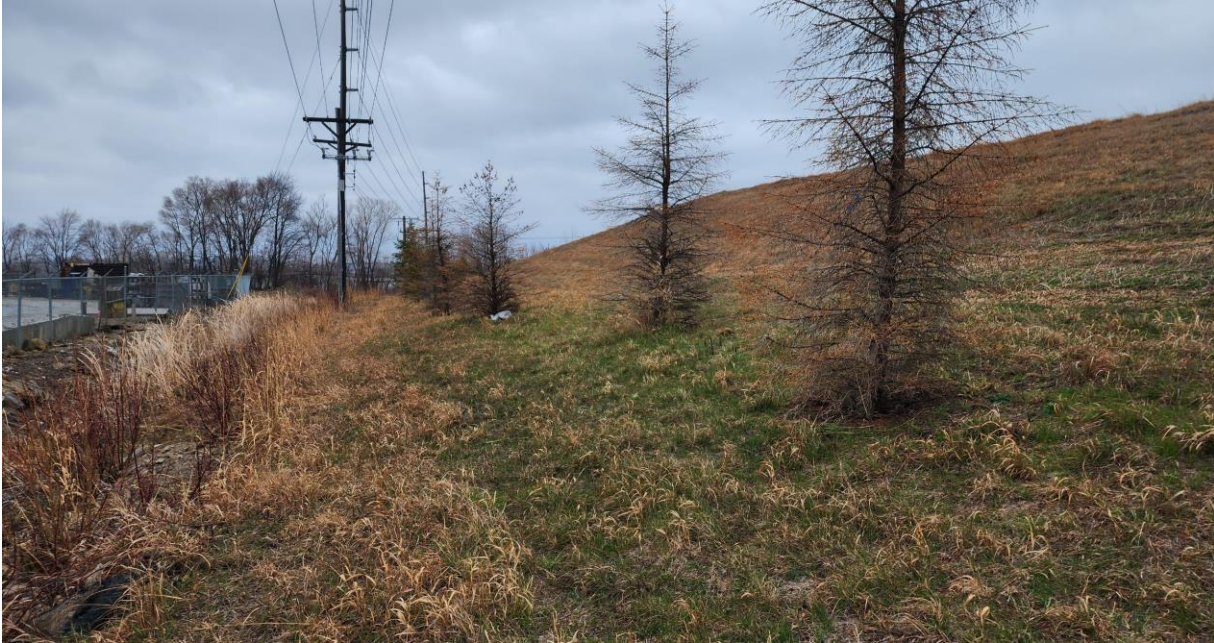
The trees planted around the landfill were inspected. It appears one more tree apparently died or succumb to stresses since the October 2023 inspection. Drought conditions coupled with rhizosphaera needle cast fungus was likely responsible for elevated tree mortality observed in 2023. The recent drought conditions and tree survivorship in previous, wetter periods indicates that the tree death is not from a landfill impact.

Photo 3. Example of tree mortality on west side of landfill.

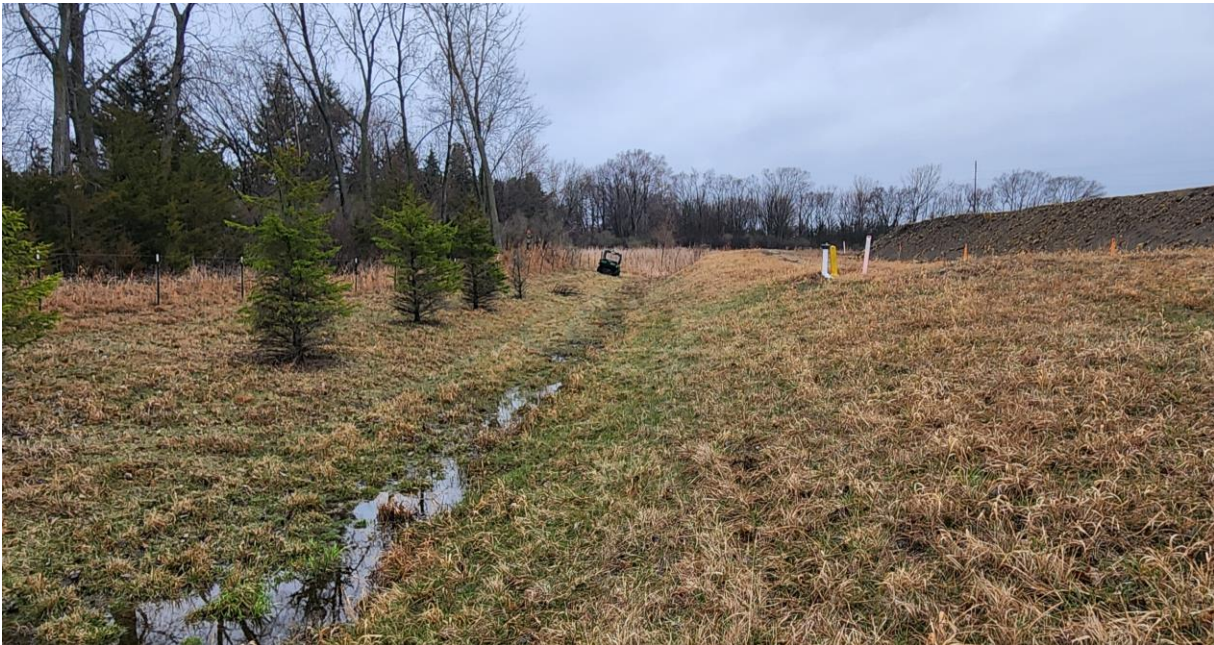
The landfill areas with final cover on the north and west sides of the landfill flow to the unnamed ditch west of the landfill. Surface water from the east flows to the south and leaves the site at Viking Road. No erosion in drainage pathways was observed. Vegetation has been established and is in good condition. The east drainage channel contained water flowing toward the stormwater retention basin. The retention basin appeared to be functioning as designed and was discharging during the inspection. Grass on the closed areas was still dormant from the winter season but appeared to have acceptable coverage and consistent with previous inspections.

Photo 4. Water in the east drainage channel. Note healthy trees in foreground.

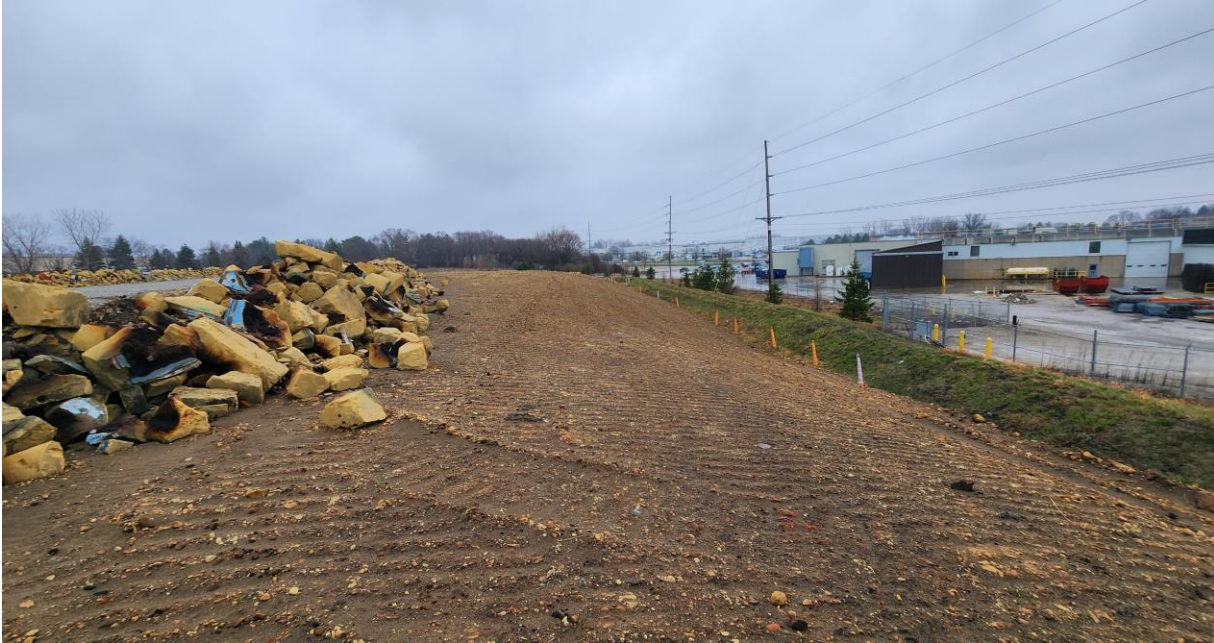
Foundry sand blocks are placed along the gravel access roads. The large blocks of foundry sand are occasionally crushed as required for continued landfill operation. During the inspection, all foundry sand was observed within the landfill berm. No operations were observed during the inspection.

Photo 5. Example of crushed and spread foundry sand with uncrushed blocks on left, on the east side of the landfill.

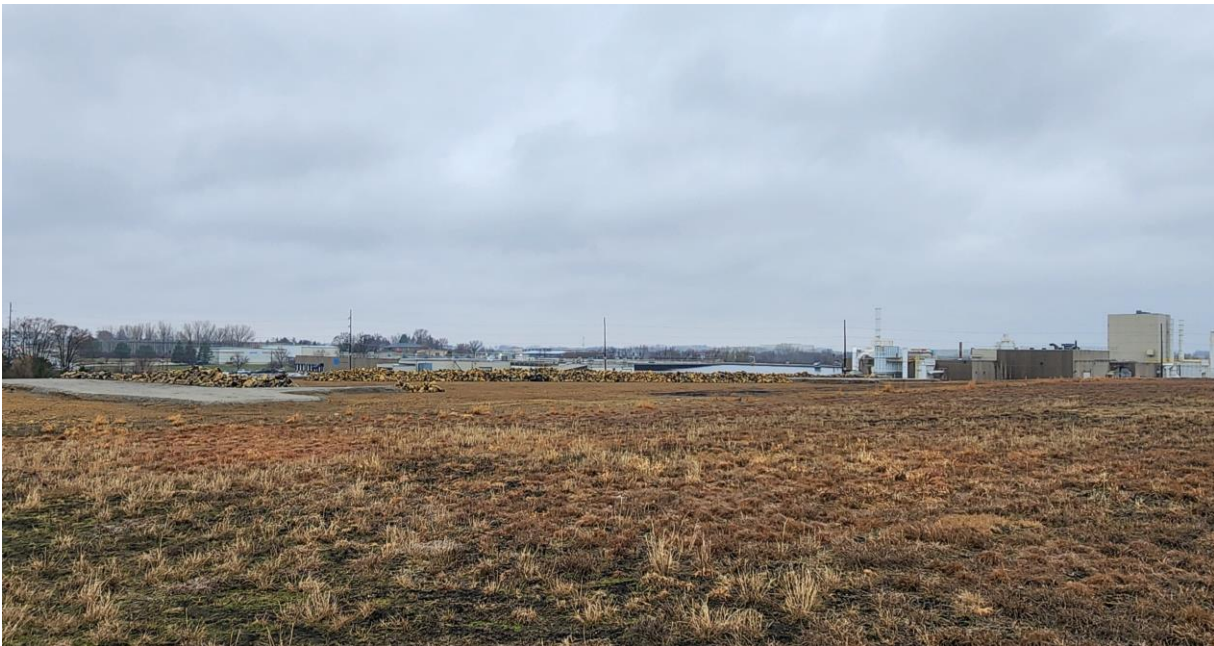
Photo 6. View from northeast corner of the landfill. Looking southwest. Upper portion of new access road visible to the left.
