**RE: SEMI-ANNUAL INSPECTION – SPRING, 2024
JACKSON COUNTY SANITARY LANDFILL
IDNR PERMIT #49-SDP-01-74C - CLOSED
HLW PN 6040-22A.751**

SITE PLAN
 INSPECTION - SPRING 2024
 JACKSON COUNTY SANITARY LANDFILL
 MAQUOKETA, IOWA

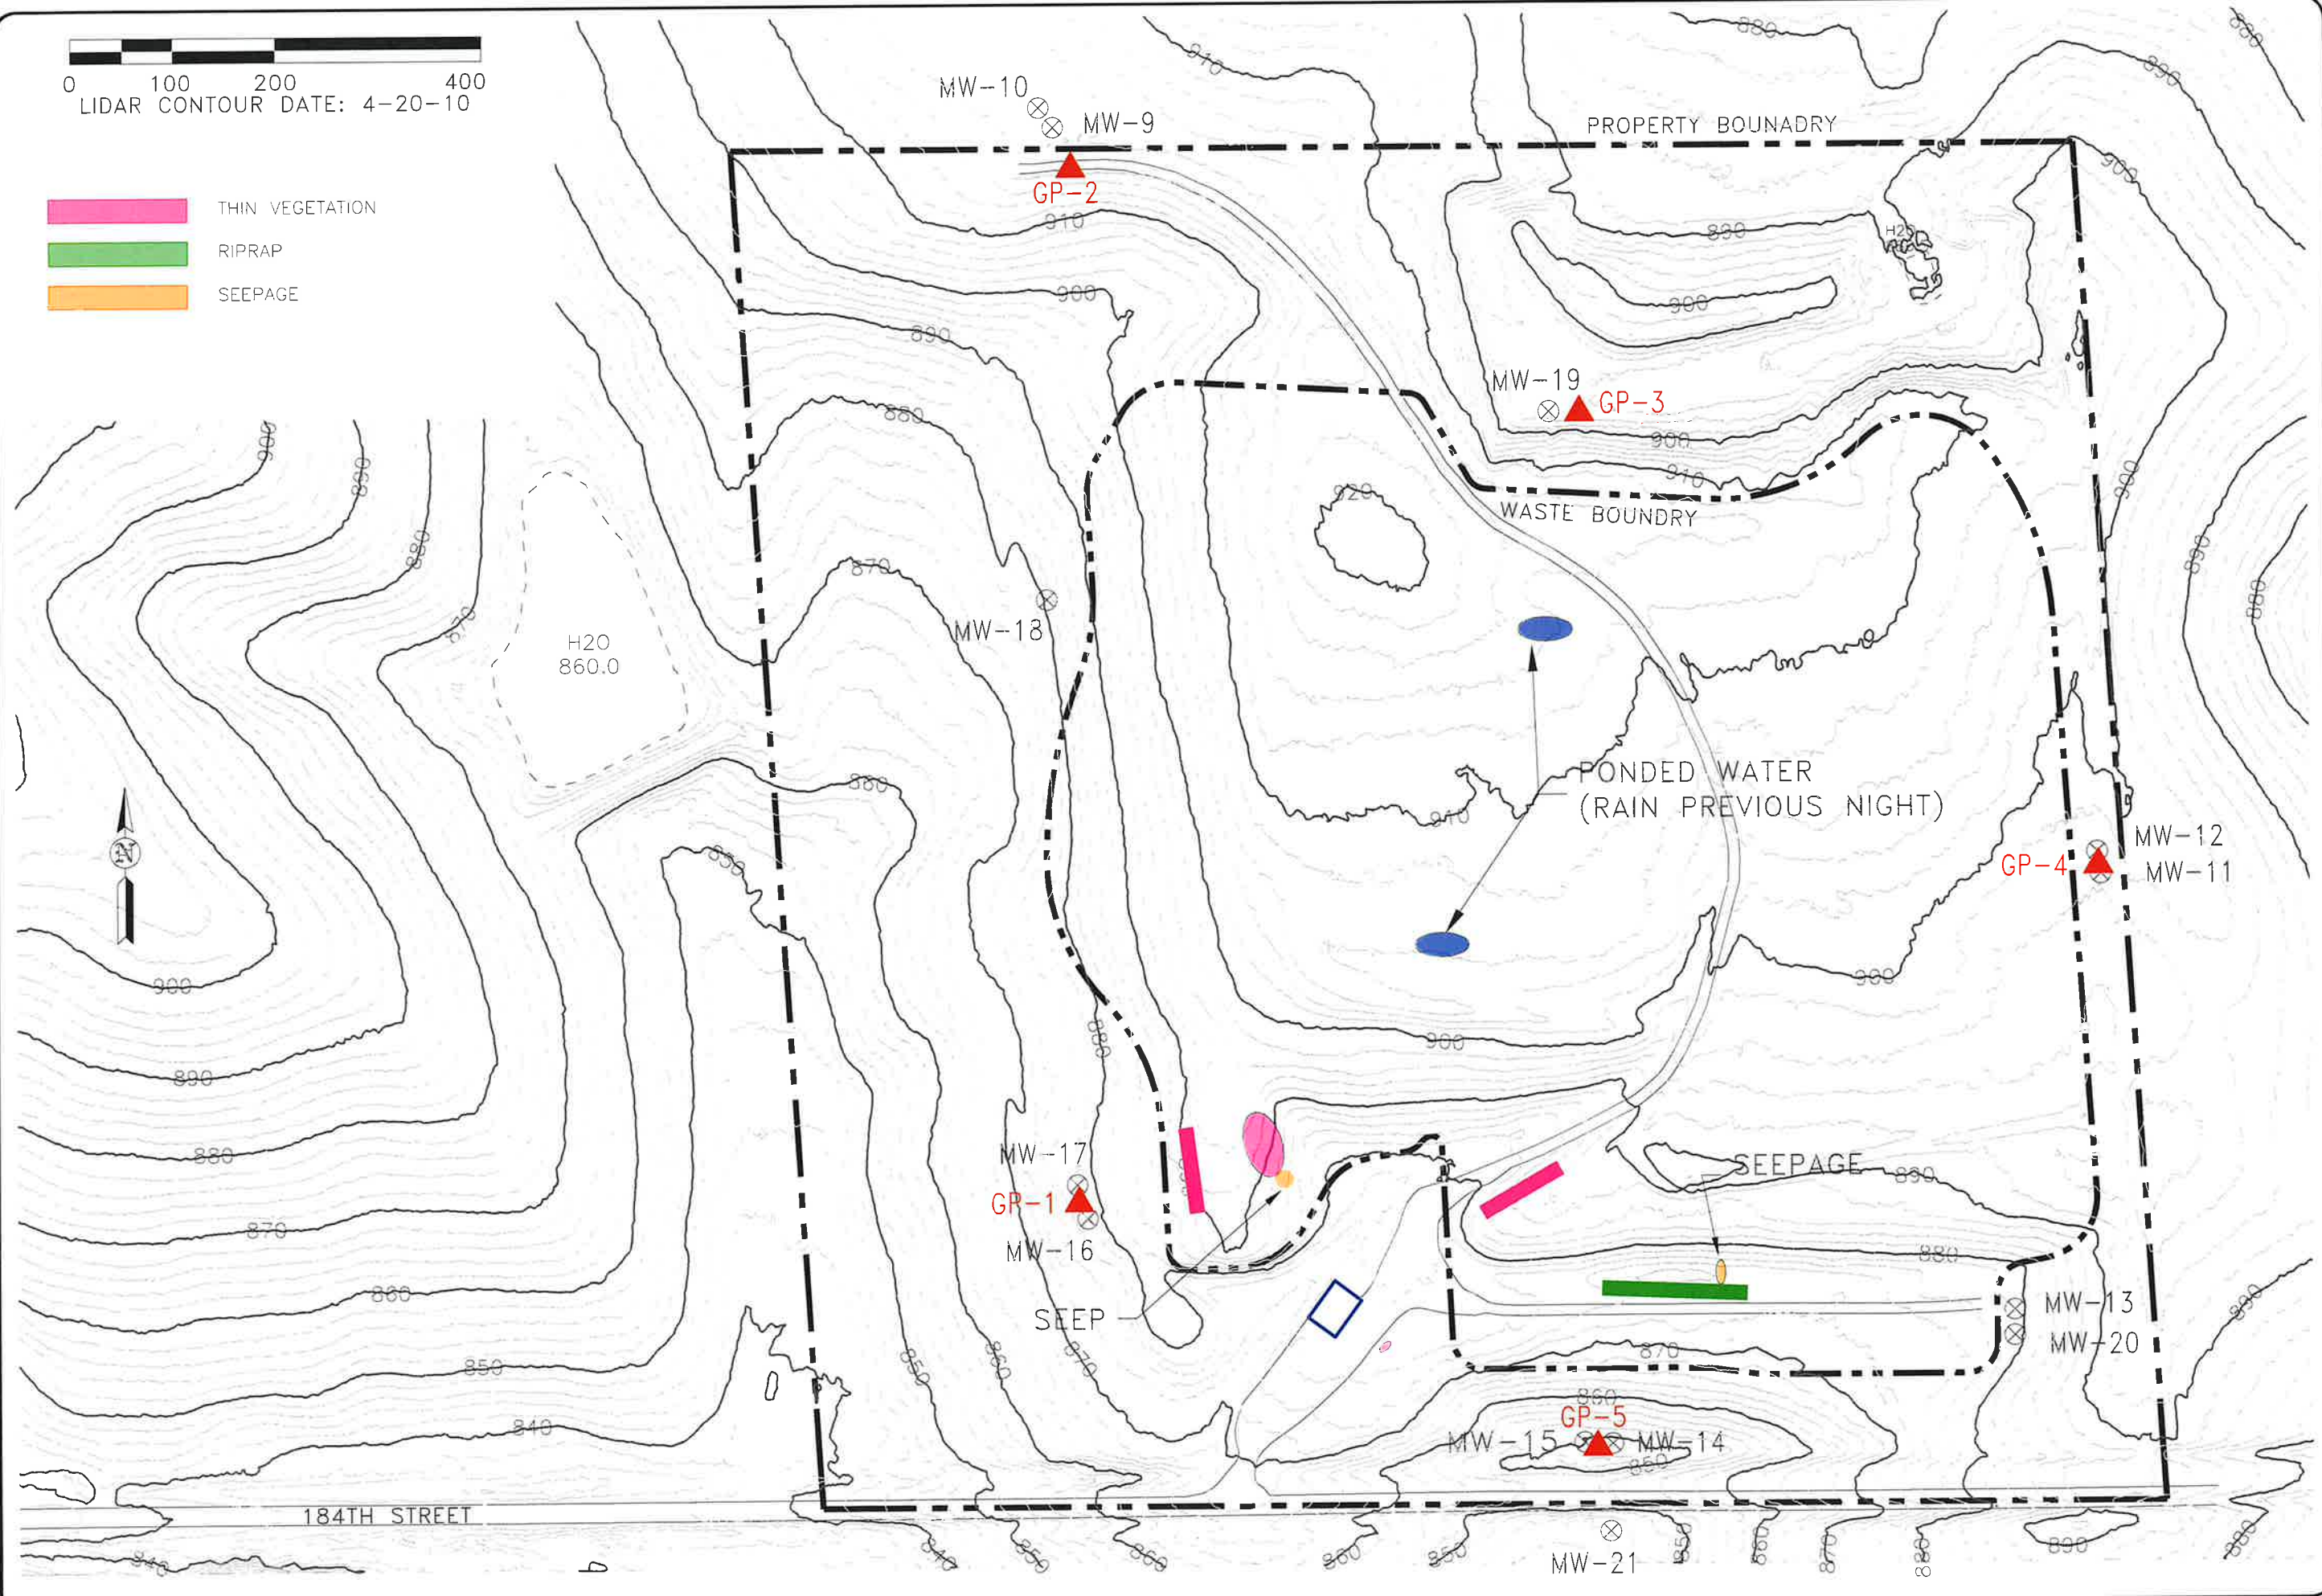
FIGURE: 1

The bare areas previously noted east of GP-1 were reseeded; however, the vegetation remains thin in the reseeded areas and it appears that the seeding was not effective. Other areas of sparse vegetation were also noted during the inspection – these areas are shown on the attached figure and will continue to be monitored during future inspections.

A small potential leachate seep was noted in the immediate vicinity of the rut repairs (120 feet northwest) of the storage shed during the Spring, 2022 inspection. This area was visited during this inspection and was again active.

Areas of surface water ponding were noted during the inspection following the previous night's rain. The vegetation on the cap appears relatively uniform and did not suggest differences in vegetation due to long term ponding in the identified areas (see attached map).

The riprap area at the location of the former leachate seep east of the maintenance building was reviewed. Liquid was noted ponded in the riprap. The riprap has appeared to work well to date in reducing wildlife damage to vegetation in this area. Note that deer have damaged a portion of the slope north of the riprap immediately adjacent to the riprap area at the approximate location shown on the attached figure. Slight flow was noted from this area to the rip-rap area below. The riprap area appears to contain this flow.

1. Install passive gas venting south of GP-3 to limit potential gas migration to the north.
2. Continue to monitor the vegetation damage north of the riprap area for signs of leachate seepage.
3. Continue to monitor the area where the ruts were repaired for signs of leachate seepage.
4. Continue to monitor the riprap in the former seep area east of the maintenance building for evidence of leachate ponding or flow.
5. Continue to monitor the vegetation on the repaired areas east of GP-1. Add shallow vertical vents, topsoil, or soil amendments throughout the area to improve the vegetation as needed.
6. Continue to monitor vegetation and erosion and repair as needed.
