**RE: SEMI-ANNUAL INSPECTION – SPRING, 2024
RURAL IOWA SLF
IDNR PERMIT #42-SDP-1-72P
VERTICAL EXPANSION AREA - CLOSED
HORIZONTAL EXPANSION AREA - ACTIVE
HLW PN 6006-23A.750**

SPRING 2024 INSPECTION

RURAL IOWA SANITARY LANDFILL
ELDORA, IOWA

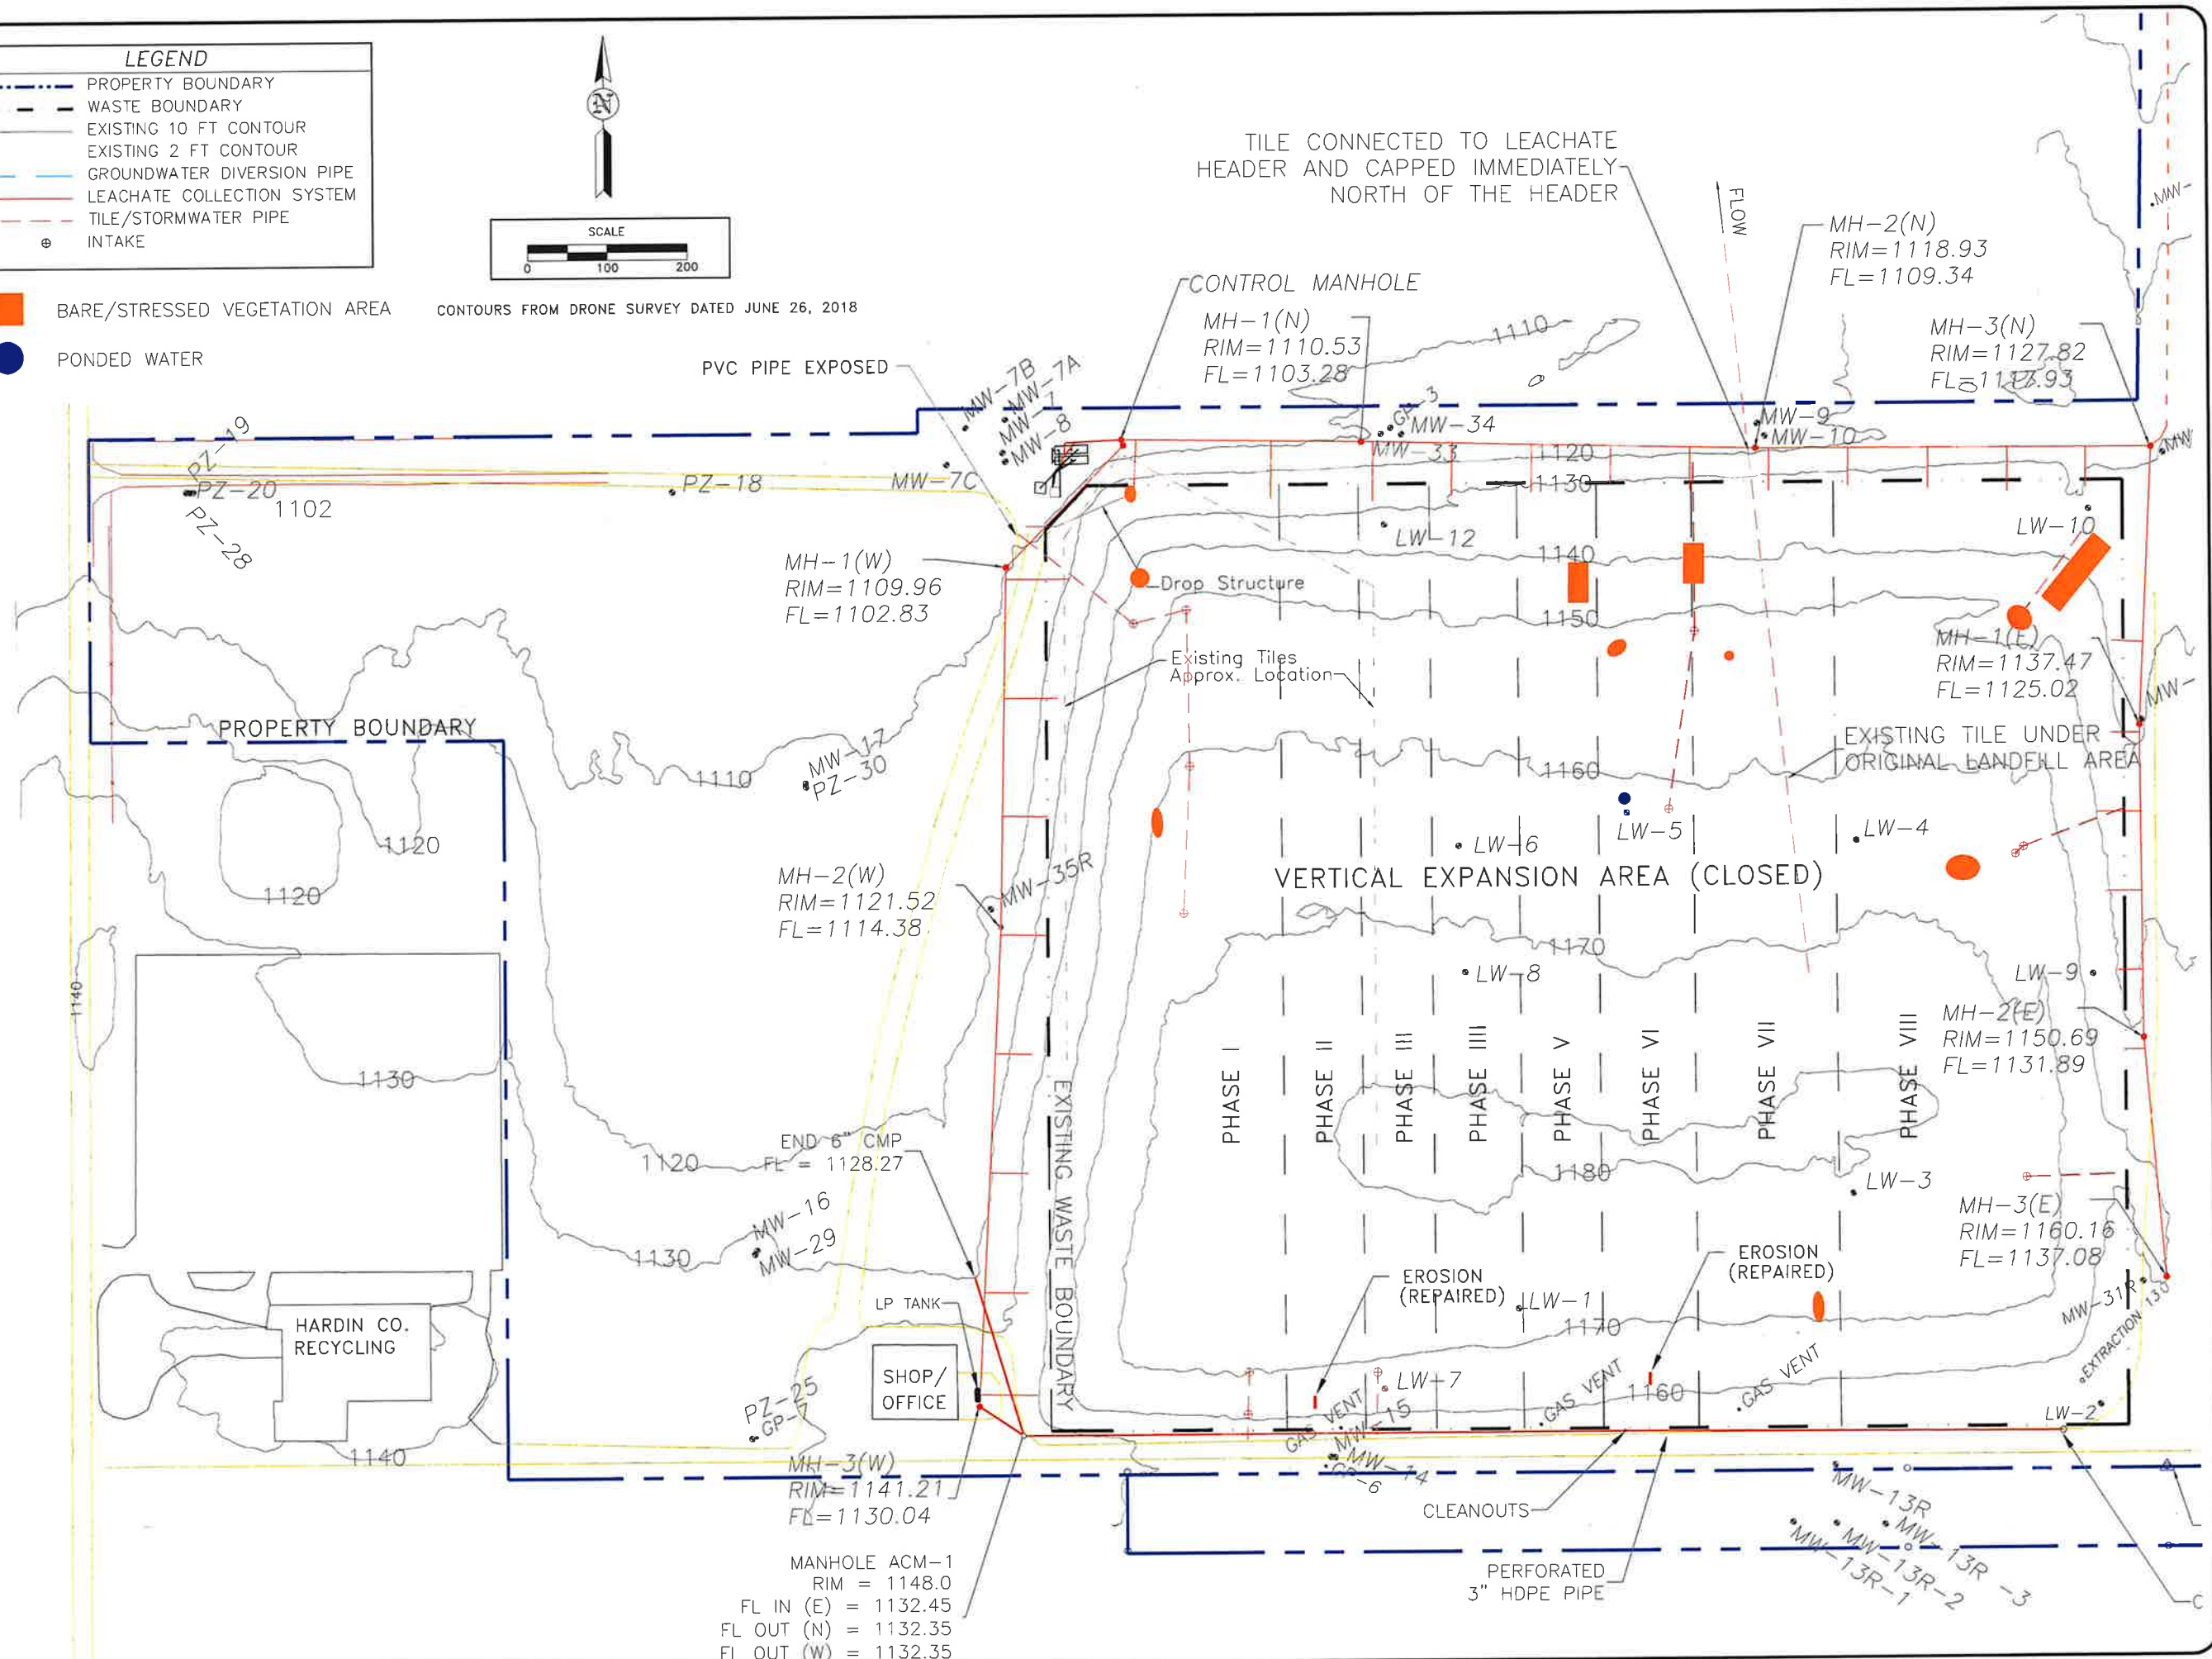
FIGURE: 1	
REVISION	NO.
DRAWN	JGH
PROJECT NO.	6006-23A
DATE	4/26/24

Vegetation is well established on the majority of the Original Landfilling Area although stressed vegetation/bare spots were noted in the areas shown on the attached figure with smaller areas located sporadically on the north slope.

The vegetation and terraces have limited the formation of significant erosion rills. A short segment of one of the terrace pipes was exposed at the toe of the west slope at the approximate location shown on the attached figure. The pipe is still functioning.

One area of ponded water was noted on the cap in the closed area near LW-5. The approximate location of the ponding is shown on the attached figure.

The erosion at the two locations noted on the bottom terrace bench on the south slope during the Spring 2023 inspection have been repaired. The areas were reseeded but vegetation is thin on the repaired areas. The approximate locations are shown on the attached figure.

- BARE/STRESSED VEGETATION AREA
- PONDED WATER

1. Continue to retrieve windblown litter.
2. Collect annual stormwater sample.
3. Add fill as needed to eliminate the ponded area near LW-5.
4. Repair/replace outlet pipe in lower sediment basin.
5. Monitor areas of soil staining noted on the intermediate cover on the east slope of Trench 3 for leachate seepage. Restore the intermediate cover at the completion of the Trench 3 Phase 2 Expansion project.
6. Cover the exposed terrace pipe.
7. Seed the bare/thin areas on the closure cap.
8. Continue removal of silt fence posts in areas where vegetation is well established.
9. Continue tree removal as needed, monitor stumps for regrowth, and treat stumps as needed.
10. Monitor level of sediment in sediment basins, ditch checks, and other sediment control structures and remove sediment as needed to maintain capacity.
