RE: Spring 2024 Biennial Inspection Report; Franklin County Sanitary Landfill;
Permit #35-SDP-01-76C; MER #9044

BIENNIAL INSPECTION REPORT - SPRING 2024

CLOSED FRANKLIN COUNTY SANITARY LANDFILL

PERMIT #35-SDP-01-76C;

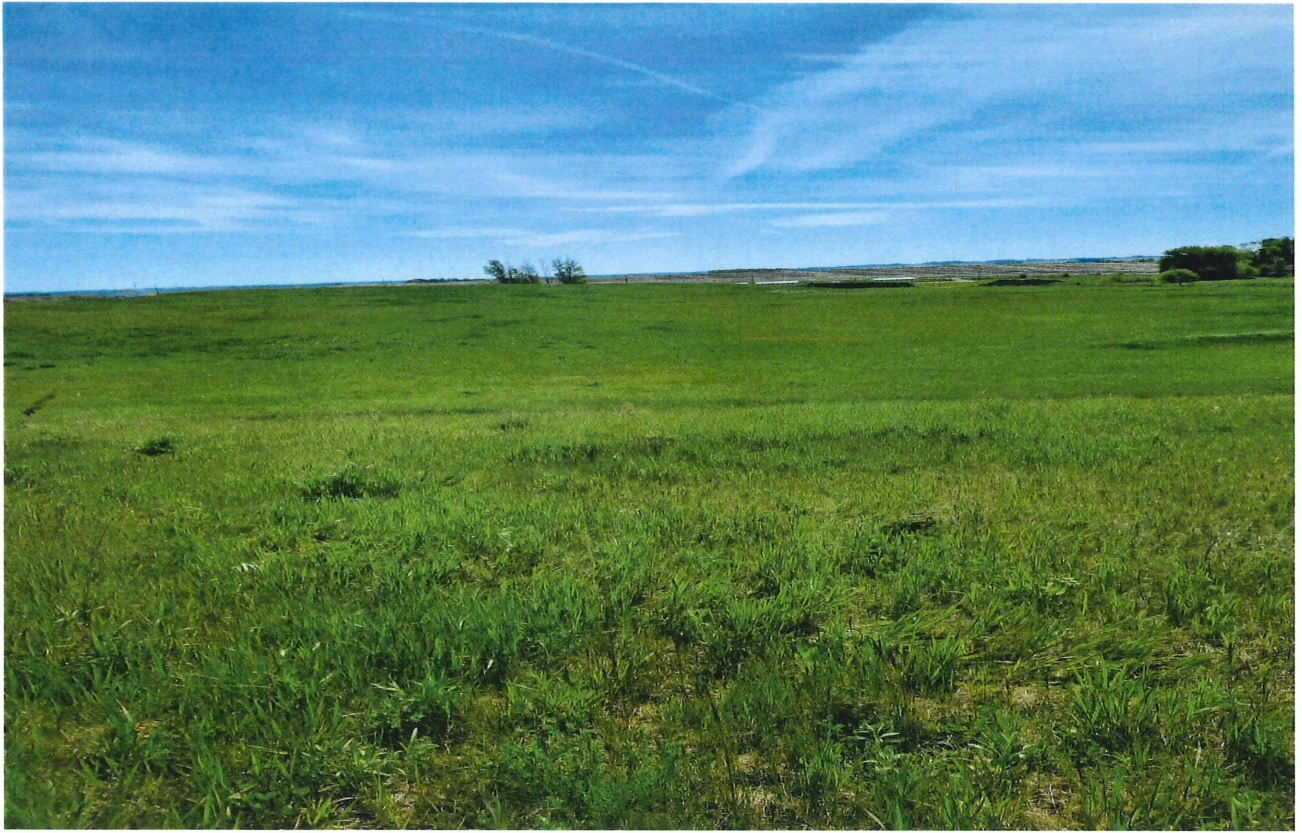
East View of East Waste Pile – May 10, 2024

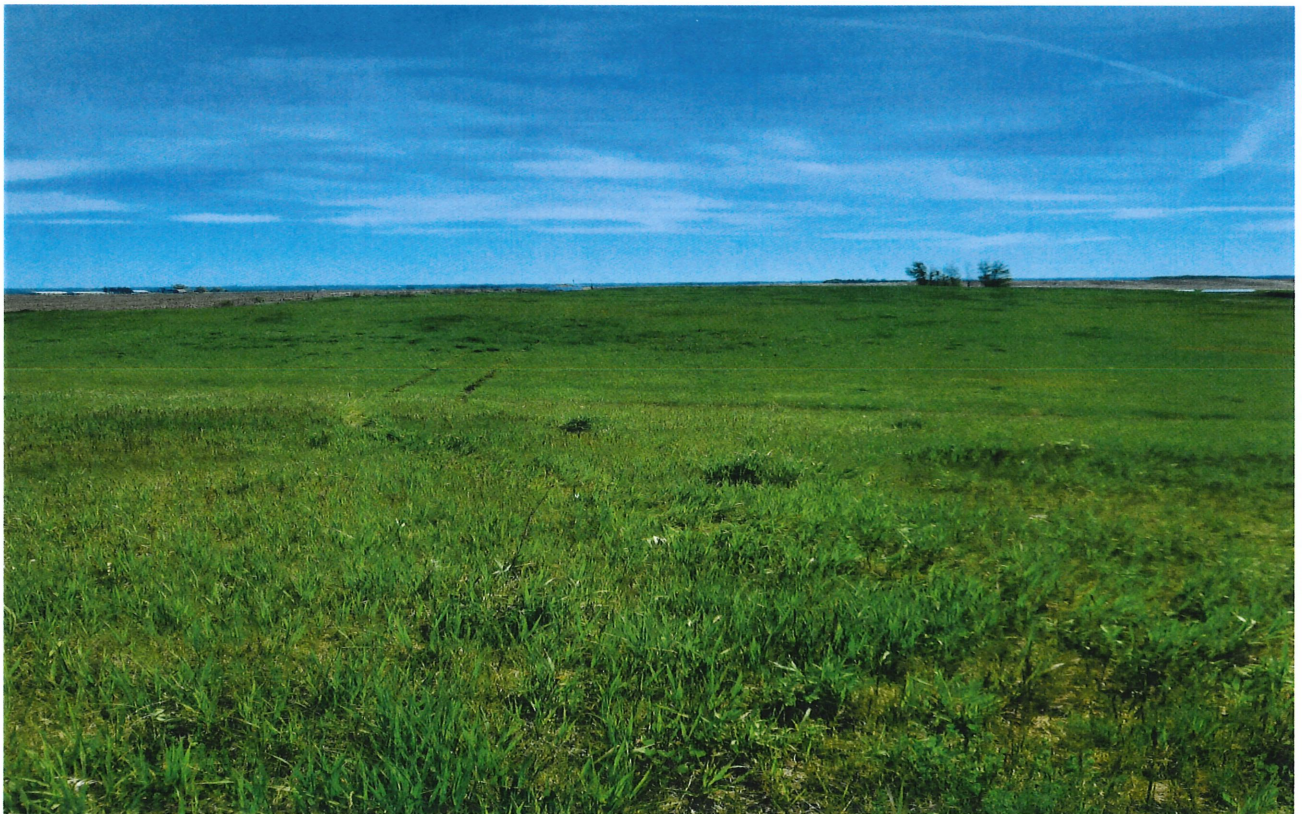
East View of East Waste Pile – May 10, 2024

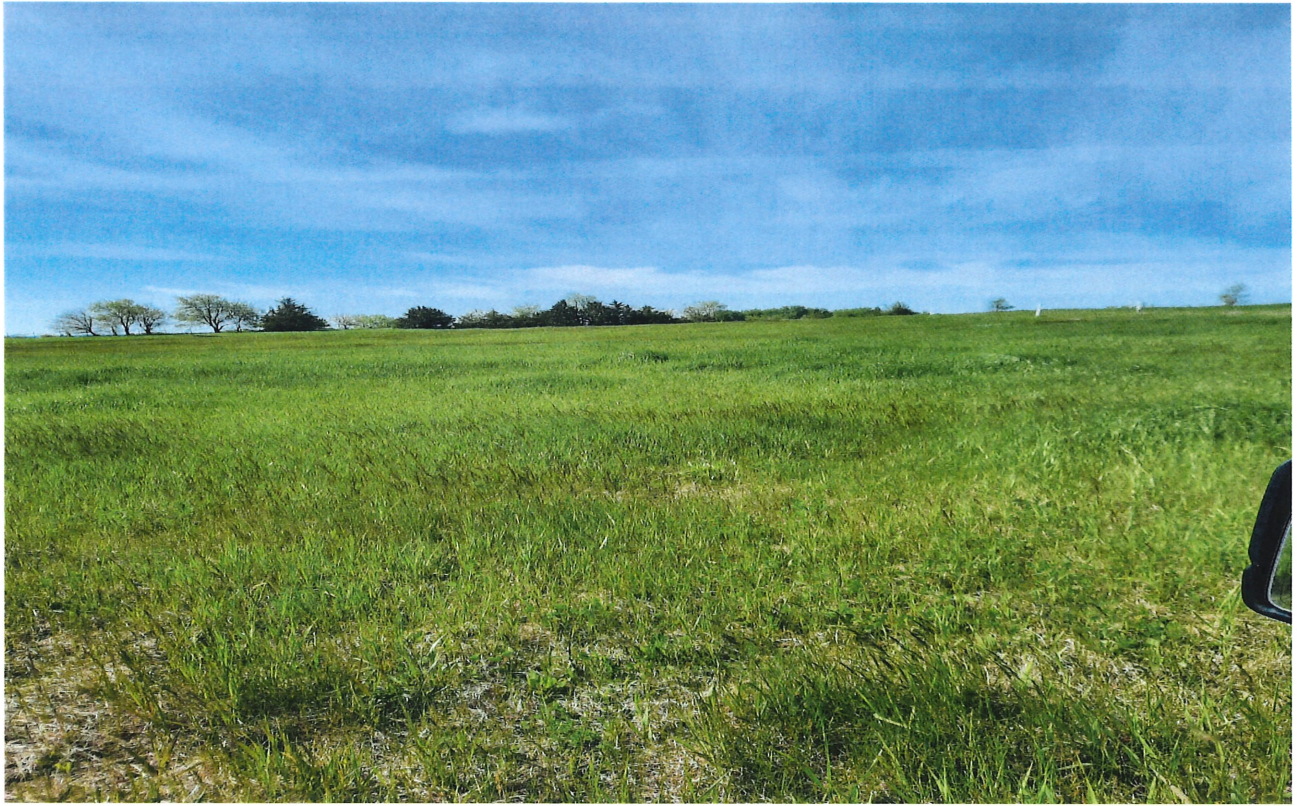
View of West Waste Pile Looking North Towards the Let Down Structure – May 10, 2024

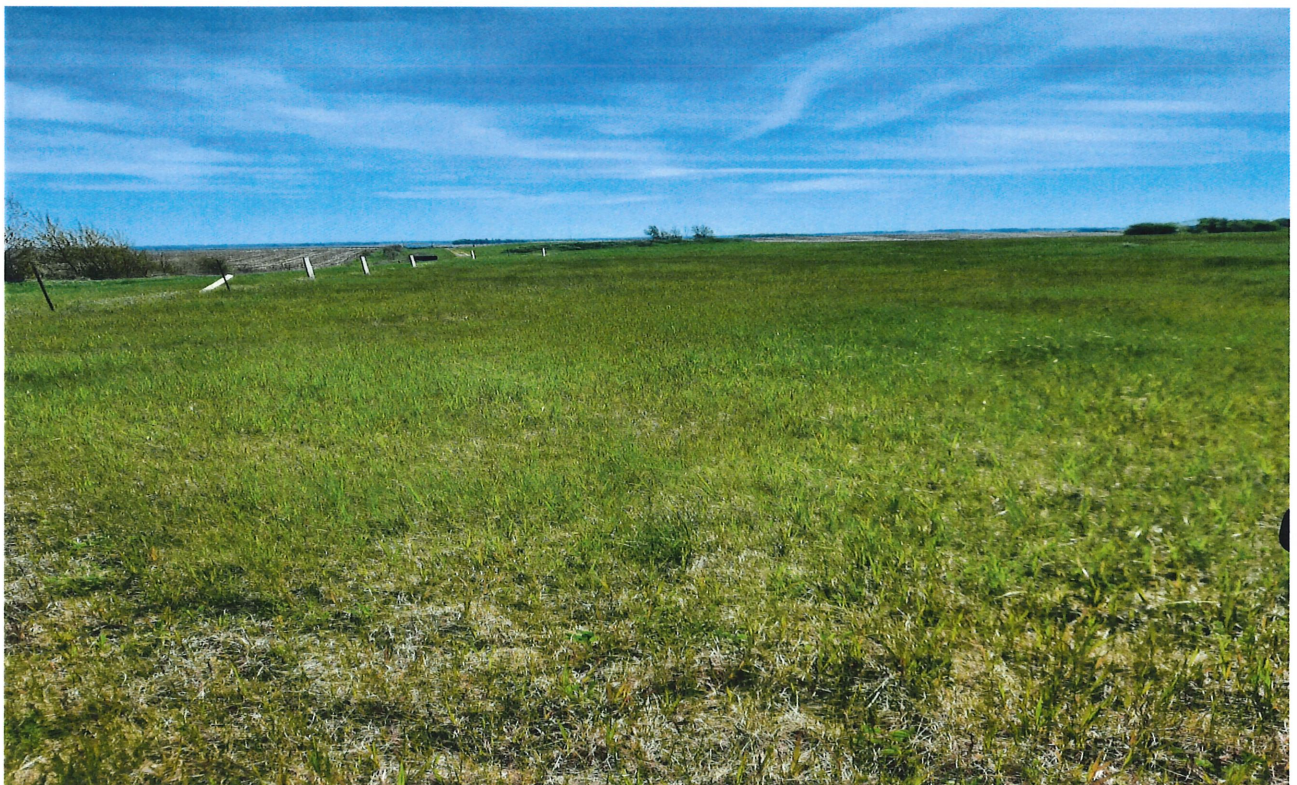
View of West Waste Pile Looking East Towards the Let Down Structure – May 10, 2024

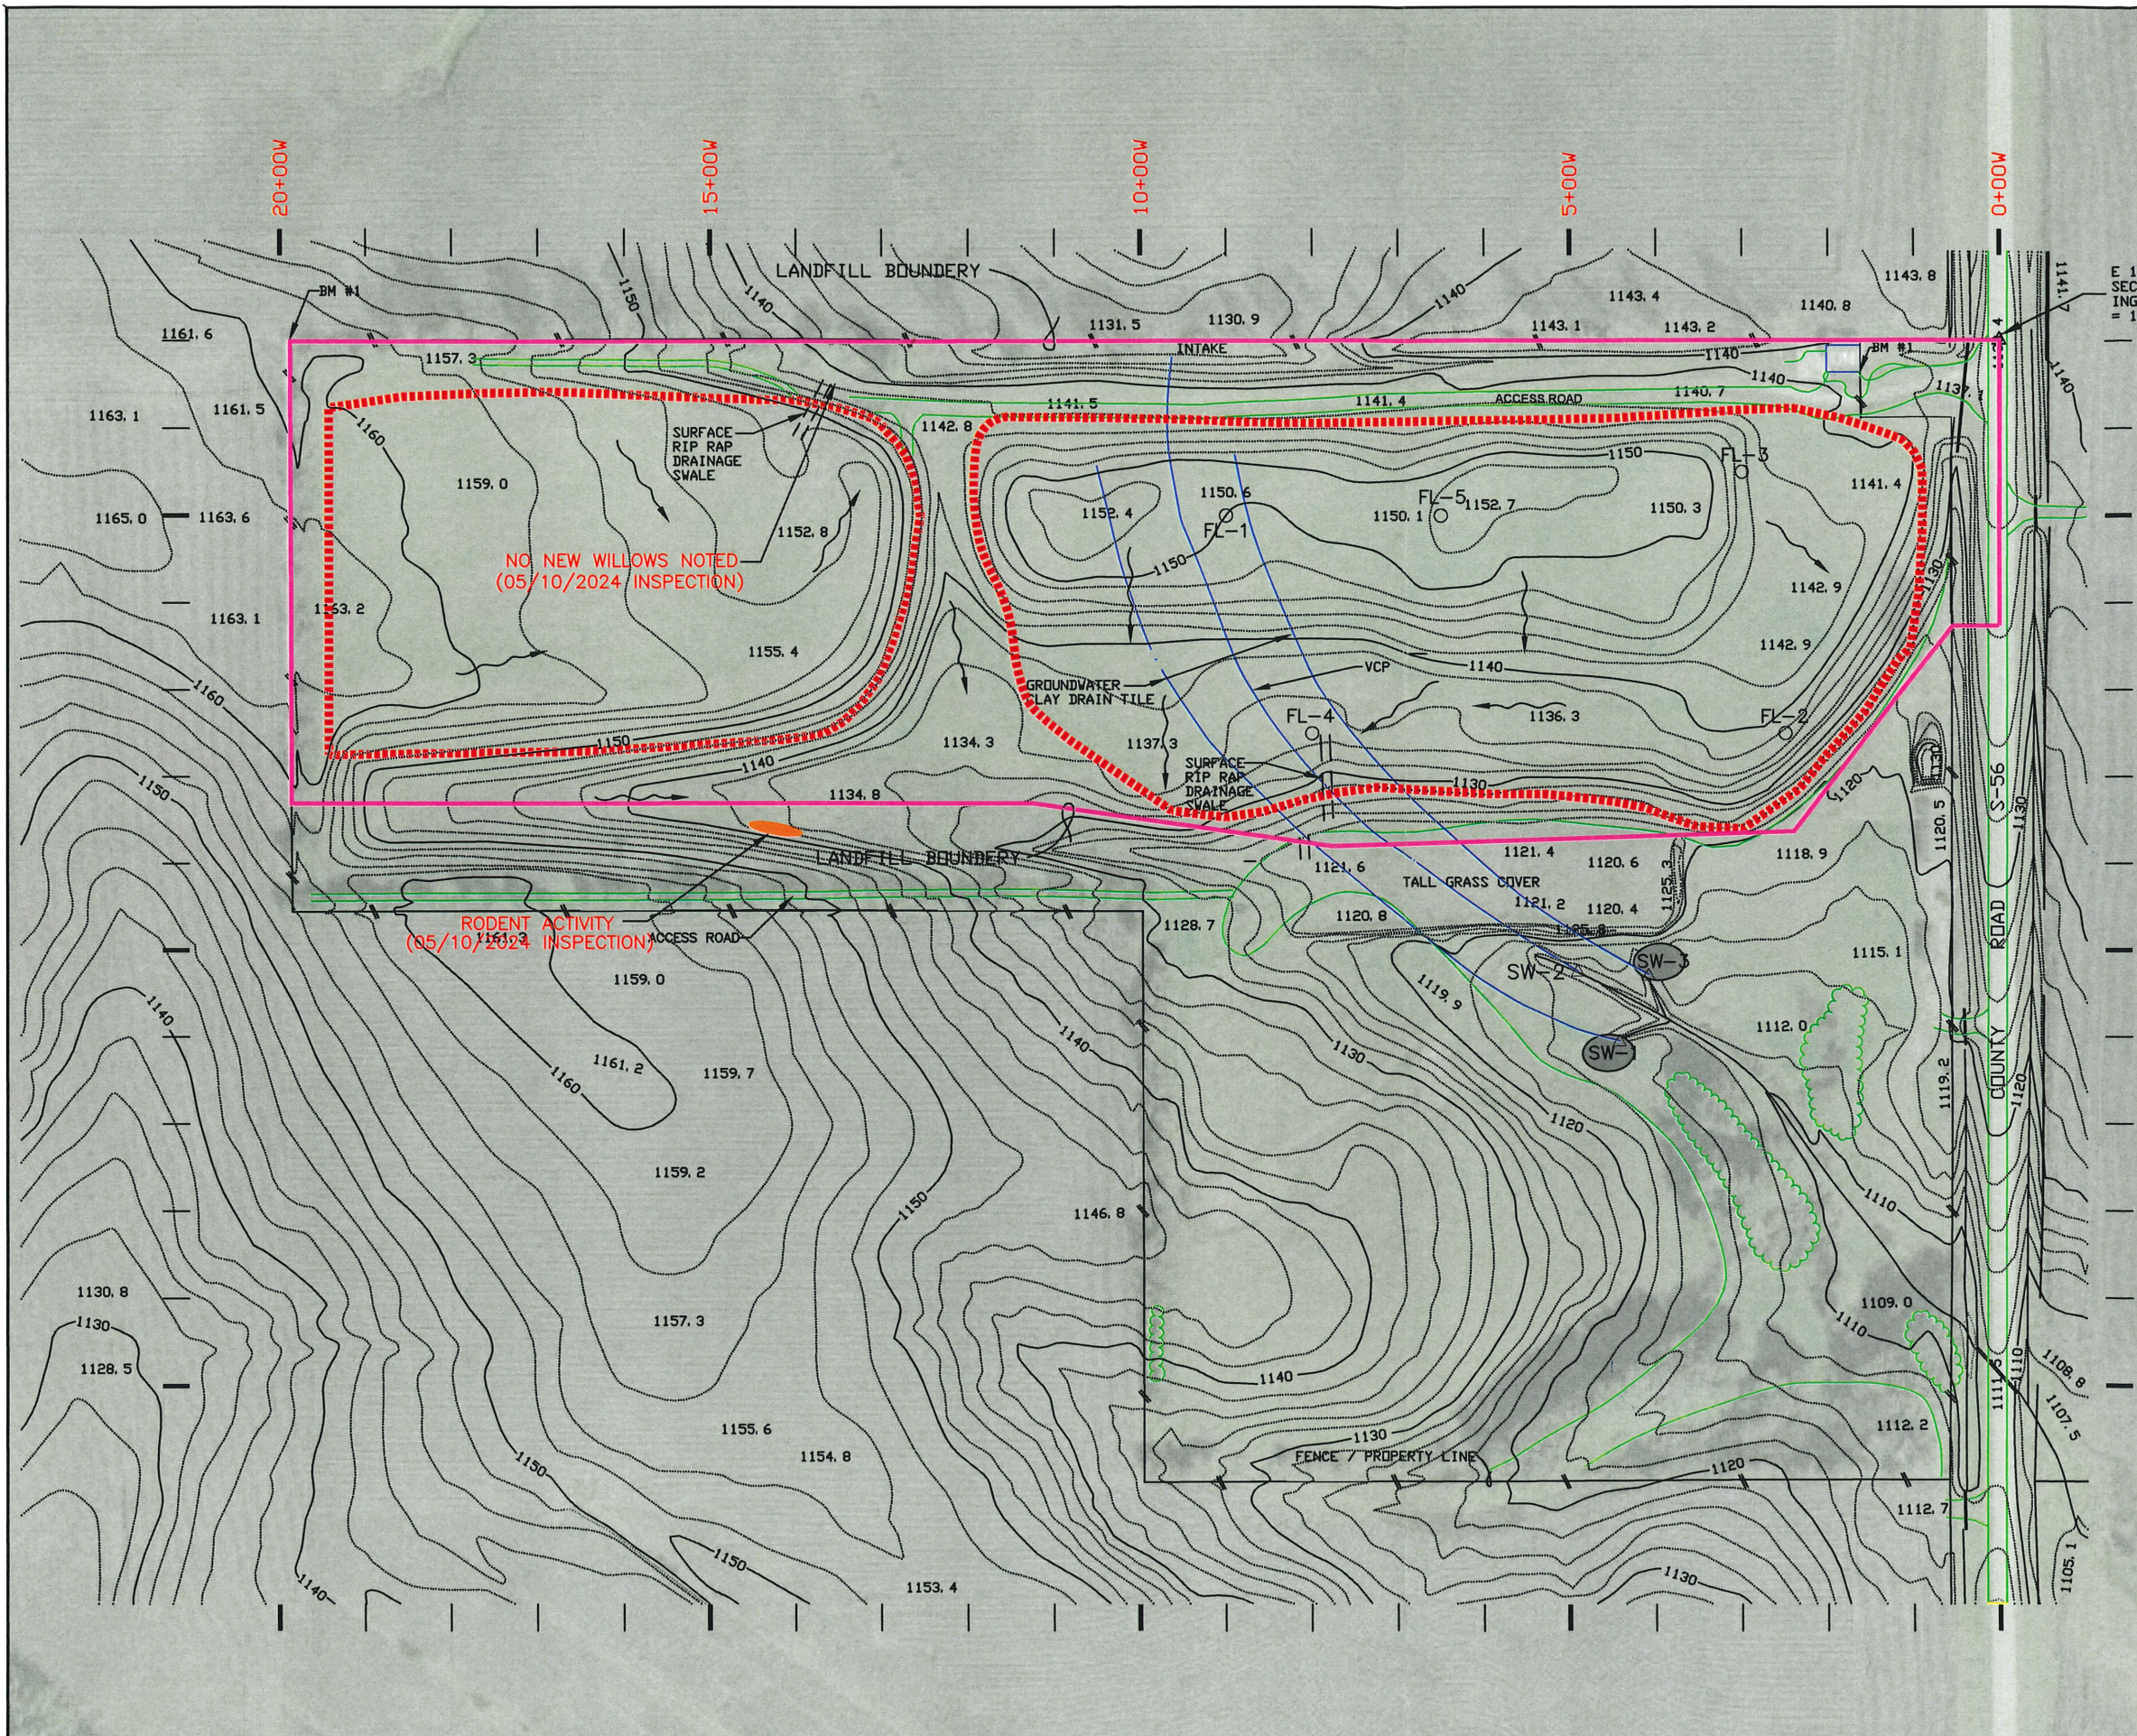
**SITE PLAT - 2024 BIENNIAL INSPECTION
 FRANKLIN COUNTY SANITARY LANDFILL**

Two points of interest were noted during this inspection. There was no new willow growth noted in the area reported in the 2022 inspection. There was no new vector (rodent) activity noted over any of the capped solid waste. There was one small area where new rodent activity was noted to the south of the site boundary. This rodent activity was located south of the west waste pile. The rodent activity location is shown on the current site inspection plat.

2g – Rodent activity was noted to the south of the buried waste pile boundary. There was no rodent activity noted over buried solid waste. (See the Inspection Plat for location of current activity)

NO NEW WILLOWS NOTED
(05/10/2024 INSPECTION)

RODENT ACTIVITY
(05/10/2024 INSPECTION)

Franklin County will continue to monitor for deep rooted or woody plants. Franklin County will continue monitor and treat the site to eradicate the rodent problem. Franklin County will continue to monitor the site periodically and repair / eliminate any problems as they occur.
