Alternative Source Demonstration: Nickel - Addendum

Metro Waste Authority
Metro Park East
Former Constructed Wetlands Treatment
System

Permit No. 77-SDP-01-72P

Submittal Date: June 26, 2024

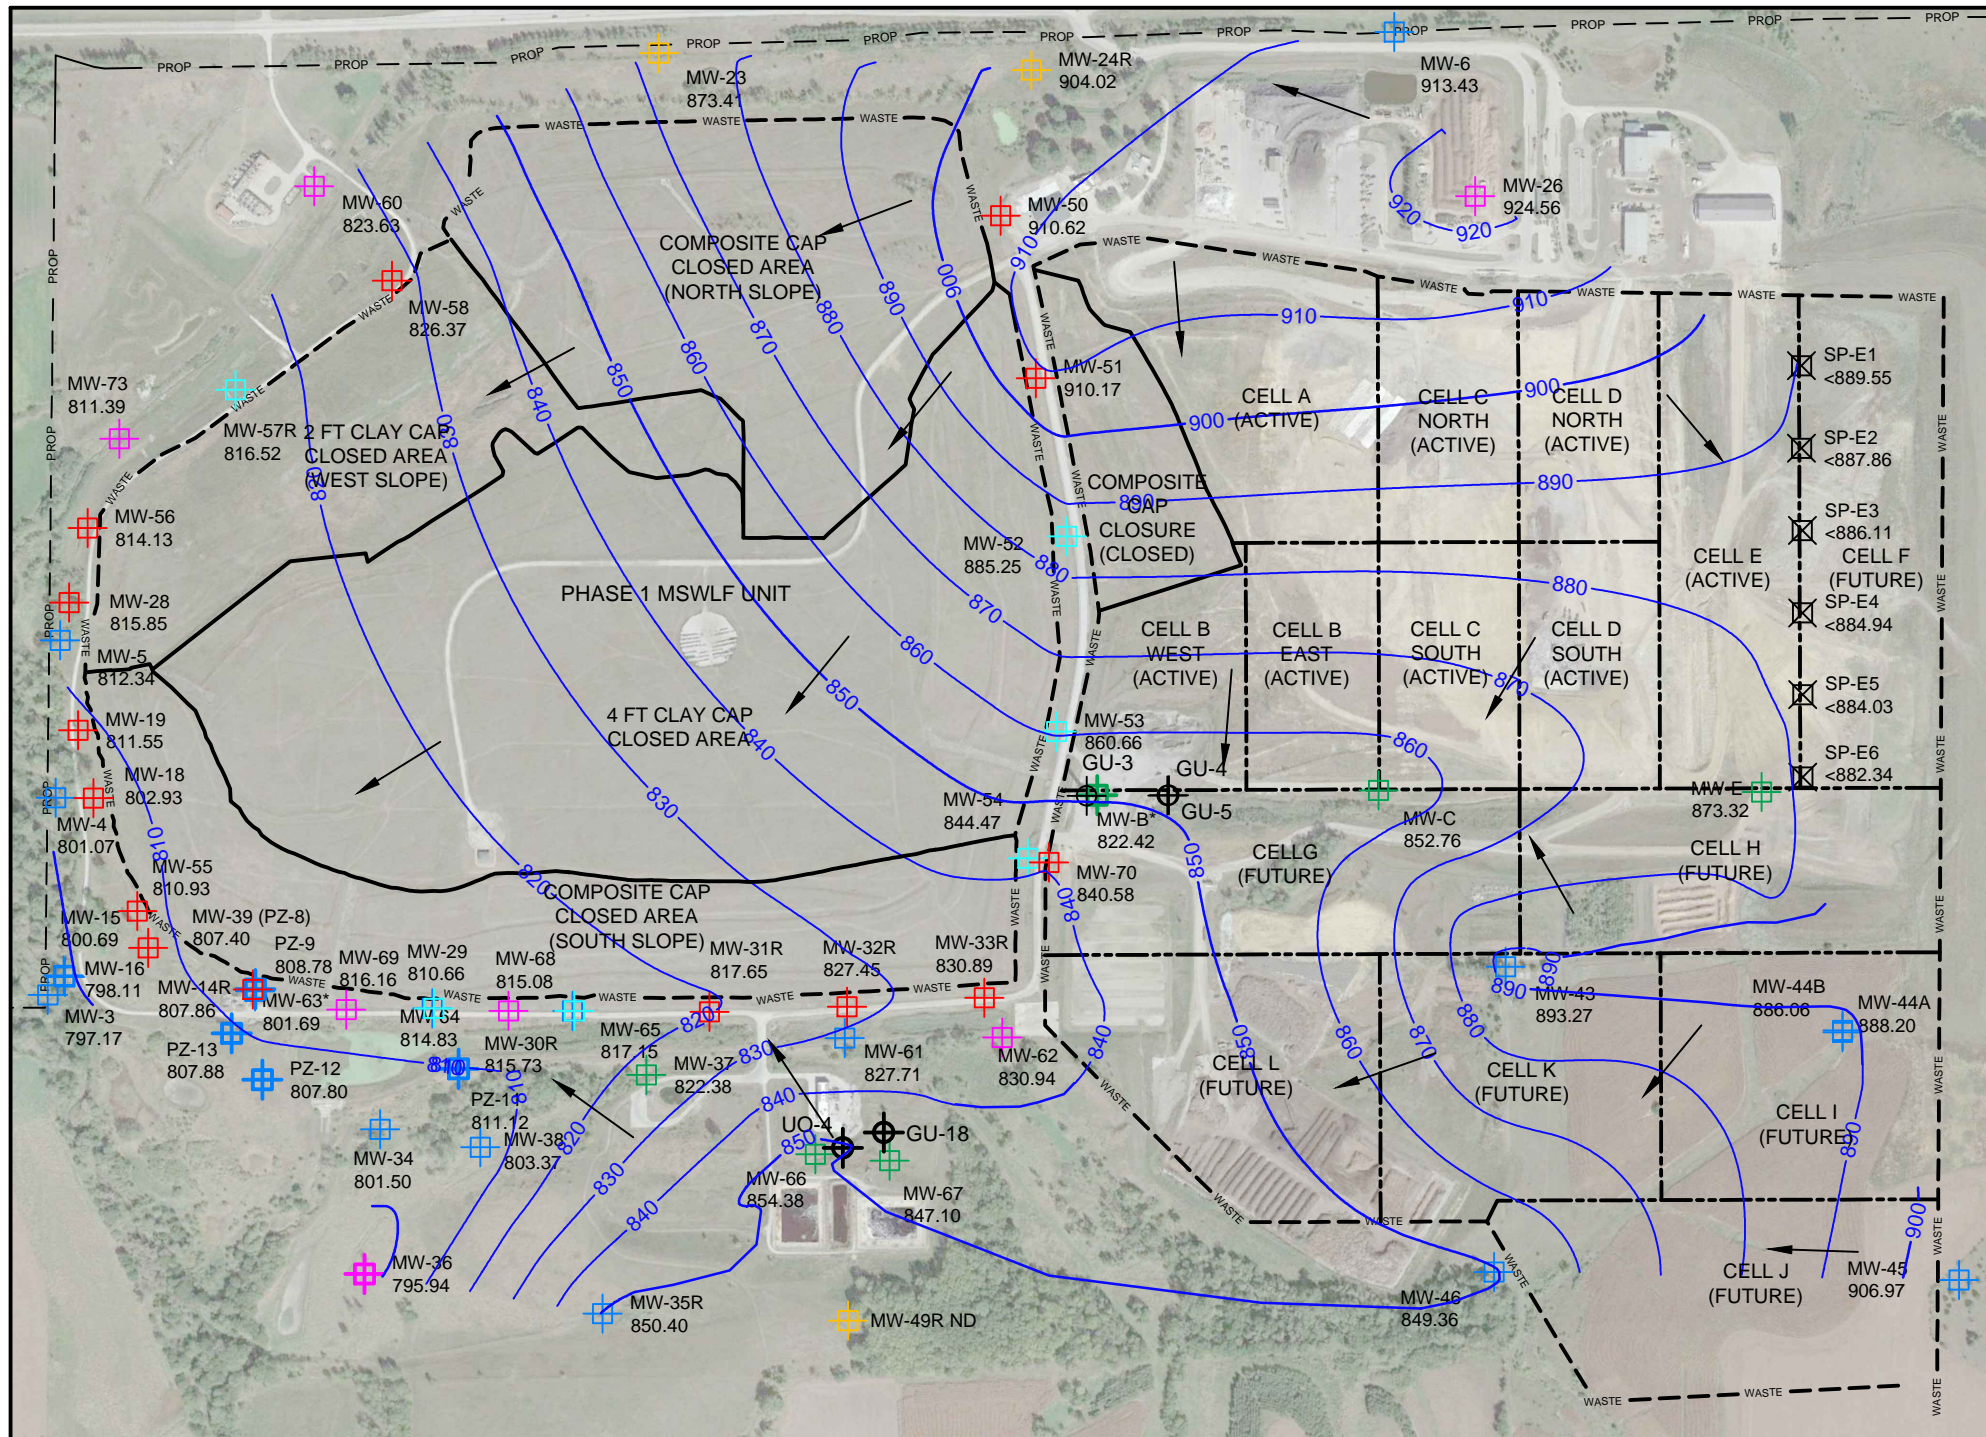
SEPTEMBER 2023 GROUNDWATER CONTOURS

Historical groundwater flow direction has been to the northwest in the area of the CWTS and monitoring well MW-66. This is depicted on **Figure 2, Attachment A** for the September 2023 groundwater monitoring event at the site. Based on the groundwater elevations calculated for monitoring wells MW-66 and MW-31R during the September 2023 monitoring event, the horizontal groundwater hydraulic gradient is 0.0567 feet of groundwater elevation per foot of horizontal distance (ft/ft). As detailed in the 2020 MSW Landfill Permit Renewal Application dated September 2020, horizontal hydraulic conductivity in glacial till sediments near the CWTS portion of the facility is approximately 2.36×10^{-4} centimeters per second (cm/sec) which is equivalent to approximately 0.669 feet per day (ft/day). The bulk horizontal flow velocity is calculated via the following equation:

Based on the September 2023 calculated hydraulic gradient and the in situ hydraulic conductivity measured at monitoring wells at the site, the bulk horizontal flow velocity is approximately 0.0379 ft/day.

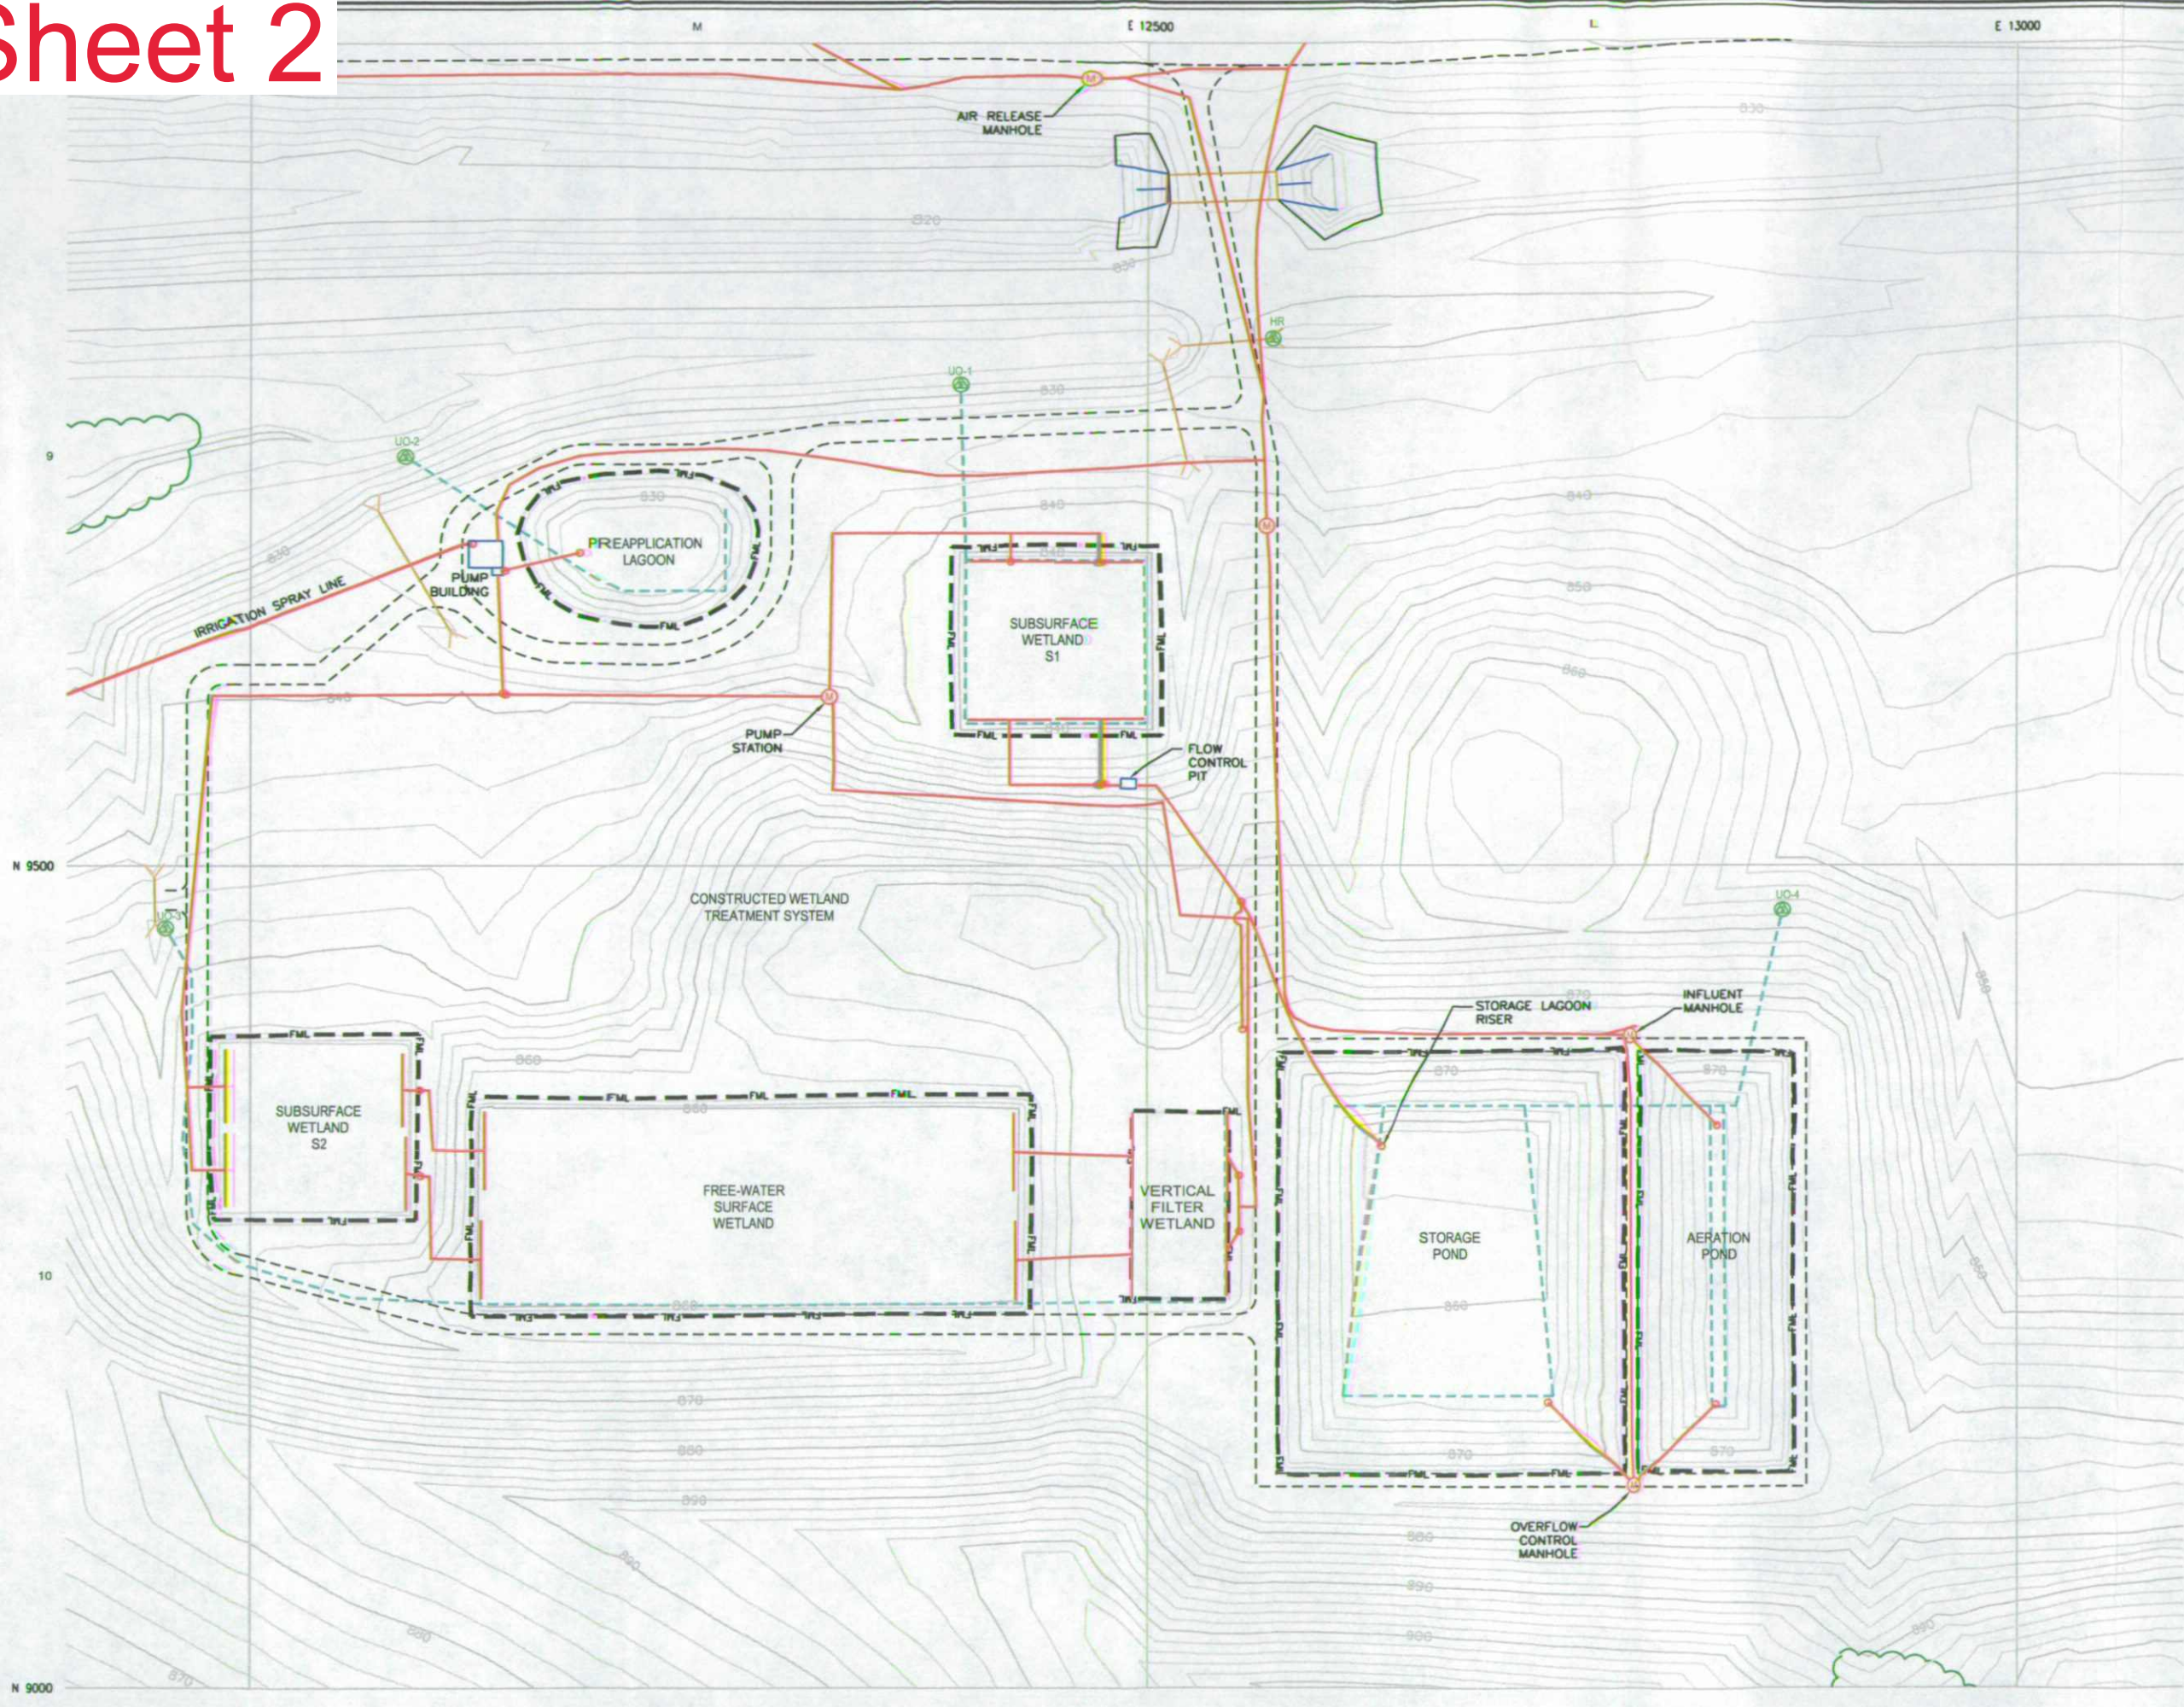
**CWTS
SITE MAP**

Based on the information provided in the Response Activities Report (Document No. 21277), dated March 30, 2001, during a routine semiannual inspection of the CWTS on March 9, 2001, the flow at the outlet for groundwater underdrain UO-4 was more than expected. Groundwater underdrain UO-4 is installed beneath the aeration and storage ponds for the former CWTS. The locations of the aeration and storage ponds at the CWTS site and other general site features during the March 2001 release are depicted on **Sheet 1** and **Sheet 2, Attachment B**. MWA personnel installed a pumping system at the UO-4 outlet and directed fluid back into the storage lagoon. The underdrain was scoped via a camera and sewer dyes were used to locate the leak in the lagoon liner. Personnel investigating the release concluded the source was the pipe boot on the effluent line in the storage lagoon. It was believed that ice formed in the pond and bonded to the 24-inch corrugated riser pipe. The lagoon level rose which caused the ice to rise. The bonded ice to the riser pipe caused the effluent piping to rise up and eventually cause a failure on the liner. **Sheet 3, Attachment B** indicates the approximate location of the torn liner and the identified release from the pond.

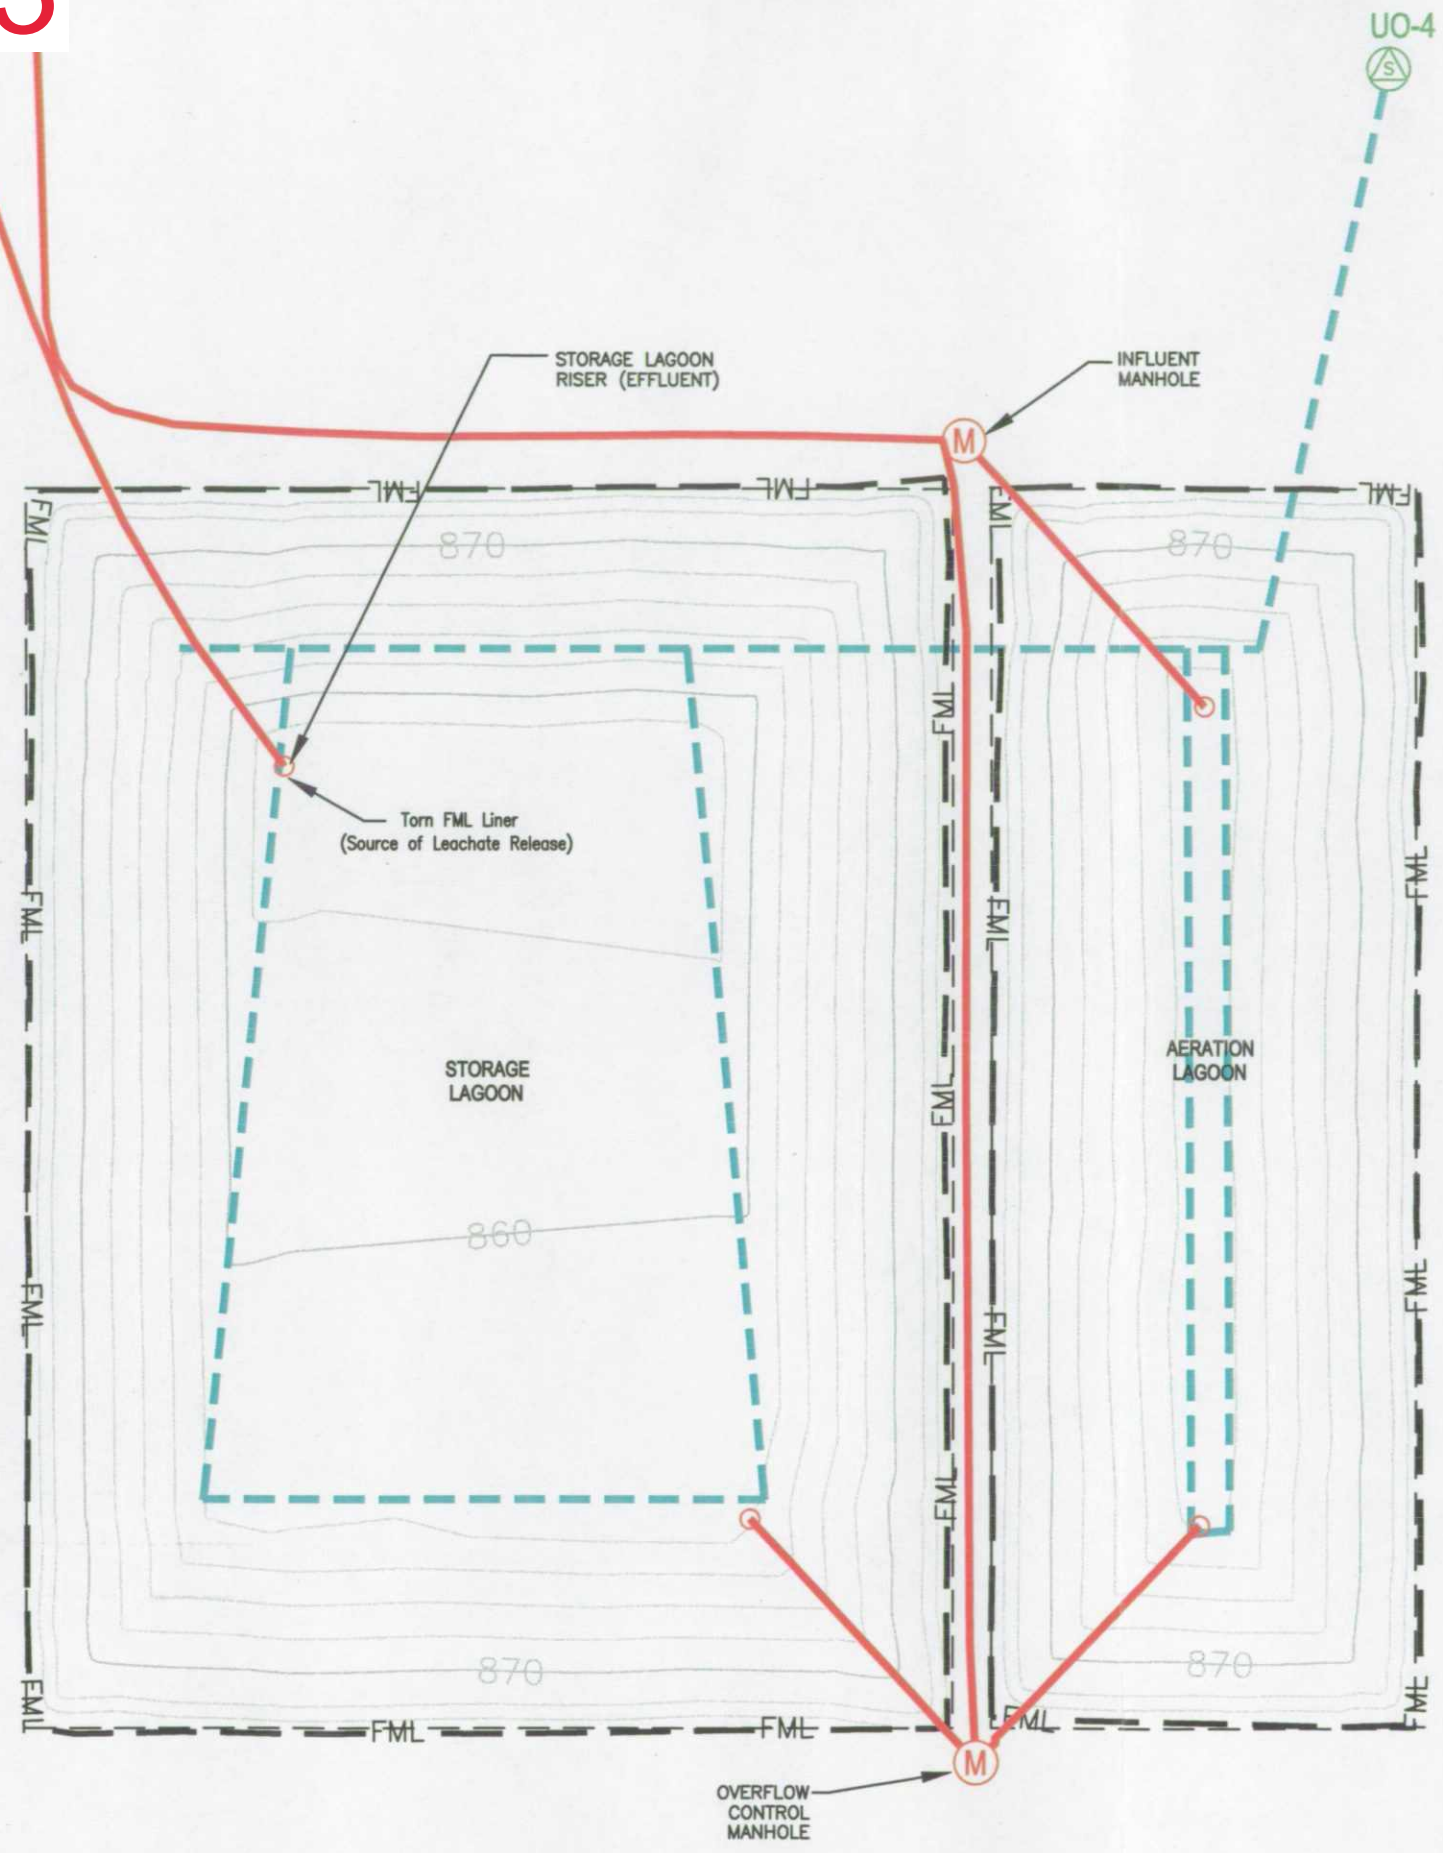
LEACHATE ROUTE

As noted in the Liner Repair Activities (Document No. 55826), dated October 22, 2001, a tear was observed in the boot around the leachate discharge pipe and a small channel was eroded through the underlying clay liner until it intersected with the underlying groundwater underdrain system. This direct connection caused fluid from the pond to enter the underdrain system which flowed and discharged out at UO-4. Since the underdrain system consists of perforated pipe and coarse drainage material encompassing the pipe, the fluid may have infiltrated into subsurface soils immediately adjacent to portions of the underdrain system prior to discharging at the UO-4 outlet.

Repair activities were conducted on the lagoon liner and pipe boot. Repair activities were completed on September 21, 2001.

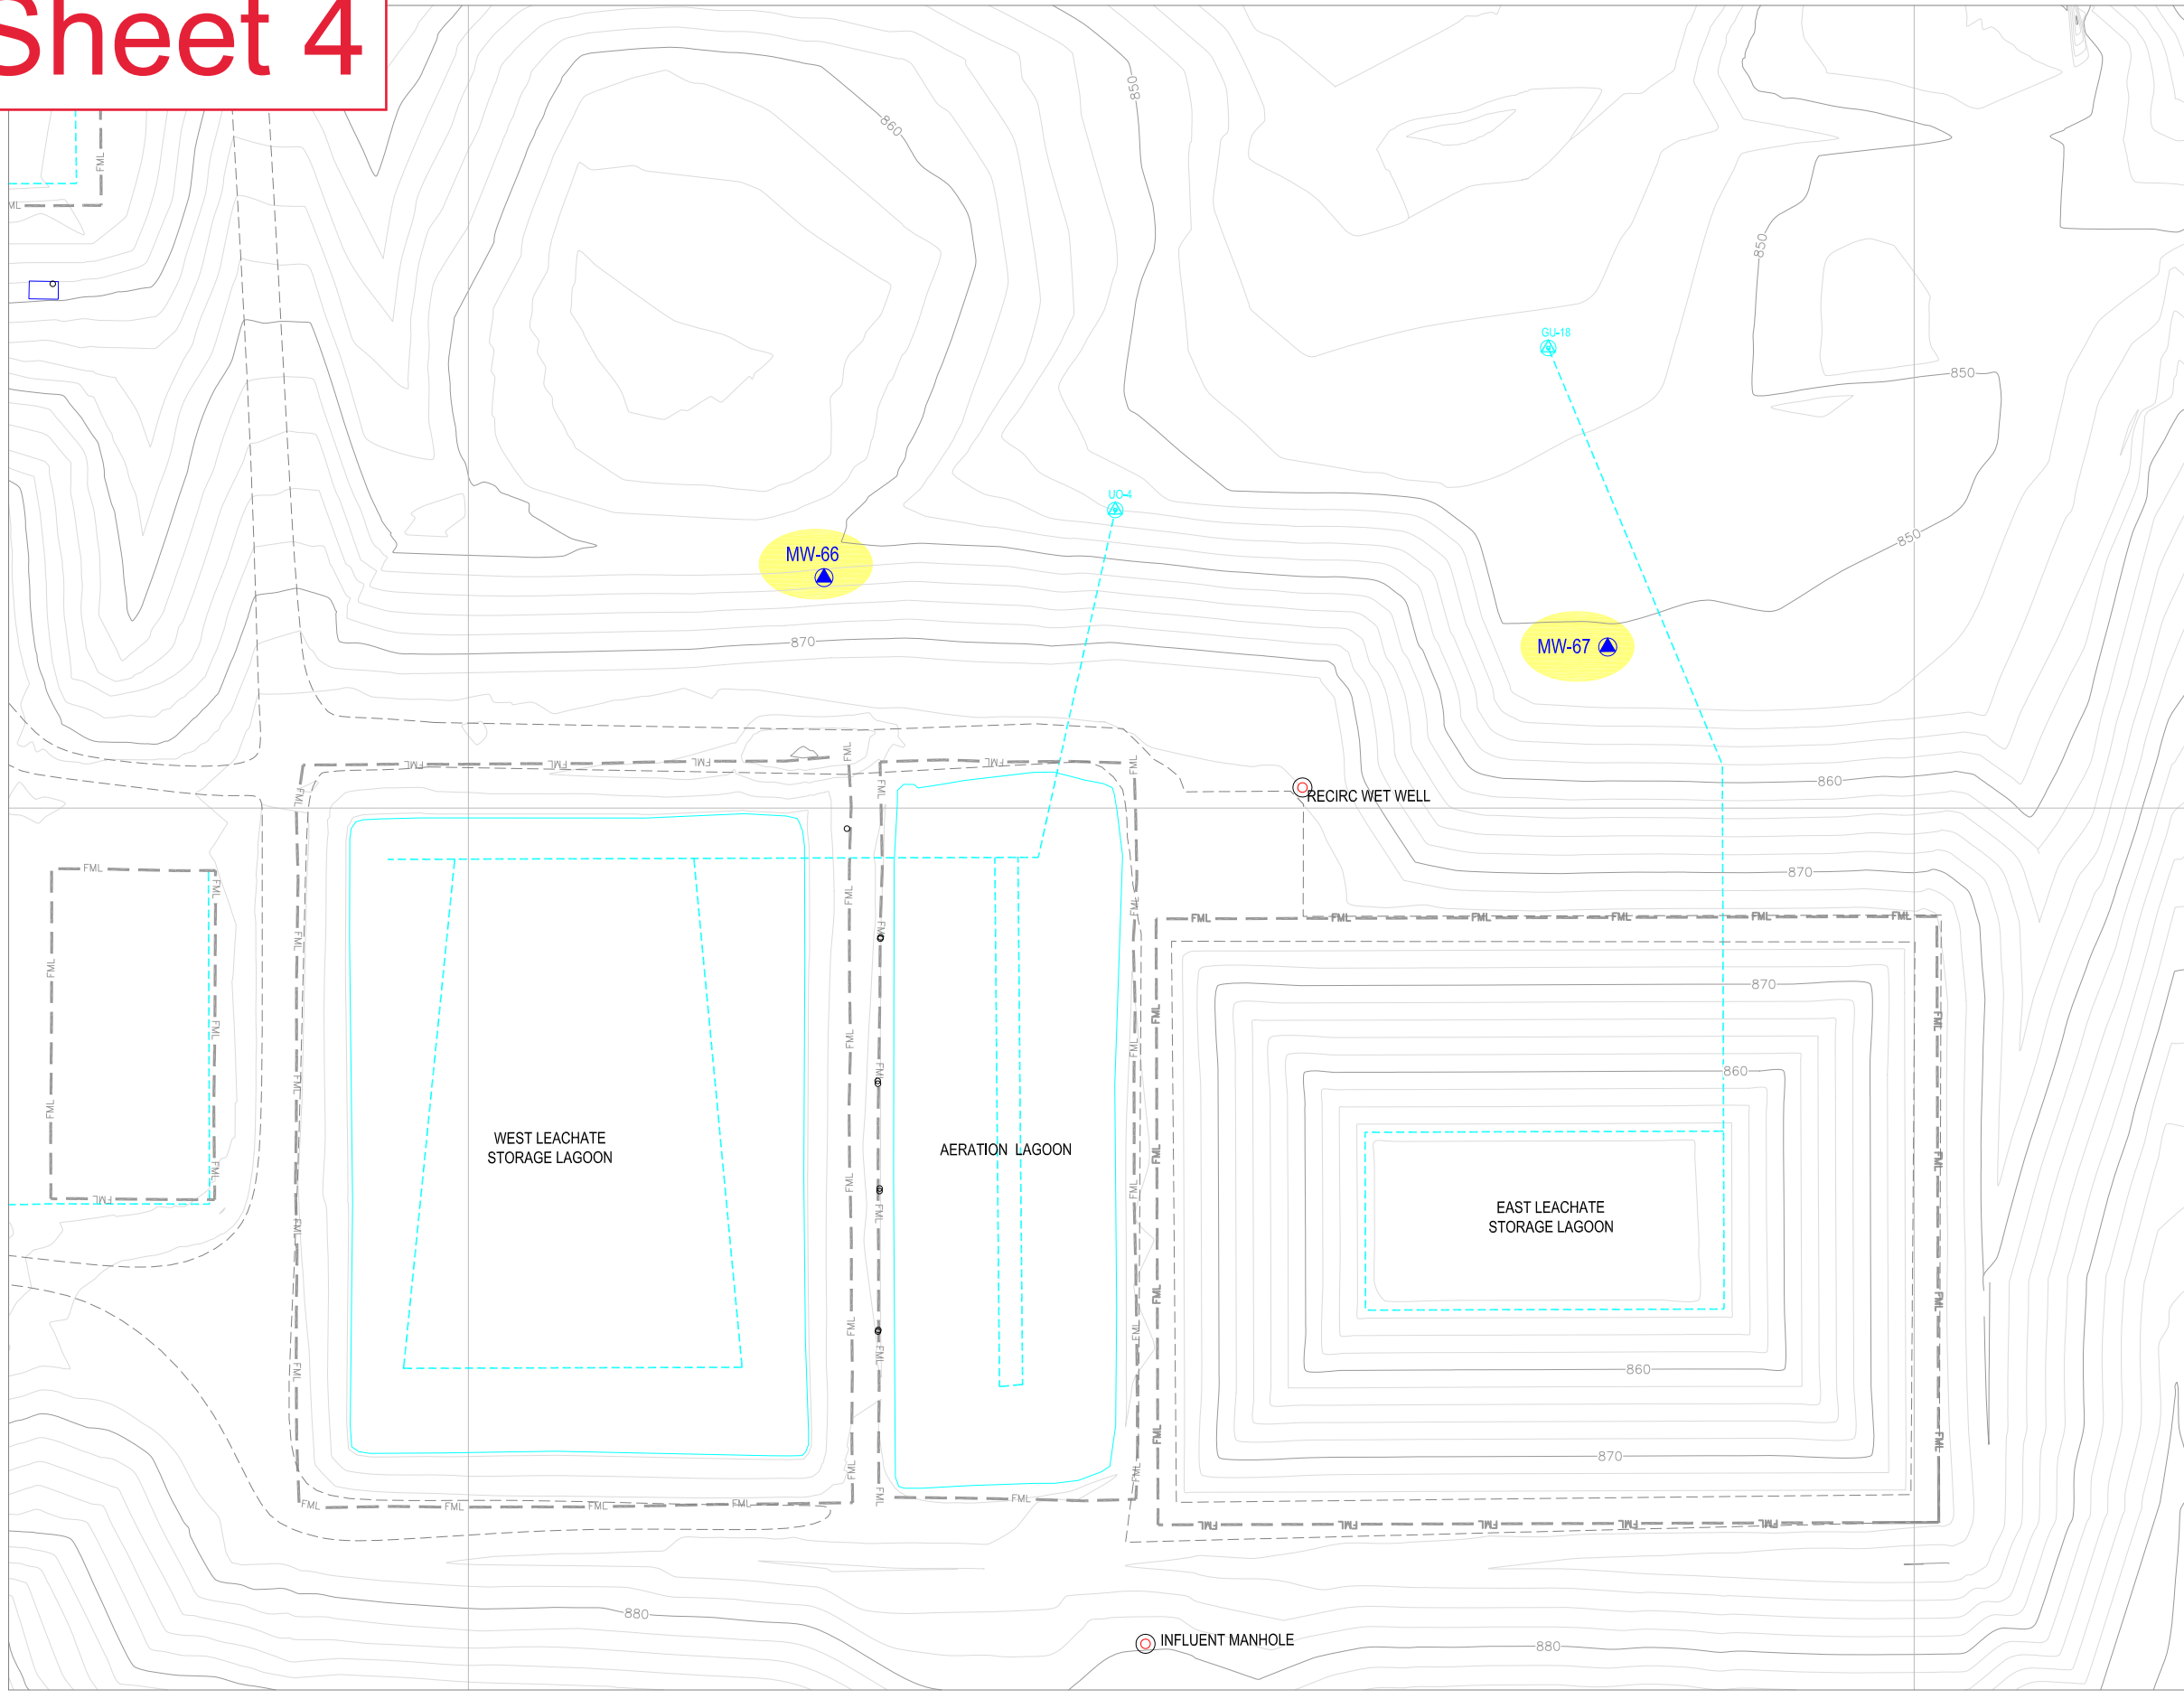
Sheet 4

Monitoring well MW-66 was installed at the site on October 22, 2013. The monitoring well was installed to be a supplemental monitoring point to UO-4 and GU-18 for the CWTS. **Sheet 4, Attachment B** depicts the location of monitoring well MW-66 relative to the storage and aeration lagoons and underdrain system. Monitoring well MW-66 is located approximately 160 feet from where the liner tear occurred in 2001. Monitoring well MW-66 is located approximately 95 to 160 feet relative to the perforated laterals and coarse drainage material of the underdrain system. Based on the general, historical groundwater flow direction interpolated at the site, monitoring well MW-66 is downgradient to crossgradient relative to the underdrain system and the location of the liner tear that occurred in 2001.
