**RE: SEMI-ANNUAL INSPECTION – FALL, 2024
AMES/STORY ENVIRONMENTAL LANDFILL
IDNR PERMIT NO. 85-SDP-13-91
HLW P.N. 6004-24A.750**

SITE PLAN
FALL 2024 INSPECTION

AMES/STORY ENVIRONMENTAL LANDFILL
AMES, IOWA

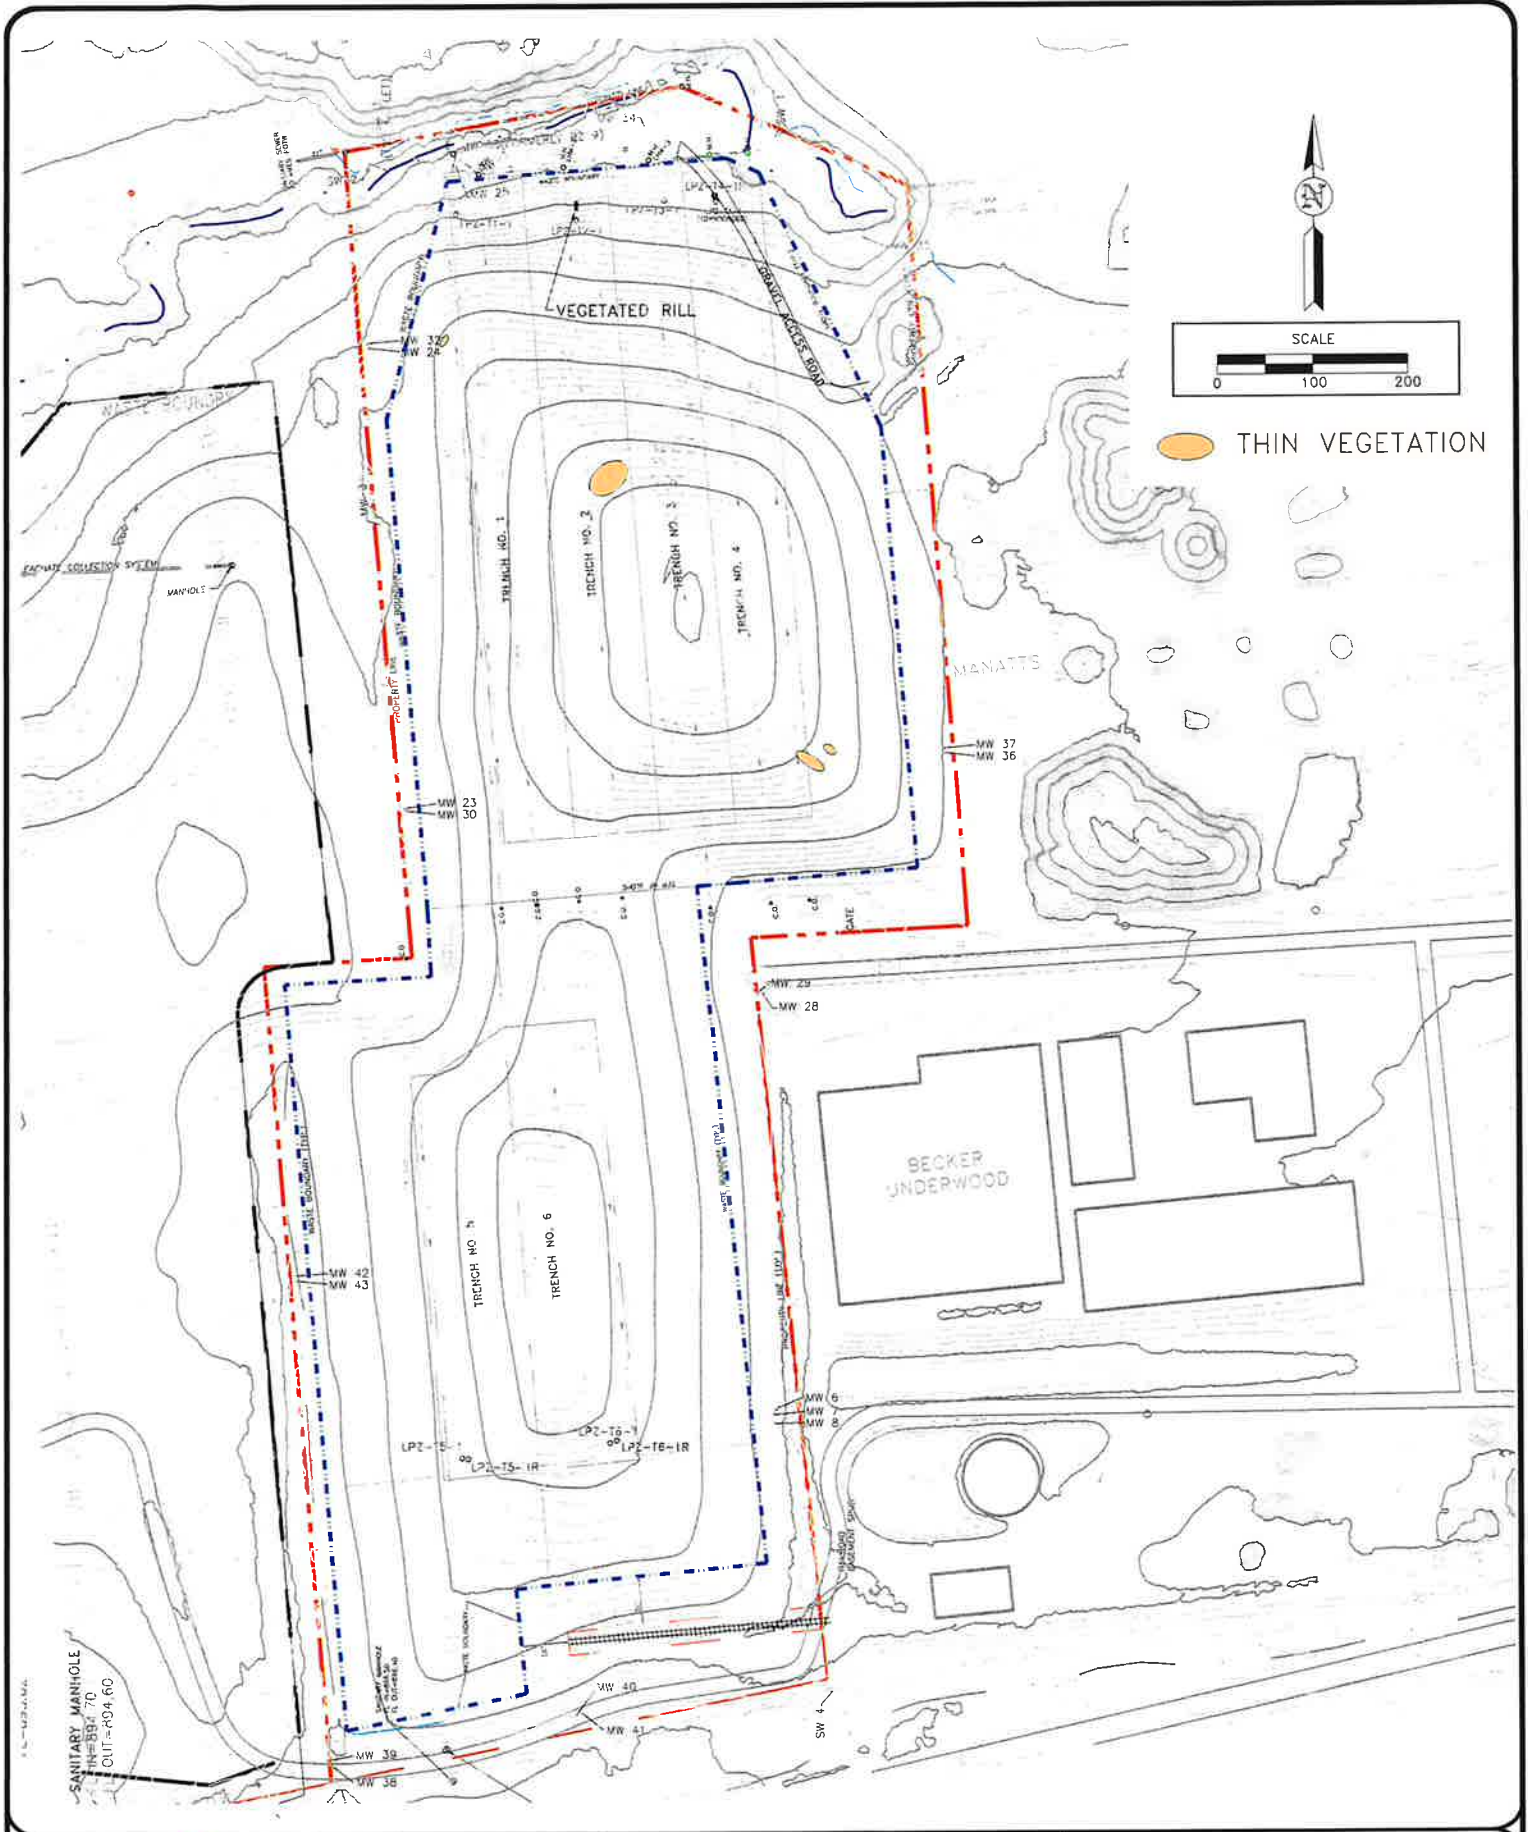
FIGURE: 1

Vegetation is in excellent condition on the majority of the north half with the exception of a few areas where thin vegetation was noted during this inspection. No erosion was noted in the areas with thin vegetation. The approximate location of these areas are shown on the attached figure.

No erosion was noted on cap with the exception of an erosion rill noted near LPZ-T2-1. The rill was referenced in past inspection reports. The rill is well vegetated and based on the condition of vegetation in this area, the rill does not appear to be active. No waste is exposed in the rill. The approximate location of the vegetated rill is shown on the attached figure.

1. Continue to monitor condition of vegetation, focusing on the areas with thin vegetation noted during this inspection, and reseed and control weeds as necessary.
2. Continue to monitor leachate levels in LPZ-T5-1R and discuss in the 2024 Annual Water Quality Report (AWQR).
3. Monitor the vegetated rill near LPZ-T2-1. Continue to monitor the remainder of the cap for erosion rills and repair as needed.
4. Continue to monitor bank erosion near MW-35 – if erosion appears to threaten the integrity of the well install bank stabilization to protect the MW.
5. Continue to remove trees from landfill cap as needed.
