**SUBJECT:** Site Visit: Permit No. 09-SDP-01-75C (Landfill) 01-RCC-1998 (HHM)

**IOWA DEPARTMENT OF NATURAL RESOURCES**  
**Field Office #1**  
**1101 Commercial Court., Ste10, Manchester, IA 52057**  
**(563) 927-2640 (ph.) (563)927-2075 (fax)**  
**Closed Sanitary Disposal Project Visit (Landfill)**

Permit # 09-SDP-01-75C

Site: Bremer Co. Landfill (Closed)

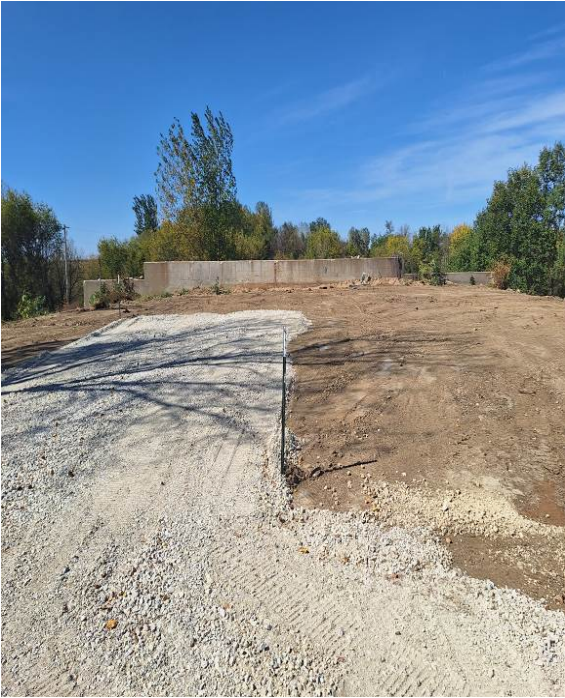
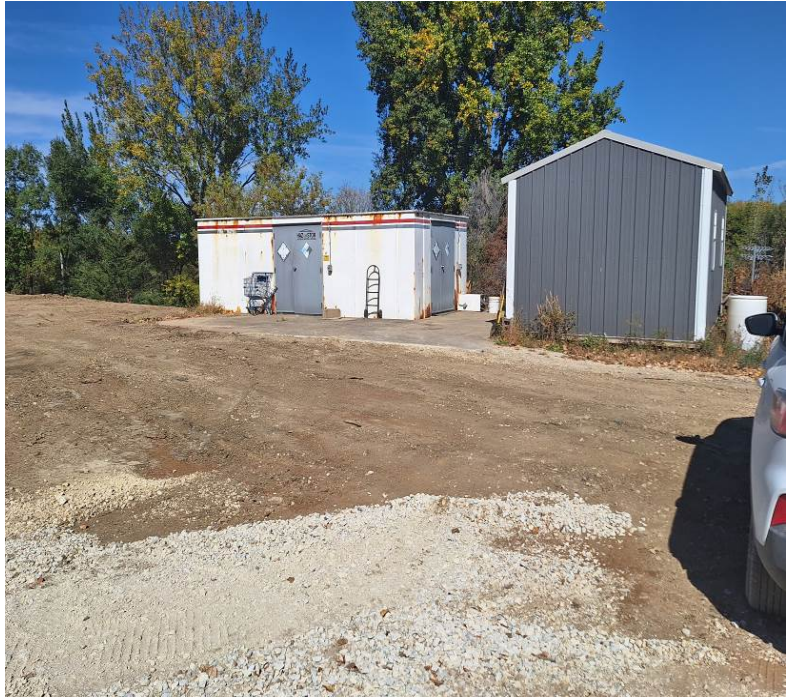
The Household Hazardous Material (HHM) area comprises two buildings: explosion-proof building and storage shed. The incinerator building was removed earlier this summer. Plans to build a new HHM building on that location were halted due to bore holes showing garbage buried under that site.

HHM is sorted under roof in either the storage shed or explosion-proof building. The chemicals are not stored in labeled areas but appear to be separated into areas of like chemicals. This facility normally provides some products to the public for reuse. However, due to the incinerator building being removed, the buildings remaining are not set up for reuse.

The storage shed s also used for chemical storage. This shed was not included in the Regional Collection Center's original site plan. The chemicals stored in this building are stored in metal drums acting as secondary containment. As was noted above, chemicals were not in labeled areas but appeared to be stored in areas of like chemicals.

The incinerator building has been removed. Chemical storage and sorting now take place in the wood storage shed and explosion-proof buildings.

- Properly label areas in the storage building and sort materials accordingly.
- Continue working with TRADEBE to remove chemicals before the 180-day requirement.

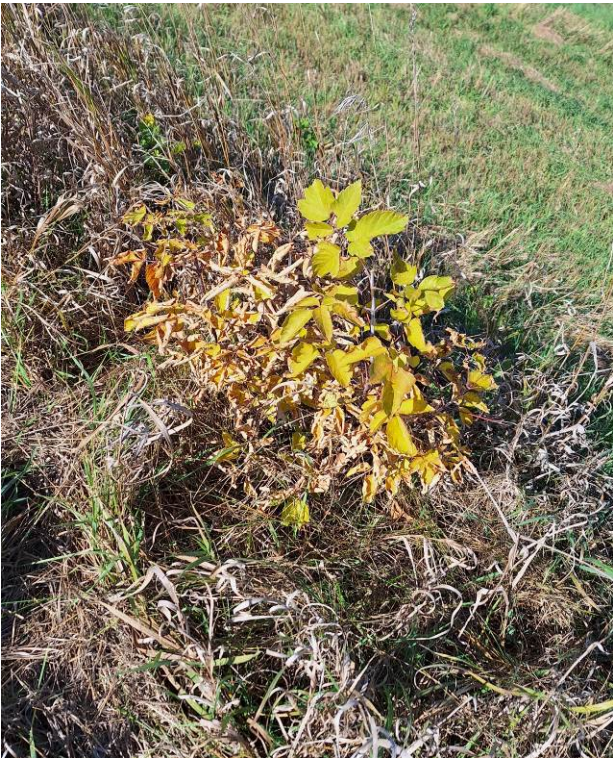
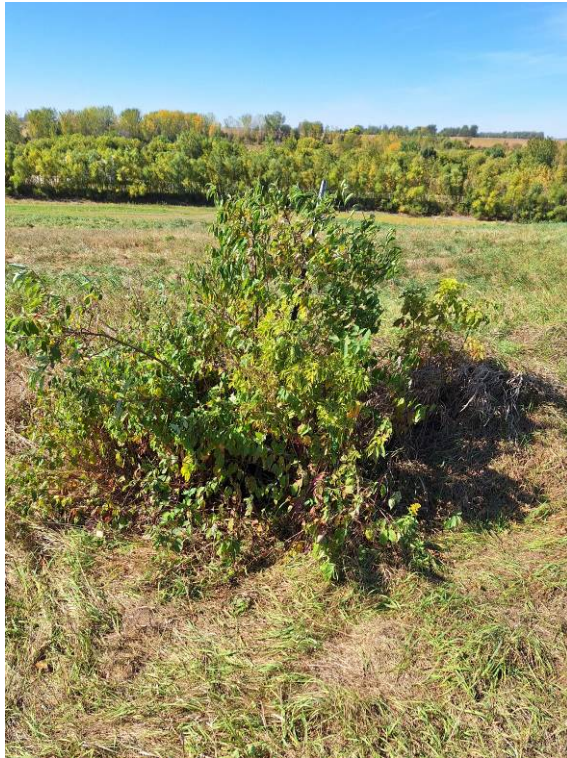
The closed landfill was well vegetated (see pictures). Trees were sprayed in mid-September and the landfill was mowed in early September. Woody vegetation was still present on the west side of the landfill cap by the tile inlet. Mr. Meeker stated he would take care of this. The rest of the landfill appeared to be in great shape as I did not see any evidence of leachate/methane seeps or erosion/rodent damage. Continue to watch for tree growth/erosion and perform maintenance accordingly.

Small trees on the north terraces were recently sprayed. Woody vegetation noted on the last inspection remains at the tile inlet on the west side of the landfill cap.

- Routinely inspect the landfill and perform maintenance as needed.
- Get a heated area for HHW handling in cold months or consider not taking HHW during these months.
- Get running water established near the HHM building.

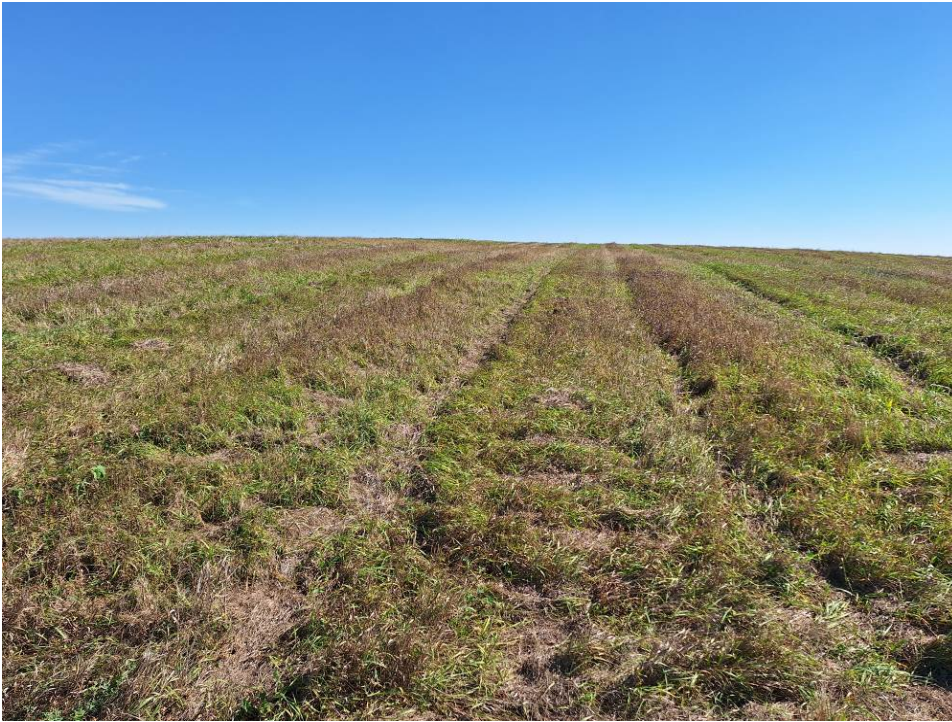
The landfill cap is well vegetated and was recently mowed.
