Our reference: 056934-LTR-20

October 30, 2024

**Fall 2024 Semi-Annual Engineering Inspection**  
**Viking Pump Foundry Sand Landfill**  
**Permit No. 7-SDP-12-89P-FSL**

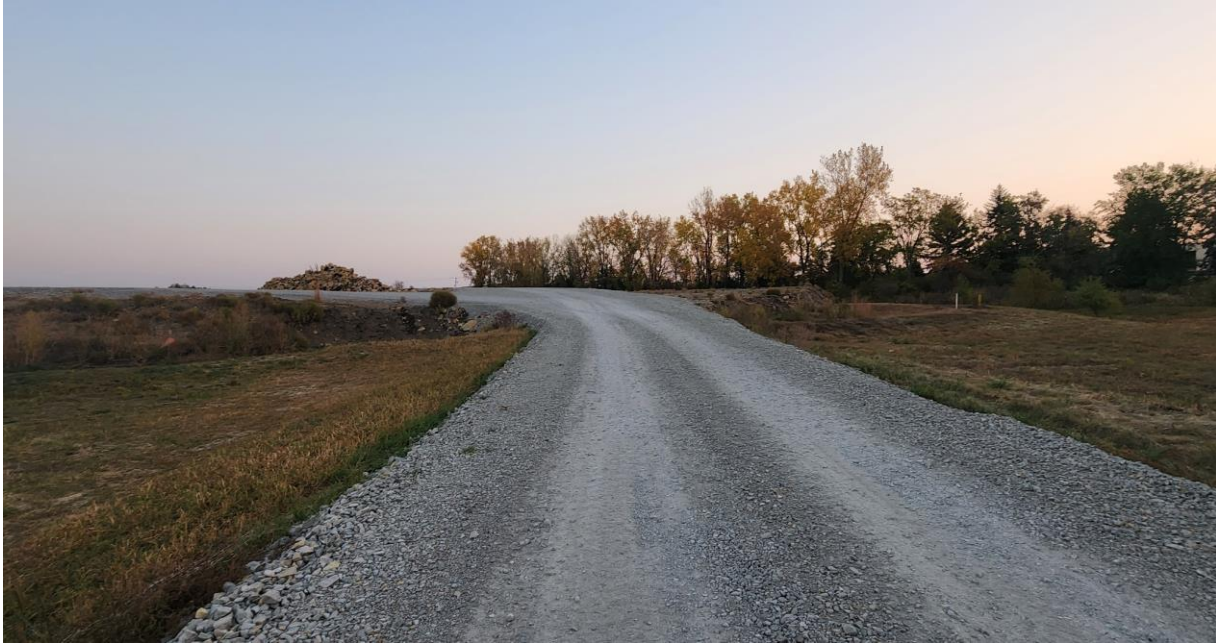
Foundry sand blocks are placed along the gravel access roads. The large blocks of foundry sand are occasionally crushed as required for continued landfill operation. During the inspection, all foundry sand was observed within the landfill berm. No operations were observed during the inspection.

**Photo 1. View of access road into landfill (looking northeast). All foundry sand is contained in the designated fill areas.**

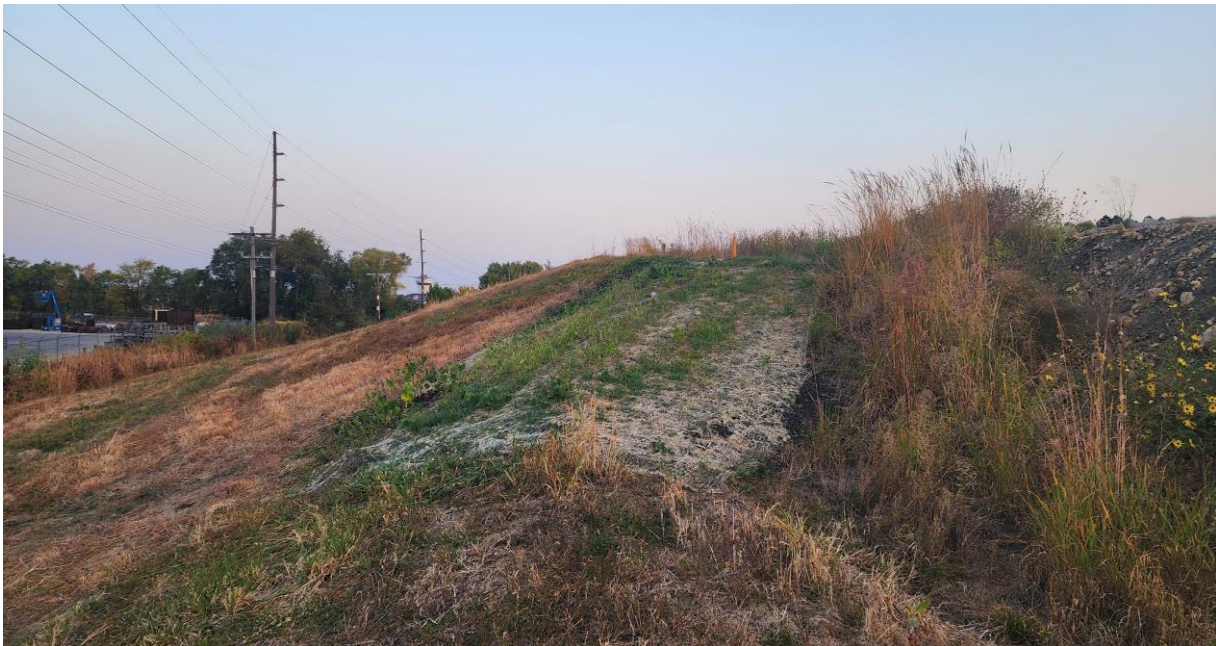
The site was dry at the time of inspection. Normally moist-to-wet areas were dry. The stormwater basin located east of the access road had been mowed, providing evidence of the dry conditions. No water was identified in drainage channels or discharging from the stormwater basin. The dry conditions led to brown grass, but good cover was evident. Several areas were also reseeded and matted since the April inspection.

**Photo 2. West side of landfill (looking north) at edge of closed section showing recently reseeded and matted area.**

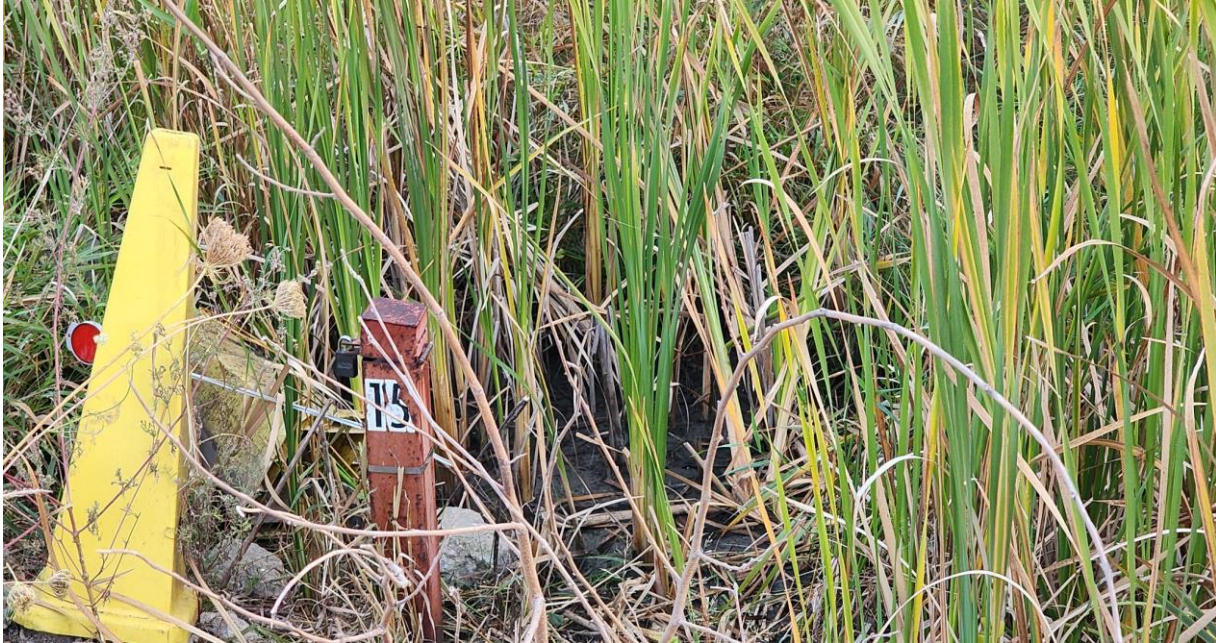
Photo 3. Dry conditions at MW-15. There is typically some surface water at this location upgradient of SW-1.

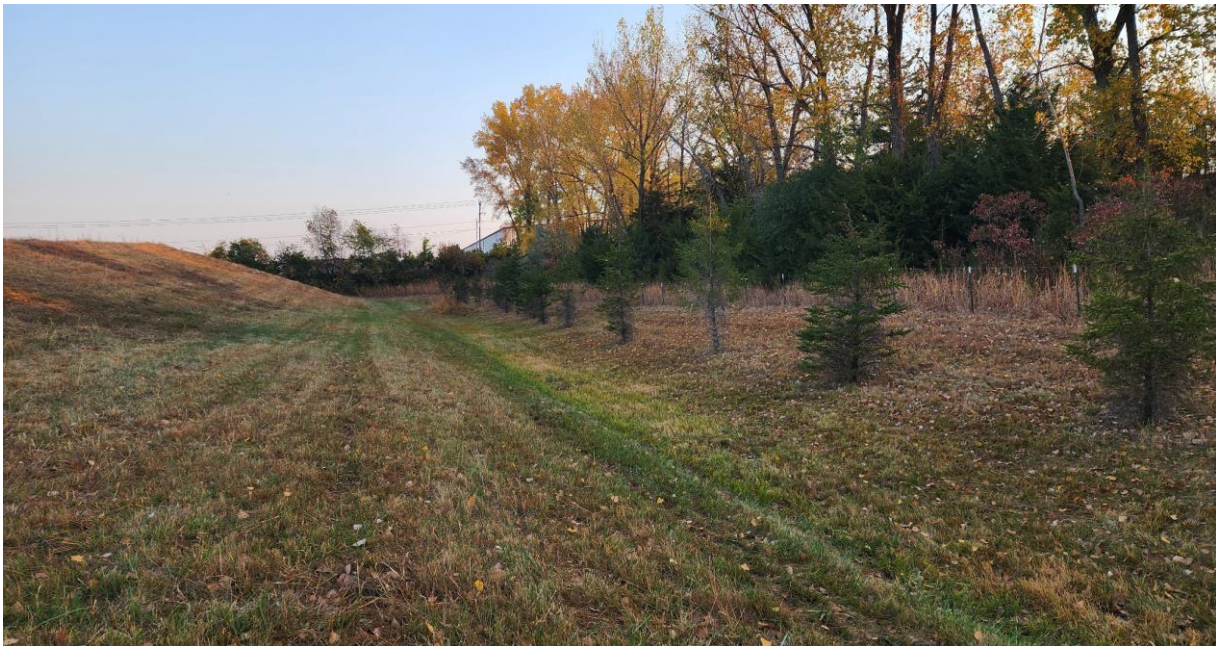
Photo 4. East drainage looking north toward MW-14. The channel was dry.

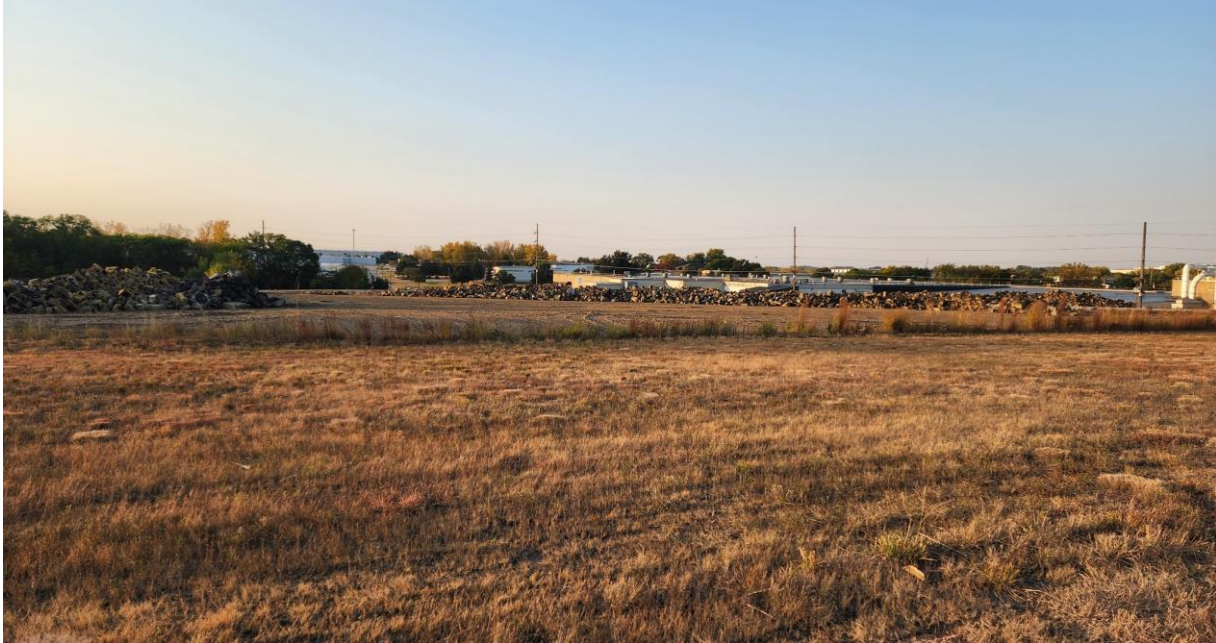
Photo 5. View looking south from top of north side of landfill. Looking toward active filling areas.

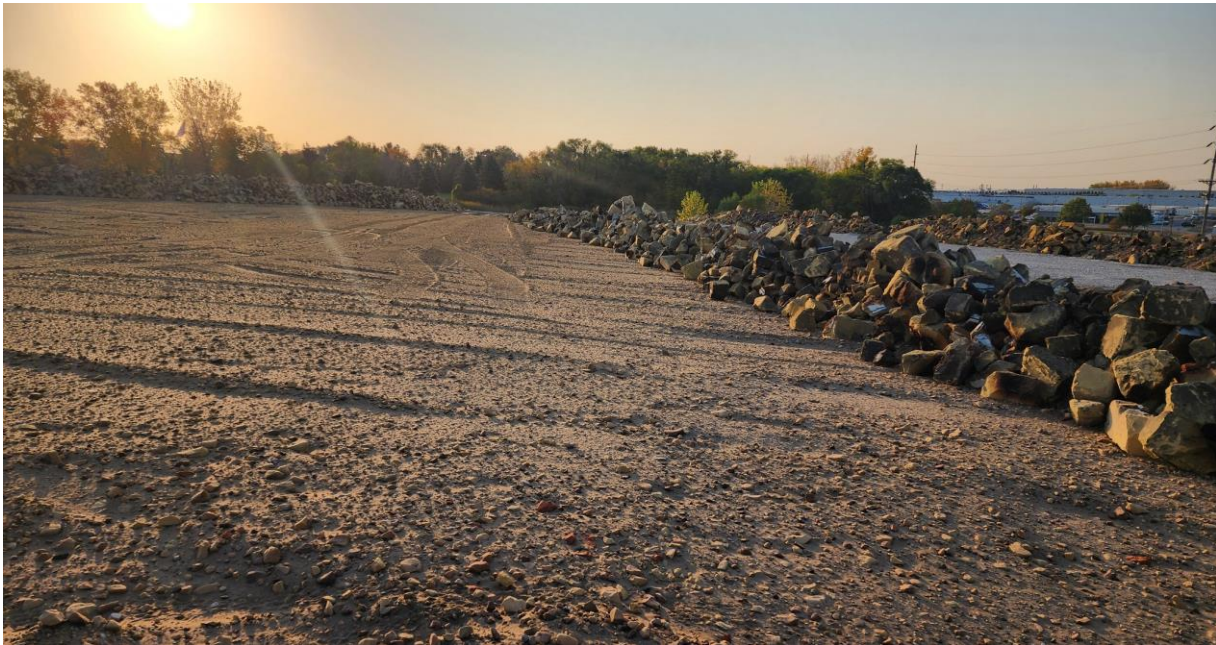
Photo 6. Looking southeast over previously crushed foundry sand with staged molds placed along the gravel access road shown to the right.
