**RE: SEMI-ANNUAL INSPECTION – FALL, 2024
RURAL IOWA SLF
IDNR PERMIT #42-SDP-1-72P
VERTICAL EXPANSION AREA - CLOSED
HORIZONTAL EXPANSION AREA - ACTIVE
HLW PN 6006-23A.750**

FALL 2024 INSPECTION

RURAL IOWA SANITARY LANDFILL
ELDORA, IOWA

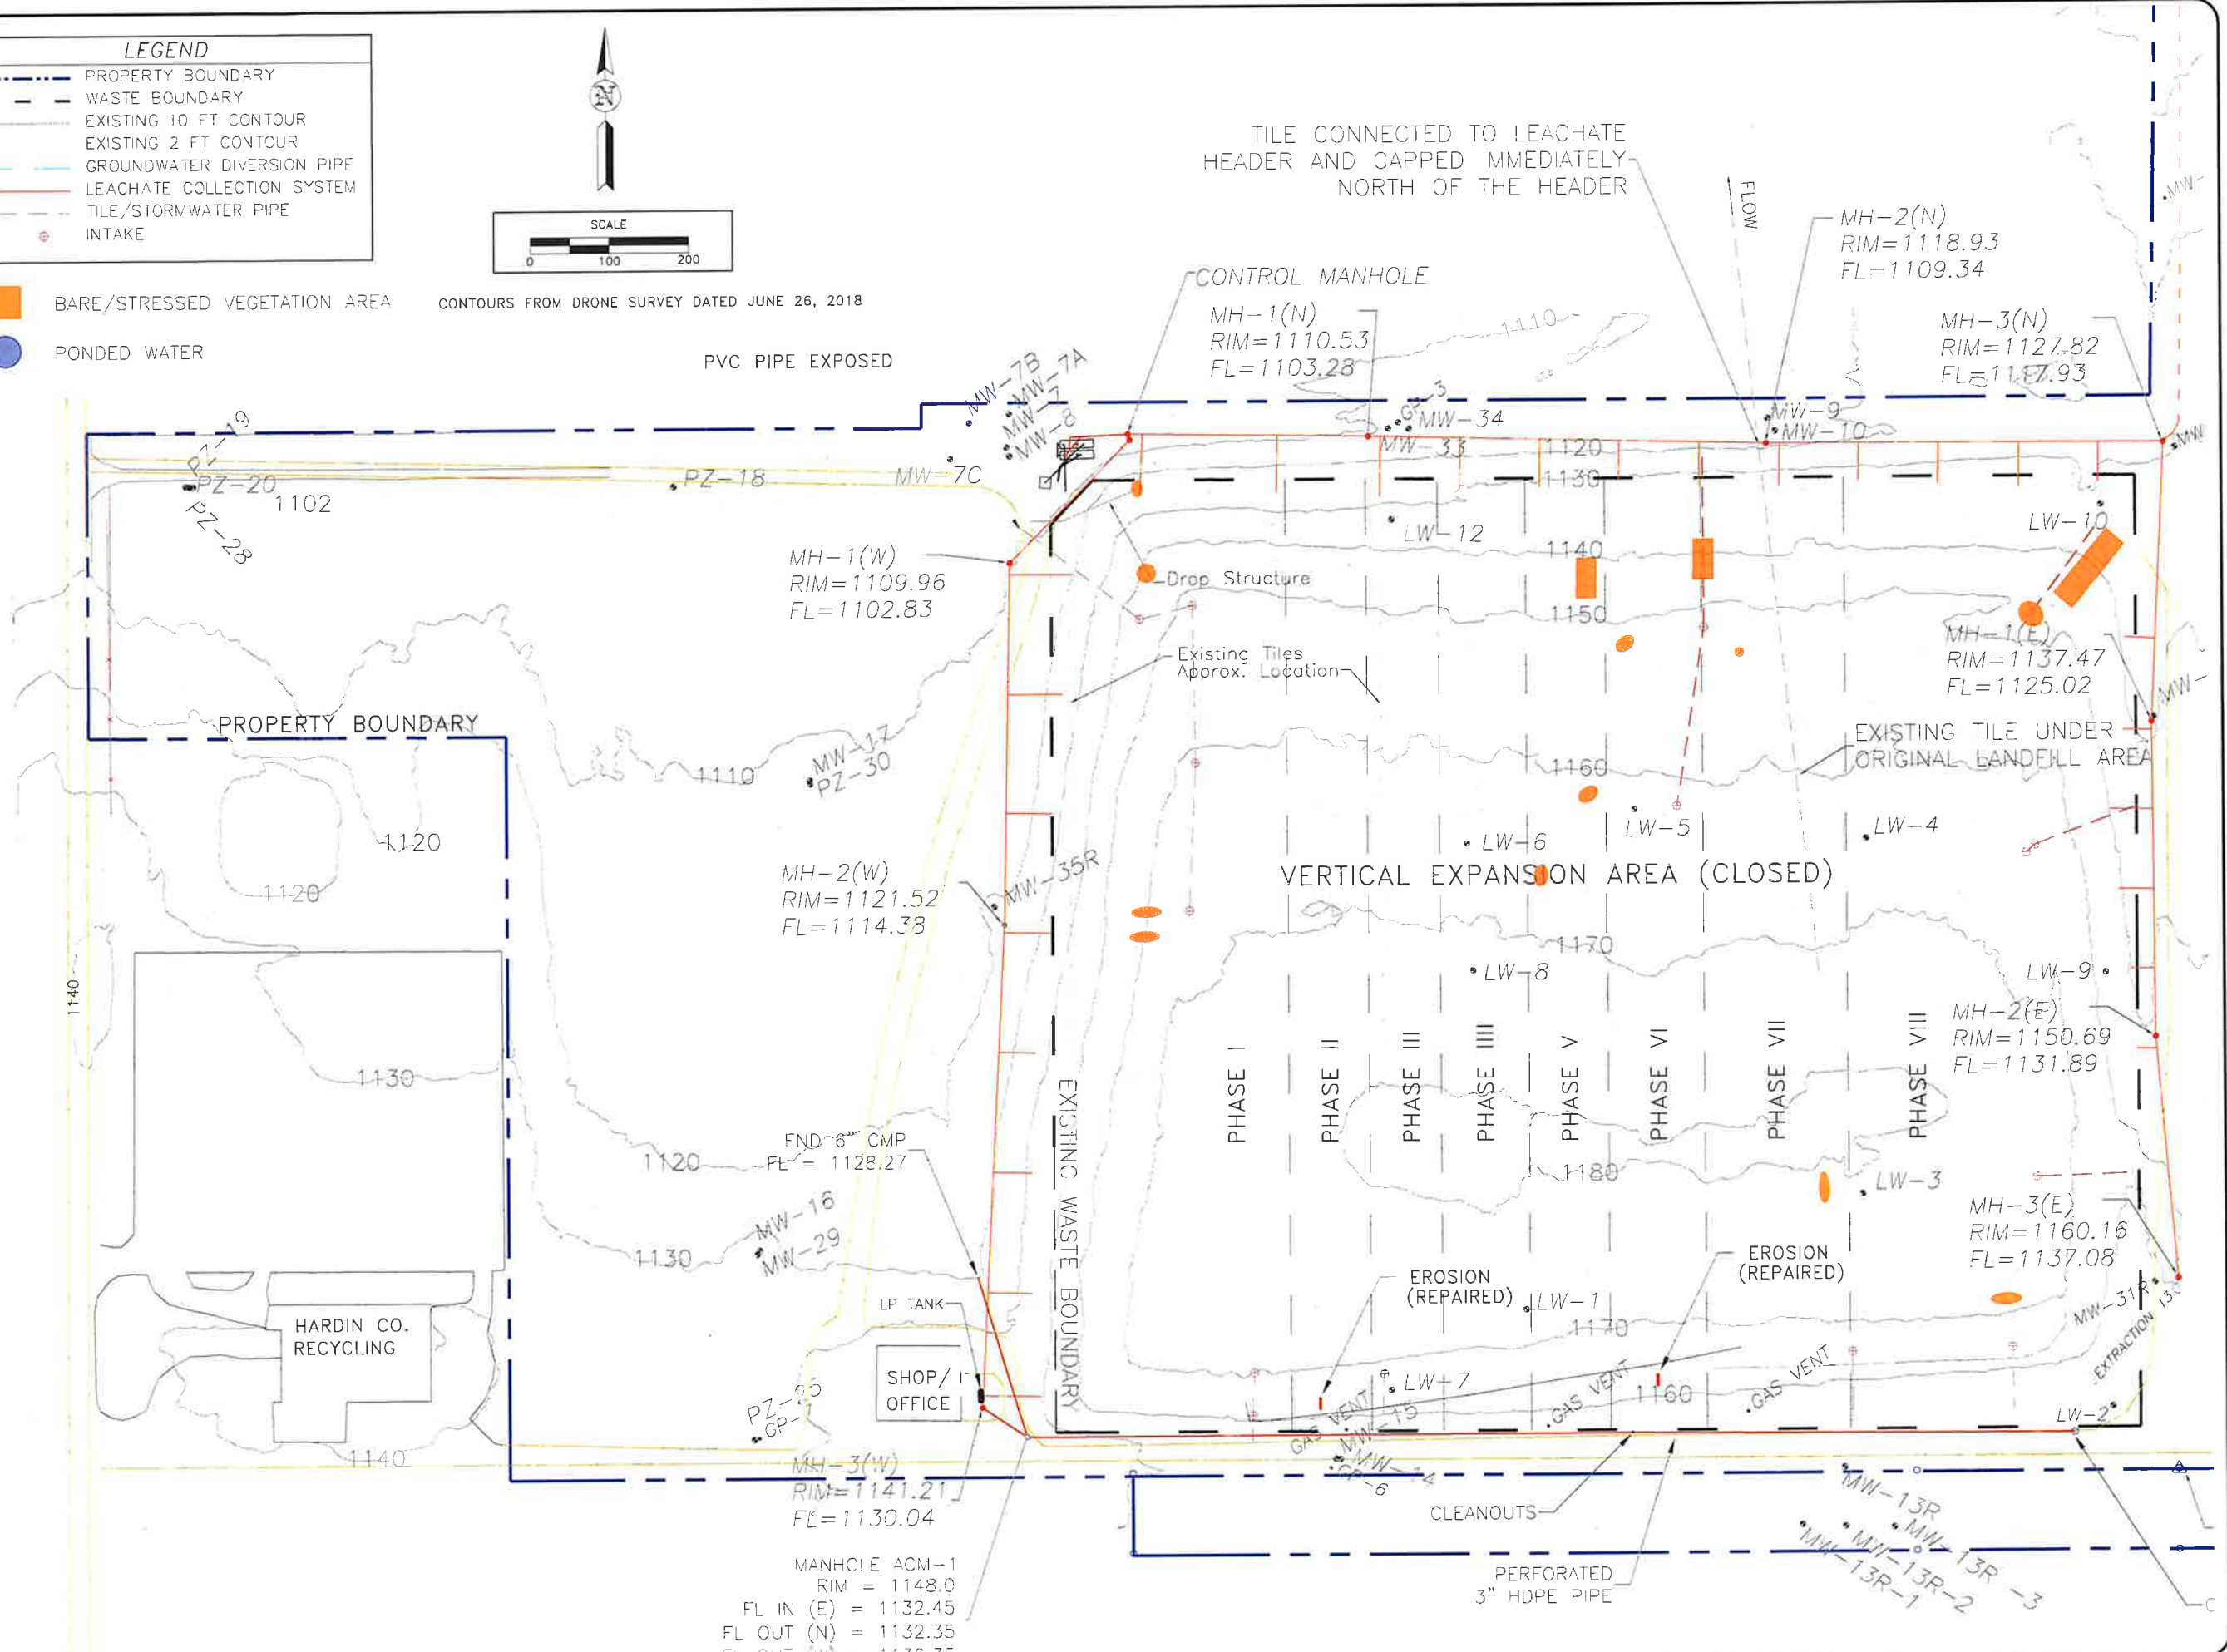
FIGURE: 1	
NO.	DATE
REVISION	PROJECT NO.
DRAWN	6006-23A
JGH	DATE
	10/24/24

Vegetation is well established on the majority of the Original Landfilling Area although stressed vegetation/bare spots were noted in the areas shown on the attached figure with smaller areas located sporadically on the north slope. Mr. Jass reported that soil has been added to several of the bare areas noted during the inspection and that Hardin County has been contacted and areas of the intermediate cover will be hydroseeded either this year (weather dependent) or next Spring.

The vegetation and terraces have limited the formation of significant erosion rills. A short segment of one of the terrace pipes was exposed at the toe of the west slope at the approximate location shown on the attached figure. The pipe is still functioning.

- BARE/STRESSED VEGETATION AREA
- PONDED WATER

1. Continue to retrieve windblown litter.
2. Remove sediment from the ditch west and north of Trenches 1 and 2.
3. Collect annual stormwater sample.
4. Install passive gas vents.
5. Cover the exposed terrace pipe.
6. Seed the bare/thin areas on the closure cap and intermediate cover.
7. Continue tree removal as needed, monitor stumps for regrowth, and treat stumps as needed.
8. Monitor level of sediment in sediment basins, ditch checks, and other sediment control structures and remove sediment as needed to maintain capacity.
