SUBJECT: Site Visit: Permit No. 06-SDP-02-81P

**Sanitary Disposal Project Visit (Landfill)**

**Permit # 06-SDP-02-81P**

**Site: Benton Co. Landfill      Weather Conditions: 70° / cloudy / 15 MPH south wind**

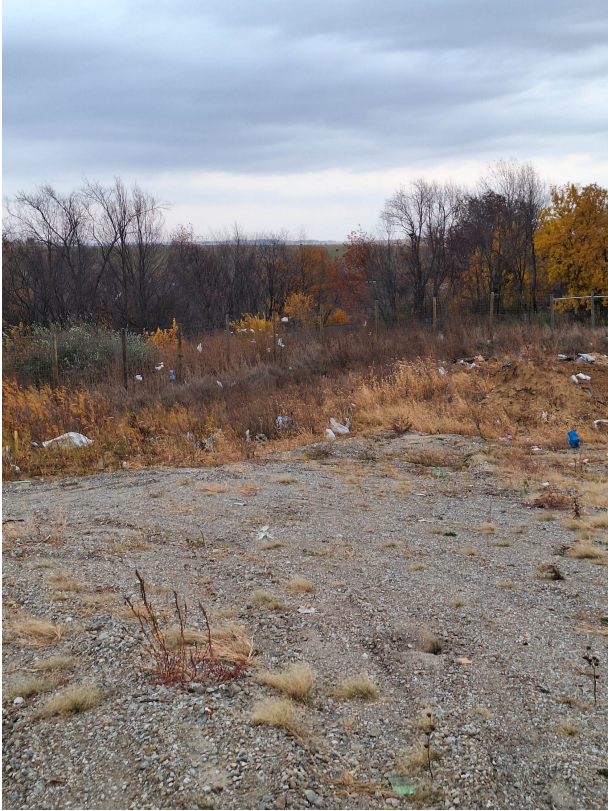
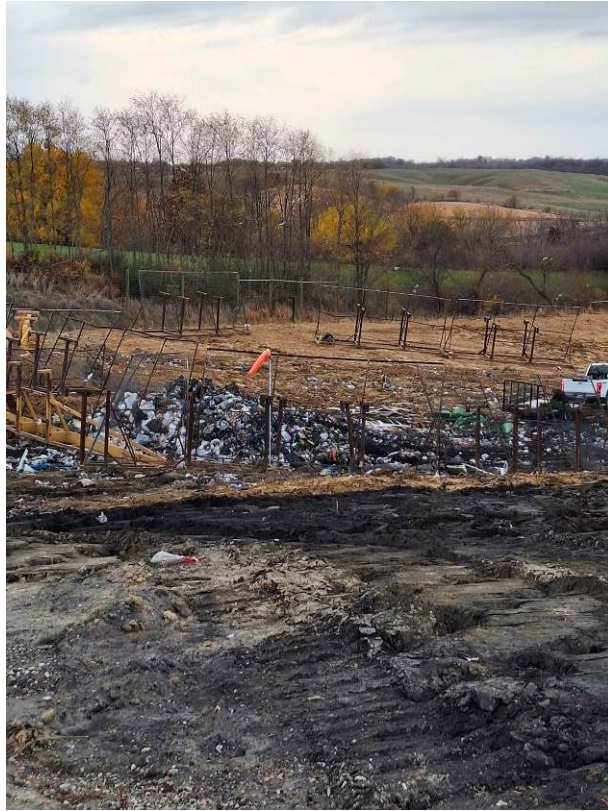
- Most of the oil barrels in the garage appeared to be full. Contact the contractor to remove the used motor oil.
- A substantial amount of litter was noted along the north and east sides of the landfill. Mr. Werner noted two days of higher winds had caused the issues. The catch fence around the perimeter caught most of the litter but some was observed in the trees (picture 1 and 2). Clean up the litter as soon as possible.

Litter along the fence line and some in the trees.

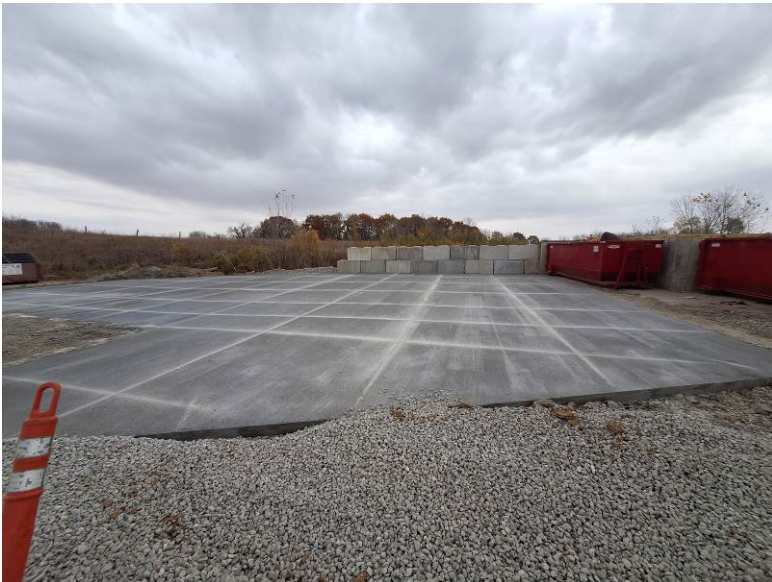
- A concrete pad was recently poured on the north end of the customer drop-off area (picture 3). This area will be used for scrap metal collection.
- The HHM building was mostly empty. Mr. Werner stated he had recently taken a load of HHM to the Linn County Landfill.

New concrete pad will soon be the scrap metal collection area.
