**RE: BIENNIAL INSPECTION REPORT – 2025
CLARKE COUNTY SANITARY LANDFILL – NORTH SITE (CLOSED)
HLW PN 6037-24A.200**

2025 BIENNIAL INSPECTION
 NORTH SITE
 SPRING 2025 INSPECTION
 SOUTH SITE
 CLARKE COUNTY SANITARY LANDFILL
 CLARKE COUNTY, IOWA

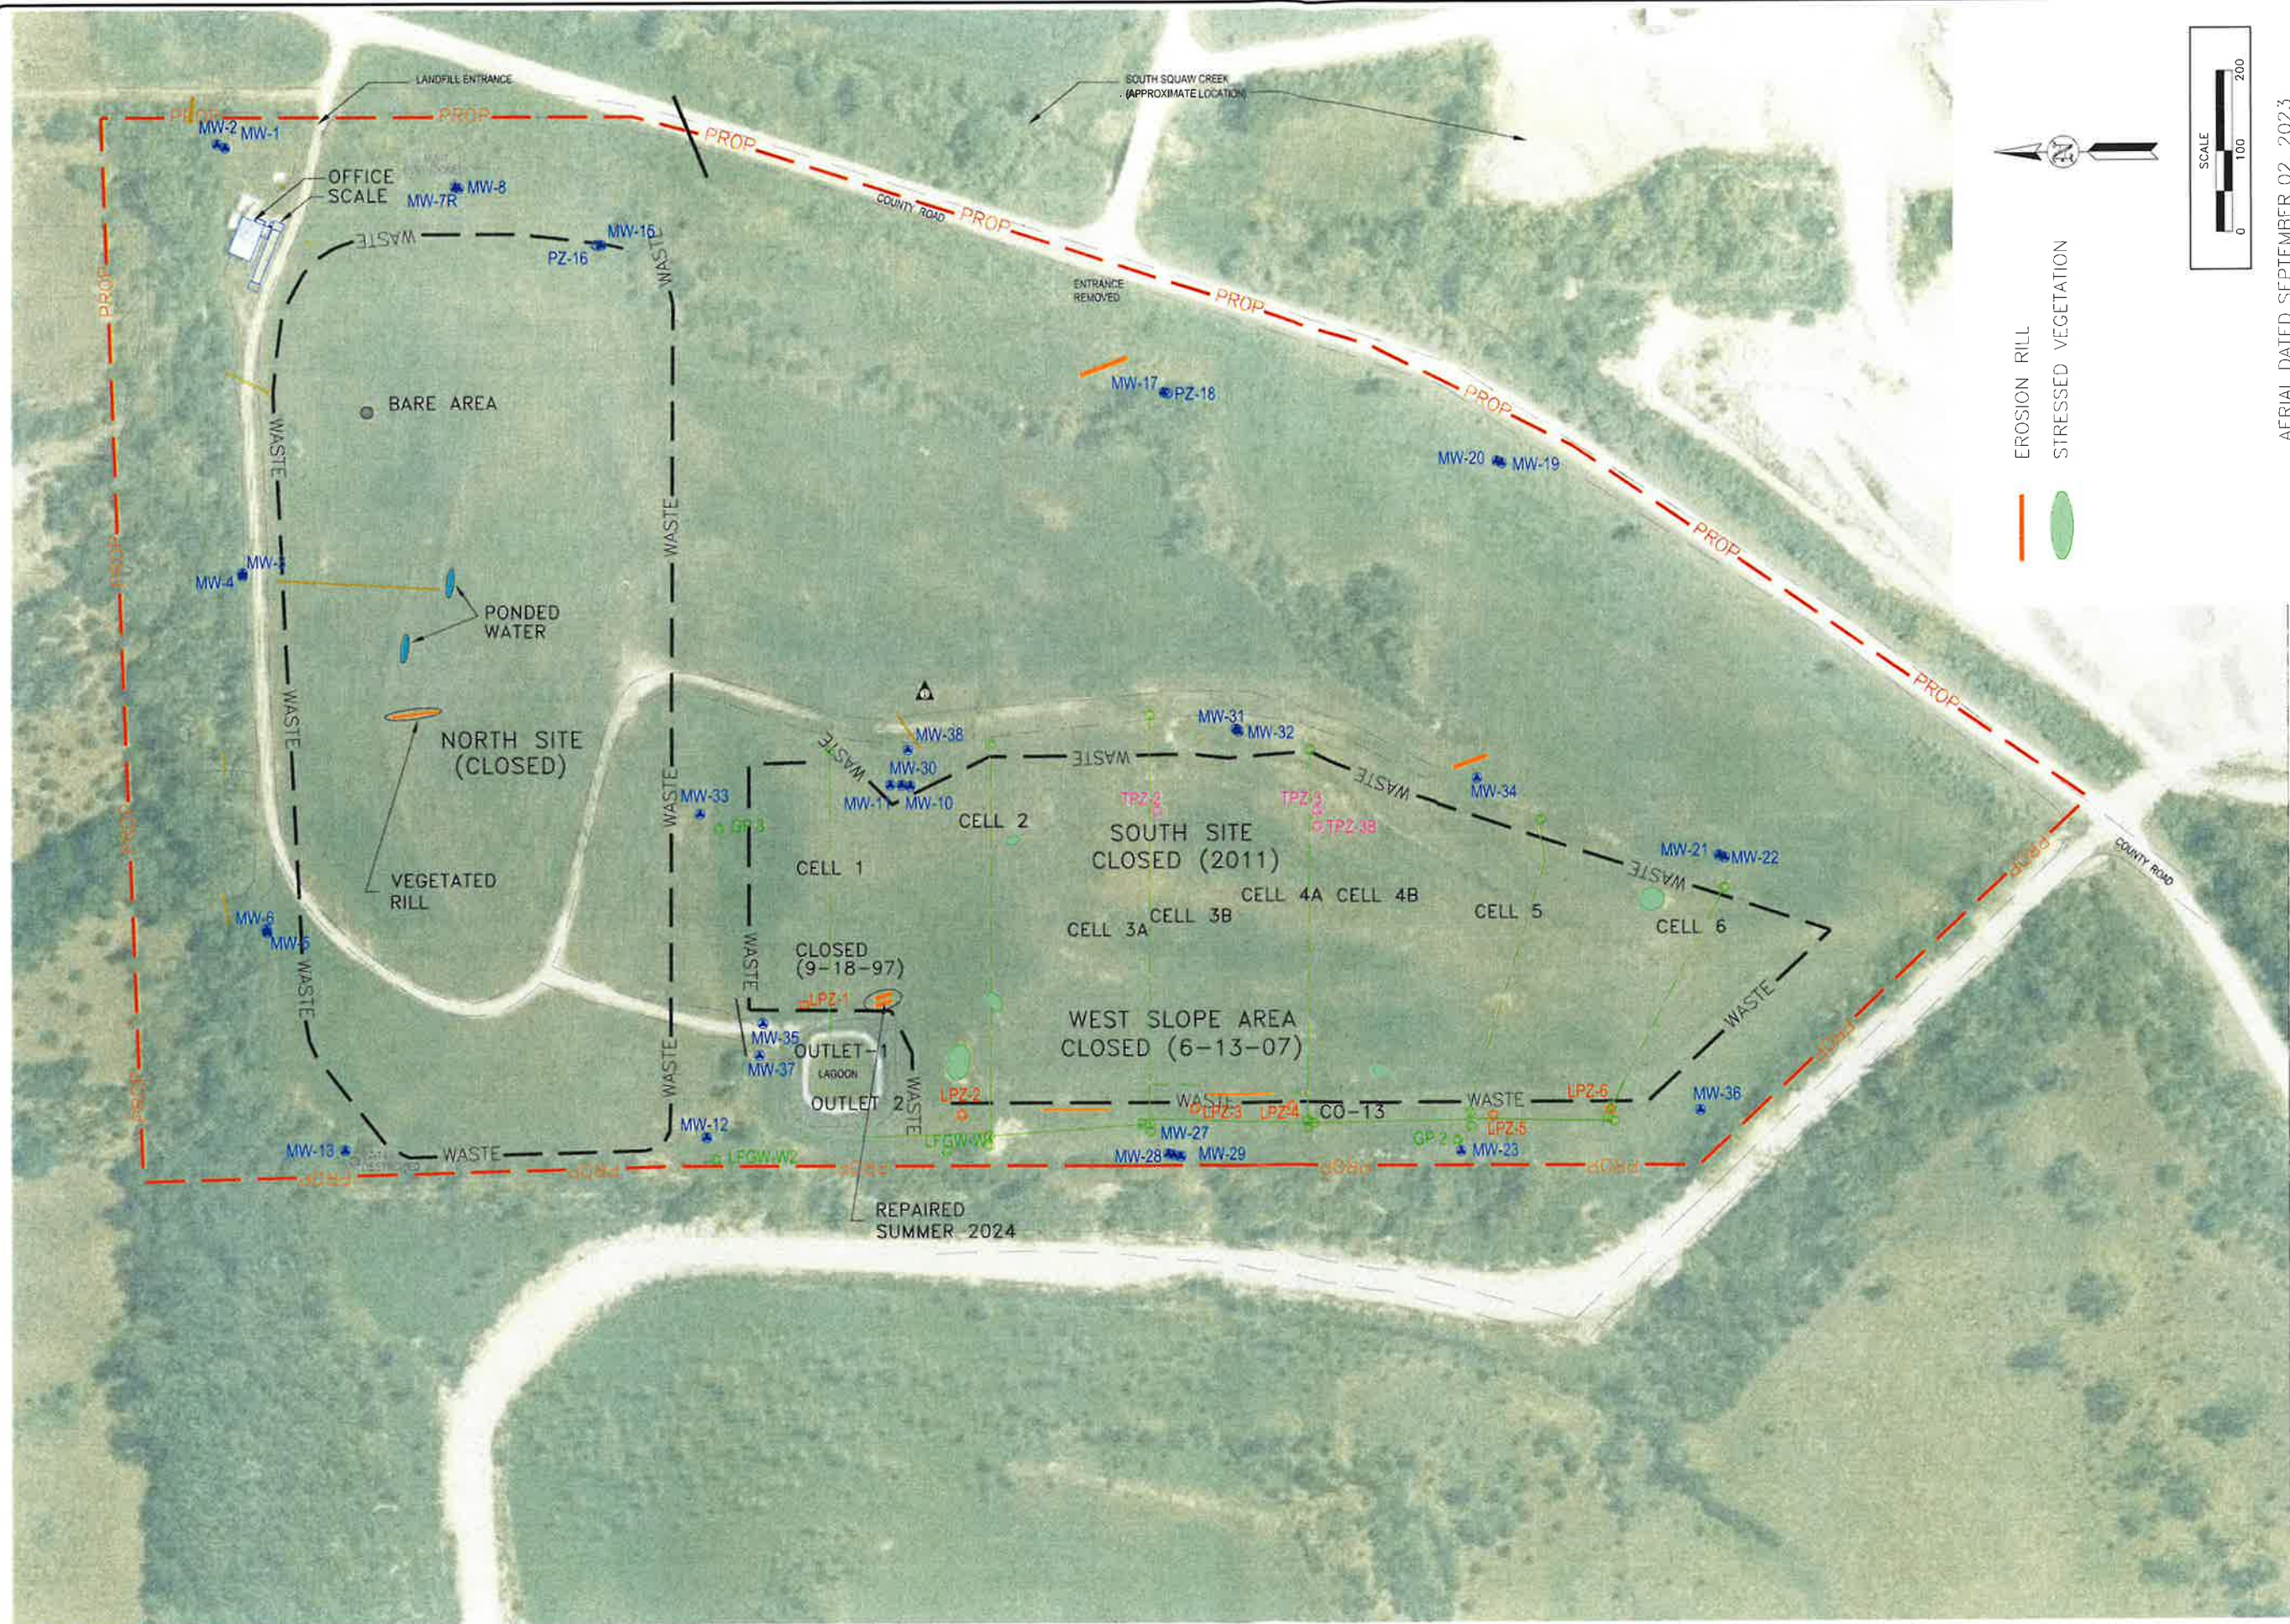
FIGURE: 1

A bare area was noted on the slope in the northeast quadrant of the waste boundary. The surface of the soil in this area was very rocky, no erosion or other ground disturbance was noted. The approximate location of the bare area is shown on the attached figure.

Ponded water was noted at the upper terrace intake immediately east of the intake. The approximate location of the ponding is shown on the attached figure. It appears a small area of the terrace channel is below the intake grade. Fill should be added in this area to restore channel flow to the intake. The vegetation in this area did not show evidence of long term ponding; however, frequent ponding may lead to additional settlement in the channel.

Ponded water was noted in the lower terrace channel approximately 60 feet west of the intake. The ponding appeared to be temporary with no vegetation changes noted in this area.

Several small vegetated erosion rills were noted on the north slope, with the largest (approximately 6" deep) noted between the two terraces approximately 120' west of the intakes. The approximate location of this rill is shown on the attached figure. The vegetation within and adjacent to the rills was in excellent condition.

1. Add fill east of upper intake to restore flow to the intake.
2. Monitor the ponding west of the lower intake for vegetation changes.
3. Monitor the vegetated rills on the north slope. If the rills become active repair as necessary.
4. Monitor vegetation and erosion and repair as necessary.
5. Monitor diversion and drainage systems and repair as necessary.
