**RE: SEMI-ANNUAL INSPECTION – SPRING, 2025
AMES/STORY ENVIRONMENTAL LANDFILL
IDNR PERMIT NO. 85-SDP-13-91
HLW P.N. 6004-24A.750**

SITE PLAN
 SPRING 2025 INSPECTION
 AMES/STORY ENVIRONMENTAL LANDFILL
 AMES, IOWA

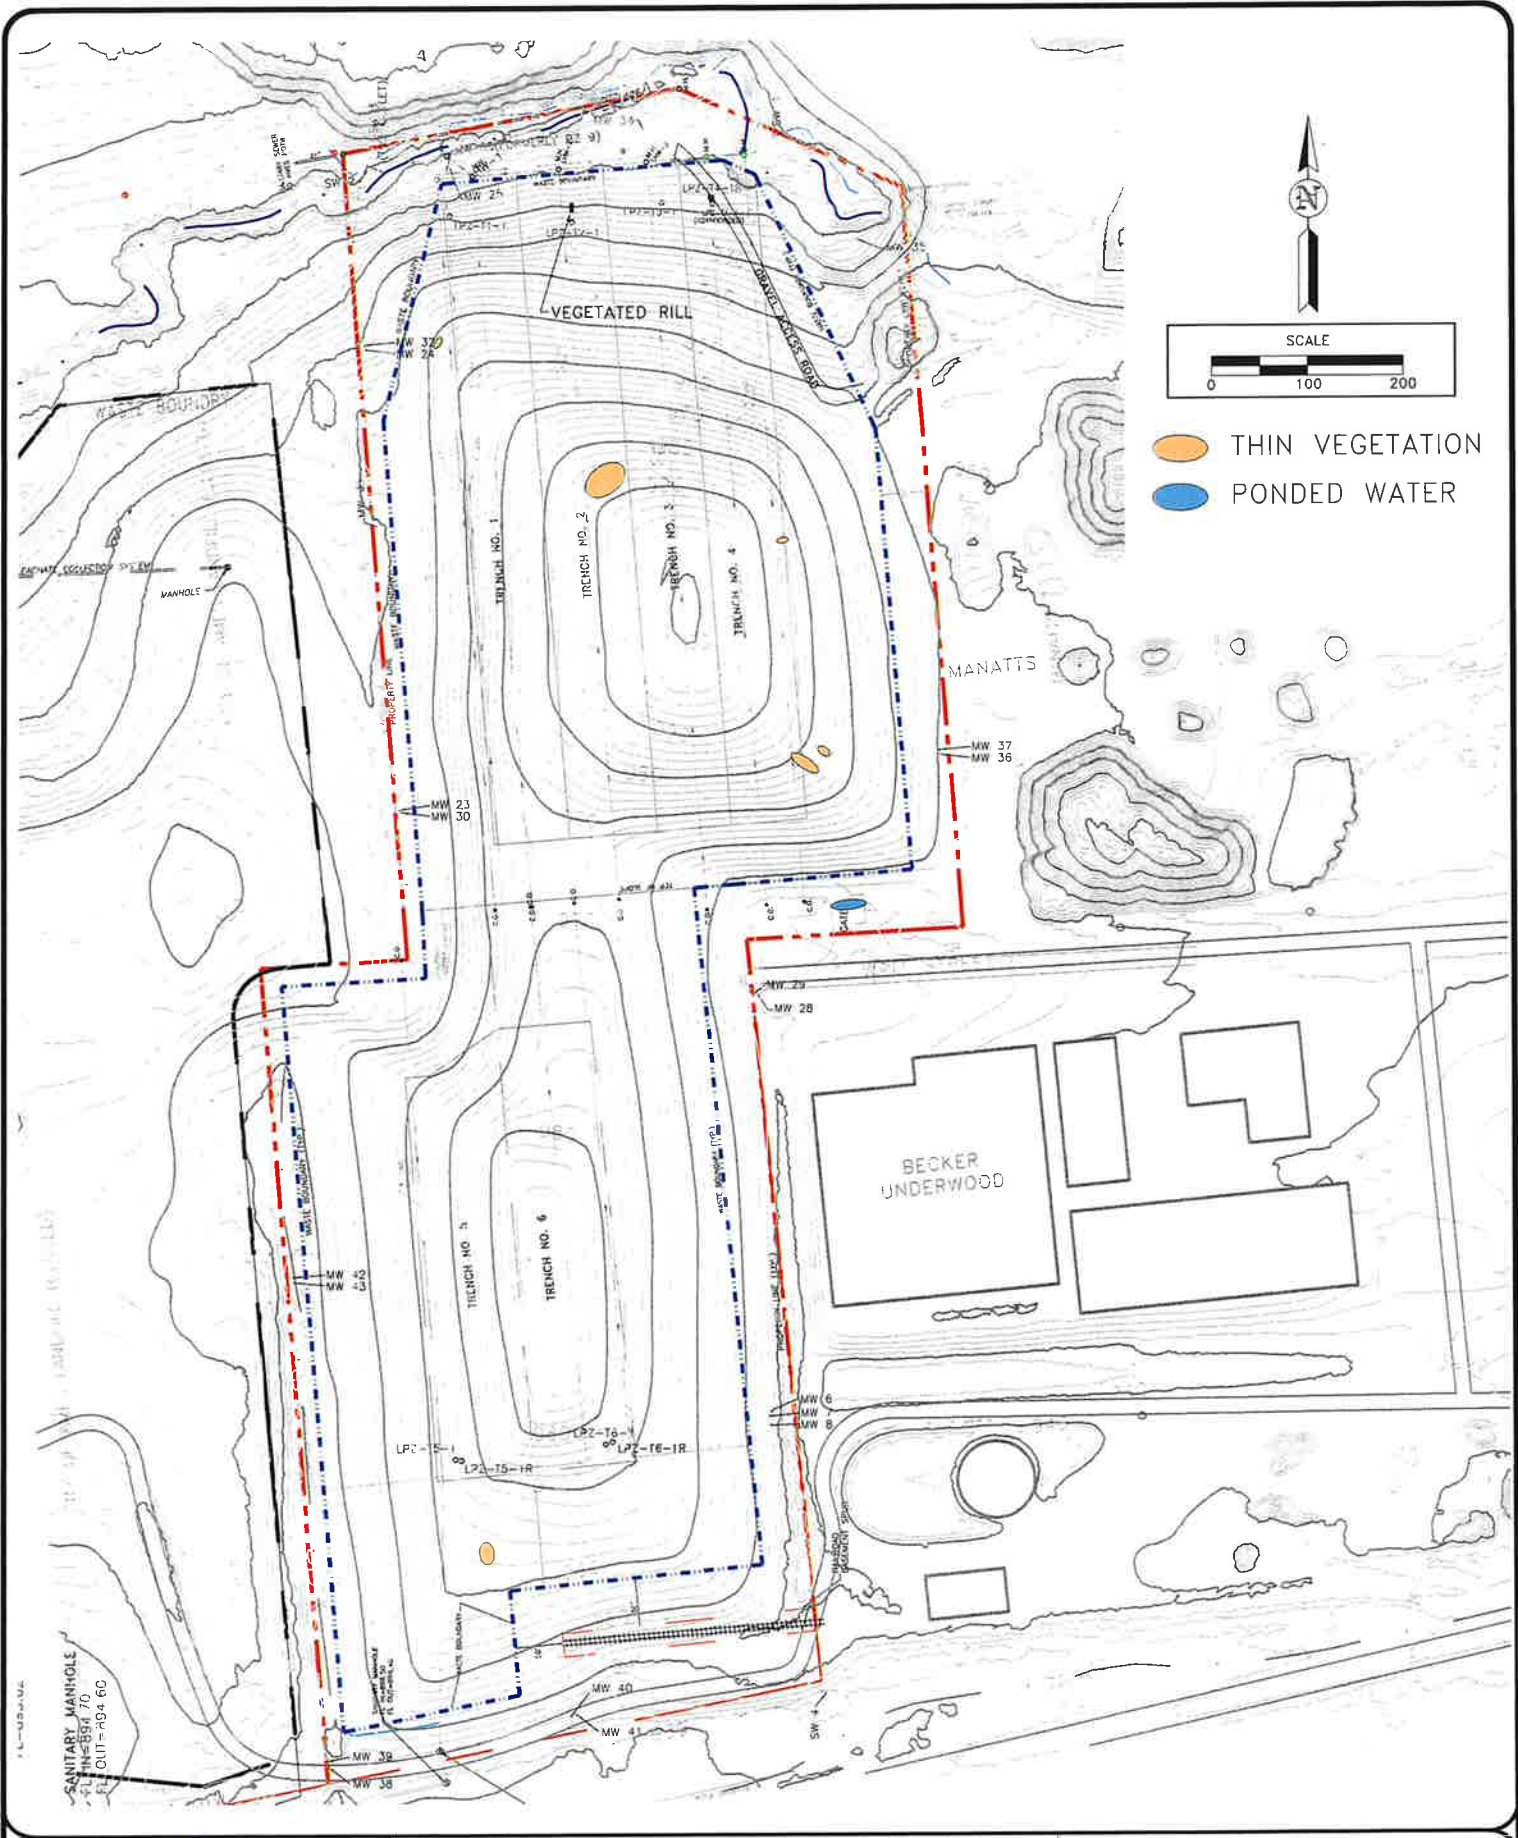
FIGURE:		1	
REVISION	NO.	DATE	
DRAWN JGH	PROJECT NO. 6004-10A	DATE 3/27/25

Vegetation is in excellent condition on the majority of the north half with the exception of a few areas where thin vegetation was noted during this inspection. No erosion was noted in the areas with thin vegetation. The approximate locations of these areas are shown on the attached figure. Note that vegetation had not yet started to emerge on the landfill cap as of the date of the inspection.

No erosion was noted on cap with the exception of an erosion rill noted near LPZ-T2-1. The rill was referenced in past inspection reports. The rill is well vegetated and based on the condition of vegetation in this area, the rill does not appear to be active. No waste is exposed in the rill. The approximate location of the vegetated rill is shown on the attached figure.

One area of ponded water was noted during the inspection. The ponding was noted immediately north of the entrance gate in the area of the former access road, the ponding was outside of the solid waste boundary. The approximate location of the ponding is shown on the attached figure.

1. Complete Monitoring Well Maintenance Performance Reevaluation Plan
2. Continue to monitor condition of vegetation, focusing on the areas with thin vegetation noted during this inspection, and reseed and control weeds as necessary.
3. Continue to remove trees from landfill cap as needed.
4. Continue to monitor leachate levels in LPZ-T5-1R and discuss in the 2025 Annual Water Quality Report (AWQR).
5. Monitor the vegetated rill near LPZ-T2-1. Continue to monitor the remainder of the cap for erosion rills and repair as needed.
6. Continue to monitor bank erosion near MW-35 – if erosion appears to threaten the integrity of the well install bank stabilization to protect the MW.
