**RE: BIENNIAL INSPECTION REPORT – 2025
CITY OF AMES SANITARY LANDFILL (CLOSED)
HLW PN 6001-24A.750**

SITE MAP
 2025 BIENNIAL INSPECTION
 AMES SANITARY LANDFILL
 AMES, IOWA

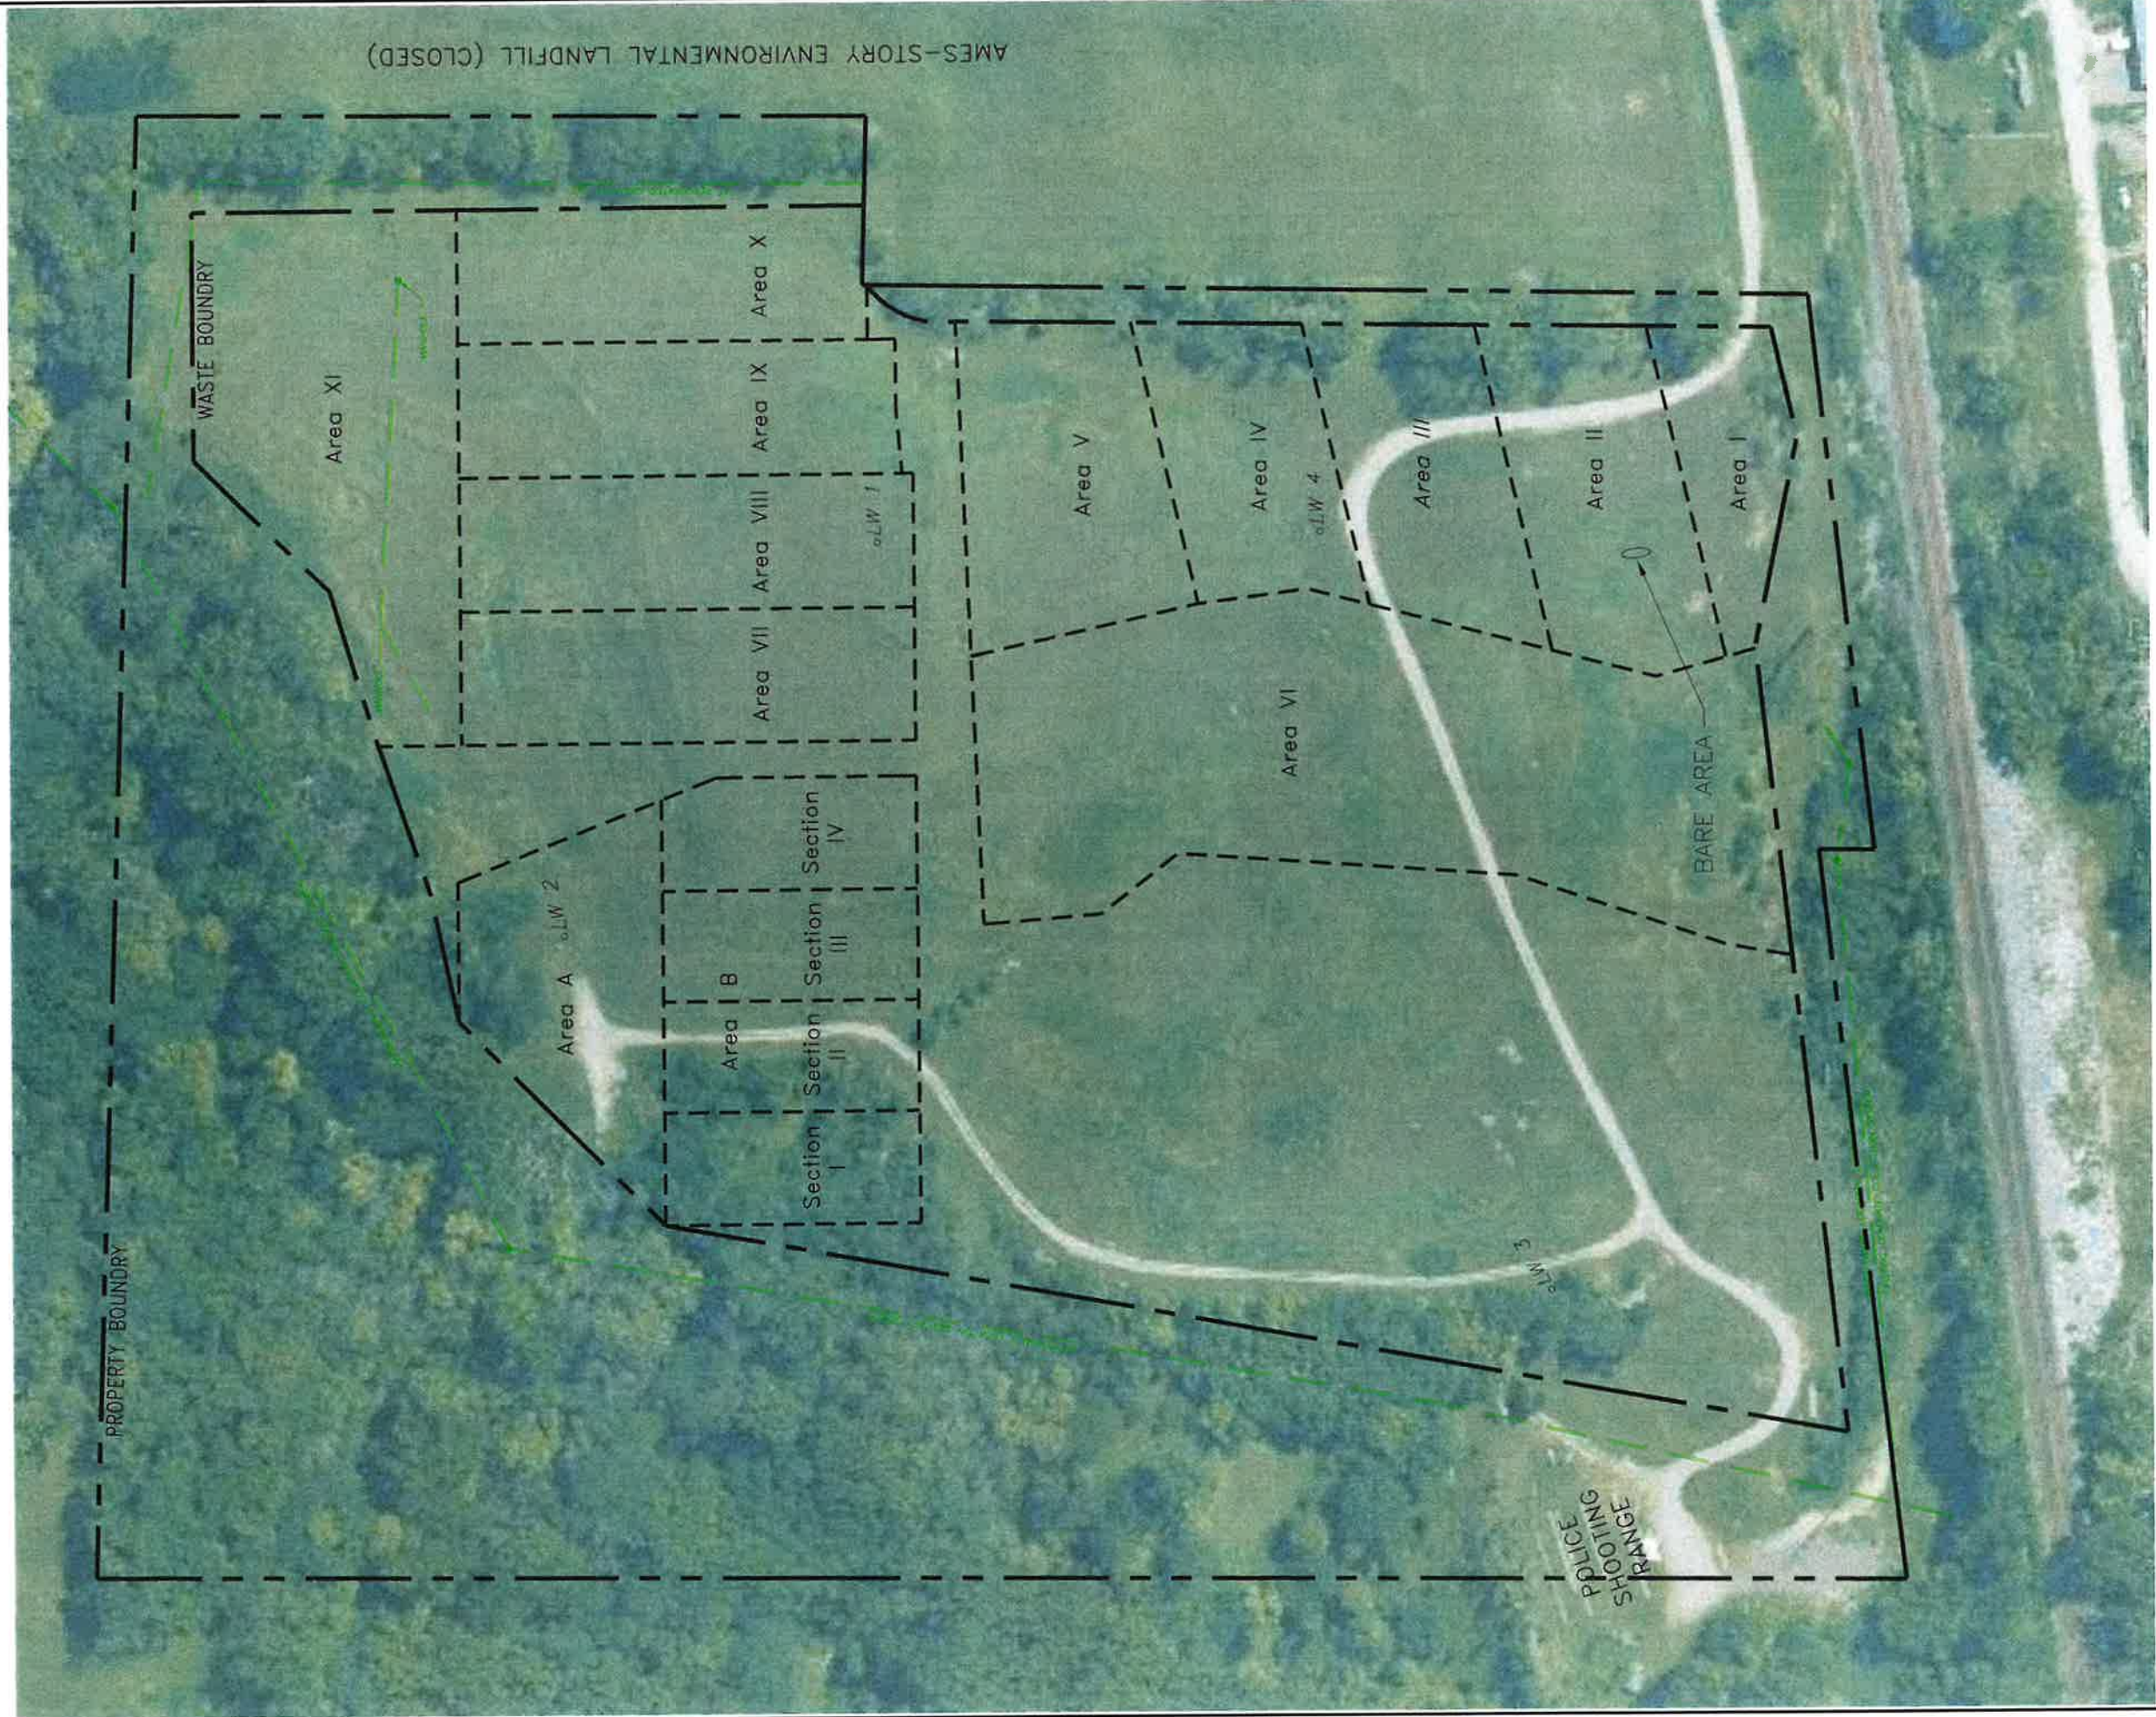
FIGURE: 1

The landfill vegetation is in good condition. One bare area was noted, the approximate location is shown on the attached figure. Compost has been stockpiled near this area. Mr. Peebler reported that the compost would be spread over this area and it would be reseeded.

City staff plans to abandon the remaining leachate wells (4) on site to eliminate obstacles encountered during site mowing and improve site maintenance. The locations of the leachate wells are included on the attached figure. Additional information is contained in the LCSPE that accompanies this report.

1. Continue collection and disposal of leachate as per the Environmental Covenant.
2. Add compost to the bare area and reseed. Continue to monitor vegetation and erosion and repair as necessary.
3. Remove saplings growing on cap.
4. Remove the leachate wells.
5. Continue to monitor diversion and drainage systems and repair as necessary.
