RE: Cass County Sanitary Landfill
Spring 2025 Semi-Annual Inspection
IDNR Permit #15-SDP-01-75C

SPRING 2025 INSPECTION

CASS COUNTY SANITARY LANDFILL
ATLANTIC, IOWA

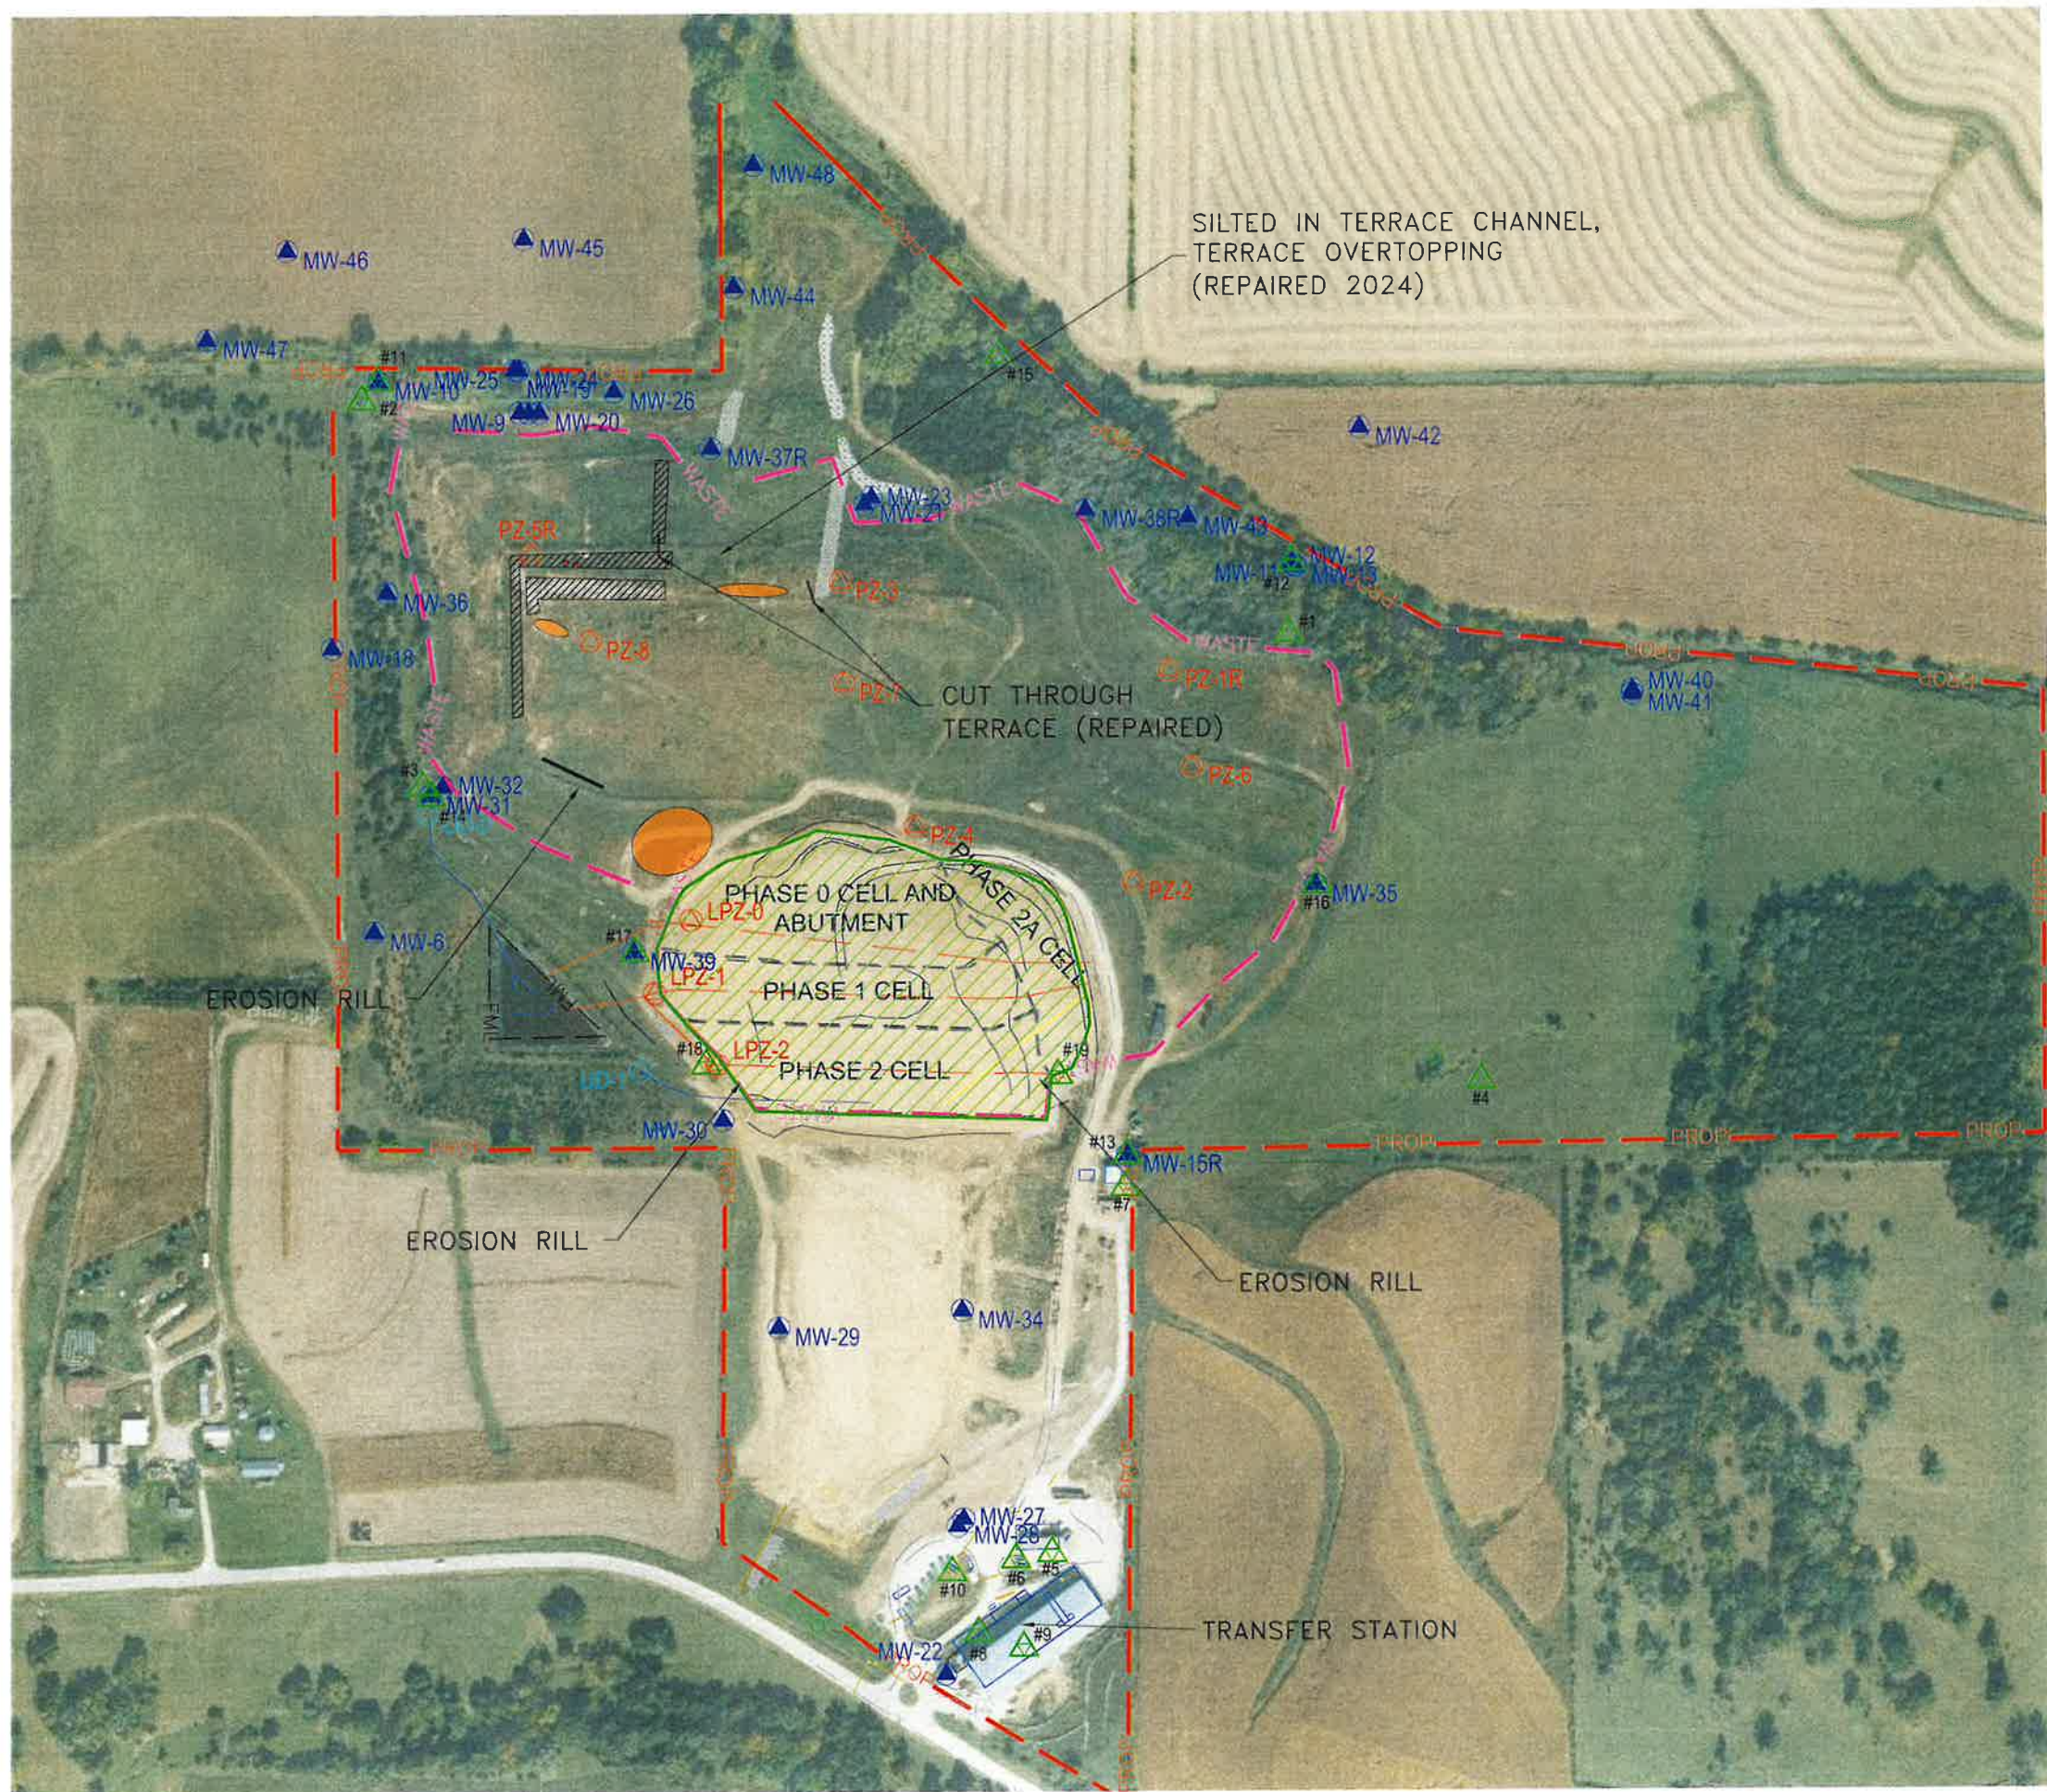
FIGURE: 1		NO.	DATE
REVISION		PROJECT NO.	DATE
DRAWN	JGH	6055-24A	4/17/25

7. Diversion and drainage systems have been installed as detailed in the submitted plans. No ponded water was observed during this inspection. Numerous issues with the terraces on the closed unlined area were noted during the Fall, 2024 inspection including silted in terrace channels and overtopped/eroded terraces. These areas have been repaired. No vegetation growth was noted in the repair areas. An erosion rill was noted east of MW-31/MW-32 at the approximate location shown on the attached figure.
8. Most of the closed unlined areas of the site demonstrate good vegetative growth with the exception of a few areas of stressed vegetation noted on the cap. These areas are shown on the attached figure. Numerous saplings were also noted on the closed unlined area

Two areas with moist surface soils were noted near PZ-5R. The approximate locations of these areas are included on the attached figure. No free water was noted.

MINIMAL TO NO VEGETATION RELATED TO TERRACE REPAIRS
-

THIN VEGETATION
-

LEACHATE SEEP

1. Seed terrace repair areas.
2. Repair LPZ-2.
3. Repair erosion rill.
4. Monitor moist areas near PZ-5R
5. Continue tree removal from the cap.
6. Monitor vegetation on closed lined area and reseed as necessary.
7. Continue to monitor site vegetation and repair/reseed as necessary.
8. Continue to monitor site erosion, drainage, and diversion systems and repair as necessary.
