**RE: SEMI-ANNUAL INSPECTION – SPRING, 2025
RURAL IOWA SLF
IDNR PERMIT #42-SDP-1-72P
VERTICAL EXPANSION AREA - CLOSED
HORIZONTAL EXPANSION AREA - ACTIVE
HLW PN 6006-23A.750**

SPRING 2025 INSPECTION

RURAL IOWA SANITARY LANDFILL
ELDORA, IOWA

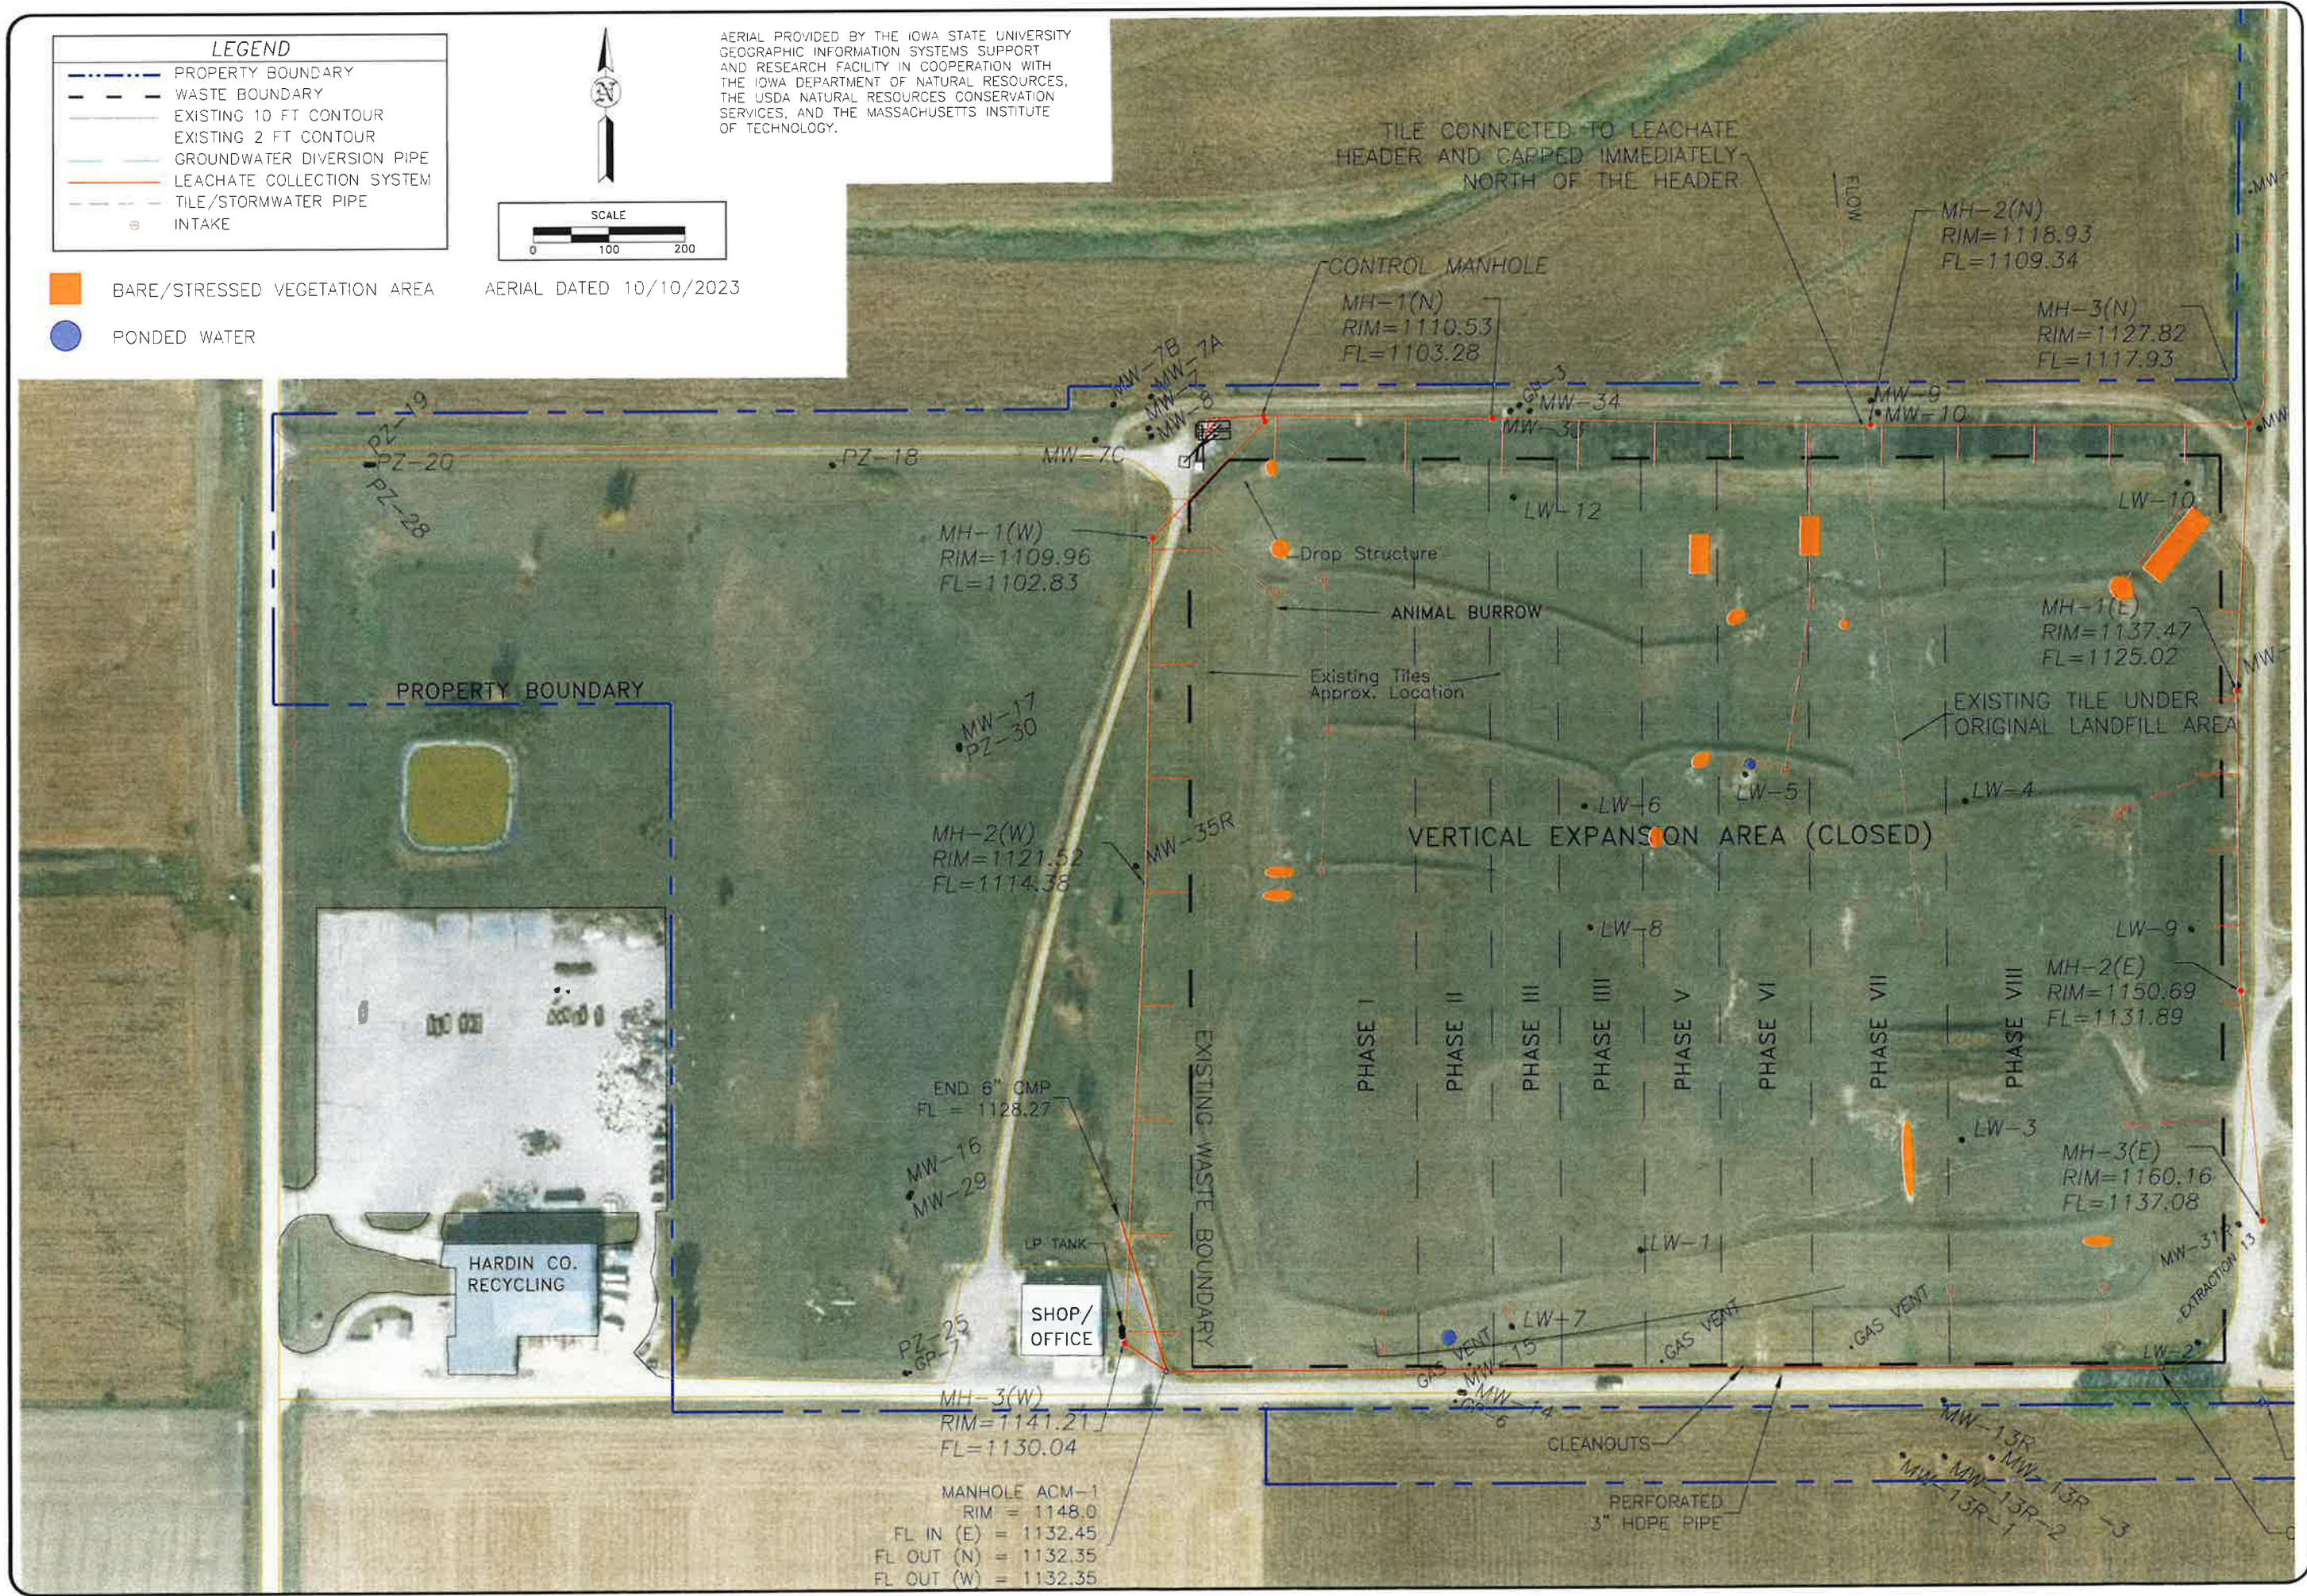
FIGURE: 1

Vegetation is well established on the majority of the Original Landfilling Area although stressed vegetation/bare spots were noted in the areas shown on the attached figure with smaller areas located sporadically on the north slope. Soil has been stockpiled at several of the bare areas and will be spread when conditions allow. Mr. Krum and I discussed the option of placing clean rock in some of the areas where vegetation cannot be established to control potential erosion.

Two areas of ponded water were noted in the closed area, the approximate locations are shown on the attached figure.
