Calhoun County Sanitary Landfill

Spring 2025 Biennial Landfill Inspection Report

Permit #13-SDP-01-72C

Evergreen Engineers Project #9042

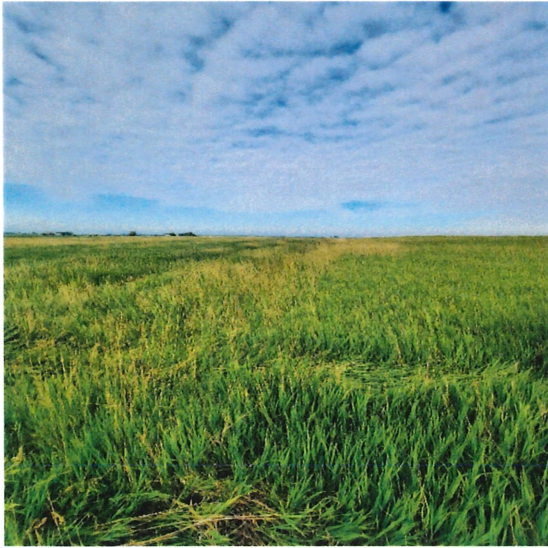
The repaired section (completed in September 2020) showed plush, green vegetation. No erosion or ponding was observed. The remainder of the site also showed no signs of sparse vegetation or structural issues.

(repaired portion of landfill looking to the West)

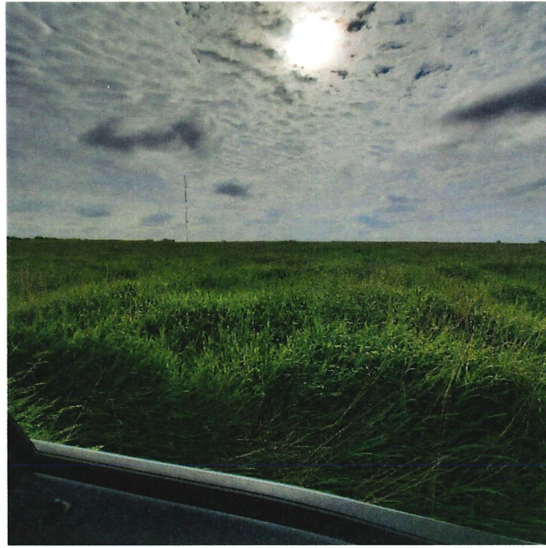
(repaired portion of landfill looking to the East)
