RE: Humboldt County Sanitary Landfill - Spring 2025 Biennial Landfill Inspection Report
Permit #46-SDP-02-83C; Evergreen Engineers #9041

Humboldt County Sanitary Landfill

Spring 2025 Biennial Landfill Inspection Report

Evergreen Engineers Project #9041

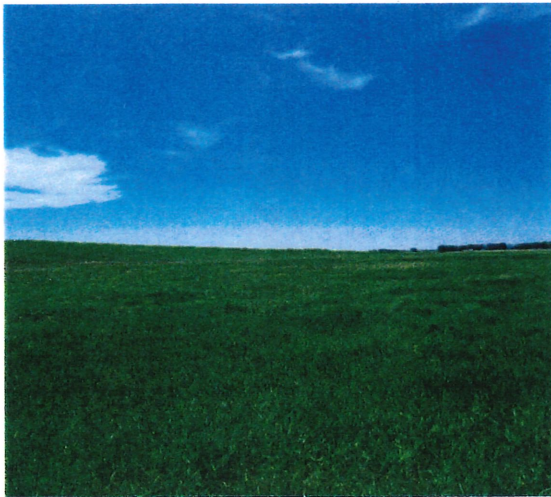
Photos were taken of the north side of the landfill, showing the repaired areas over old trench-filled solid waste locations.

(North Side of Landfill Looking to the West)

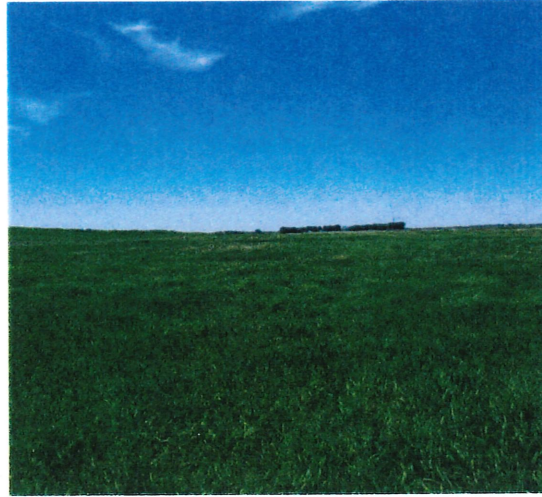
(North Side of Landfill Looking to the West)
